**Channel Maintenance Alternatives and
Sediment-transport Studies for the
Rio Grande Canalization Project:
Final Report**

**Statement of Work and Statement of Work Addendum for Channel Maintenance Alternatives
and Sediment-transport Studies for the Rio Grande Canalization Project**

October 20, 2015
Contract No. IBM09D0006
Order No. IBM14T0016

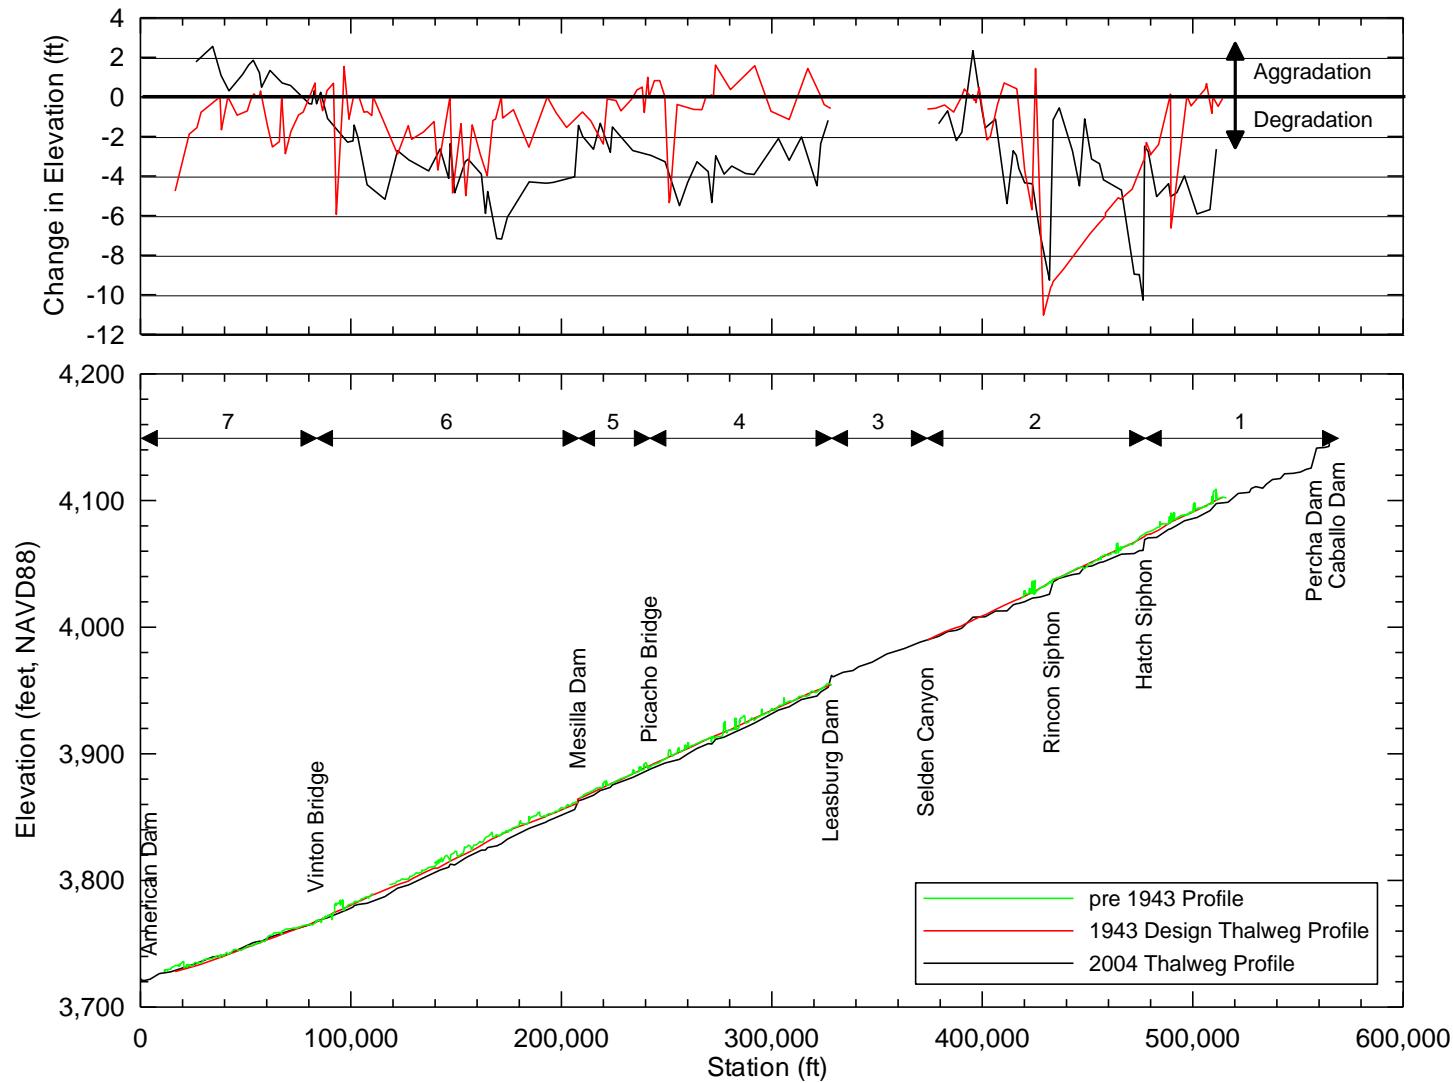
Subreach 1 extends from Percha Dam to the Hatch Siphon, a distance of 13.4 miles. The channel has degraded between 4 and 6 feet since the canalization in 1943 (**Figure 2.1**), and the bed material has coarsened as a result. The bed slope in the subreach is 0.00083 (4.4 ft/mi), and the bankfull capacity of the channel varies from 3,500 cfs to greater than 6,000 cfs. Based on the existing base model of the RGCP (USACE, 2007), at a flow of 5,000 cfs in the subreach, the average channel top width is about 180 feet, the average hydraulic depth is 6.2 feet, and the average velocity is 4 fps. The distance between the levees in the subreach varies from 750 to 800 feet.

Subreach 2 extends from the Hatch Siphon to the head of Selden Canyon, a distance of 20 miles. Immediately downstream of the Hatch Siphon, the channel has degraded about 10 feet since 1943 (Figure 2.1). For the remainder of the upper part of the subreach, the degradation reduces from about 6 feet in the upstream end to about 1 foot upstream of the Rincon Siphon. Downstream of the Rincon Siphon, there has been about 9 feet of degradation, but the degradation diminishes in the downstream direction to about 2 feet. Upstream of Bignell Arroyo there has been about 2 feet of aggradation since 1943. Depending on the location within the subreach the bed material varies from sand to gravel. The bed slope in the subreach is 0.00074 (3.9 ft/mi), and the bankfull capacity of the channel varies from 3,500 to 4,500 cfs. At a flow of 4,000 cfs in the subreach, the average channel top width is about 270 feet, the average hydraulic depth is 4.4 feet, and the average velocity is 3 fps. The distance between the levees in the subreach varies from 750 to 800 feet.

Figure 2.1. Pre-canalization, 1943 design and 2004 thalweg profiles of the RGCP. Also shown are the changes in elevation between the pre-canalization and 1943 profiles (green line) and between the 1943 profile and the 2004 profile (red line) [from USACE (2009)].

Subreach 5 extends from the Picacho Bridge to the Mesilla Diversion Dam, a distance of 6.5 miles. The comparative thalweg data (Figure 2.1) indicate that there has been 2 to 3 feet of historical degradation in this subreach since 1943. However, USIBWC has historically performed extensive sediment-removal activities in the vicinity of Mesilla Diversion Dam, so the thalweg profiles do not show the aggradational tendencies at the downstream limit of this subreach. The bed slope in the subreach is 0.00074 (3.9 ft/mi), and the bankfull capacity of the channel ranges between 3,500 and 4,500 cfs. At a flow of 4,000 cfs in the subreach, the average channel top width is about 360 feet, the average hydraulic depth is 3.3 feet, and the average velocity is 2.9 fps. The bed material in the subreach is sand and under low-flow conditions the bed of the channel is braided. The distance between the levees in the subreach varies from 750 to 800 feet. A considerable percentage of both banks within the subreach is revetted. A number of west side arroyos that drain the Upper Santa Fe Group deliver sediment to the Rio Grande between the Picacho Drain (~Sta 2160+00) and the Mesilla Diversion Dam.

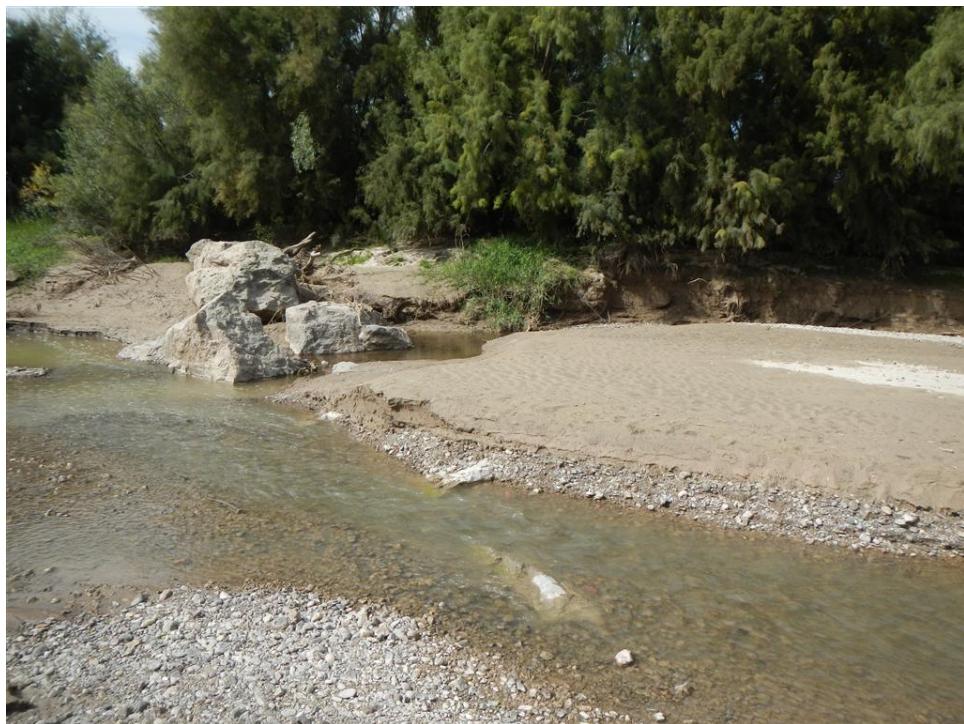
Photo A.2. View along the right bank crest portion of the Tierra Blanca Vortex Weir. Note the sediment deposition along the portion of the weir in the main channel.

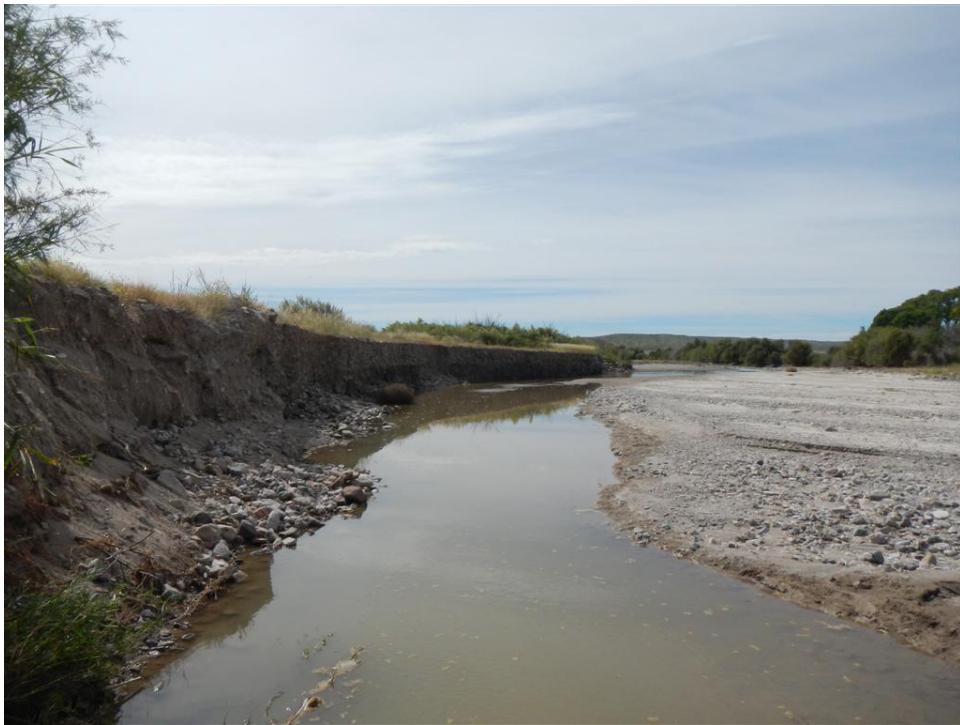
Photo A.5. View downstream along the eroding left (east) bank opposite the Tierra Blanca Creek fan.

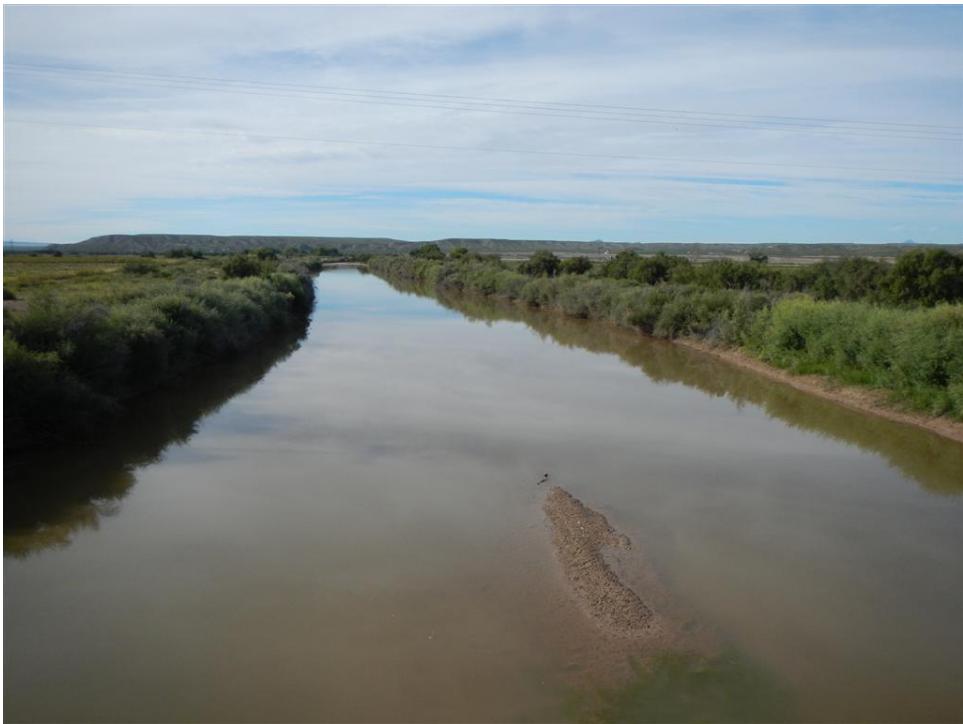
Photo A.7. View downstream from the Garfield Bridge to the backwater affected reach above the Tierra Blanca Creek fan.

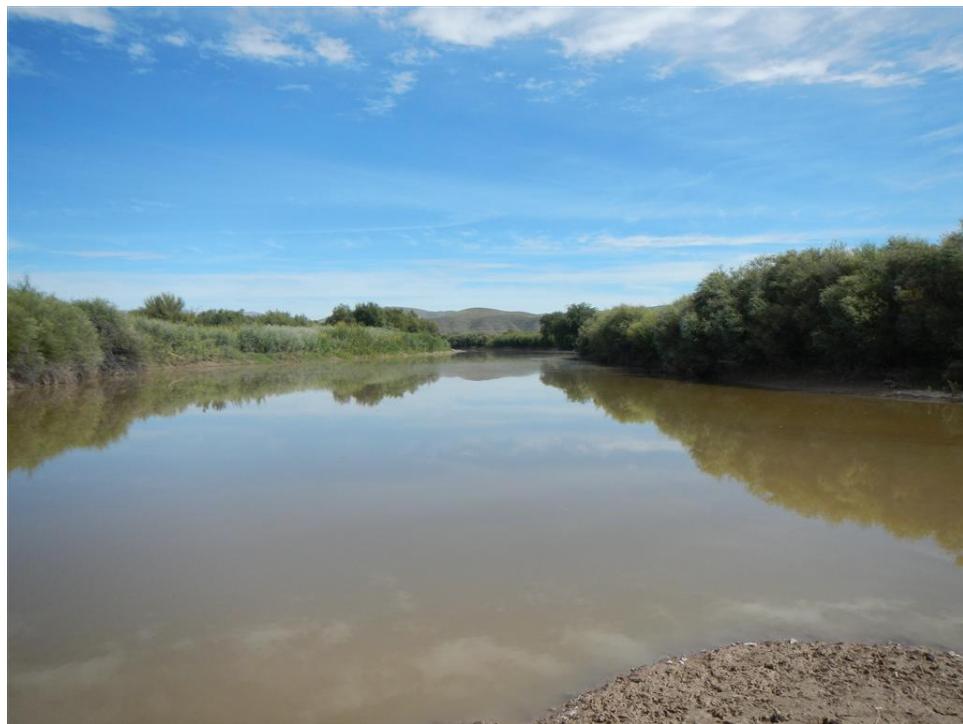
Photo A.8. View upstream to the backwater affected reach above the Sibley Arroyo fan.

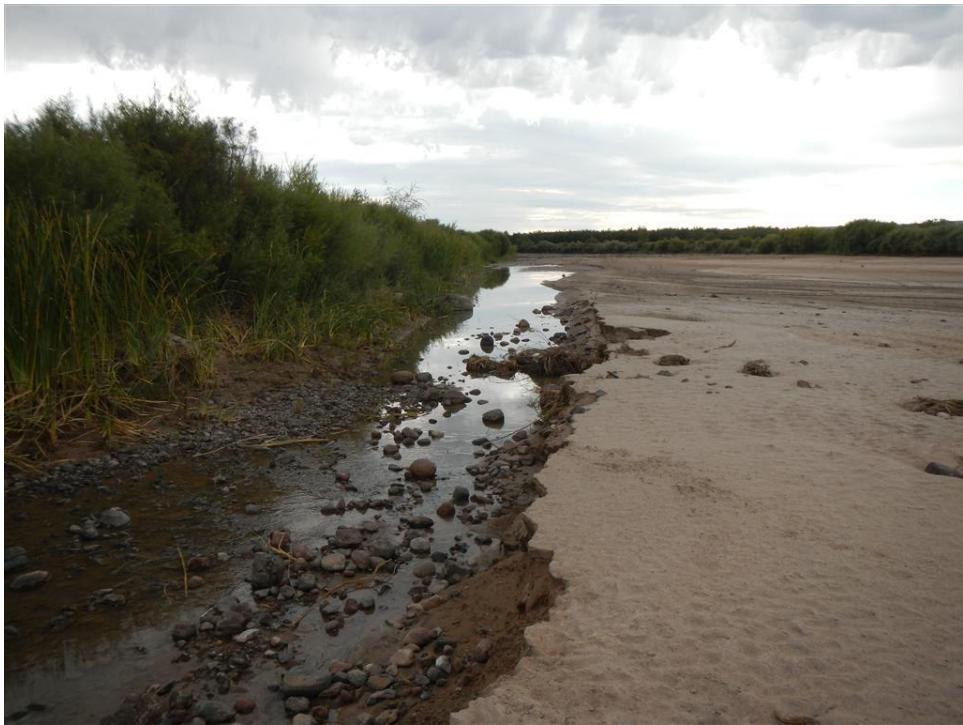
Photo A.17. View downstream along the distal portion of the Placitas Arroyo fan showing the coarse material delivered by recent monsoon events overlain by sandy material that has been delivered more recently.

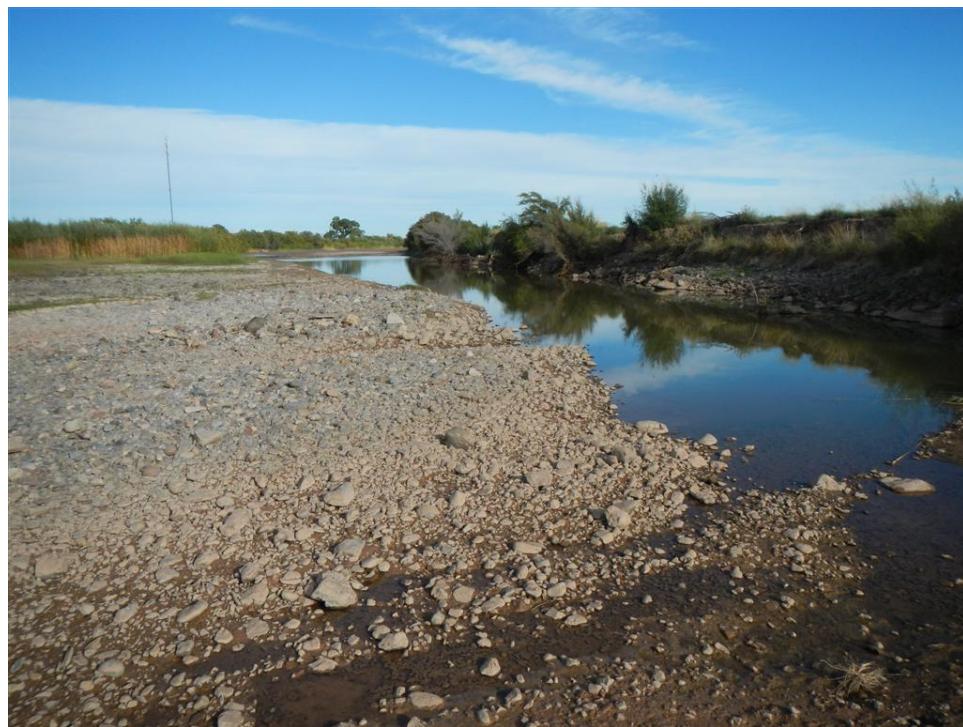
Photo A.20. View along distal portion of Thurman II Arroyo fan at the point of constriction.

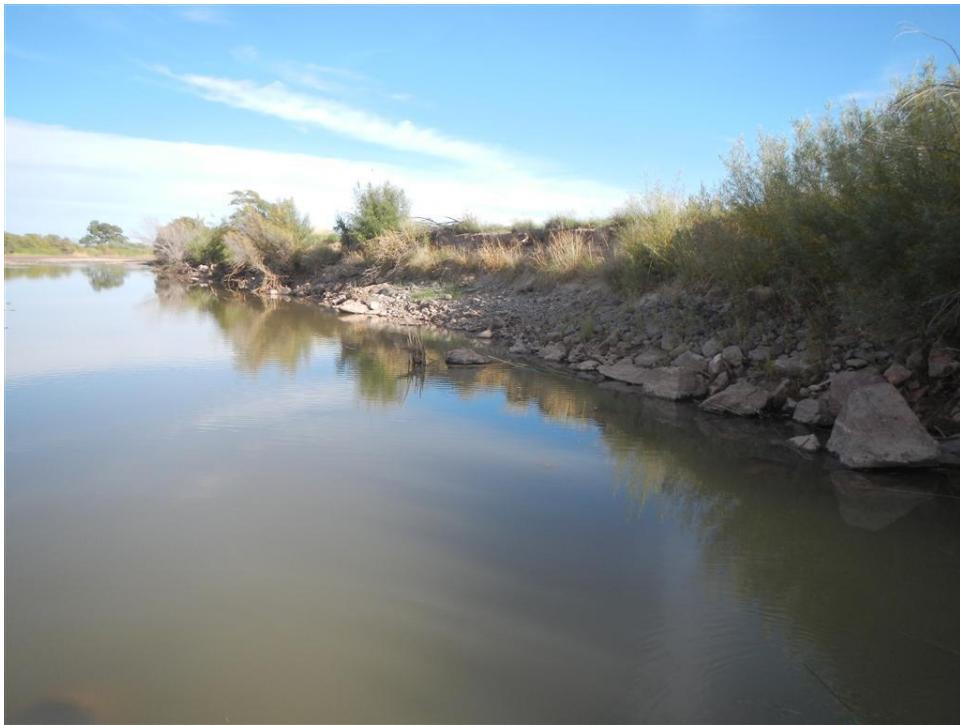
Photo A.21. View downstream along right bank of RGCP opposite the Thurman II Arroyo where coarse fan materials appear to have been placed to protect the bank.

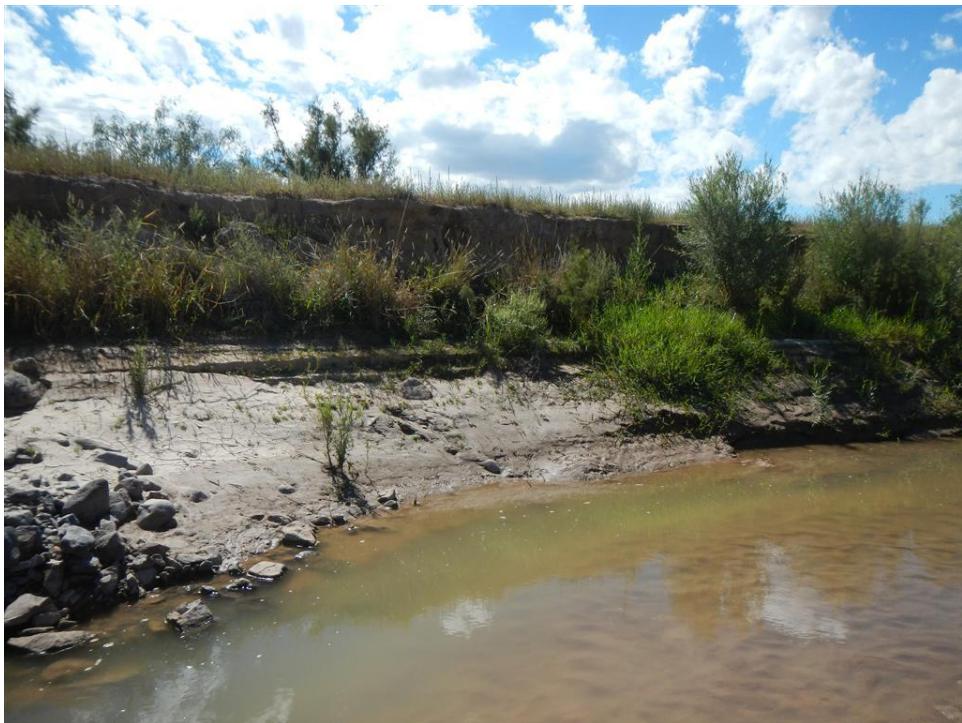
Photo A.35. View upstream along the west bank opposite the Rincon Arroyo fan, where fan materials have been placed along the toe of the bank but erosion of the upper bank has continued.

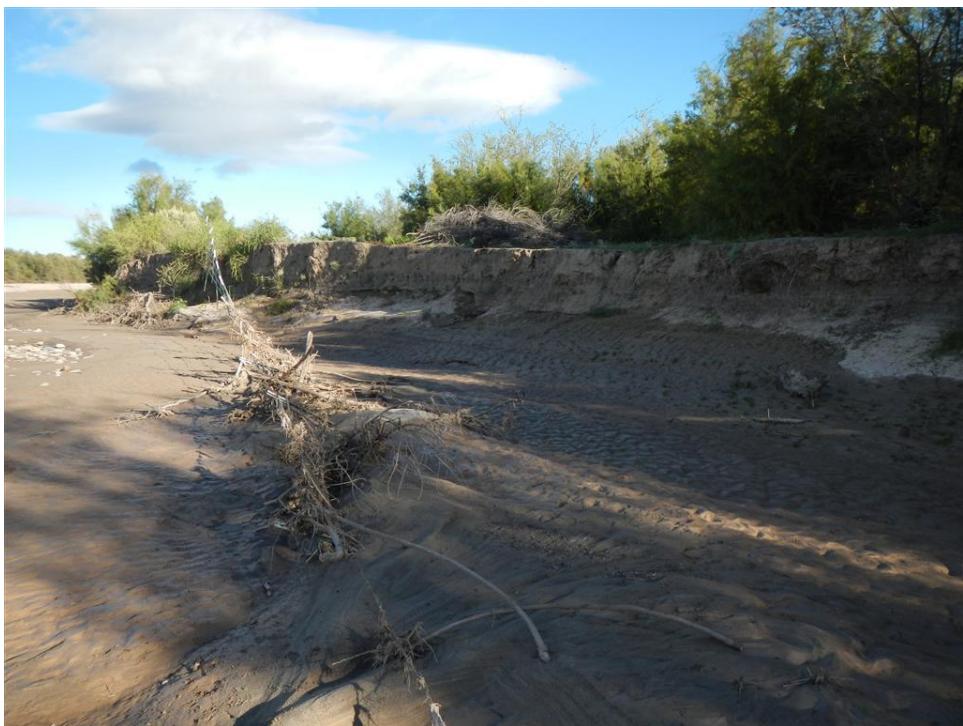
Photo A.46. View looking upstream along the eroding east bank of the river opposite the Rock Canyon fan.

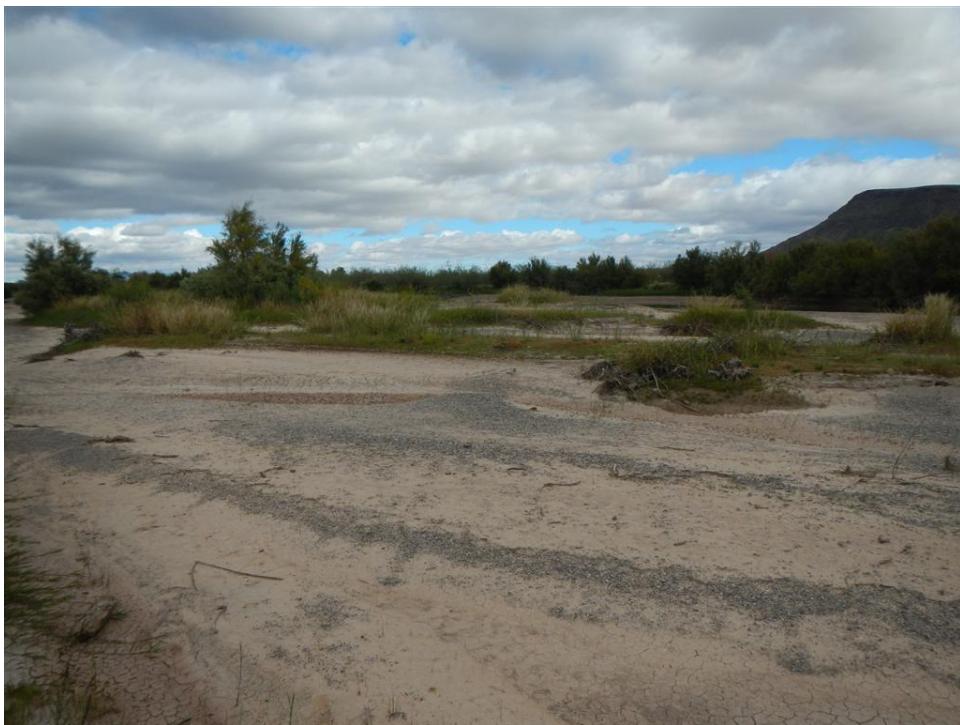
Photo A.48. View upstream to the vegetated islands in the expansion zone through Problem Location 5. Note the relatively young vegetation on many of the islands that indicates the islands have formed during the recent drought period.

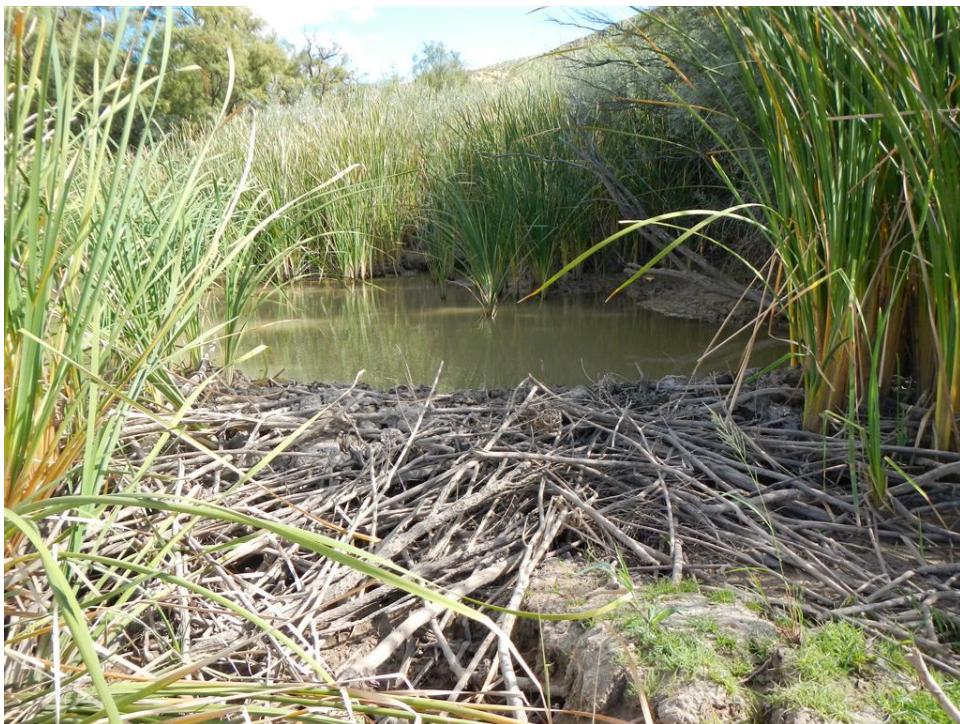
Photo A.50. View to outlet of Rincon/Tonuco Drain that is affected by beaver activities.

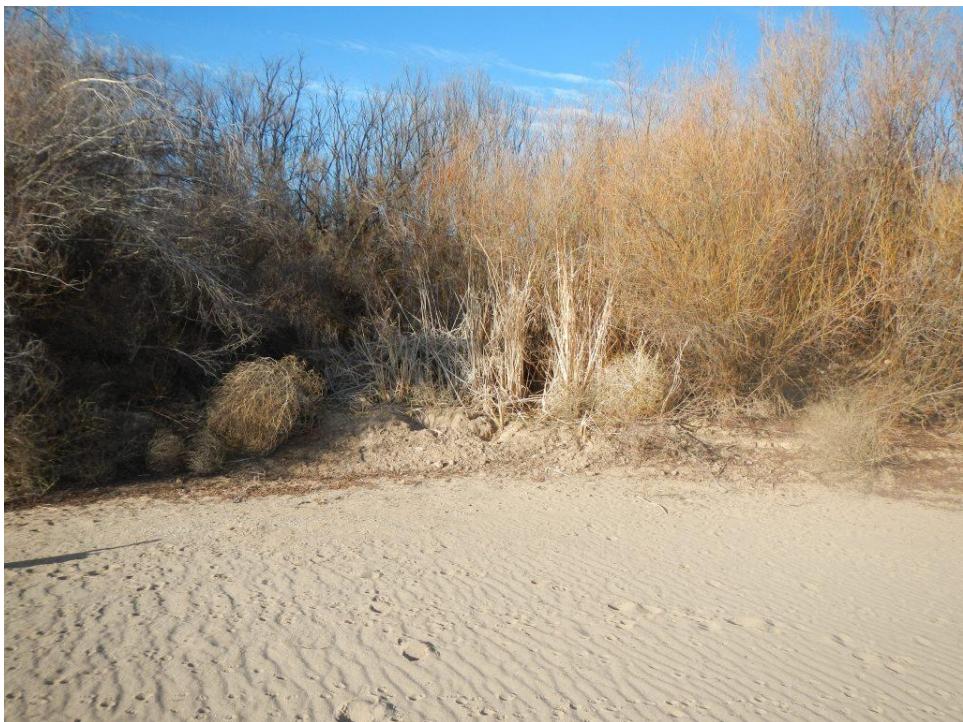
Photo A.54. View of the mouth of Picacho Drain, where the bed of the drain is perched about 2 feet above the riverbed.

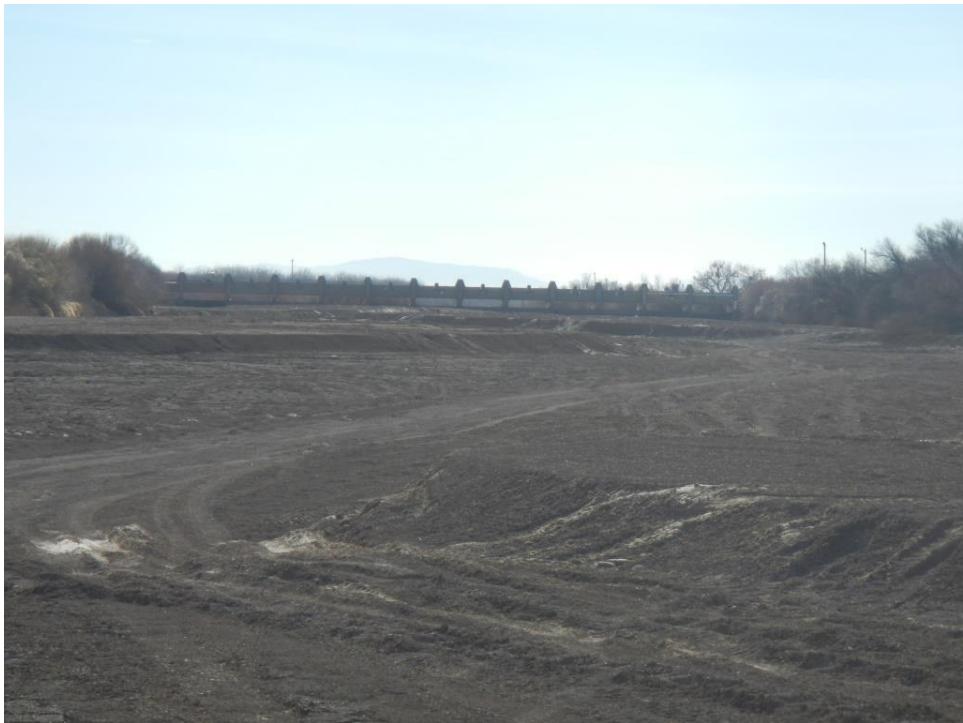
Photo A.61. View downstream to the depositional bars in the backwater zone upstream from Mesilla Dam.

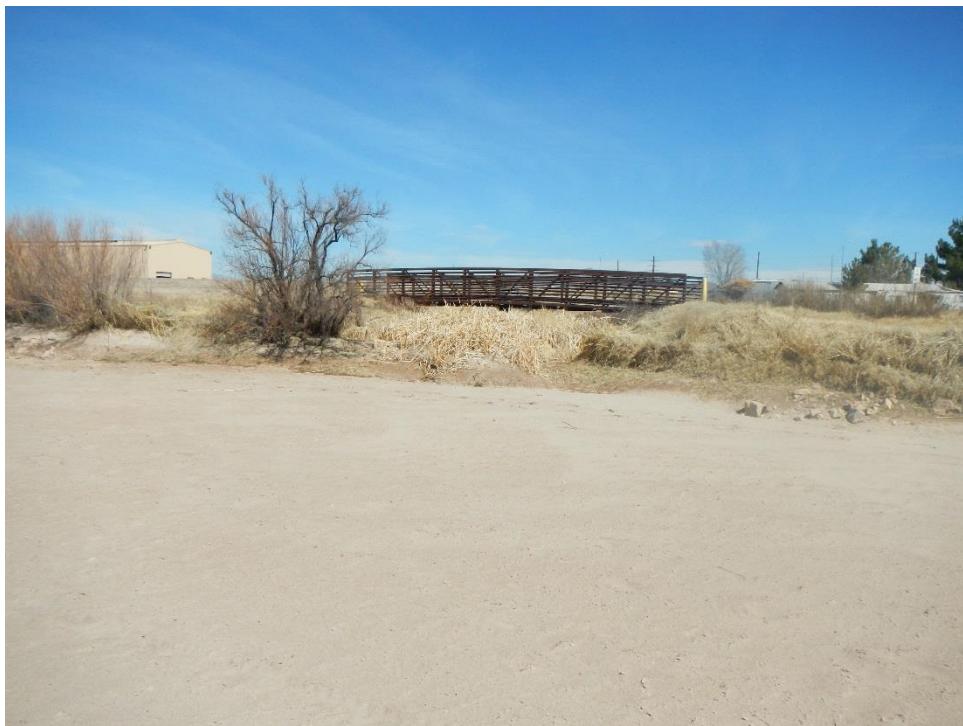
Photo A.65. View to mouth of the East Drain where the bed of the drain has become overgrown with cattails.

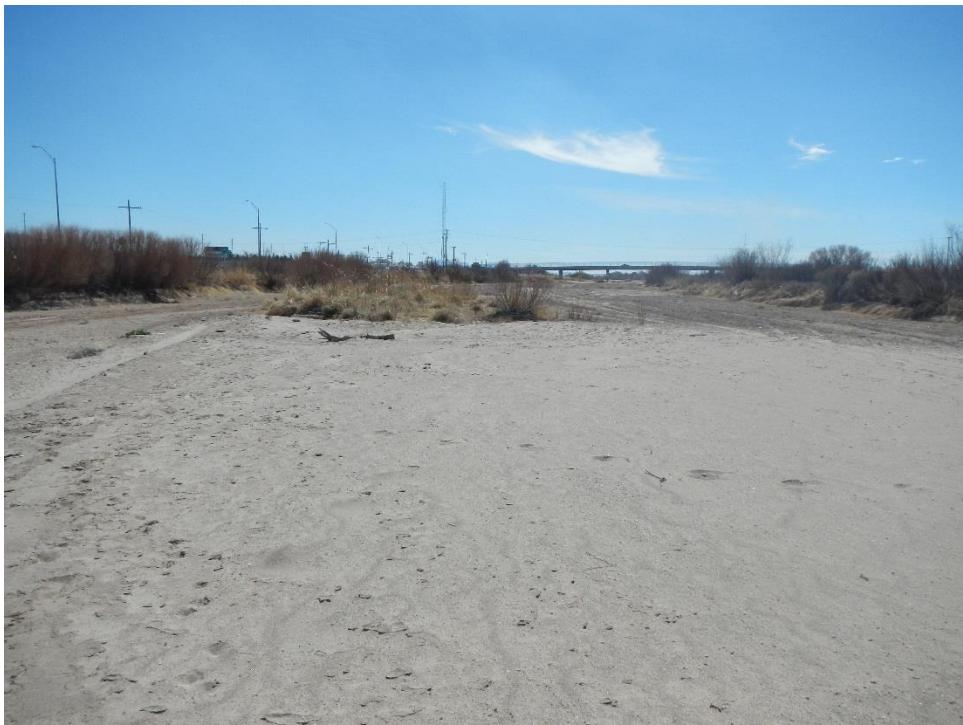
Photo A.68. View downstream to a low-elevation, grassy mid-channel bar that has formed in the reach downstream from the East Drain where the main channel top width is relatively wide.

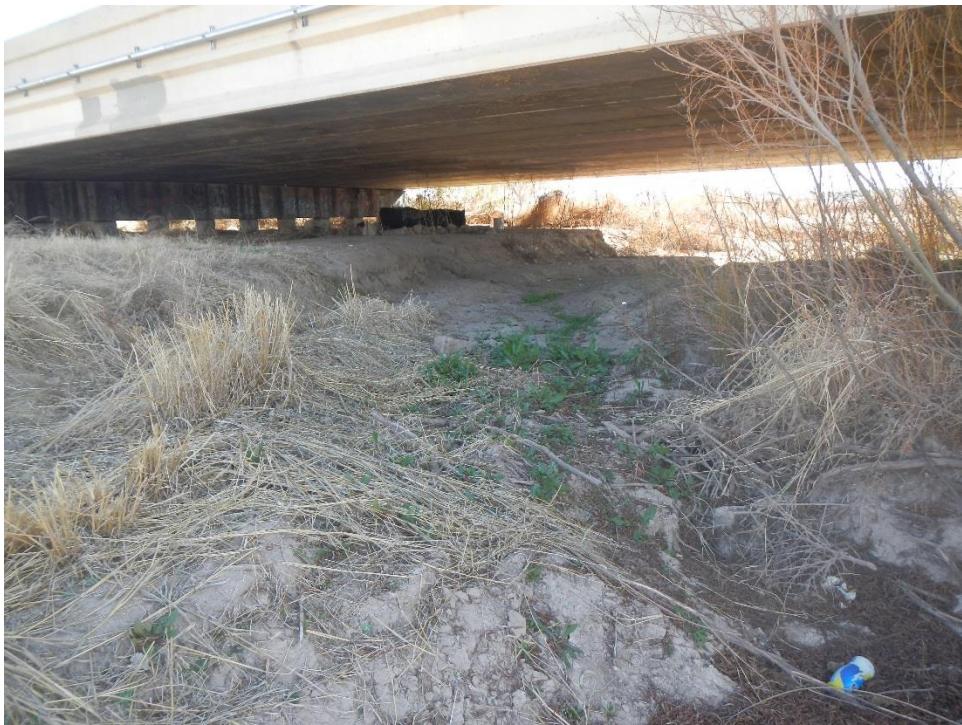
Photo A.73. View downstream to the eroding left bank under Country Club Bridge that is a result of flows deflecting off of the debris on Pier Set no. 2 (not shown in photograph).
