From:
Kirk Lowery, P.E.

Date: June 21, 2017
Arcadis Project No.: LA003315.0000

Subject:
June 2017 Summary Report of Inclinator Readings
Remediation Design of Levee Floodplain Failure within the
Upper Brownsville Levee Reach Lower Rio Grande Flood
Control Project – IBM15D0001 – IBM15T0015

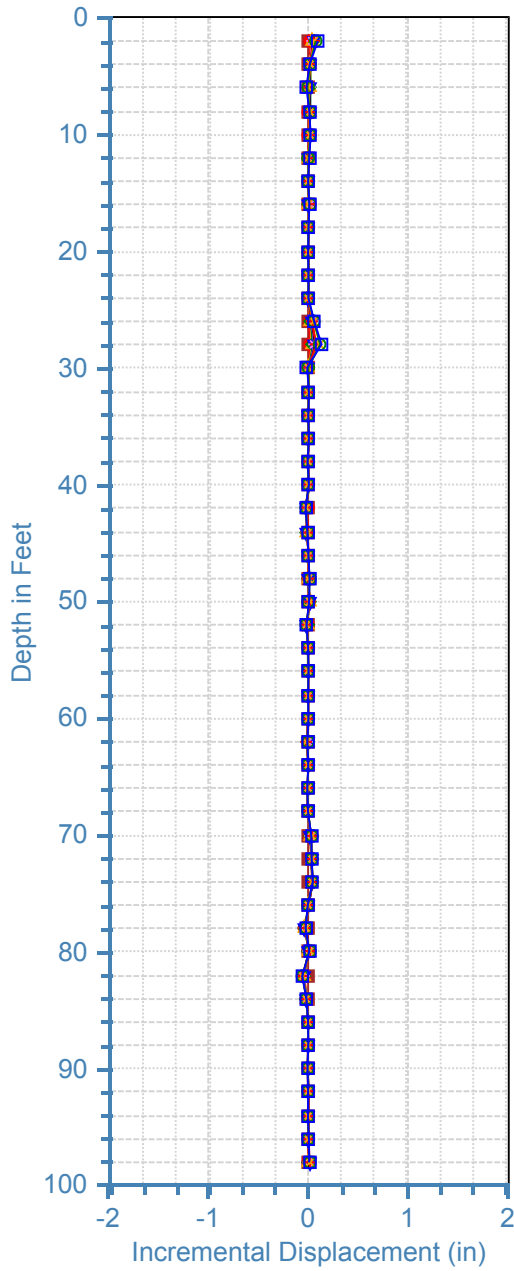
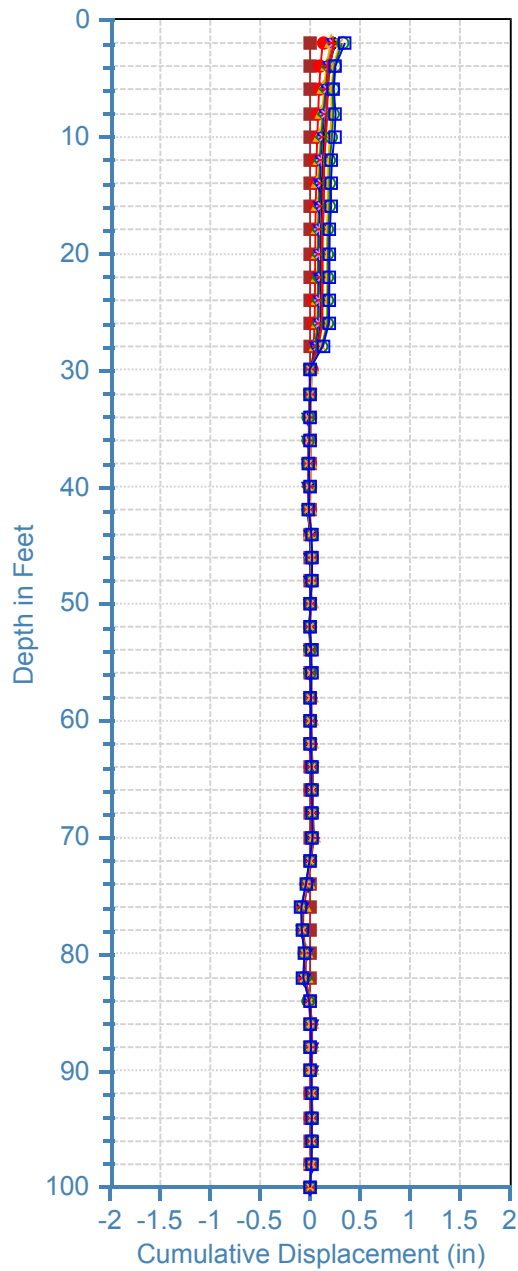
IBWC Arc-1 A - Axis

Inclinometer ARC-1: The base readings for inclinometer ARC-1 were collected on June 22, 2016. The ARC-1 cumulative plot in the A-Axis direction shows a slight progressive movement starting at depths between 28 and 30 feet. This depth corresponds with the interpreted Alluvium/Pleistocene interface presented in Figure 2 of Arcadis' December 2, 2016 *Draft Geotechnical Assessment Report*. Comparing the measurements taken in April 2017 to June 2017, the displacement increases 0.012 inches towards the Rio Grande (A-Axis) at a depth of 28 feet. This inclinometer will continue to be monitored on the normally scheduled frequency to determine if there is any increase in cumulative displacements. The displacement parallel to the levee are comparatively smaller and does not show any sign of movement in this month's readings.

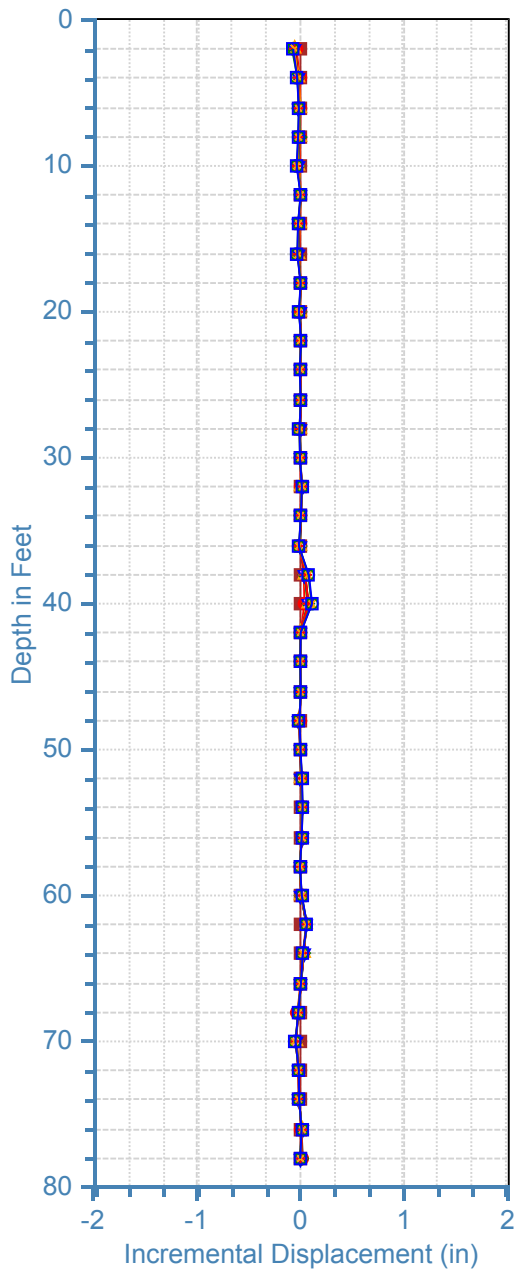
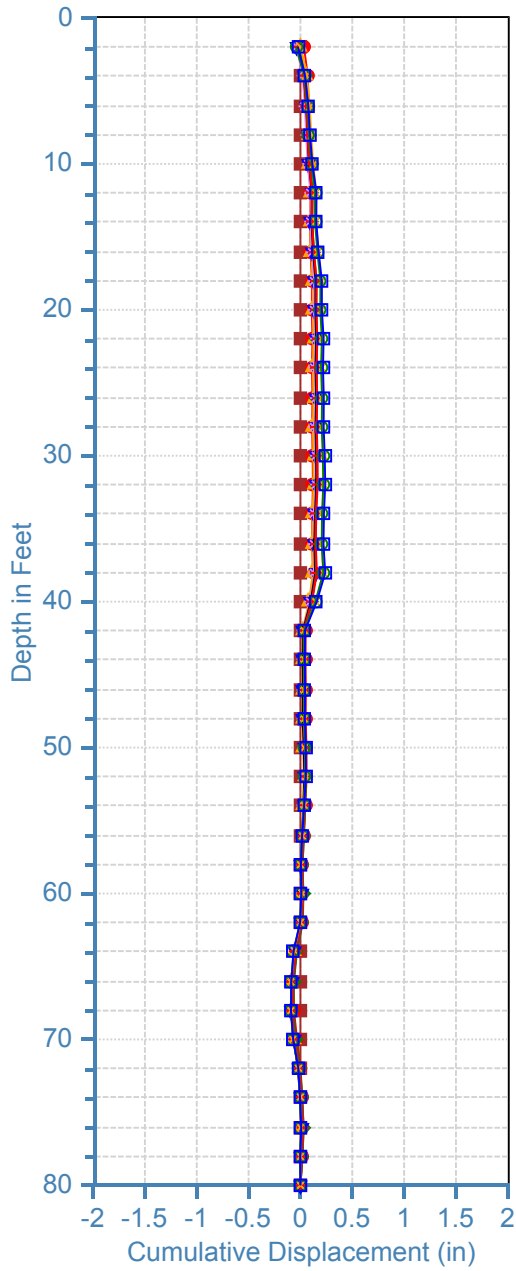
IBWC Arc-2 A - Axis

Inclinometer Arc-2: The base readings for inclinometer ARC-2 were collected on June 17, 2016. The ARC-2 cumulative displacement plot in the A-Axis direction shows a slight displacement between the depths of 38 feet to 40 feet. This depth corresponds with the interpreted Alluvium/Pleistocene interface presented in Figure 2 of Arcadis' December 2, 2016 *Draft Geotechnical Assessment Report*. Comparing the measurements taken in April 2017 to June 2017, the displacement increases 0.018 inches towards the Rio Grande (A-Axis) at a depth of 38 feet. This inclinometer will continue to be monitored on the normally scheduled frequency to determine if there is any increase in cumulative displacements. The displacement parallel to the levee are comparatively smaller and does not show any sign of movement in this month's readings.

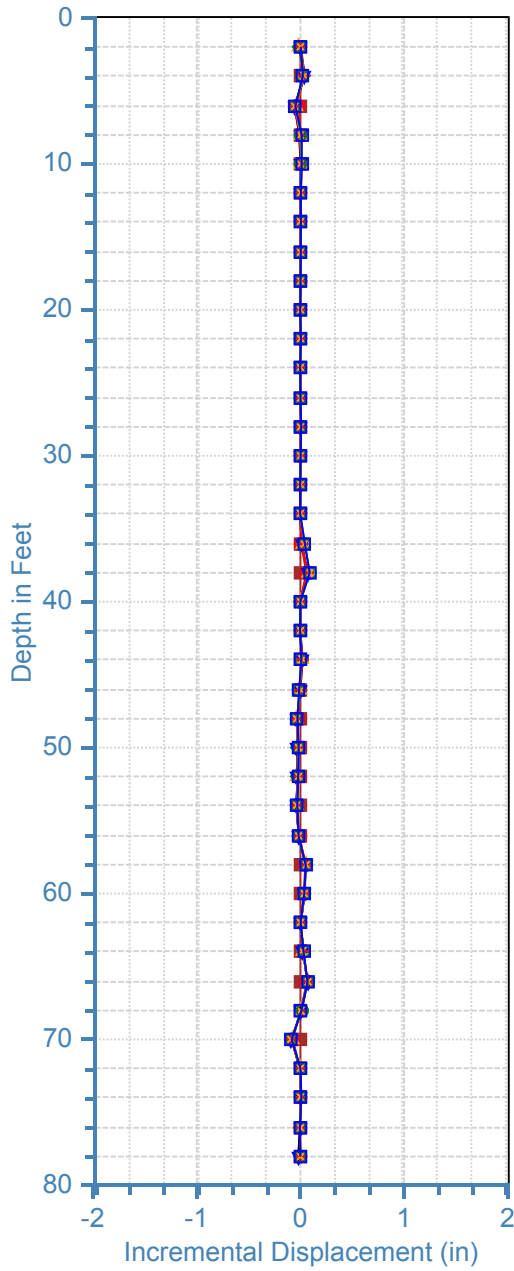
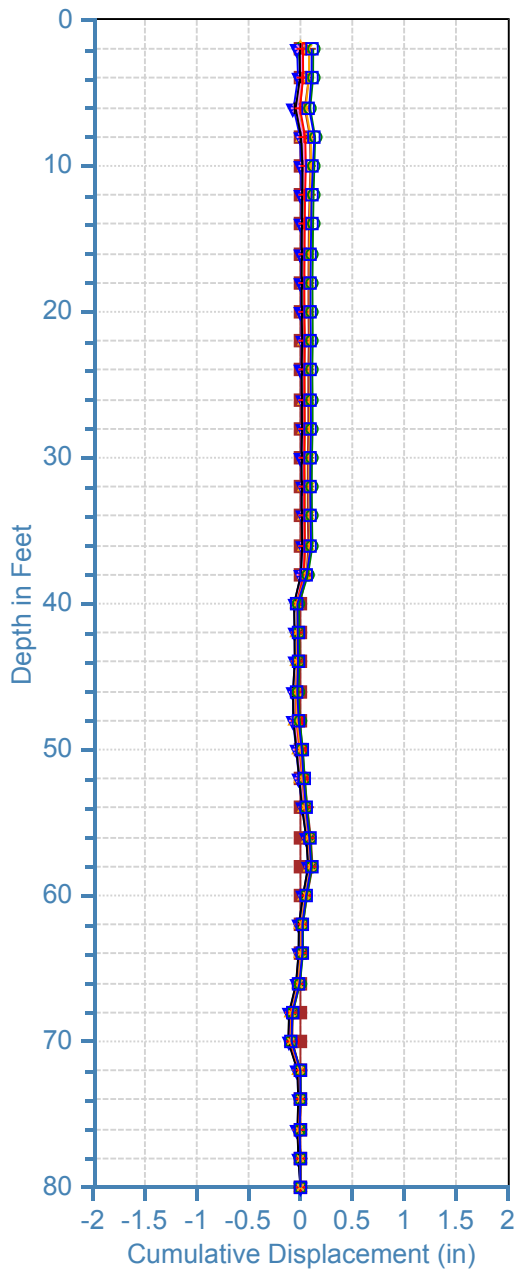
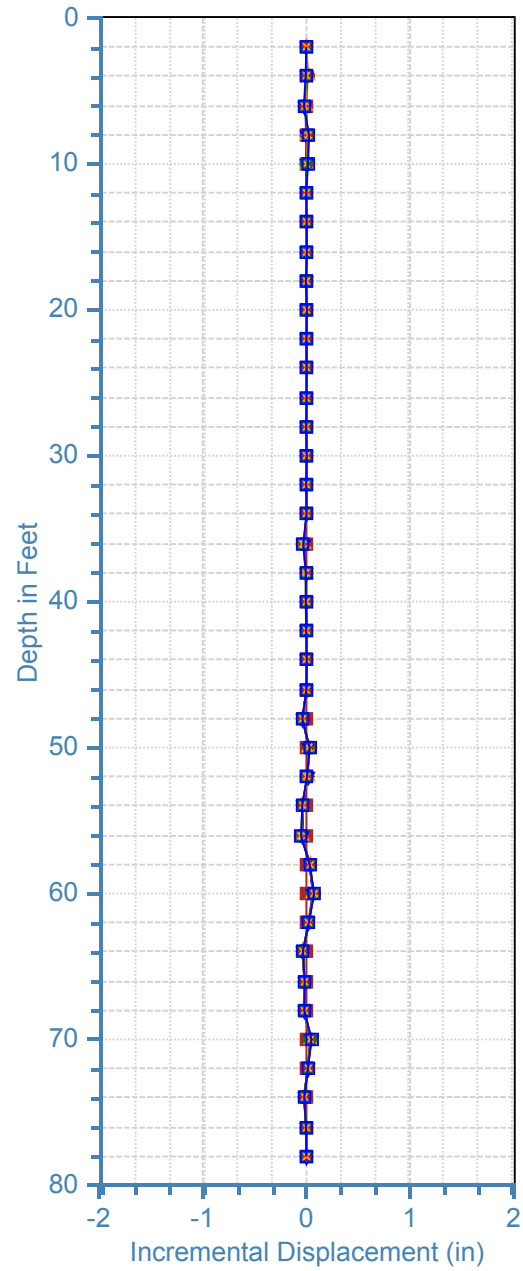
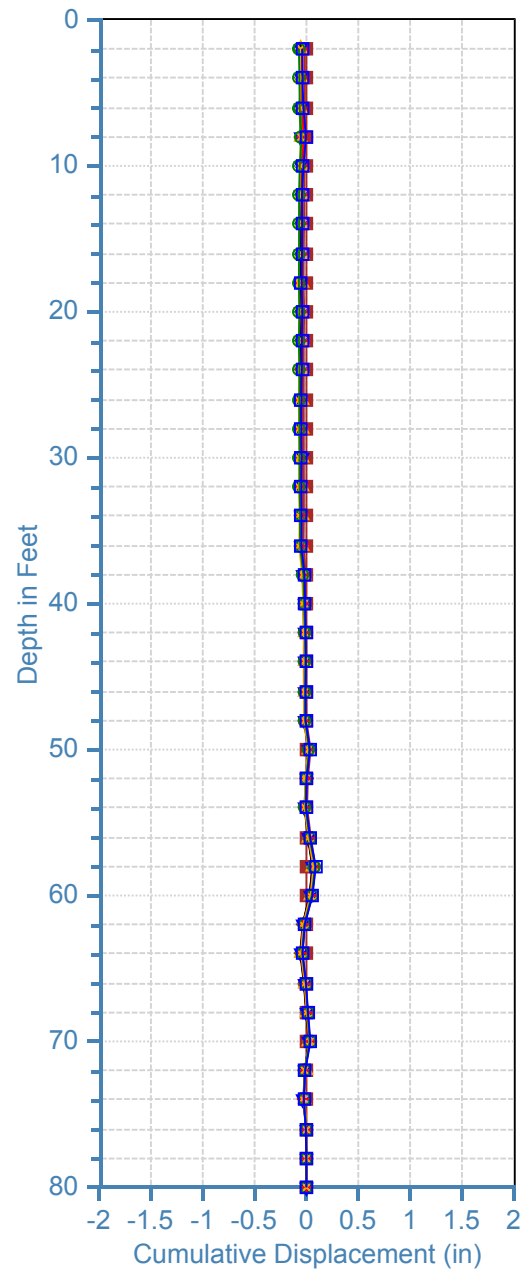
IBWC Arc-3 A - Axis

Inclinometer ARC-3: The base readings for inclinometer ARC-3 were collected on June 17, 2016. The ARC-3 cumulative and incremental displacement does not show any sign of movement on the plane perpendicular to the levee nor on the plane parallel to the levee.

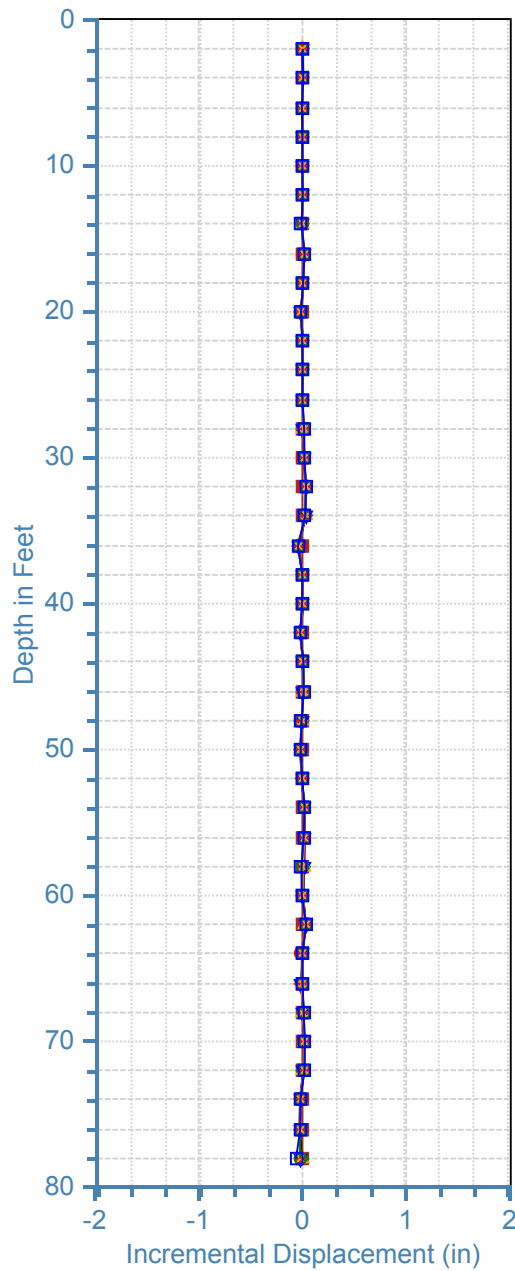
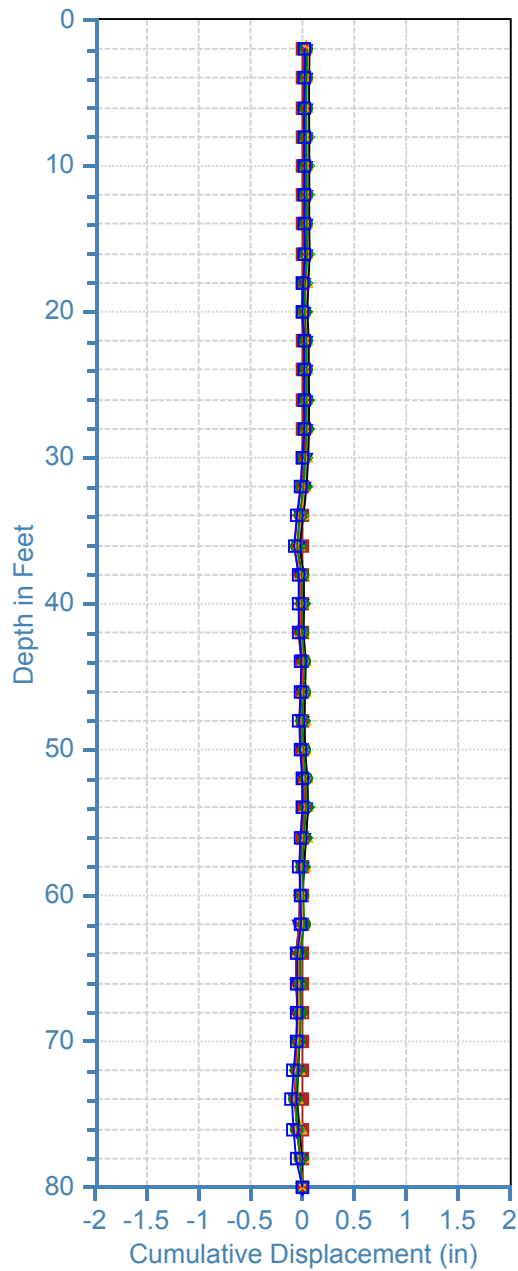
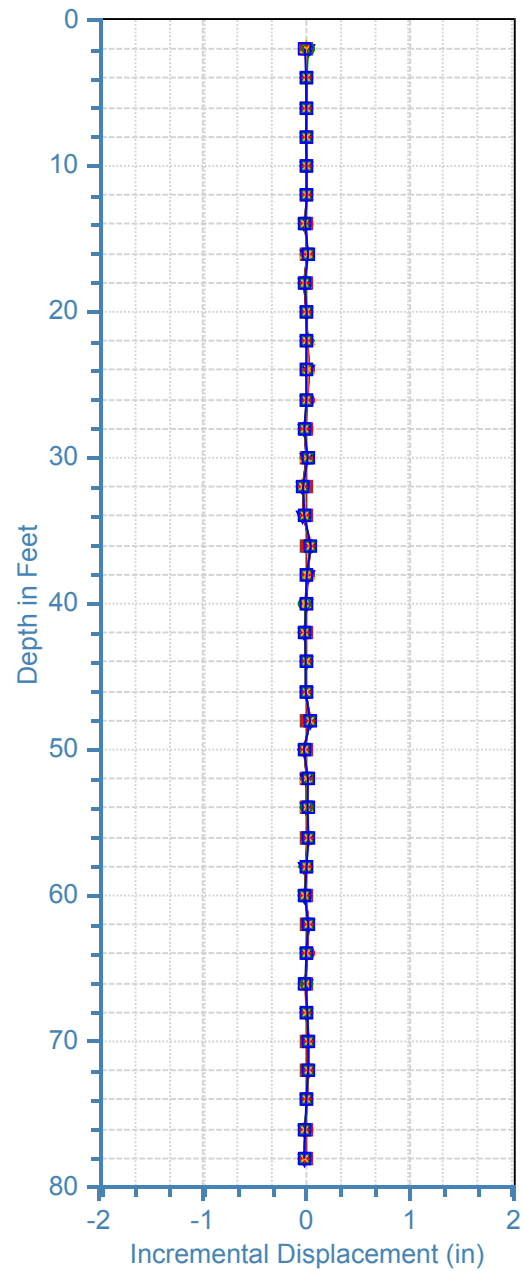
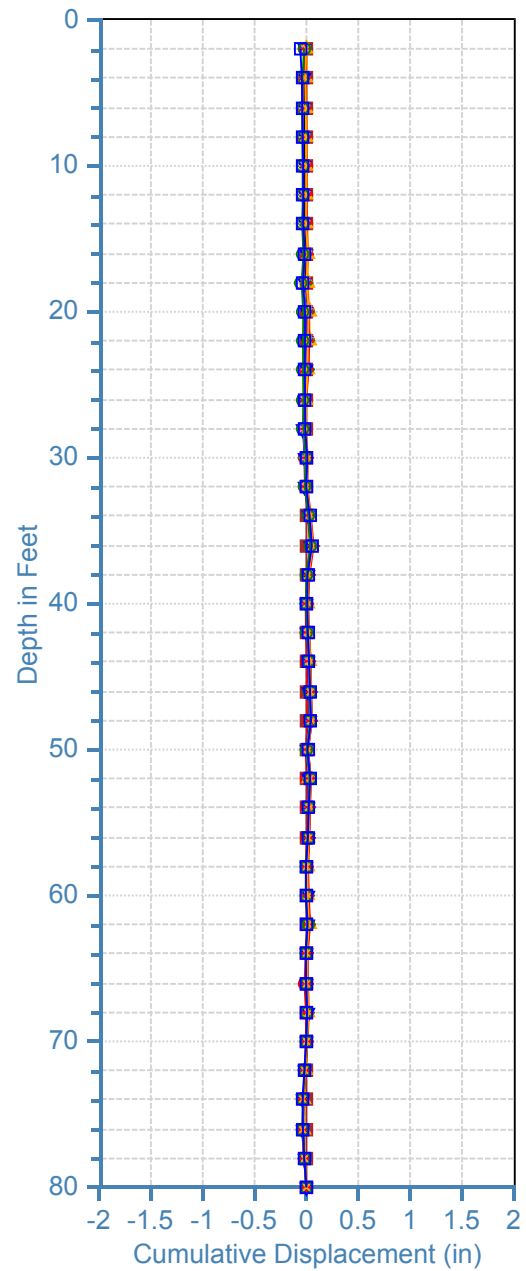
IBWC Arc-4 A - Axis

Inclinometer ARC-4: The base readings for inclinometer ARC-4 were collected on June 22, 2016. The ARC-4 cumulative and incremental displacement does not show any sign of movement on the plane perpendicular to the levee nor on the plane parallel to the levee.

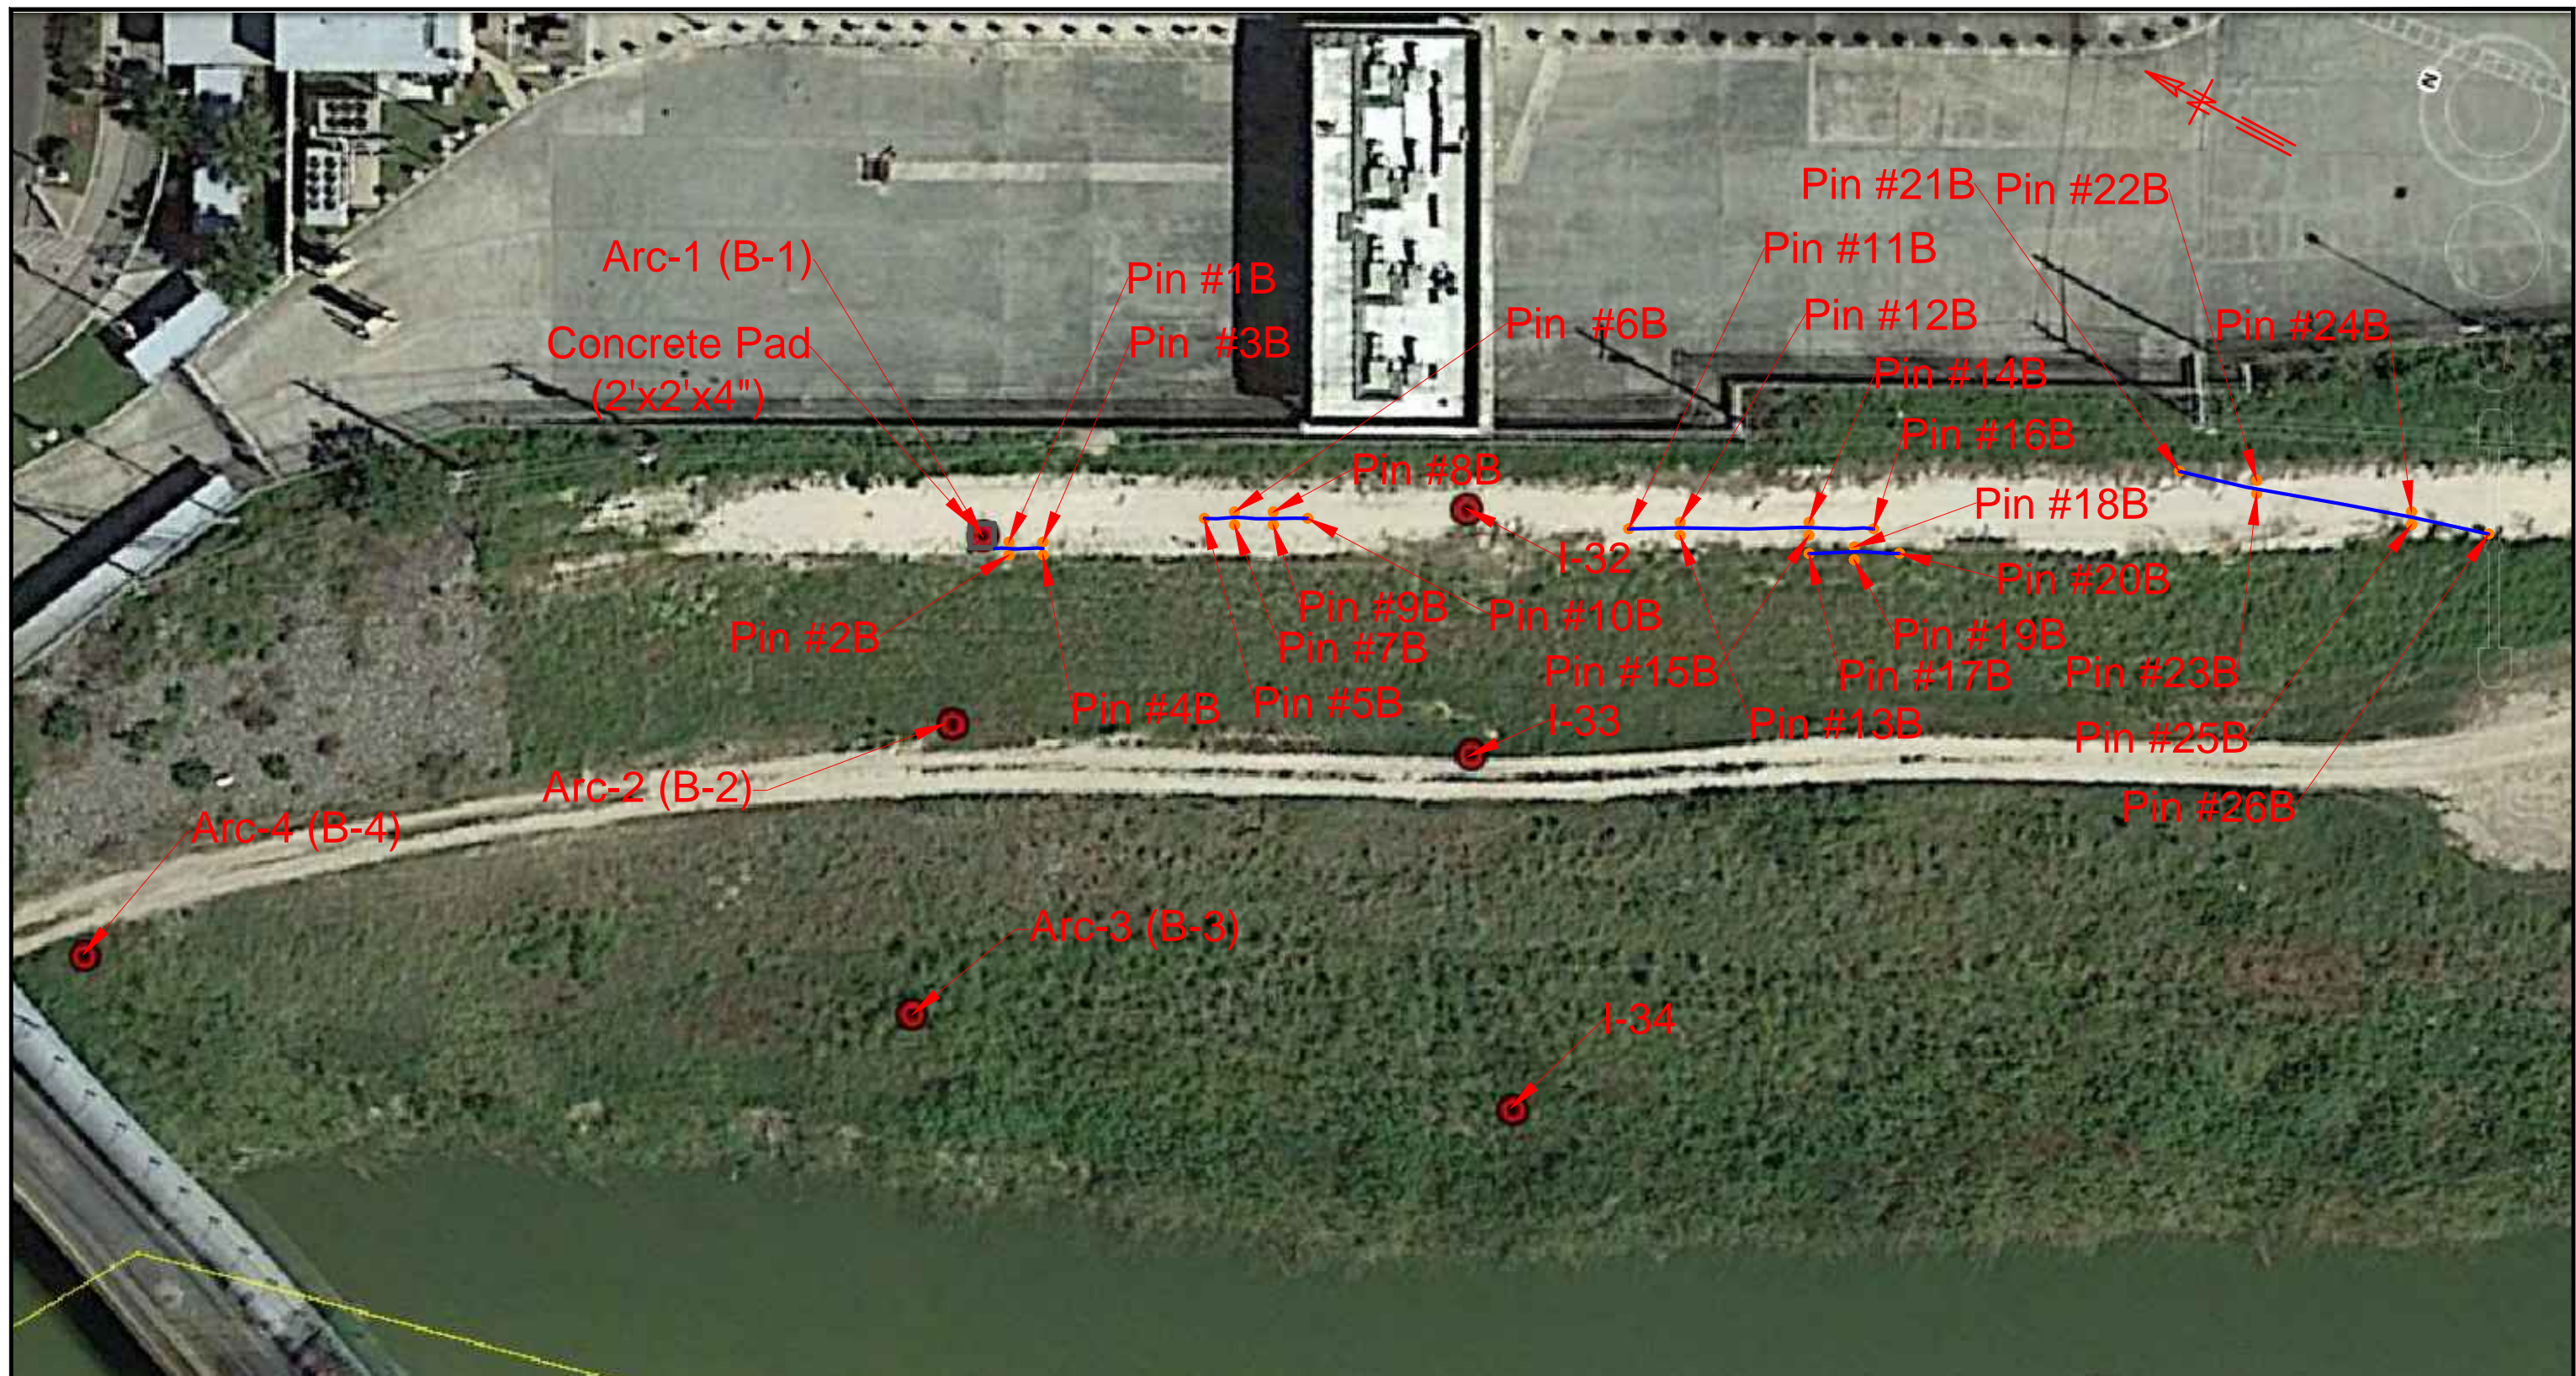
INCLINOMETER & LEVEE CRACKING LOCATION

In this month's visit to the IBWC site, the tension cracks that have been monitored since February 2017 could not be measured. The entire site was mowed and the mowing removed the 16 pin flags that were previously placed. In addition, it appears that the movement of the mowing equipment has caused some of the surface cracks to close. Due to these circumstances, Arcadis installed 26 pin flags where the surficial

cracks were visible. The locations of the cracks and the new set of pin flags are shown in Attachment B while Attachment C presents photos of the surface cracks. Some of these cracks have the same locations as those previously observed and monitored. These new pin flags will be used as a reference to measure over the next month to observe if the cracks widen or lengthen.

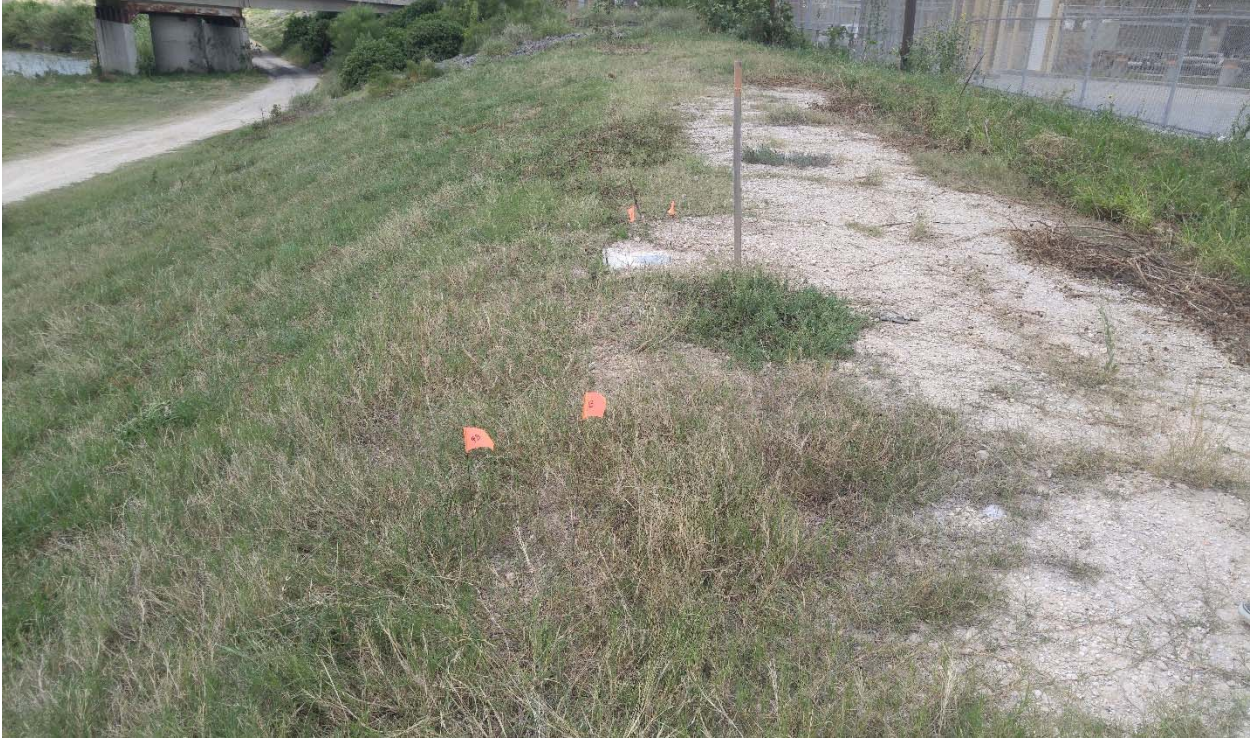
Photo 1 - Looking North - Surface Tension Crack of Pin Flags 1B through 4B.

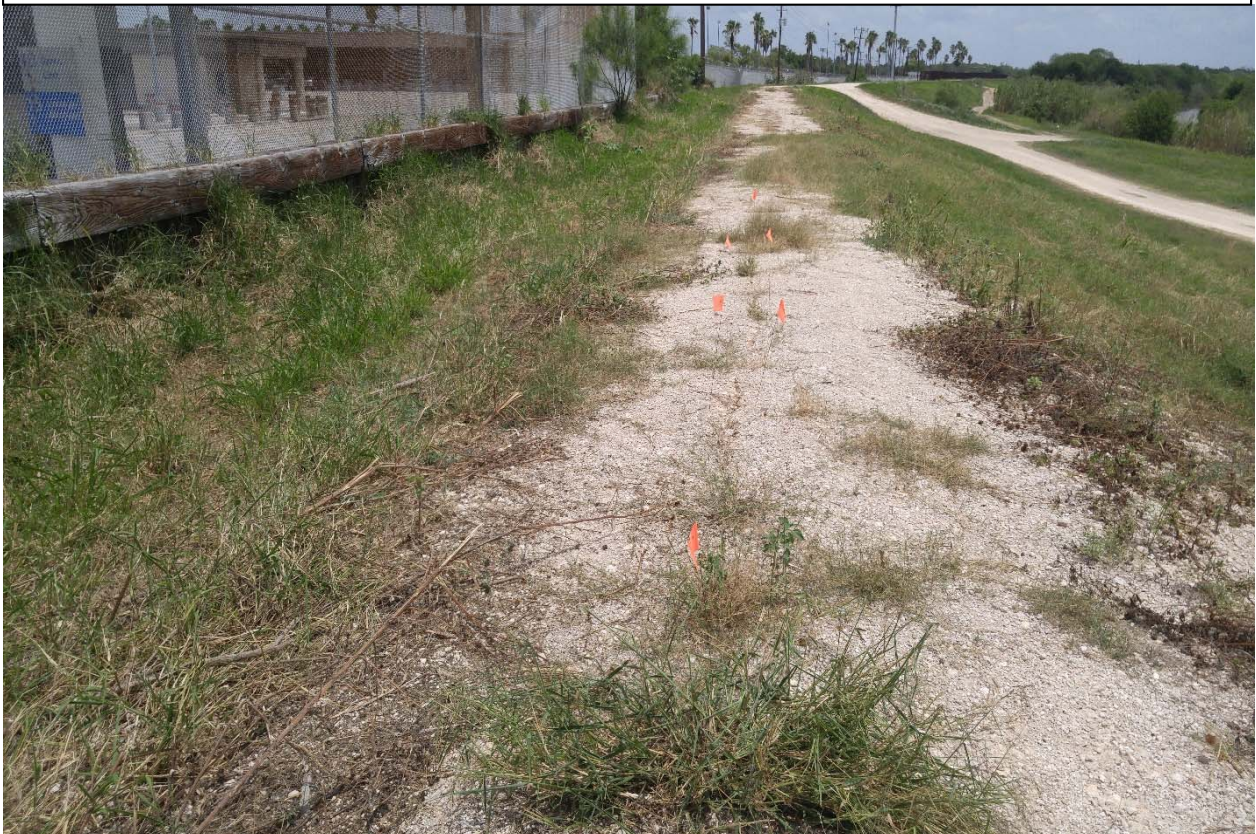
Photo 2 - Looking South - Surface Tension Crack of Pin Flags 5B through 10B

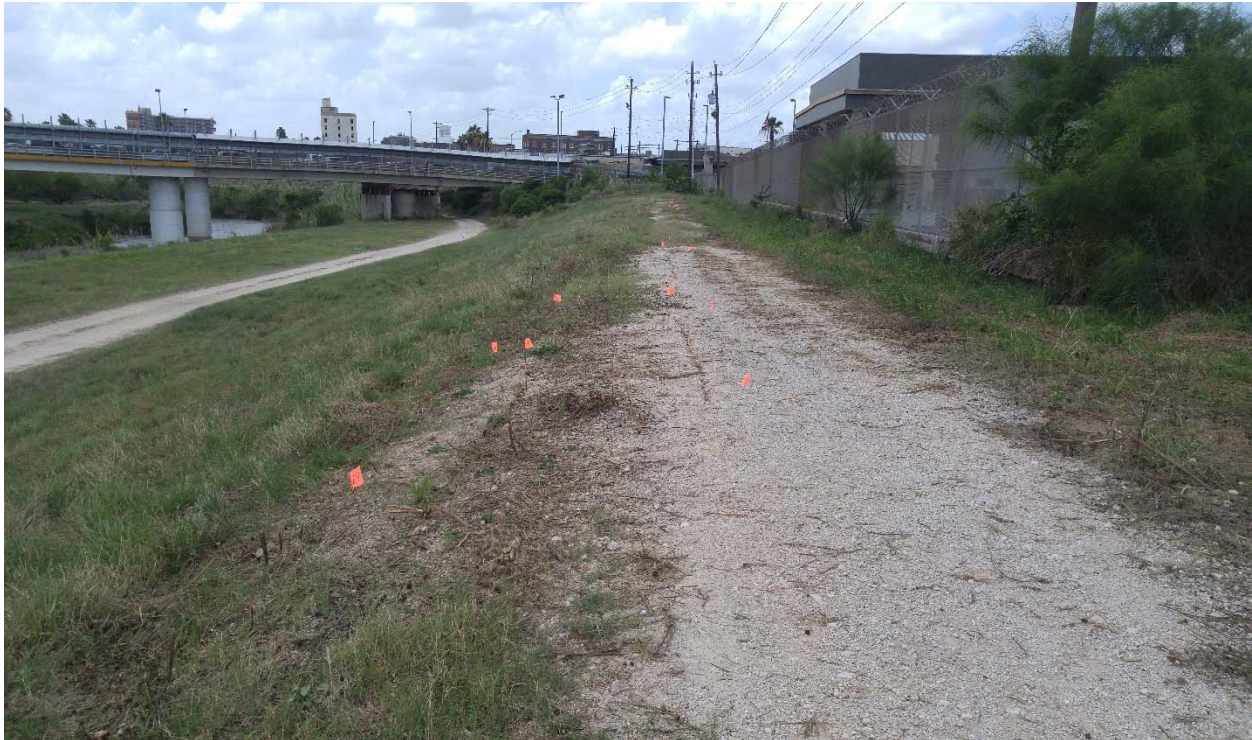
Photo 3 - Looking North - Surface Tension Crack of Pin Flags 11B through 20B.

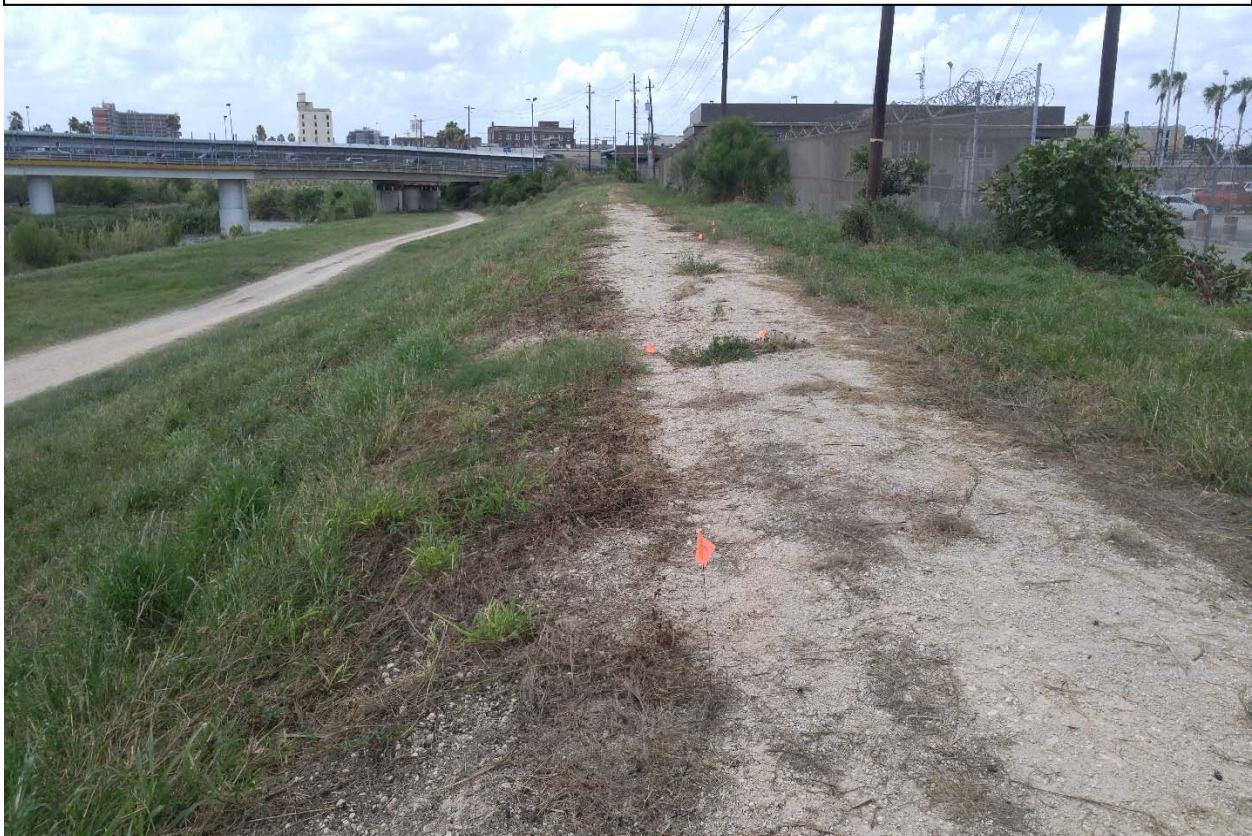
Photo 4 - Looking North - Surface Tension Crack of Pin Flags 21B through 26B.
