Riparian Habitat Restoration at Four Sites in New Mexico and Texas: Shalem Colony, Vinton A and B, and Title: Valley Creek Restoration Sites

Final Interim Annual Restoration Report Version: October 2017 to October 2018

Date: February 4, 2019

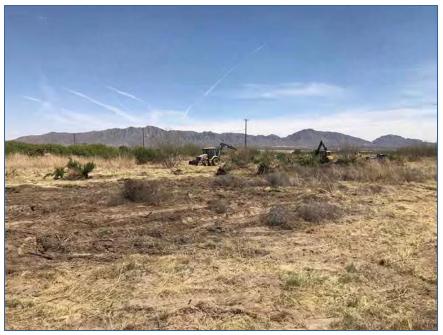
Saltcedar extraction at Vinton B, 24 April 2018

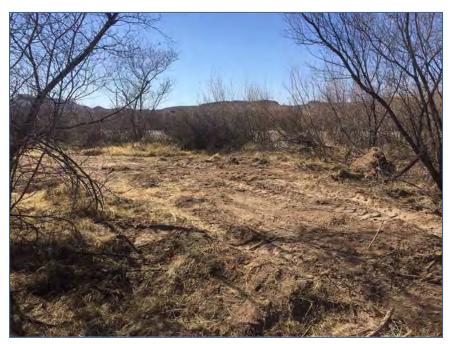
Shalem Colony restoration site after saltcedar extraction, 23 February 2018

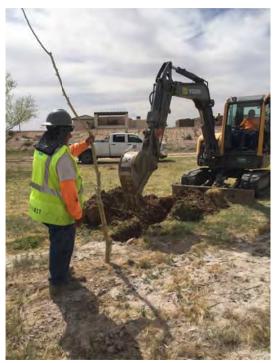
Cottonwood pole planting, Valley Creek 16 April 2018

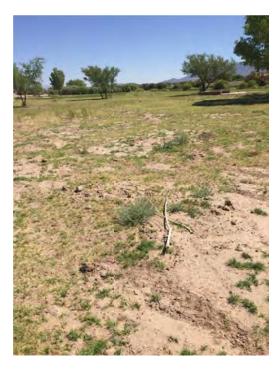
No recent evidence of herbivory was observed at any of the sites; although a dead beaver (*Castor canadensis*) was found on the Vinton A site. However, the IDEALS-AGEISS team biologists did observe other instances which had an impact, or the potential to impact, restoration efforts. Pocket gopher activity was pronounced at the Valley Creek, Vinton A, and Vinton B sites. This species has the potential to undermine root structure of planted poles. In addition, pole plantings at the Valley Creek site incurred damage from maintenance crews and vandalism due to a broken gate. As of October 2018, 317 cottonwood poles have been destroyed by maintenance crews mowing the floodplain and vandalism (18 cottonwoods damaged in June 2018) at the Valley Creek restoration site since being planted in April which has impacted the restoration efforts and is further described in Section 3.3.

Cottonwood trees damaged by vandals at Valley Creek, 21 June 2018

- Continue communication with City of El Paso to ensure longstem shrub plantings and remaining cottonwoods are not damaged by maintenance activities.
- Continue to conduct willow transplants when possible. Transplantation of mature coyote willows
 with their established root balls provides high survivorship at the sites. In addition, the habitat is well
 on its way to establishment using these mature trees.
- Maintain and even improve outreach with neighbors in the vicinity of the restoration sites. Consider density and height of the tree species planted at the sites and the potential to block residential viewsheds.

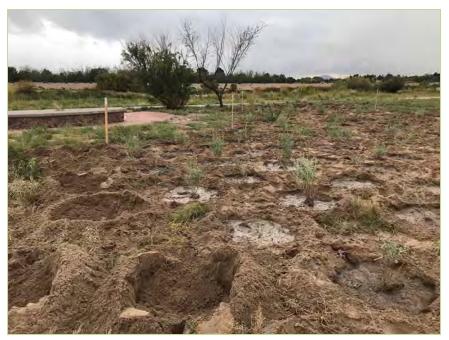
Longstem shrubs and 20 desert willows were planted at the Valley Creek restoration site at the end of October while the October 2018 monitoring was being conducted. Since these species were just planted, they were not considered in October 2018 survivorship counts.

Longstem shrubs planted at Valley Creek restoration site, 24 October 2018
