# 2016 Basin Highlights Report

**Texas Rio Grande Basin Program Update**

**International Boundary and Water Commission, U.S. Section  
Texas Clean Rivers Program**

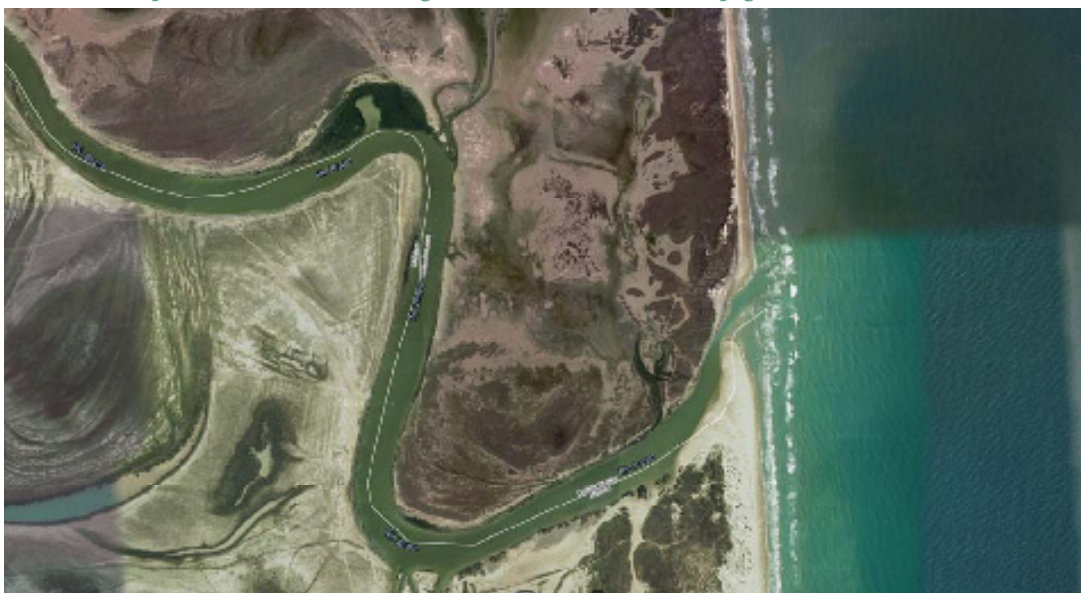
This map, made on 2/11/2016, shows the water of the Rio Grande reaching the mouth and flowing into the Gulf of Mexico

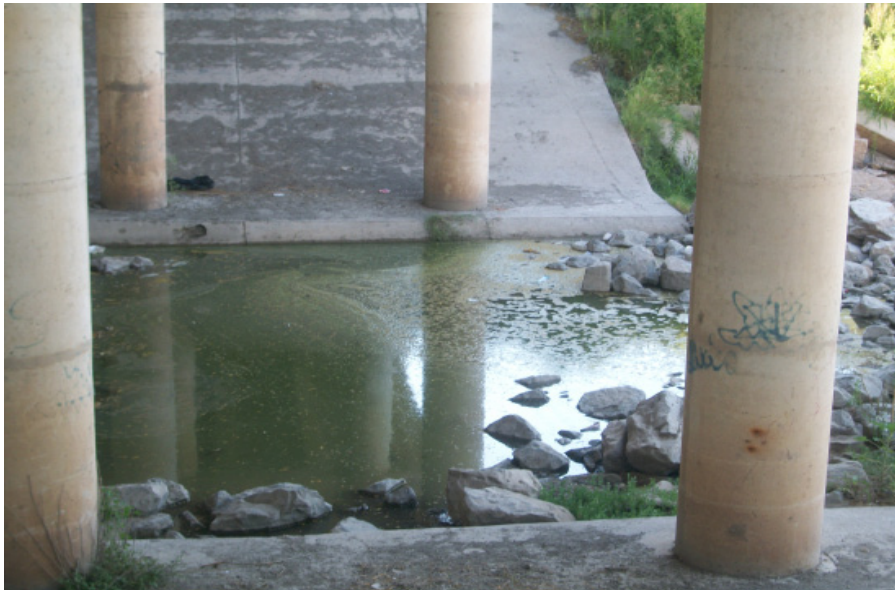
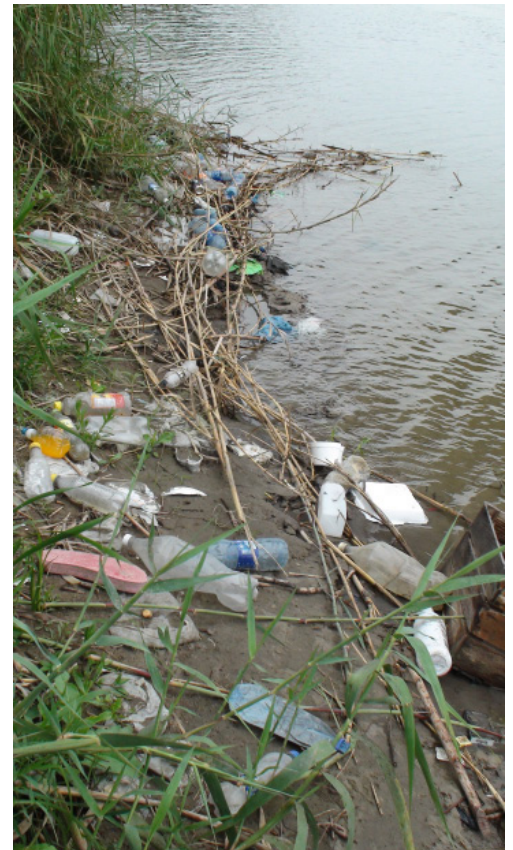
Some examples of water quality issues in the Lower Rio Grande: Pictured above, Station 13103, which has high bacteria. Pictured at right, Station 13181, trash is a big problem all along the Rio Grande.

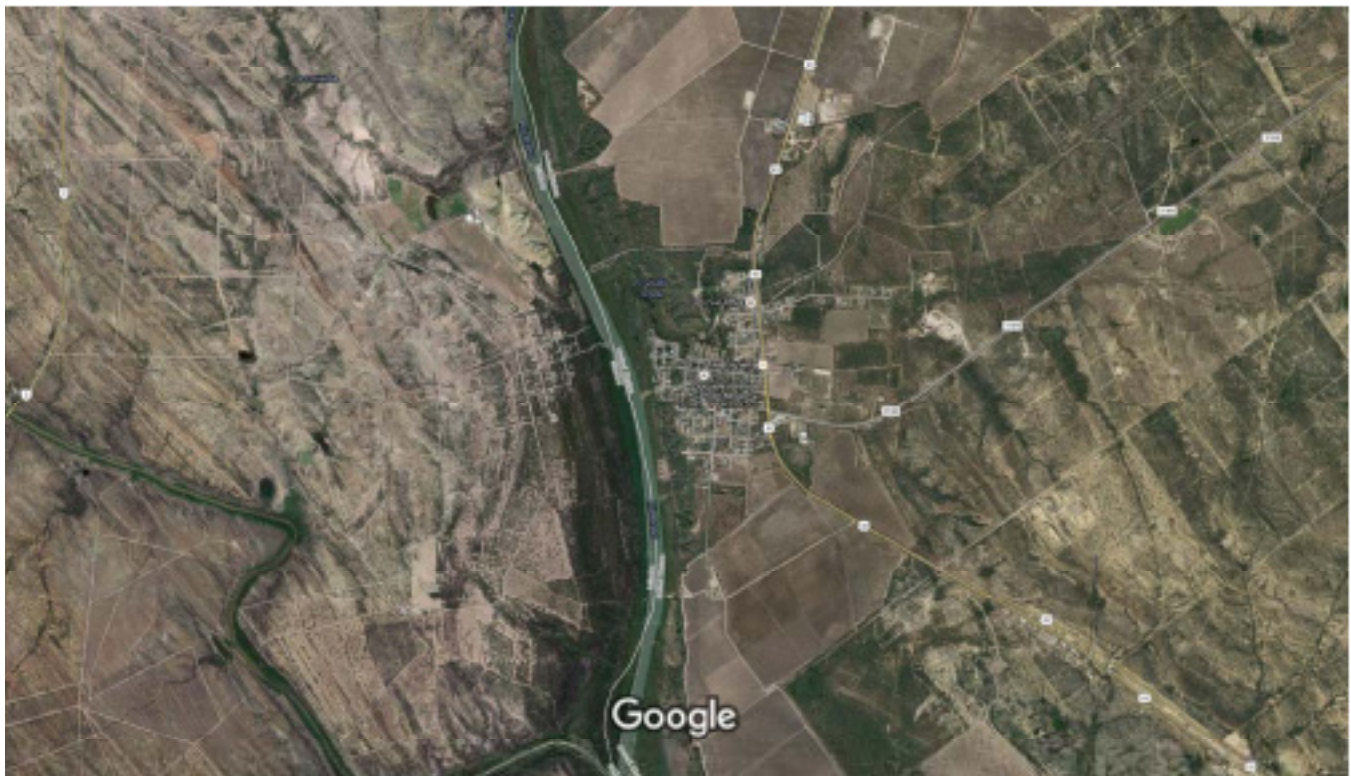
Small town of San Ygnacio on the right hand side, near Station 15818. MX side on the left side shows no development.

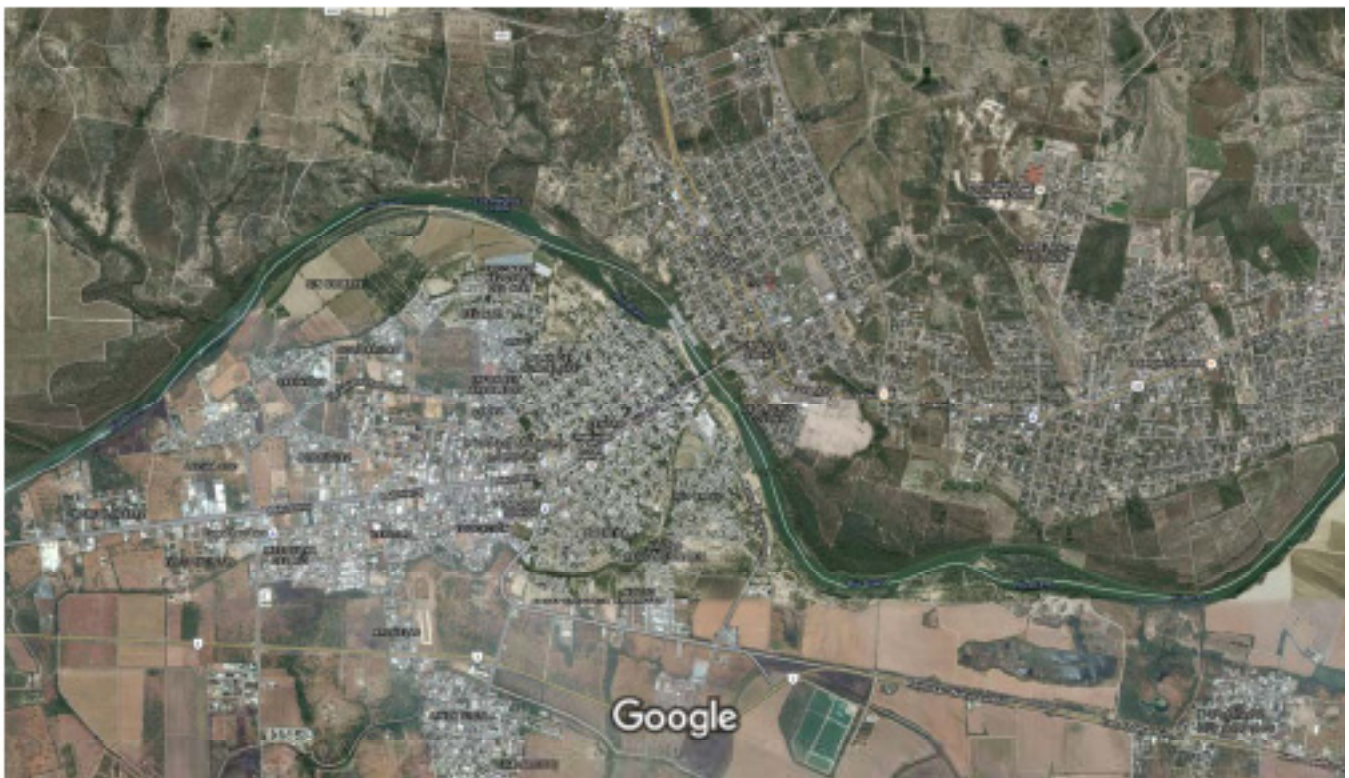
Top Map shows a large industrial area on the Mexican side of the river, no U.S. city across.

Bottom Map shows the City of Roma on the upper side of the Rio Grande, and the city of Miguel Aleman in Mexico on the underside of the river

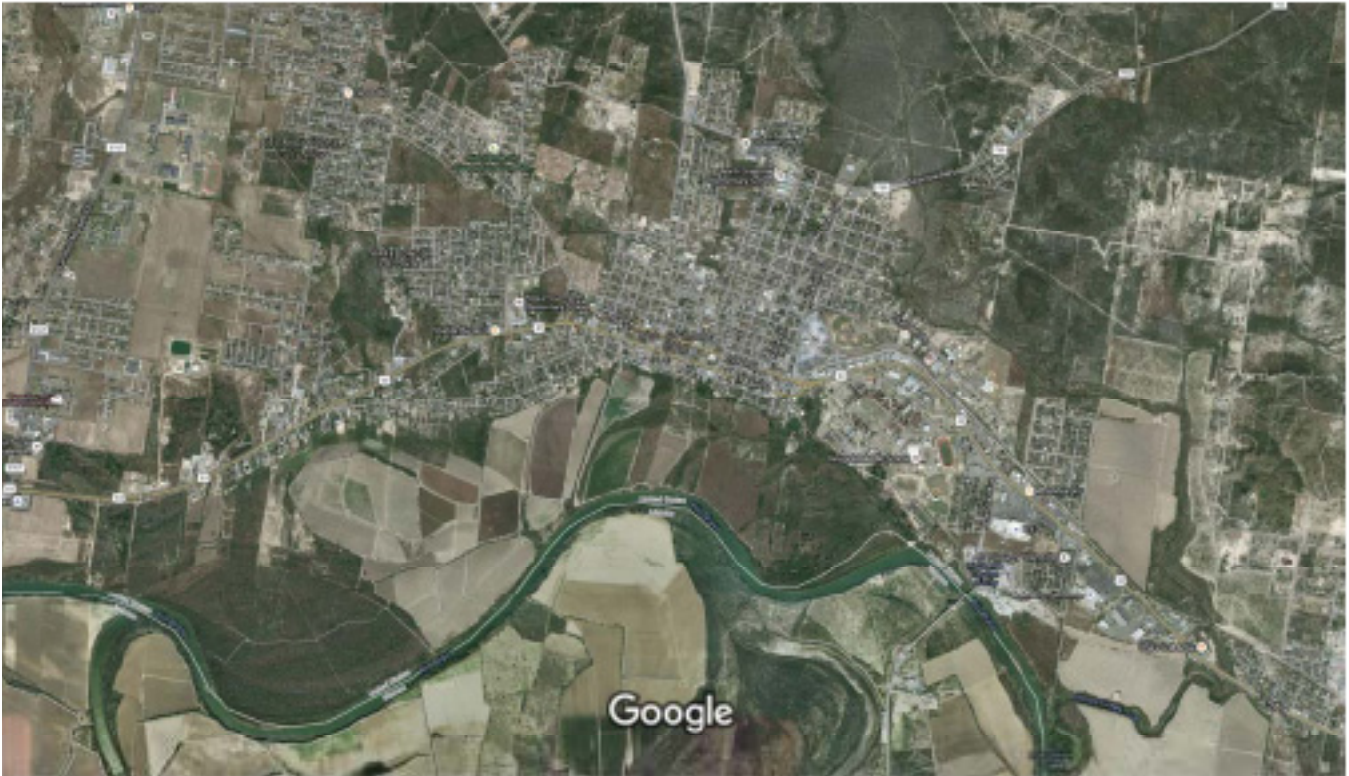
Map shows Rio Grande City, TX on the upper side of the Rio Grande. Under side is undeveloped rural land or farmland in MX.

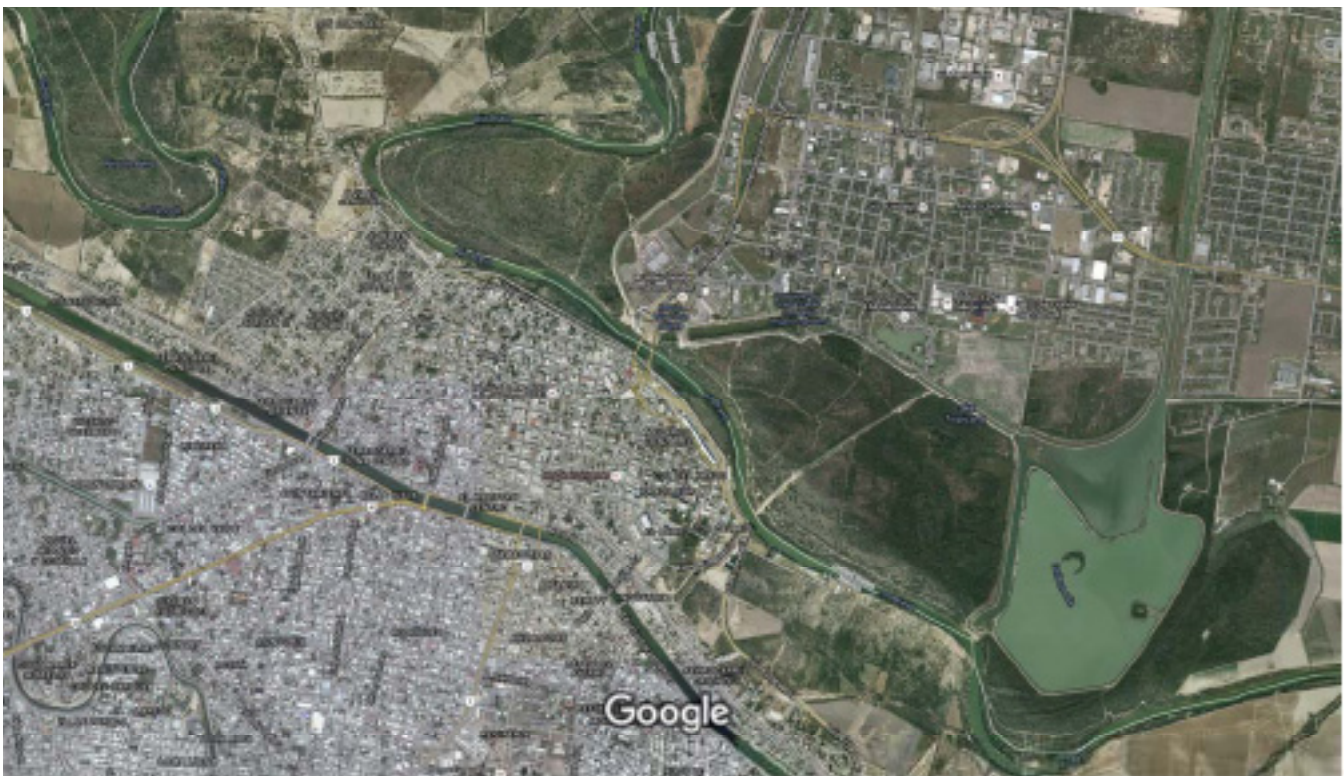
Map shows McAllen, TX on the upper right side of the river, and the city of Reynosa in Mexico on the lower left.

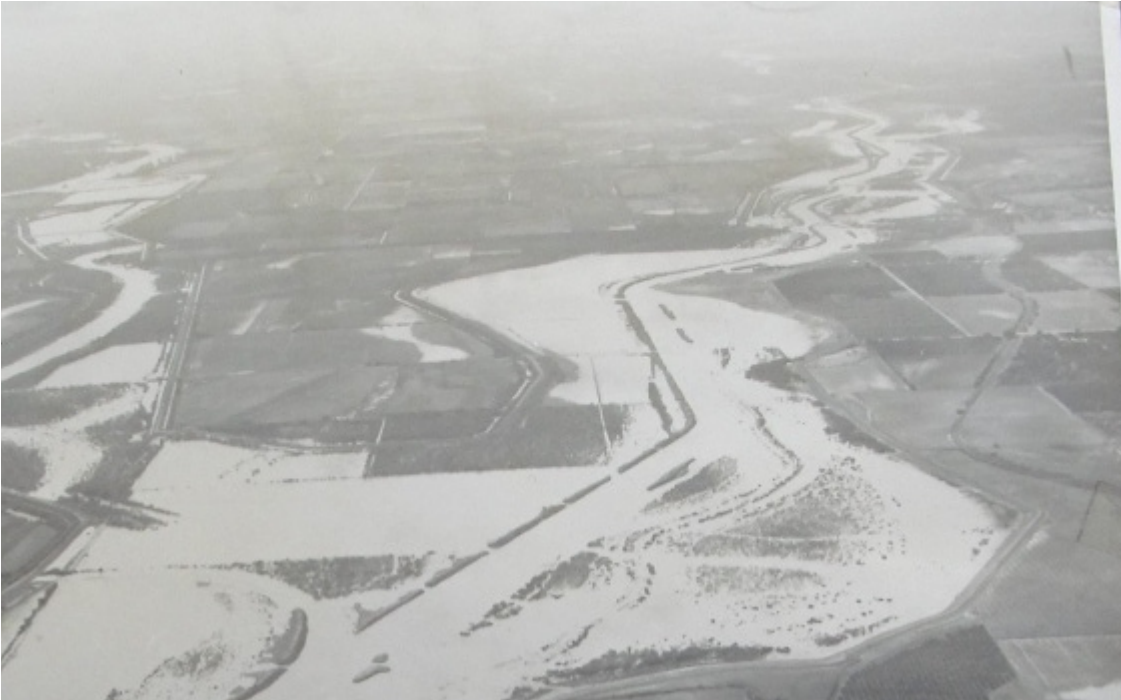
September 14, 1948: Looking west over the Mission Branch and Hackney Lake Branch floodways at their junction with the Main Floodway, with the Pharr south highway crossing the Main Floodway in the foreground. River overflow in the floodways, near maximum for this this flood at the time of the photograph, reached 6,040 second feet in the Mission Branch and 11,735 second feet in the Hackney Lake Branch.

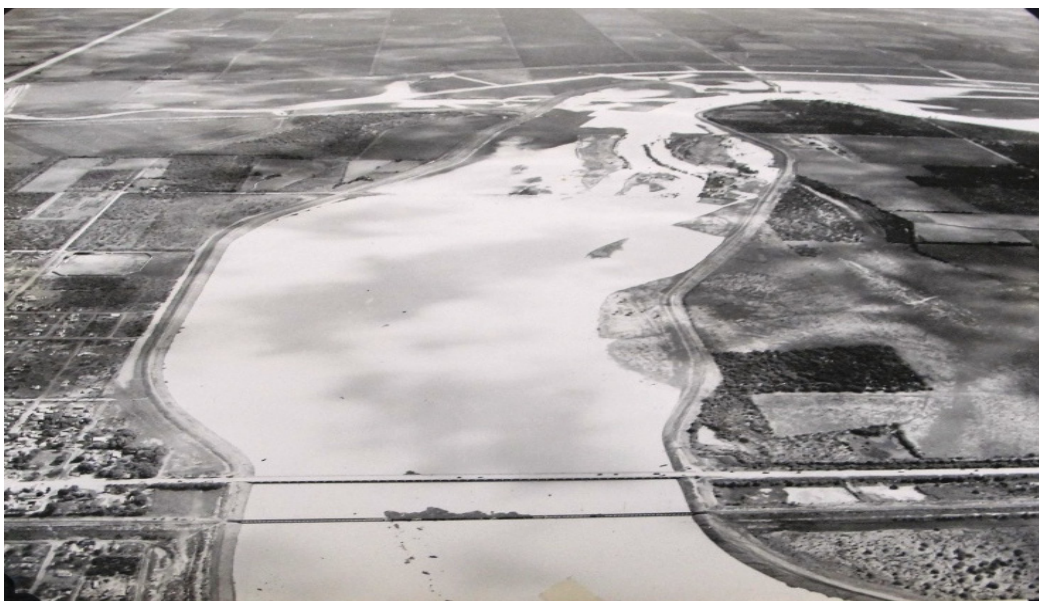
September 16, 1948: Looking south over the upstream end of the North Floodway from a point north of the highway and railroad bridges at Mercedes, TX. The junction of the floodway with the Main and Arroyo Colorado Floodways in visible in the background. Flow in the North Floodway during the mid-September flood reached a maximum at this point of 13,000 second feet the day before and was near maximum at the time of this photo.

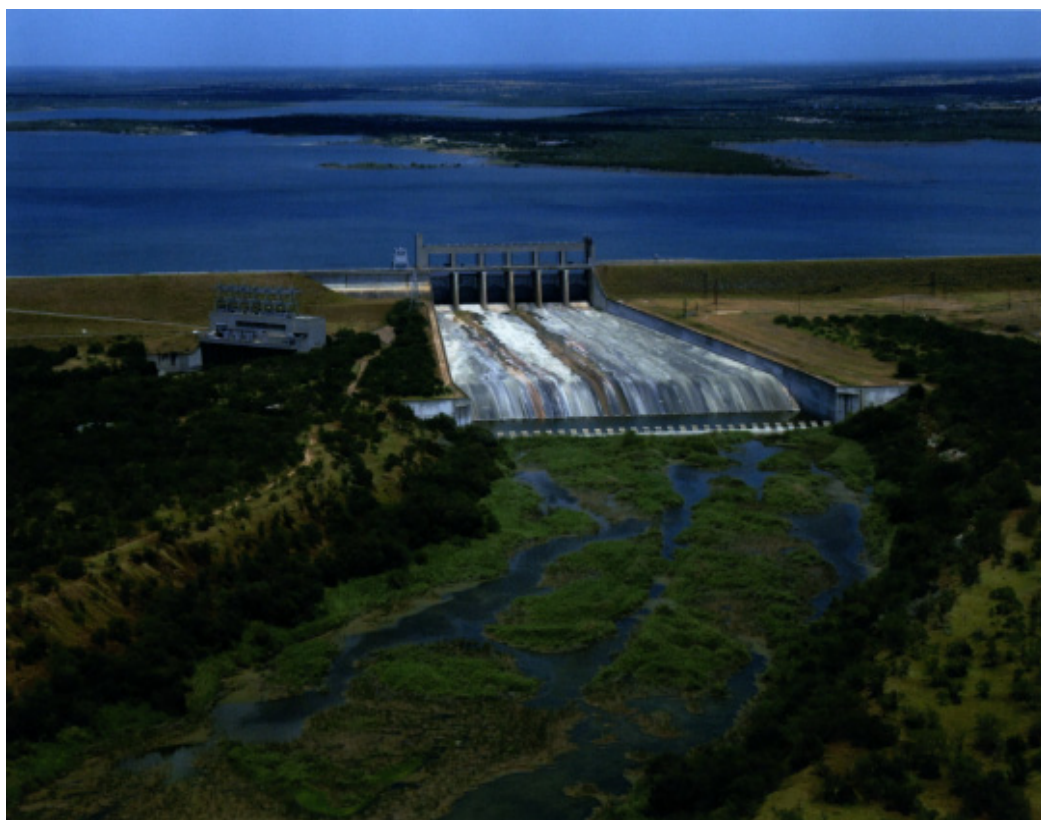
Pictured: Falcon Dam in Falcon Heights, Texas. CRP Station 15818 is the furthest downstream station before entering the Reservoir. This station is monitored by the Rio Grande International Study Center, located in Laredo, TX. Station 13189 is located on the Reservoir, near the Spillway, and Station 13186 is the first station located downstream of the dam. Both of these stations are monitored by the USIBWC Falcon Dam Field Office on a monthly basis.

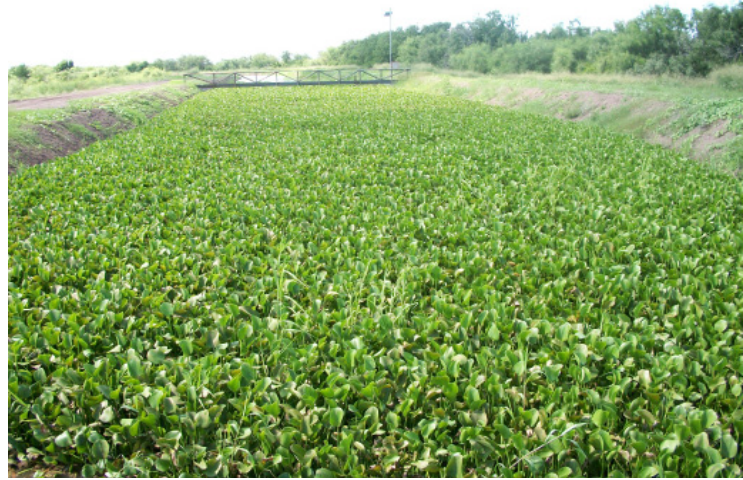
Pictured: Aquatic weeds, possibly hydrilla, completely covering a canal in the Lower Rio Grande Valley.

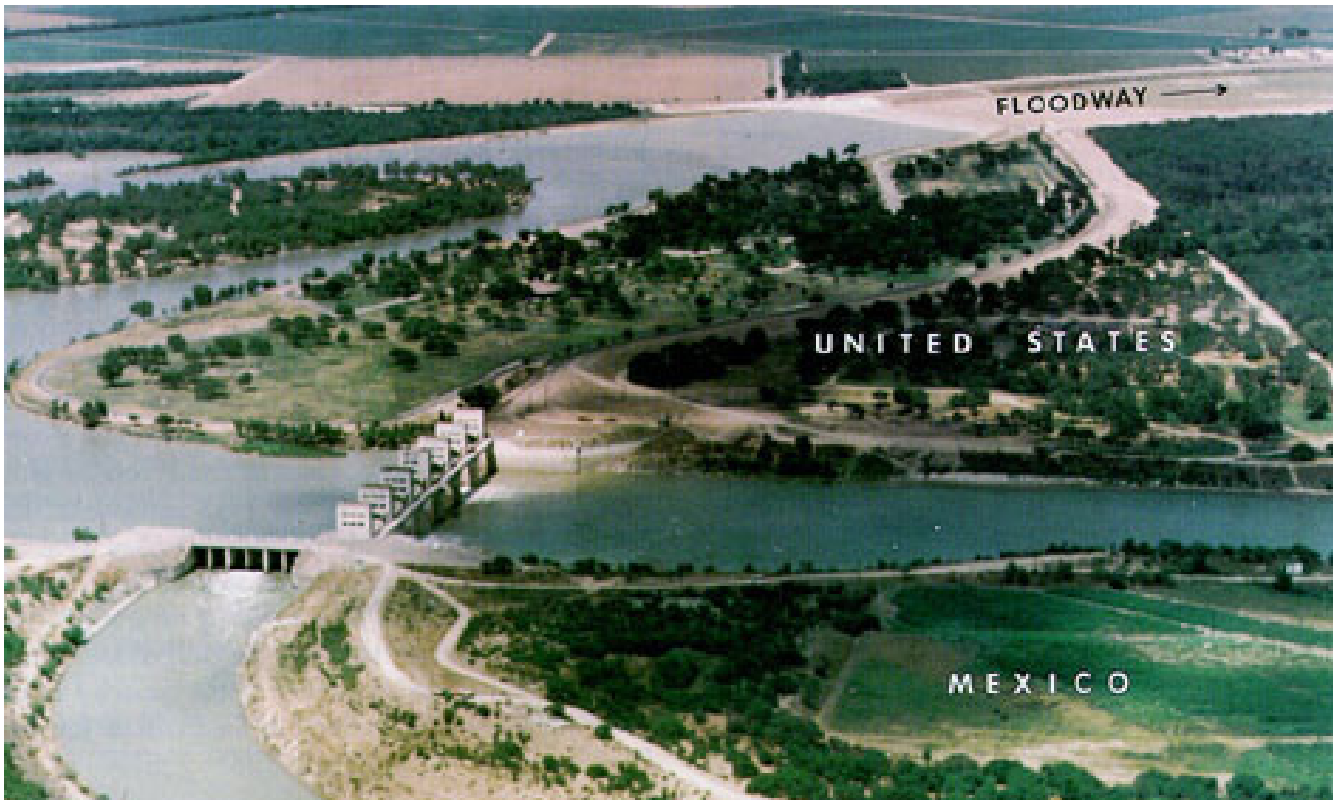
Early Aerial Photograph of Anzalduas Diversion Dam near Mission, Texas on the Rio Grande showing the U.S. off-river “Banker” Floodway, which, as a principle part of the International Project for control of floods of the Lower Rio Grande, serves to divert floodwaters from the river to the U.S. floodways. This photo also shows Mexico’s intake structure to its Anzalduas Irrigation Canal.
