# Minute 323

Environmental  
Work Group

## 2019 Implementation Report

July 2023

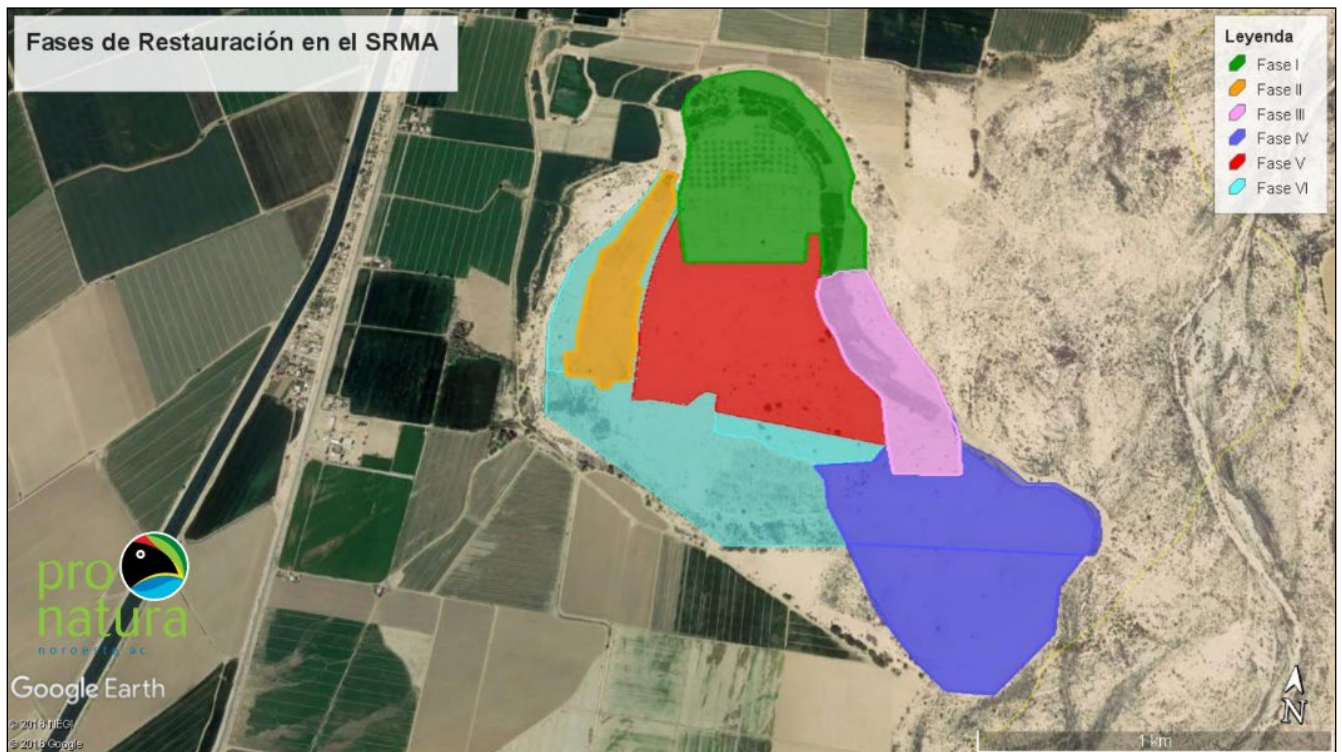
Figure 2. Restoration Phases at Miguel Aleman

In 2019 there were no restored acres in Miguel Alemán. Implementation of Phase V will include the restoration of 35 hectares (86.5 acres) of high terrace habitat, maintenance and management of Phases I, II, III and IV, plus the production of 13,500 native trees/shrubs in nurseries located at the site. Phase VI will be the last active restoration site in the Miguel Alemán complex and will include restoration of 35 additional hectares (86.5 acres). Only maintenance and management activities will be performed at the site in the future.

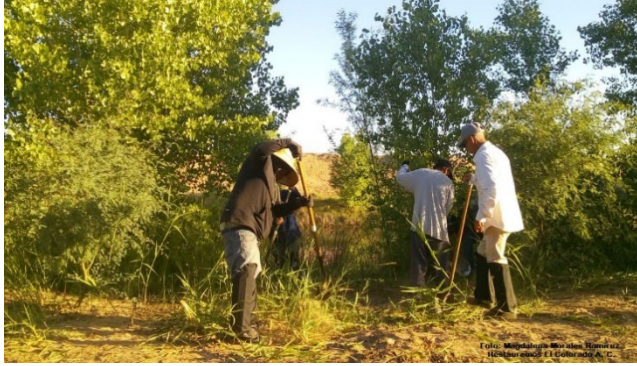
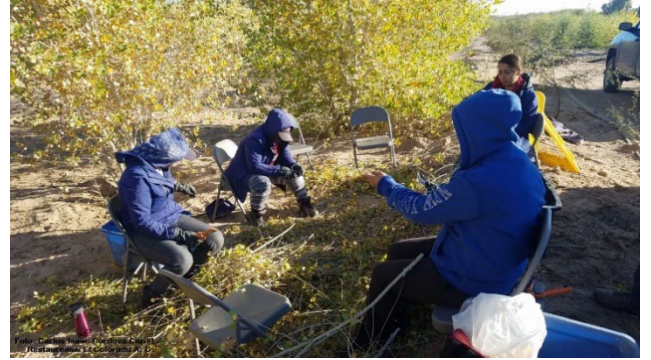
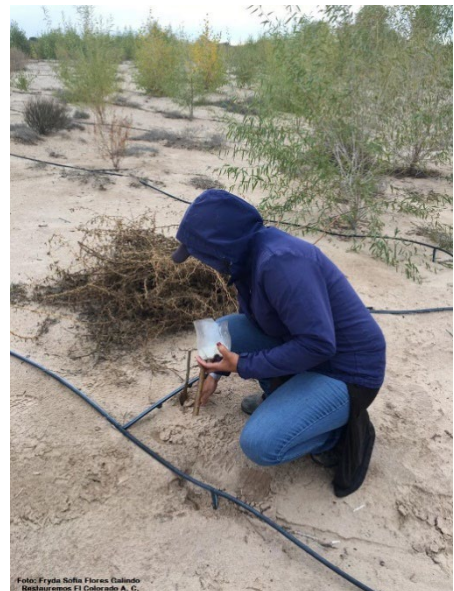
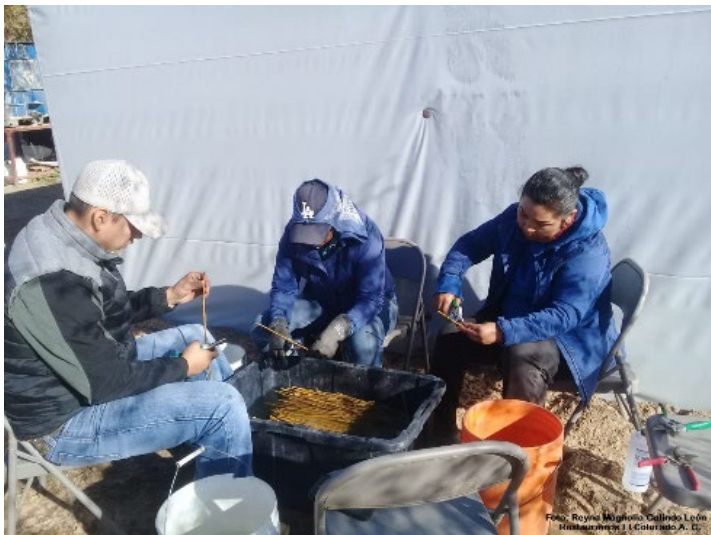
Figures 5, 6, 7, 8, 9 & 10. Maintenance and Management Activities in Chaussé

Phase 1 (see Figure 5) included the installation of two dams and one delivery point on the Canal Alimentador del Sur as well as grading and planting the site. Phase II (see Figure 5) includes the 2.1 km long corridor along the main channel of the Colorado River within the Chaussé land concession. Both phases of Chaussé were fully planted by the end of 2018, thus in 2019 all of Chaussé was under its first year of maintenance (62.6 hectares/155 acres total).

- Irrigation of all planted areas monthly (except pole-planted area)
- Maintenance and repair of all water control structures (except pole-planted area)
- Clearing invasive vegetation throughout the site
- Repair of and expansion of capacity in nurseries
- Plant production
- Replanting of eroded areas
- Repairs to the pumping, filtering and drip irrigation systems
- Repairs to levees and metal structures of gates (central and levees)
- Vegetation (survival) and hydrological monitoring (daily measurements on days of water deliveries and piezometers)

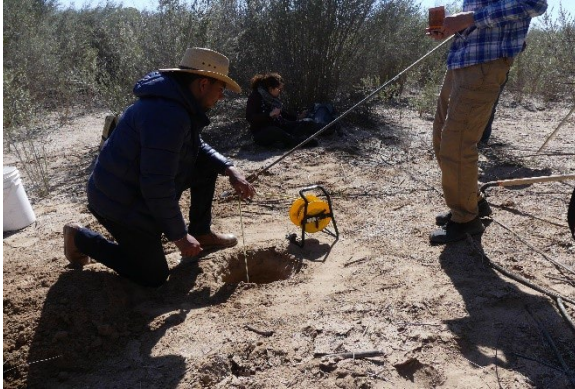
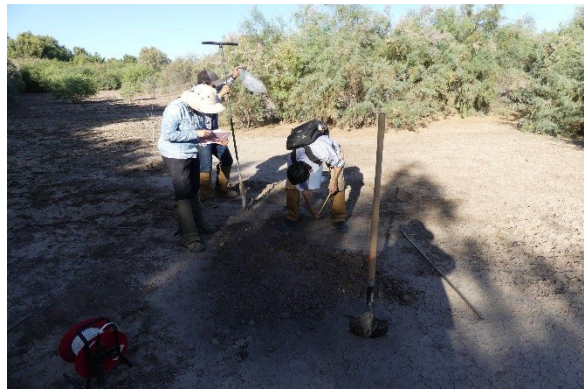
Figures 19 and 20. Sonoran Institute personnel in prospect visits. During the visits, soil samples were taken, groundwater levels were registered, and present vegetation was registered. The collected information will be used in the site's restoration design.

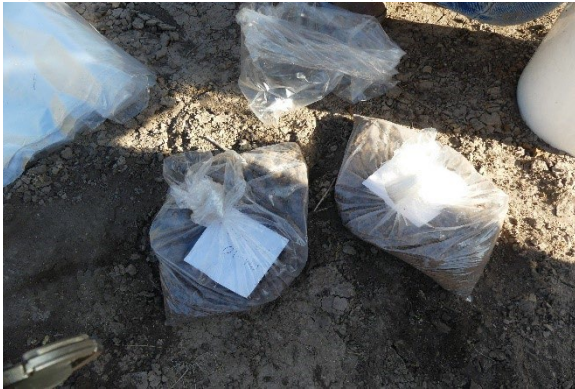
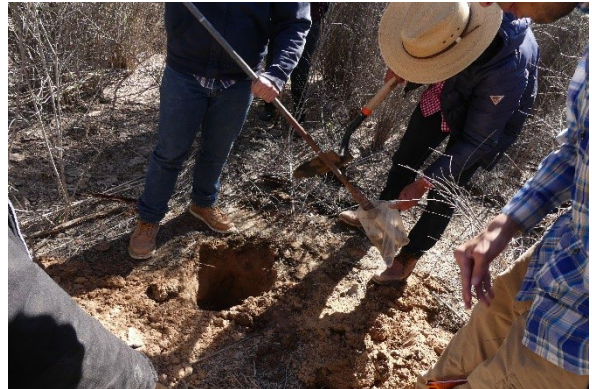
Figures 21 and 22. Soil sampling in the Laguna Larga Phase I site.

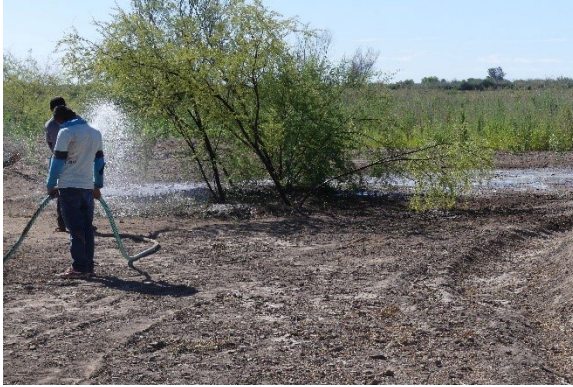
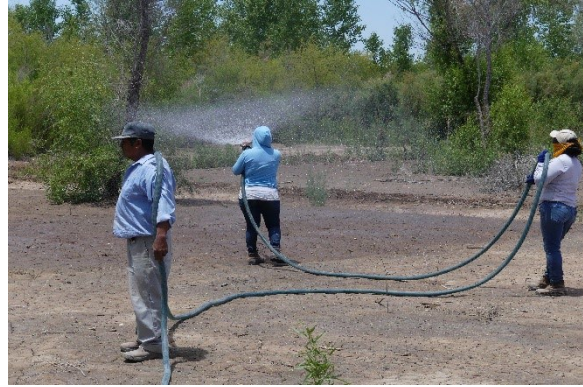
Figures 27 and 28. Hydroseeding a restoration site in Cori land concession with native tree, shrub, and herbaceous species.

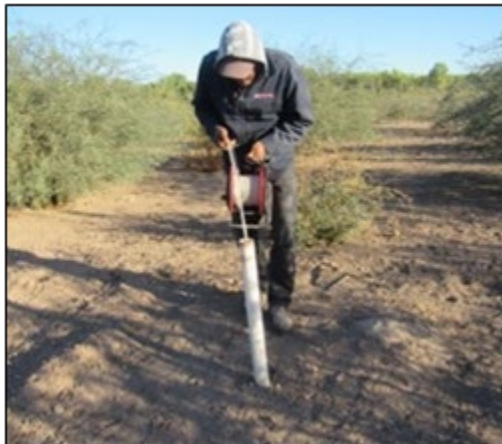
Figure 51. Measuring groundwater levels in the CILA restoration site

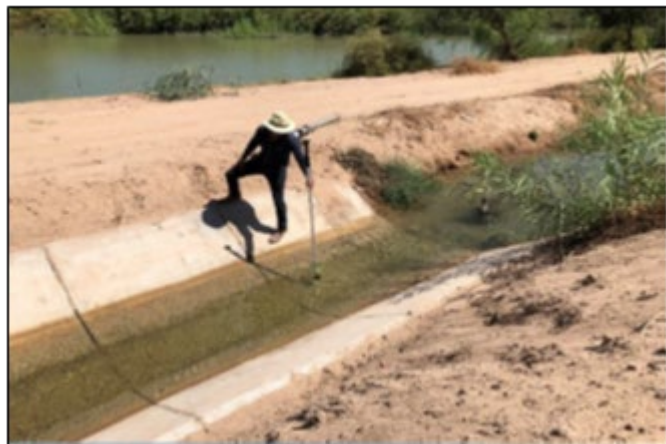
Figure 52. Measuring flows in a canal in the Herradura restoration site.

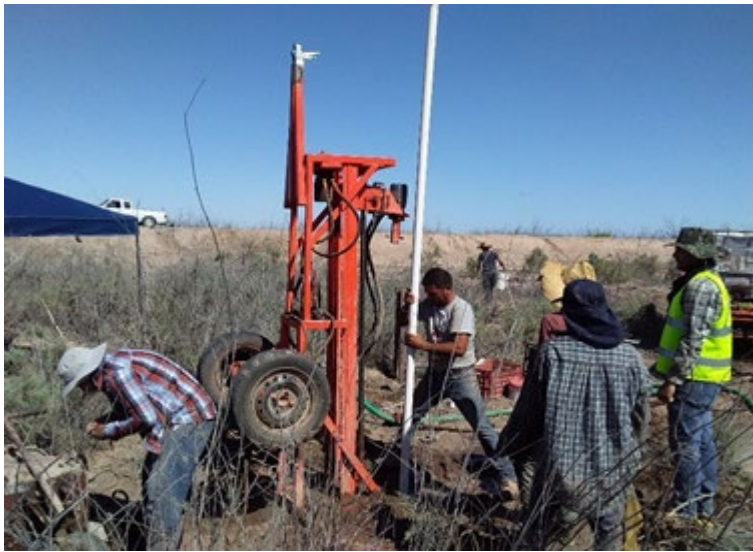
Figure 68. Estuary piezometer drilling, 2019

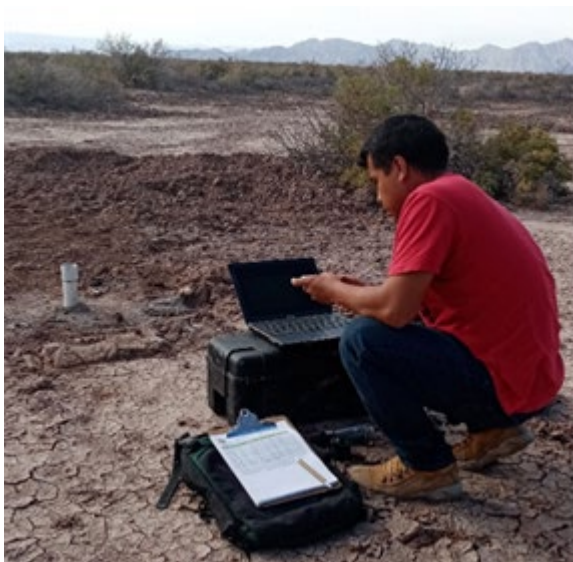
Figure 69. Downloading data from sensors installed in the estuary, 2019.

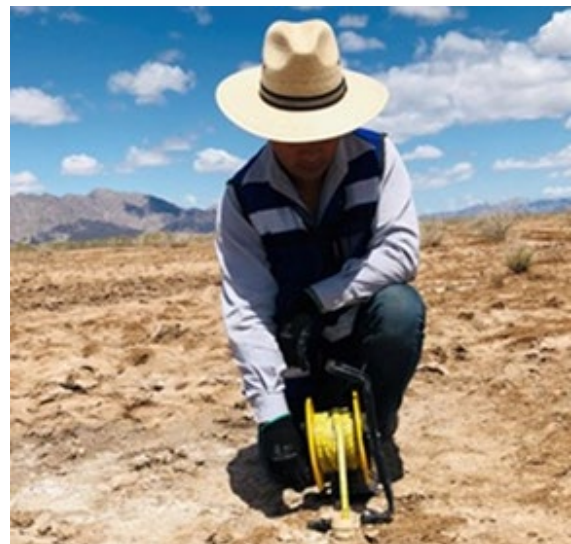
Figures 70. Measuring groundwater levels in the estuary, 2019.

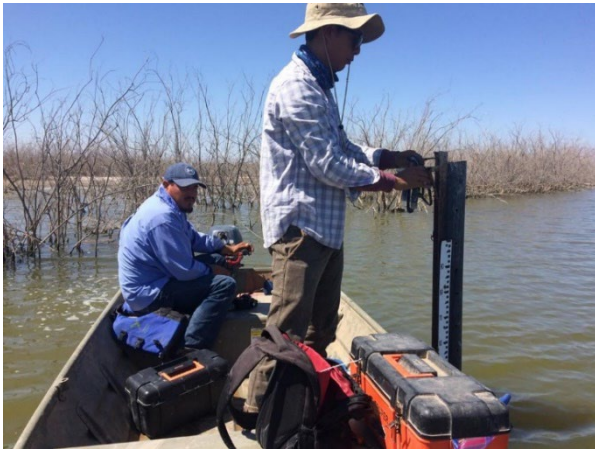
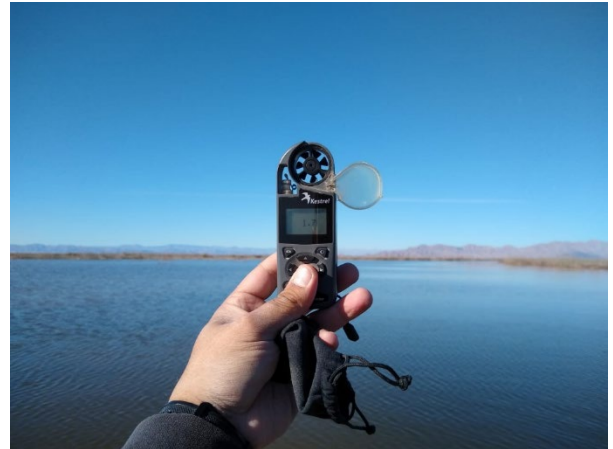
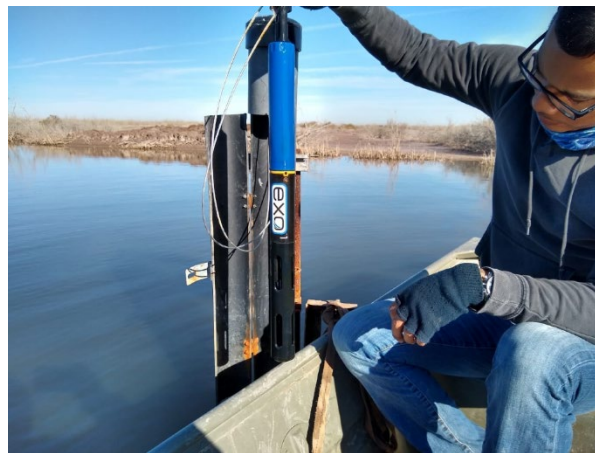
Figures 71, 72, and 73. Water quality monitoring in the Estuary, 2019

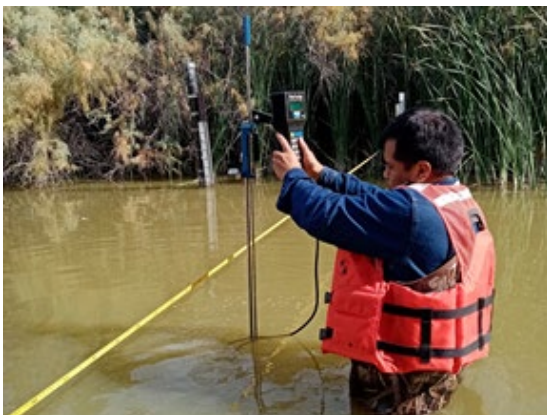
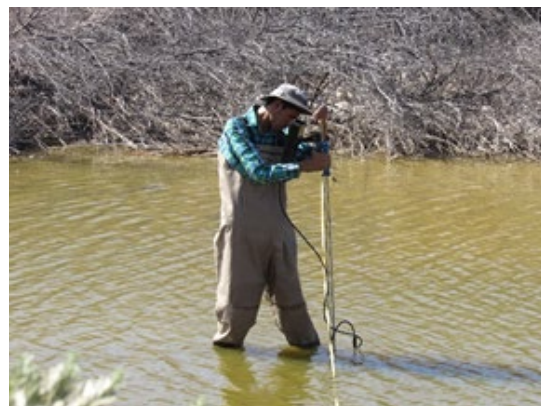
Figures 74 y 75. Measuring water flows in the Hardy River, 2019.
