Background

Located on the Rio Grande 11.81 miles (19 kilometers) north of the cities of Del Rio, Texas and Ciudad Acuña, Coahuila. It is the second international storage dam built jointly by the United States and Mexico, pursuant to the 1944 Water Treaty.

AMISTAD DAM SAFETY MITIGATION PLAN

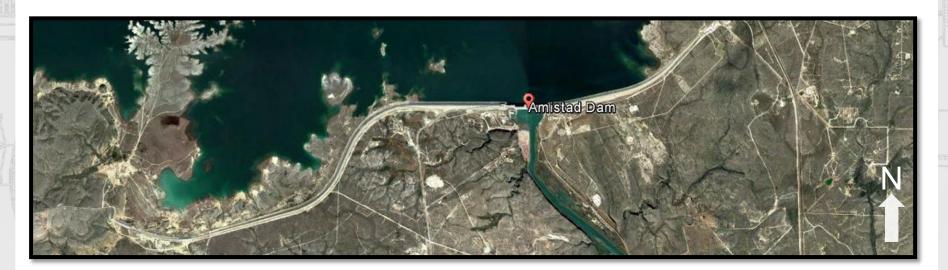
Amistad Dam Timeline of Events

Project Milestone	Commenced	Completed
Construction of the dam	1963	1969
Deliberate impoundment to conservation pool	1969	1972
Pool of record = 346.15 m (as of 30-Jan-2017)	-	Sept -1974
Construction of the hydropower facilities	1980	1983
Severe drought period, which led to discovery of numerous upstream sinkholes	1994	2004
Circular depression found and backfilled on Mexican embankment near station 7+000		1996
Remedial centerline grouting plus supplemental upstream Toe grouting on the Mexican embankment	1995	1998
US Geological Survey (USGS) investigations: surface geophysics plus monitoring well installation	2005	2006
Periodic inspection leading to joint technical advisor group formation	-	2007
Rated DSAC II		2007
Interim Risk Reduction Measures (IRRMs) implemented	2007	2011
Expert Panel Review of Amistad Dam Document	2008	2009 revised 2011
Historical low pool since first filling = 321.0 m (as of 30-Jan-2017)	-	May-2013

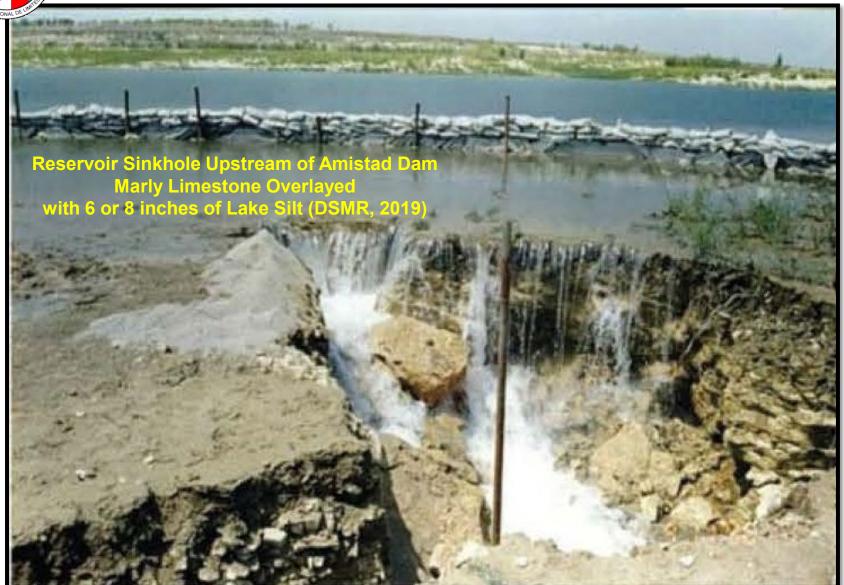
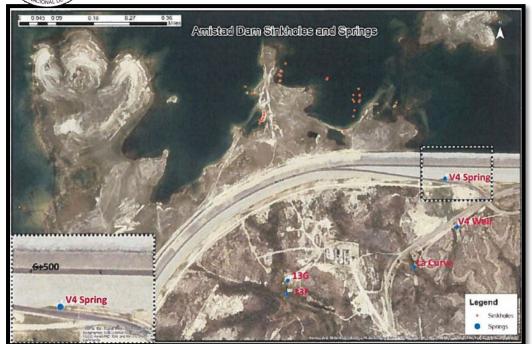
Issues

- Sink holes endanger dam
- Potential risk to the structure's stability
- Categorized Class II DSAC
- Population at risk (PAR)
- During a high pool (elev. 1,145 ft/349 m) approx. 300k to 400k people impacted
 DSAC = Dam Safety Action Classification

- Composite cutoff wall works by cutting off flow under the dam
- Grout curtain necessary first step in building wall, will reduce flow
- Concrete cutoff wall will act as barrier to flow and prevent erosion under and through dam
- Reduces the risk of failure to a tolerable level

- Series of panels excavated from the crest between the two grout curtains
- Constructed in primary and secondary sequence
- Allows for blockage of water flow through the rock foundation

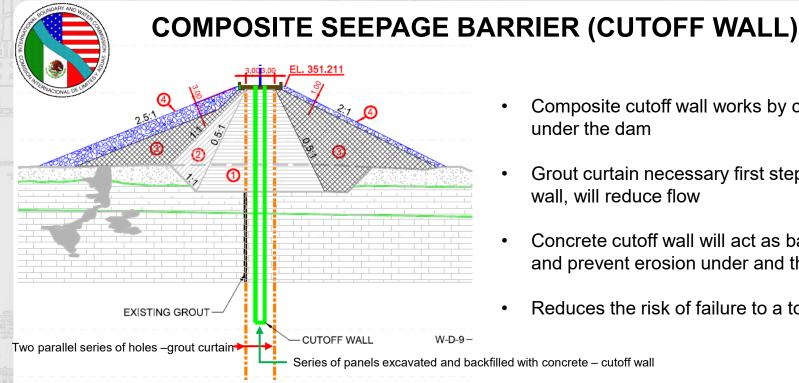
- Two parallel lines of holes, drilled from the crest, backfilled with pressurized cement grout
- Fills cavities in the karstic bedrock
- Allows for refinement of the concrete cutoff wall depths and lateral extents
- Reduces flow in the bedrock, serves as a flow barrier upstream and downstream of the cutoff wall alignment, creates exploration profiles of the dam to characterize the rock, and serves as a guide to the design of the (future) cutoff wall.

Grout curtain

Cutoff wall
