# **International Boundary and Water Commission United States Section**

## **Remediation Design of Levee and Floodplain Failure Within the Upper Brownsville Levee Reach Lower Rio Grande Flood Control Project**

### **Design Documentation Report Final Submittal**

May 2022

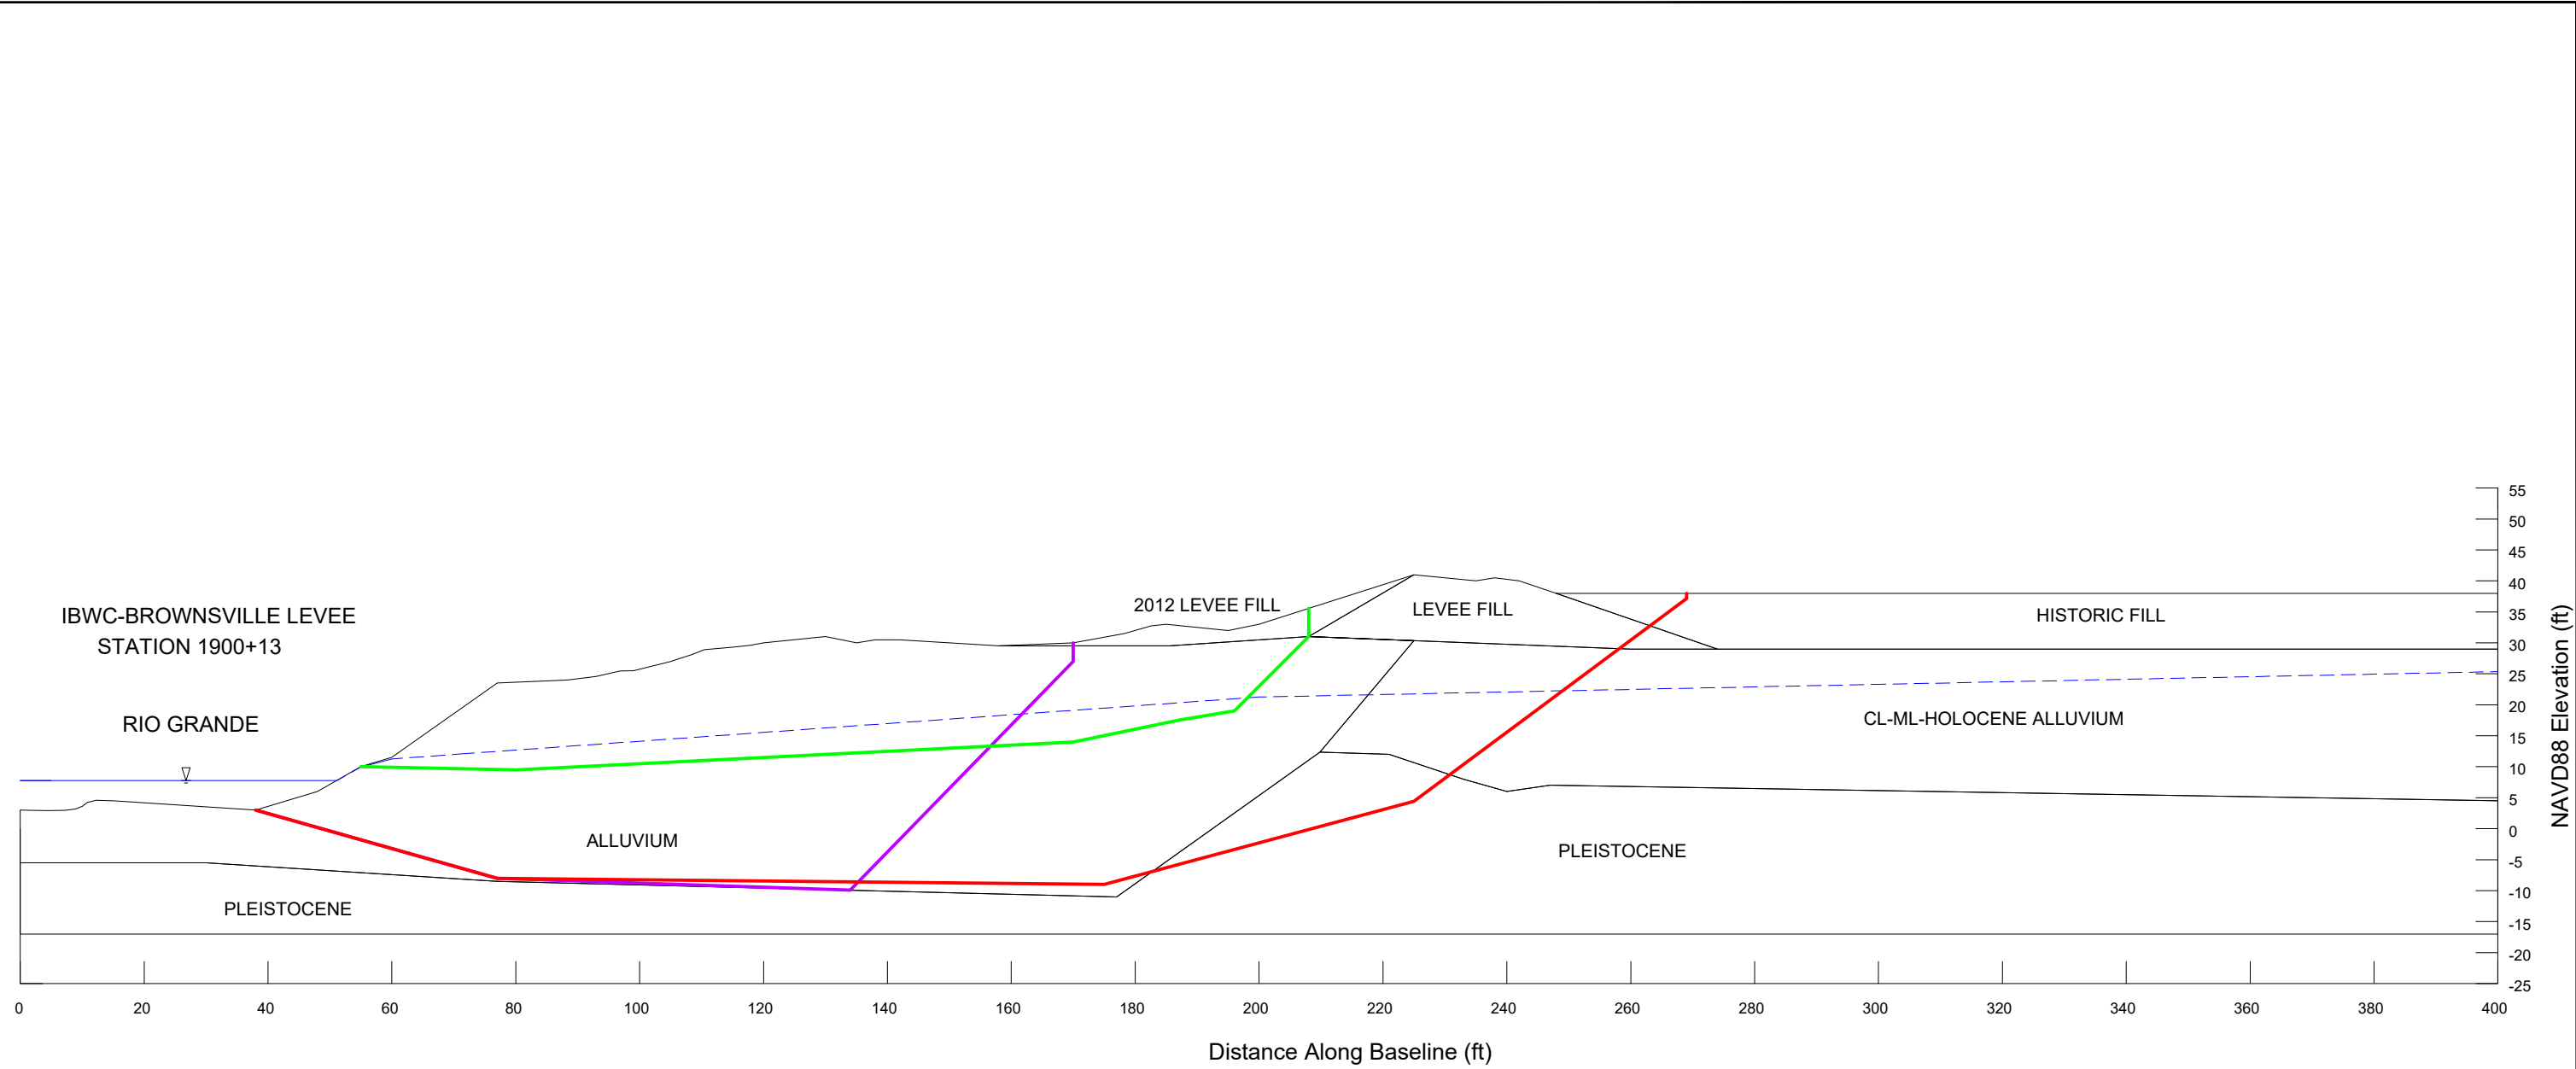
FIGURE 2

- TOE FAILURE SURFACE
- DEEP FAILURE SURFACE
- USACE FAILURE SURFACE
- - - WATER SURFACE

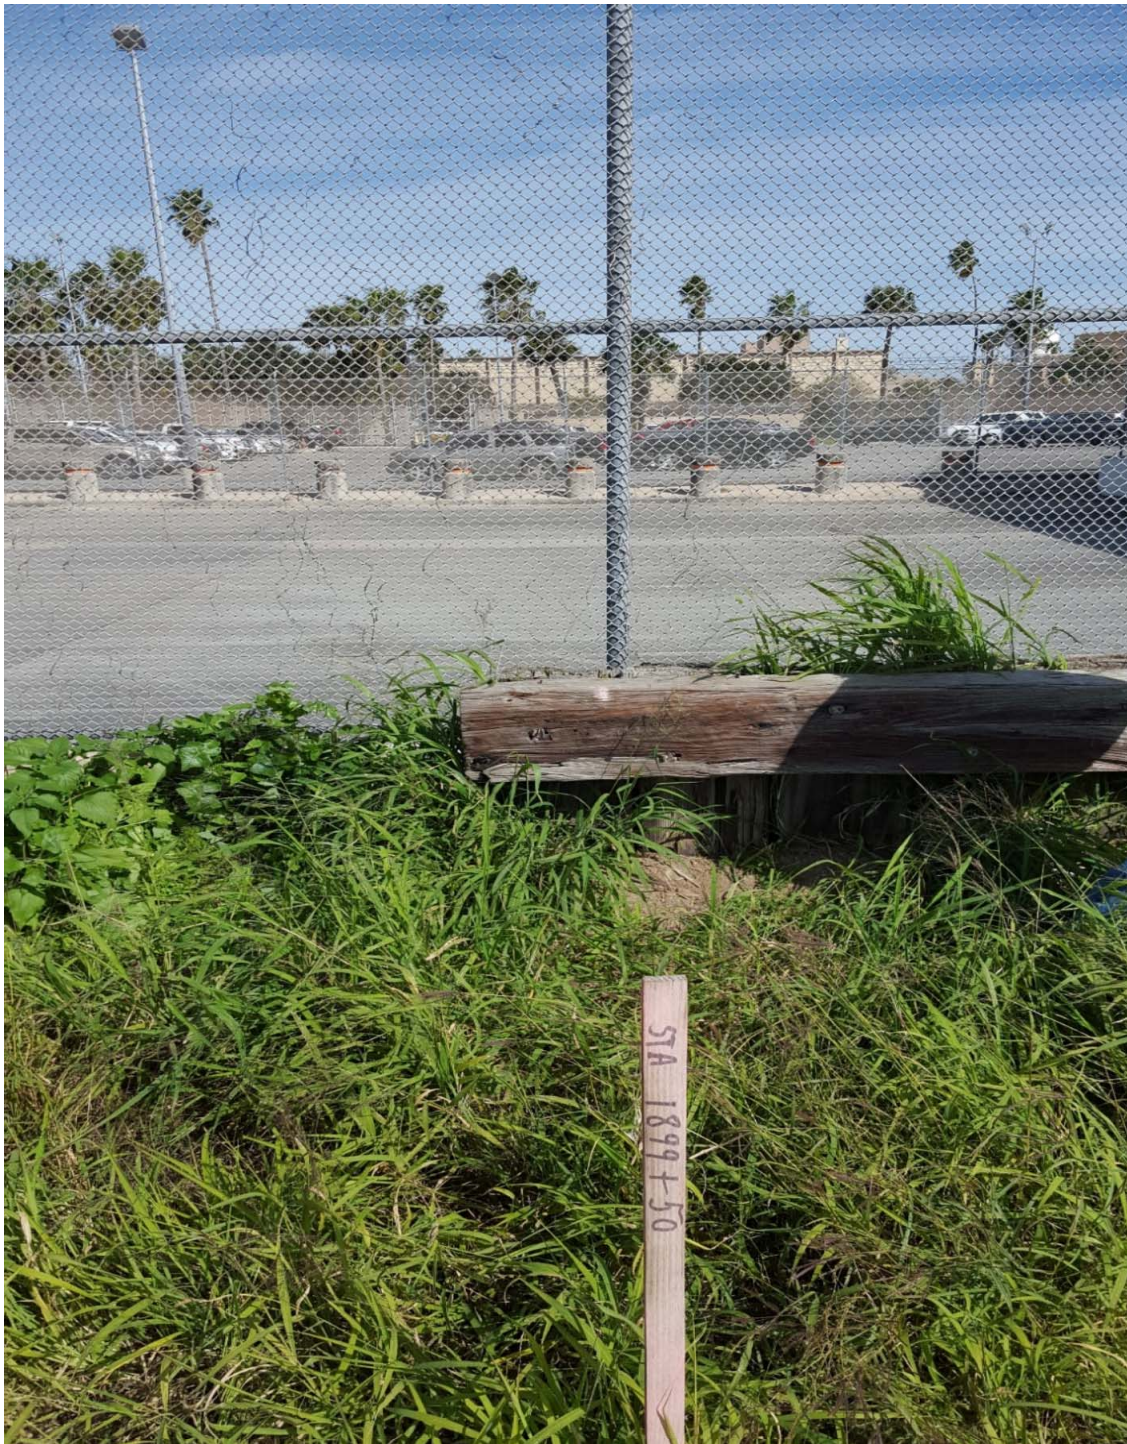
**Figure 2-4: Levee crest at Station 1899+50, looking northeast at wooden bulk head wall and Border Patrol facility parking lot**

levee. There is a wooden bulkhead wall that runs adjacent to the levee from approximately station 1899+50 to 1901+50, see Figure 2-4, its depth and purpose are unknown. Along the levee toe, there were indications of a very minor scarp at the grade break which appeared to have been there for some time. This area was not mapped during the January visit, but should be further investigated once the levee has been mowed. Photo Plate 1 in Appendix A include typical site conditions for the levee crest and toe from this visit.

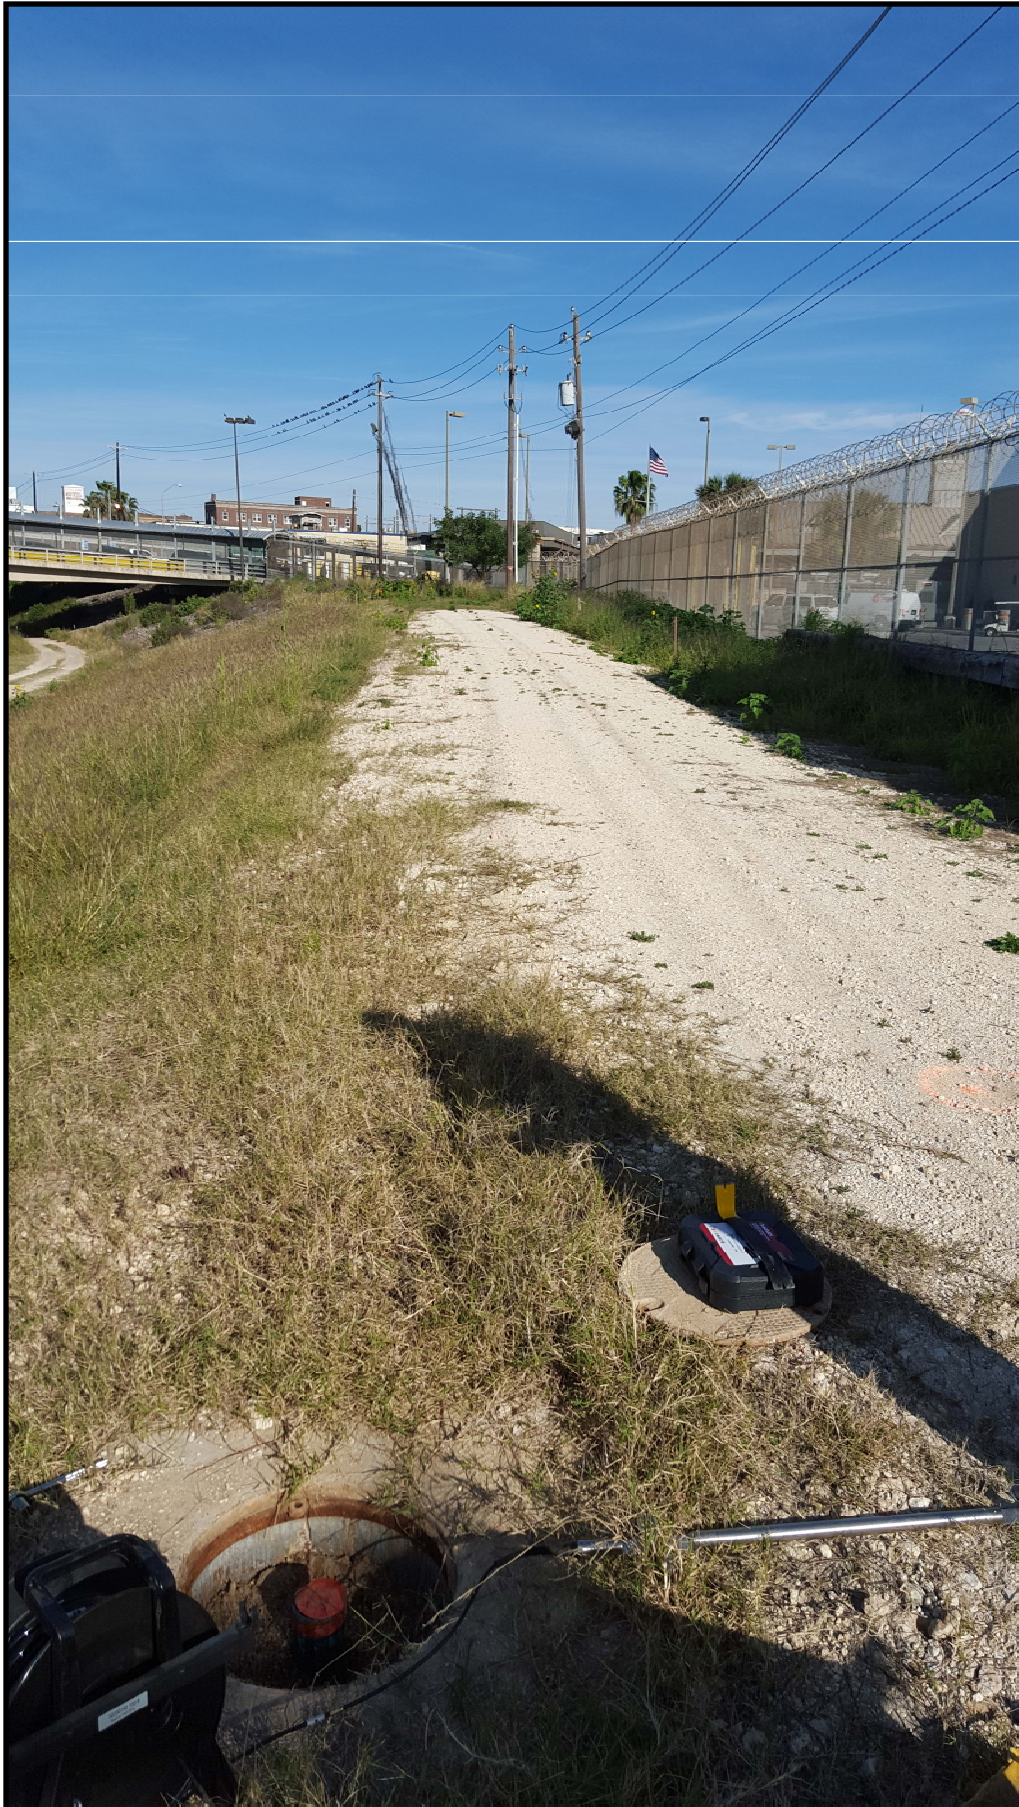
Levee crest at around STA 1900+13

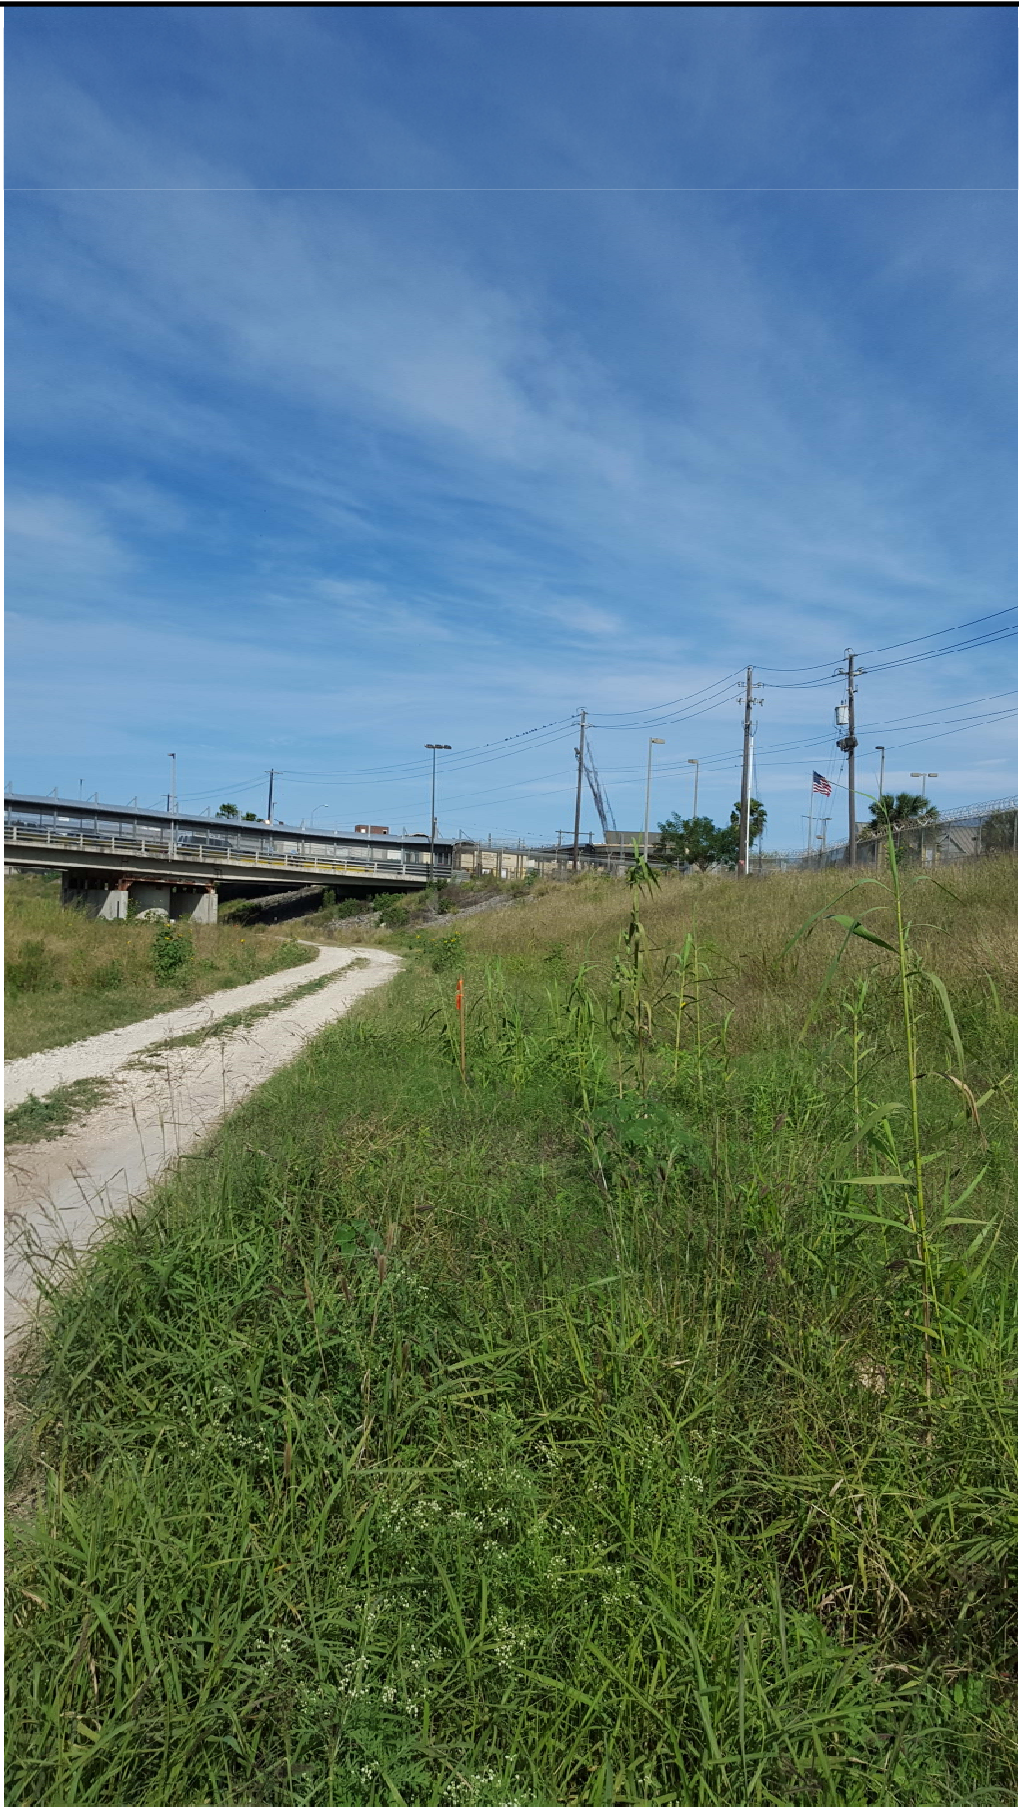
Levee toe at around STA 1900+13

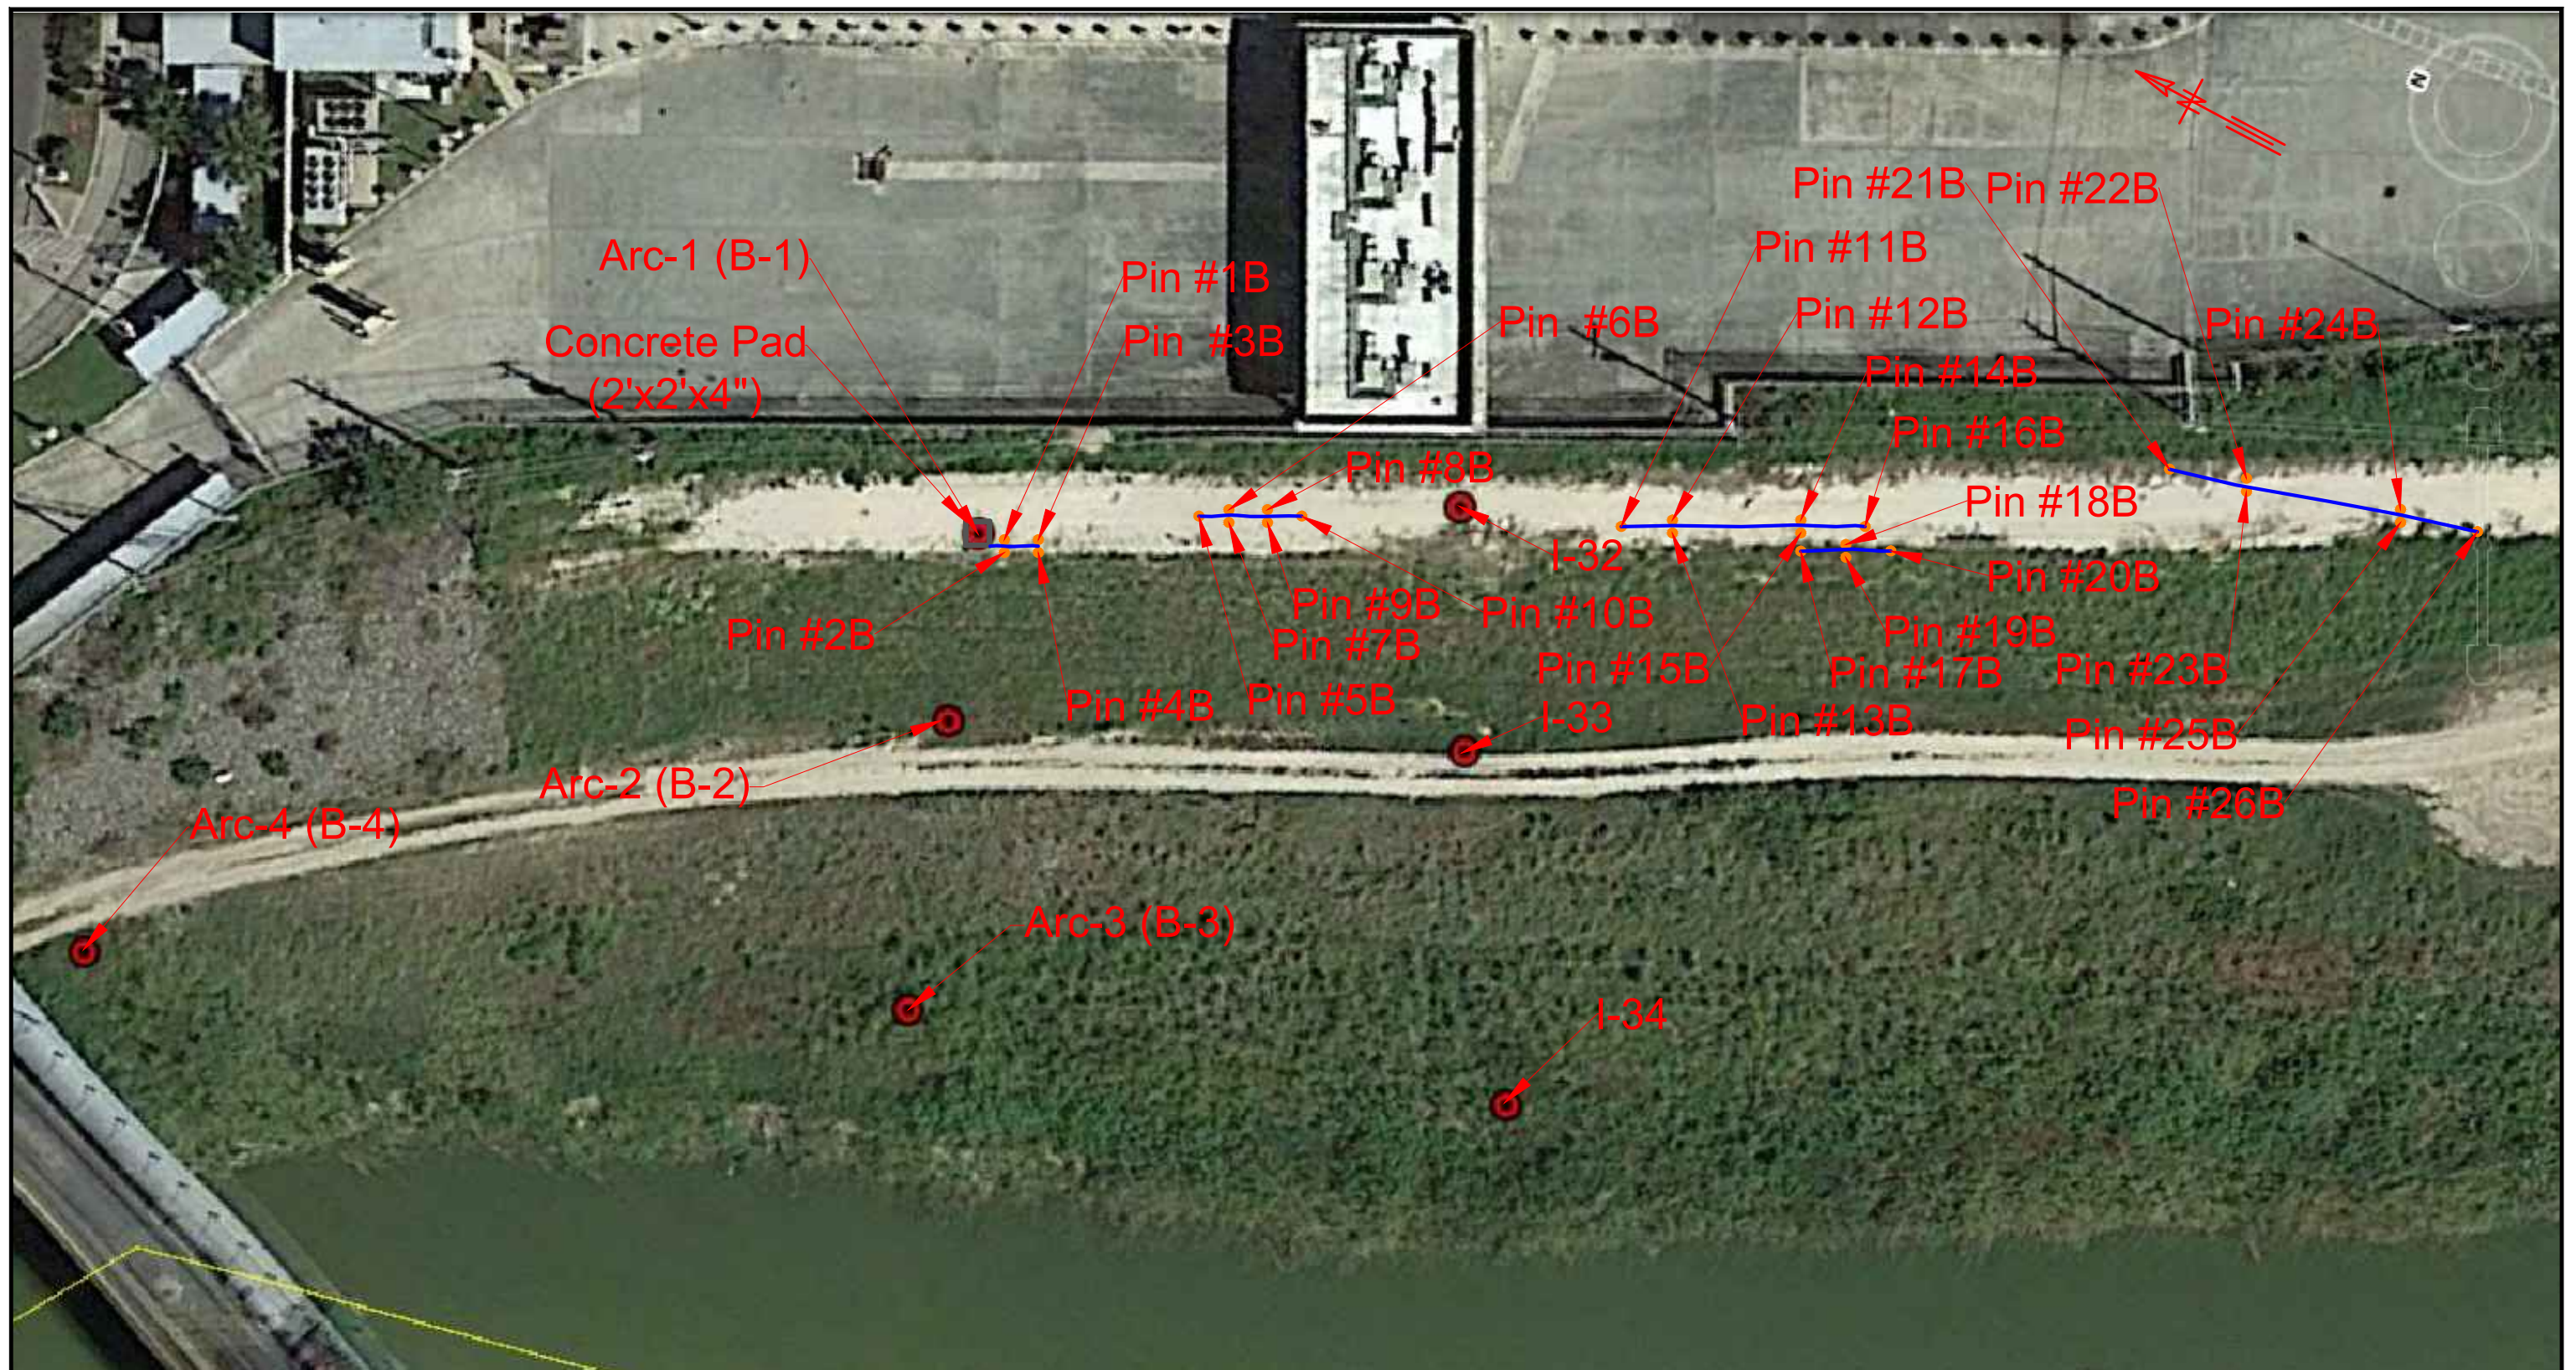
**INCLINOMETER AND LEVEE CRACKING LOCATION MAP**

**B-1:** 100 FEET BOREHOLE DRILLED AT THE TOP OF THE LEVEE

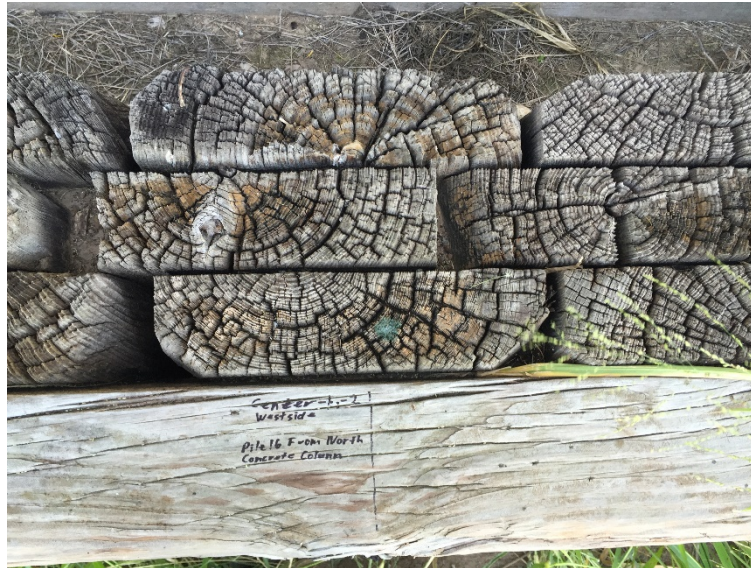
**Figure 1:** Picture of pile top near Location 2

As seen in Figures 1 and 2, the timber bulkhead wall consisted of sets of three (3) timbers installed in one (1) row to form a continuous wall. The following features could have impacted the response of the PIT signal:

During field testing of the piles, PSI noted visible features of the wall that may impact the response of the PIT signal and therefore, the results of the testing. Figures 1 and 2 present pictures taken during PSI’s site visit. Some commentary regarding the pictures is presented subsequently.

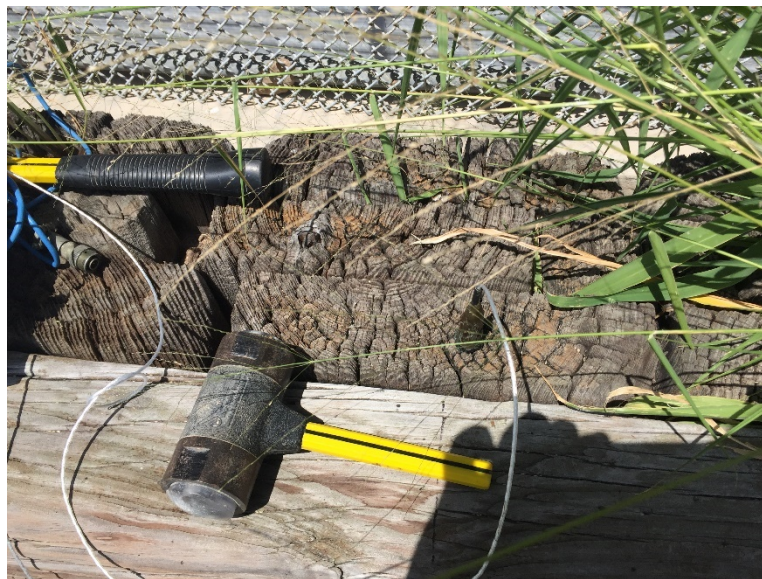
**Figure 2:** Picture of wall top near Location 1

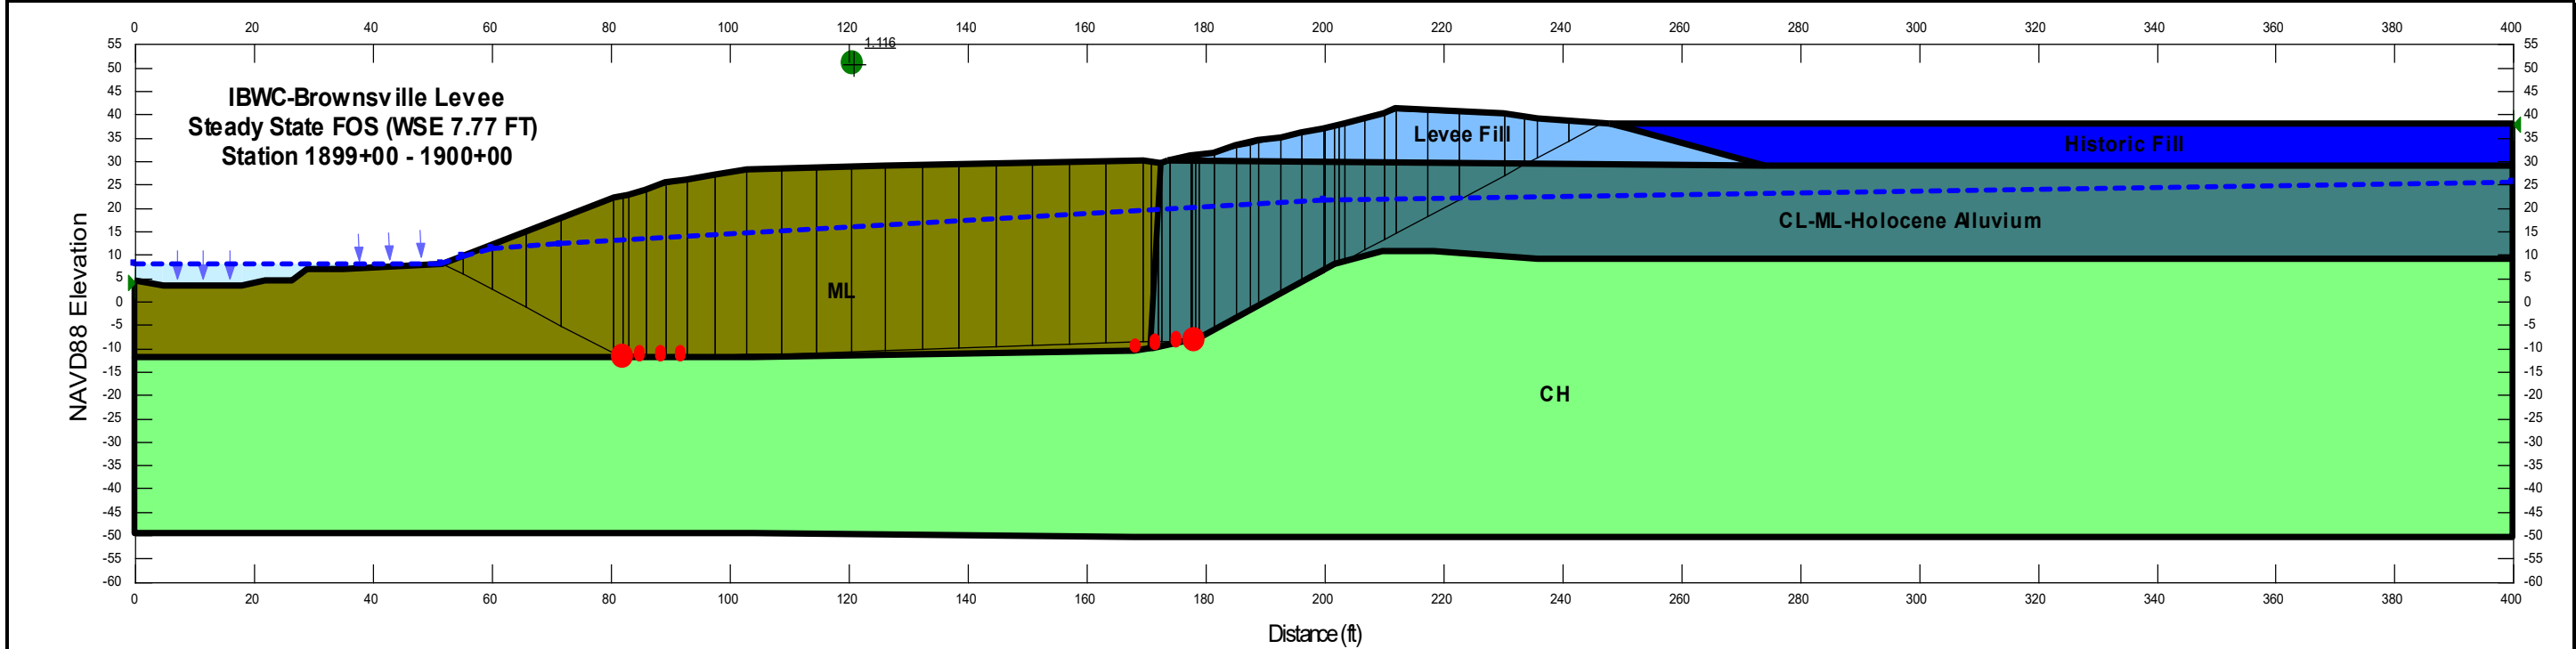
IBWC GEOTECHNICAL REPORT	
REMEDATION DESIGN OF LEVEE FLOODPLAIN FAILURE WITHIN THE UPPER BROWNSVILLE LEVEE REACH LOWER RIO GRANDE FLOOD CONTROL PROJECT	
SLOPE STABILITY - NEW MODEL STEADY STATE SEEPAGE	
ARCADIS	APPENDIX

Minimum Factor of Safety (FOS): 1.116

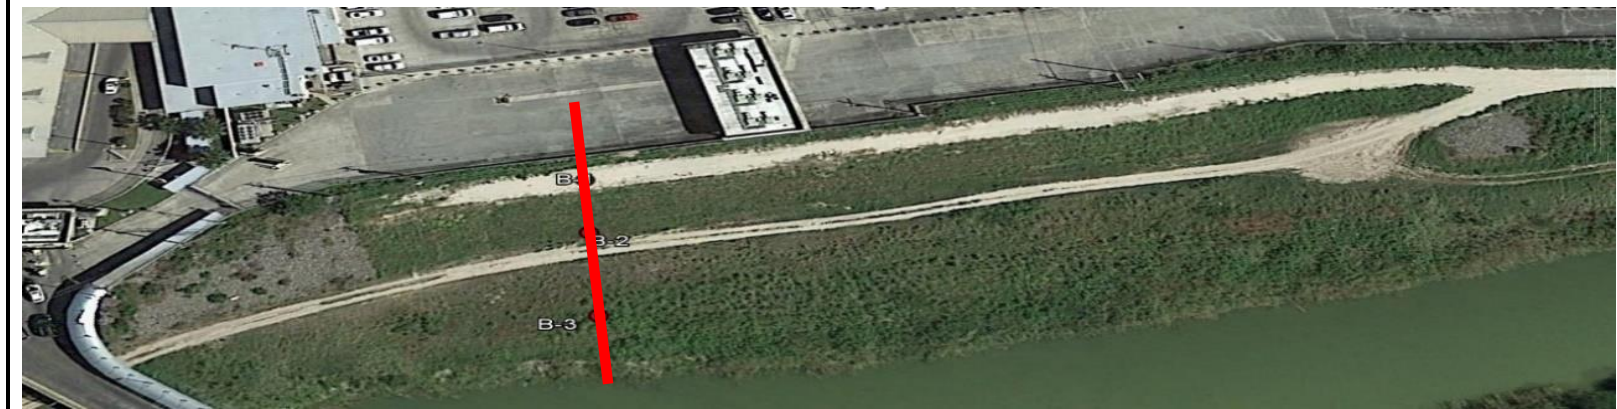
Material	Unit Weight (pcf)	c' (psf)	phi' (degree)
CH Pleistocene	121.98	90	12
CL-Holocene	123.37	225	12
ML	119.38	0	8
Levee Fill	127.34	105	12
Historic Fill	127.34	95	12
Combination 3: The cohesion (c) of the silt (ML) was assessed as 0 psf. Varied the cohesion (c) and phi of the other materials to yield a FOS of approximately 1

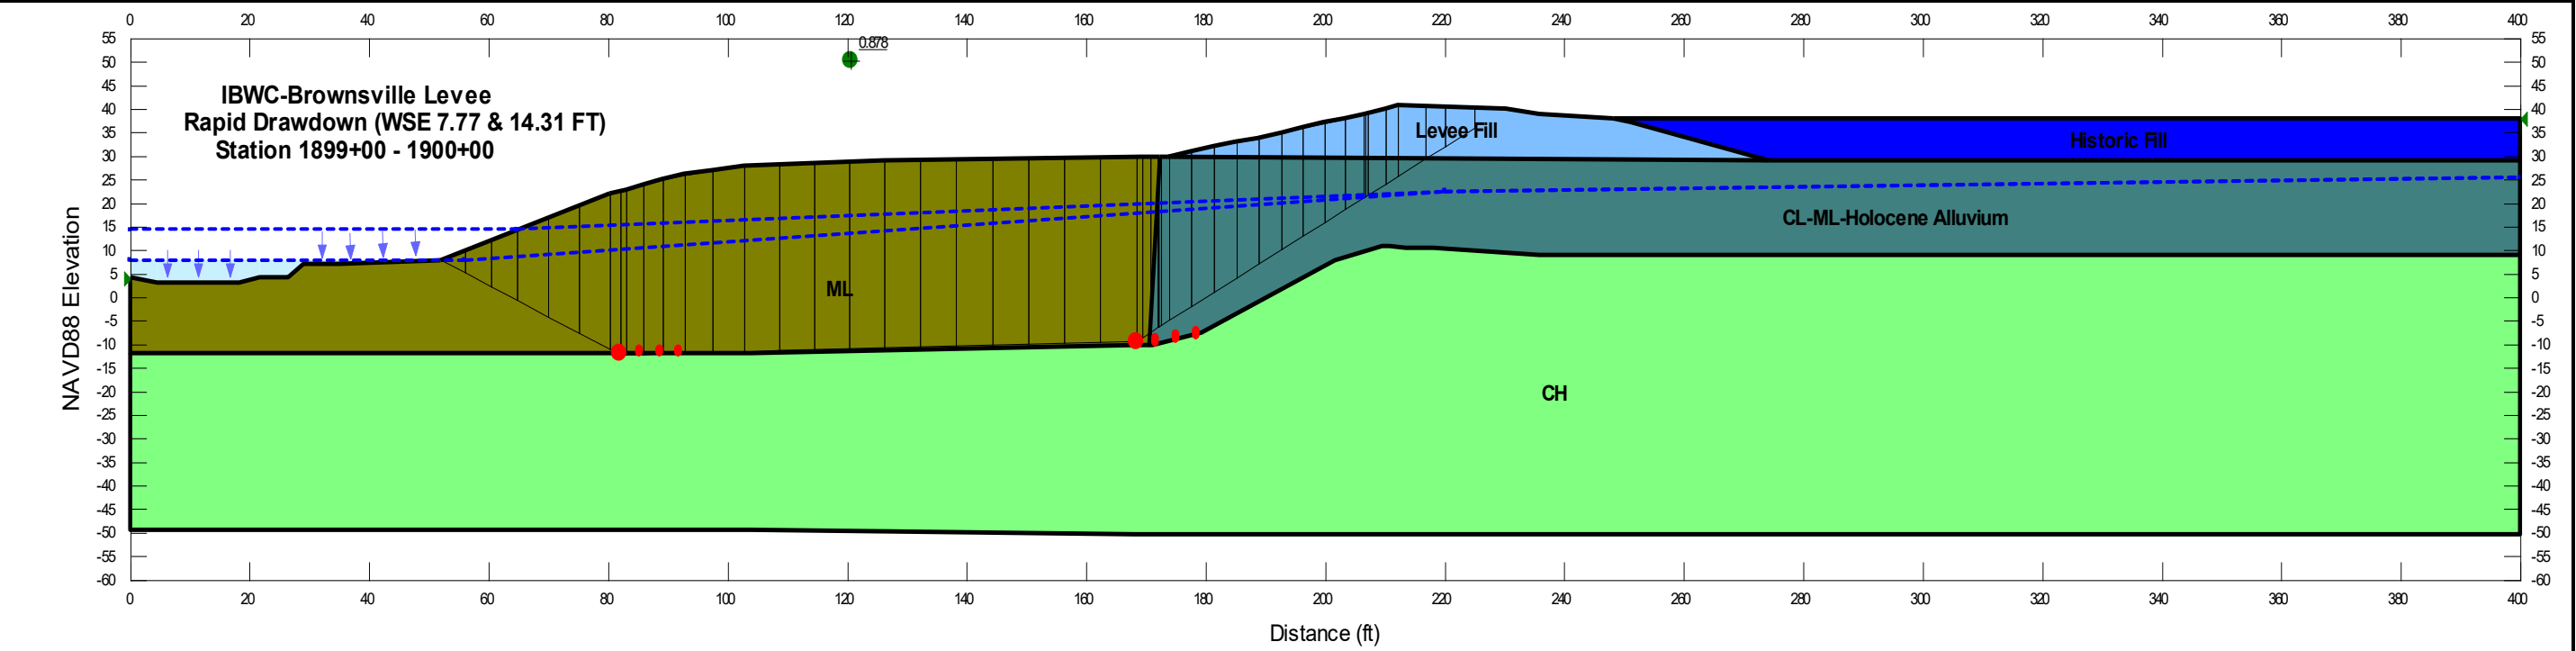
IBWC GEOTECHNICAL REPORT	
REMEDATION DESIGN OF LEVEE FLOODPLAIN FAILURE WITHIN THE UPPER BROWNSVILLE LEVEE REACH LOWER RIO GRANDE FLOOD CONTROL PROJECT	
SLOPE STABILITY - NEW MODEL STEADY STATE SEEPAGE	
ARCADIS	APPENDIX

Minimum Factor of Safety (FOS): 1.078

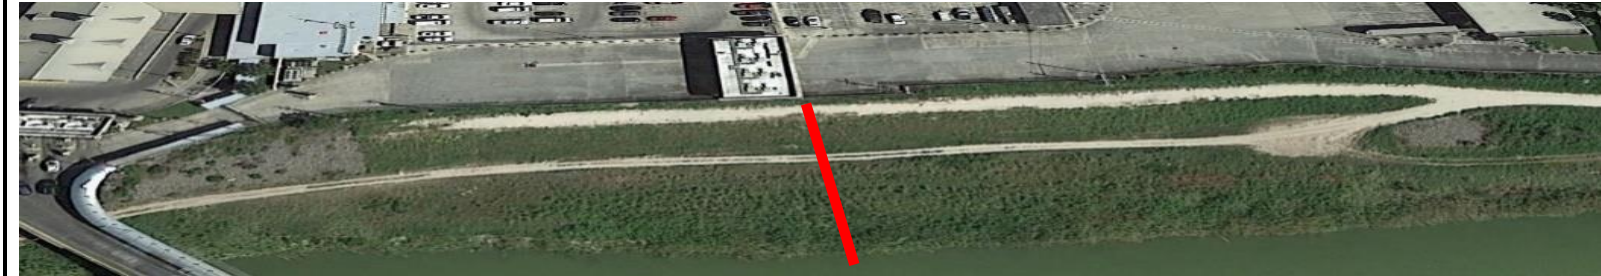
Minimum Factor of Safety (FOS): 1.552

Material	Unit Weight (pcf)	c' (psf)	phi' (degree)
CH Pleistocene	121.98	200	12
CL-Holocene	123.37	460	13
SM	117	0	32
ML	119.38	230	0
2012 Levee Fill	127.34	300	12
Levee Fill	127.34	300	12
Historic Fill	127.34	200	24
Soft ML	125.98	150	0
DMZ	120	1536.8	0
Combination 1: The angle of internal friction (phi) of the silt (ML) was assessed as 0 degrees. Varied the cohesion (c) and phi of the other materials to yield a FOS of approximately 1

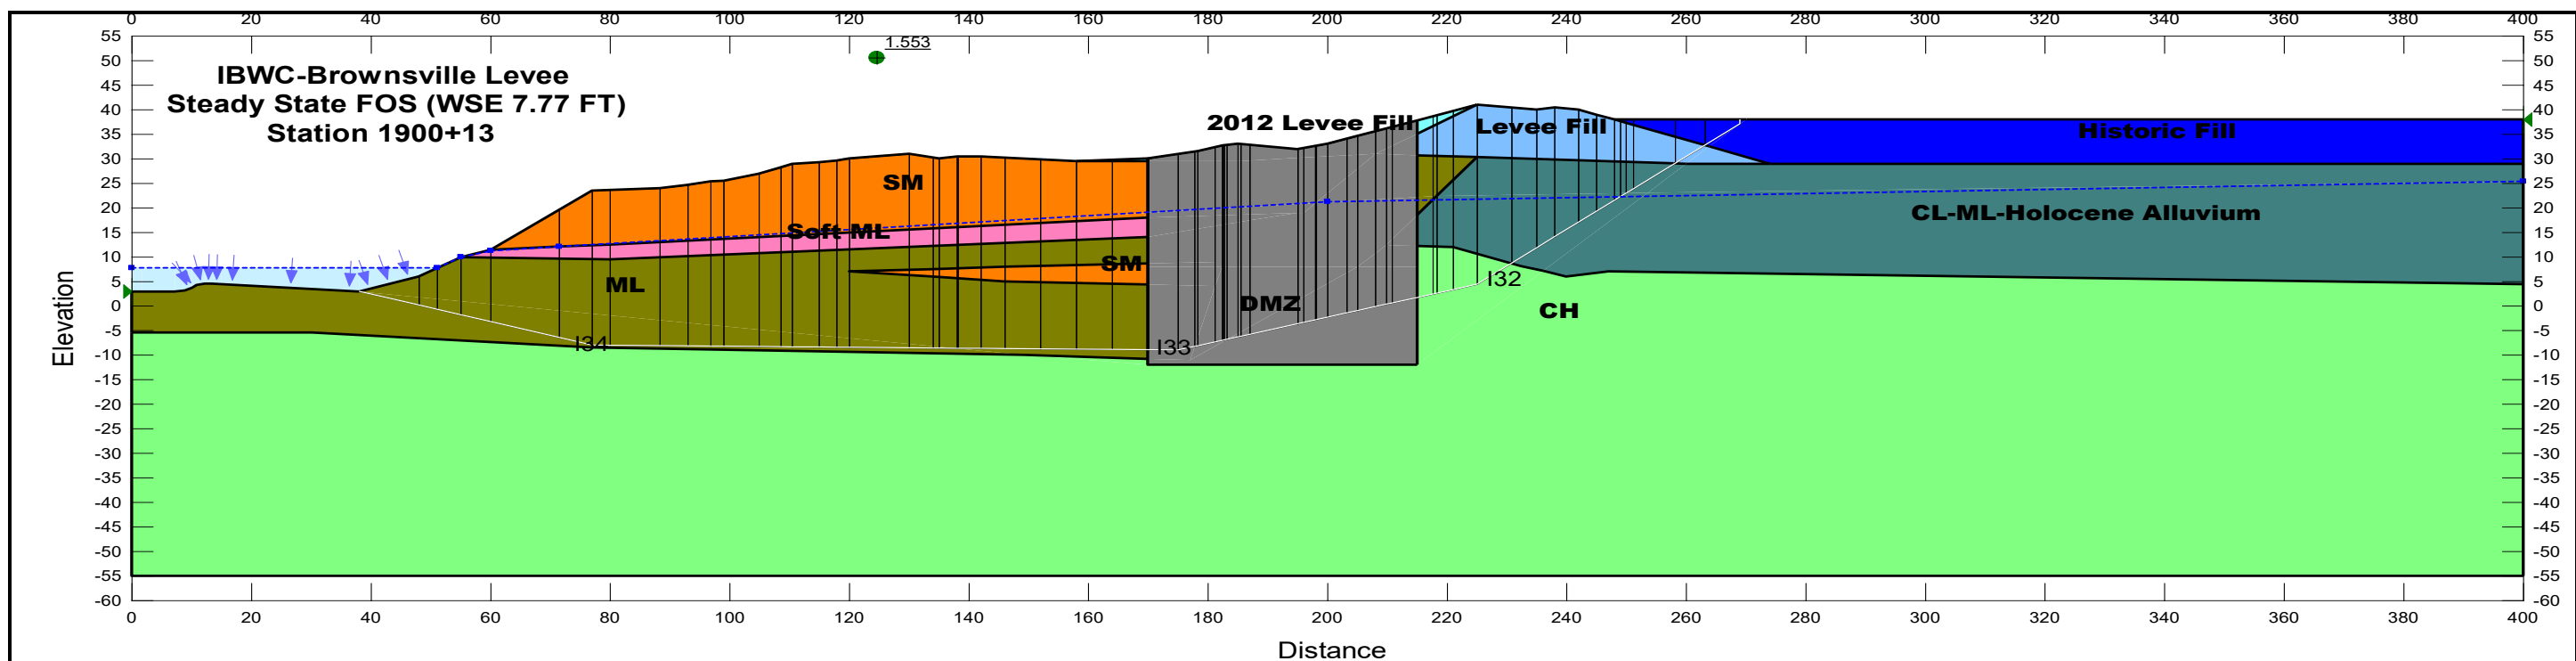
IBWC GEOTECHNICAL REPORT	
REMEDATION DESIGN OF LEVEE FLOODPLAIN FAILURE WITHIN THE UPPER BROWNSVILLE LEVEE REACH LOWER RIO GRANDE FLOOD CONTROL PROJECT	
SLOPE STABILITY MODEL - DEEP SOIL MIXING ASSESSMENT	
STEADY STATE SEEPAGE	
ARCADIS	APPENDIX

Minimum Factor of Safety (FOS): 1.553

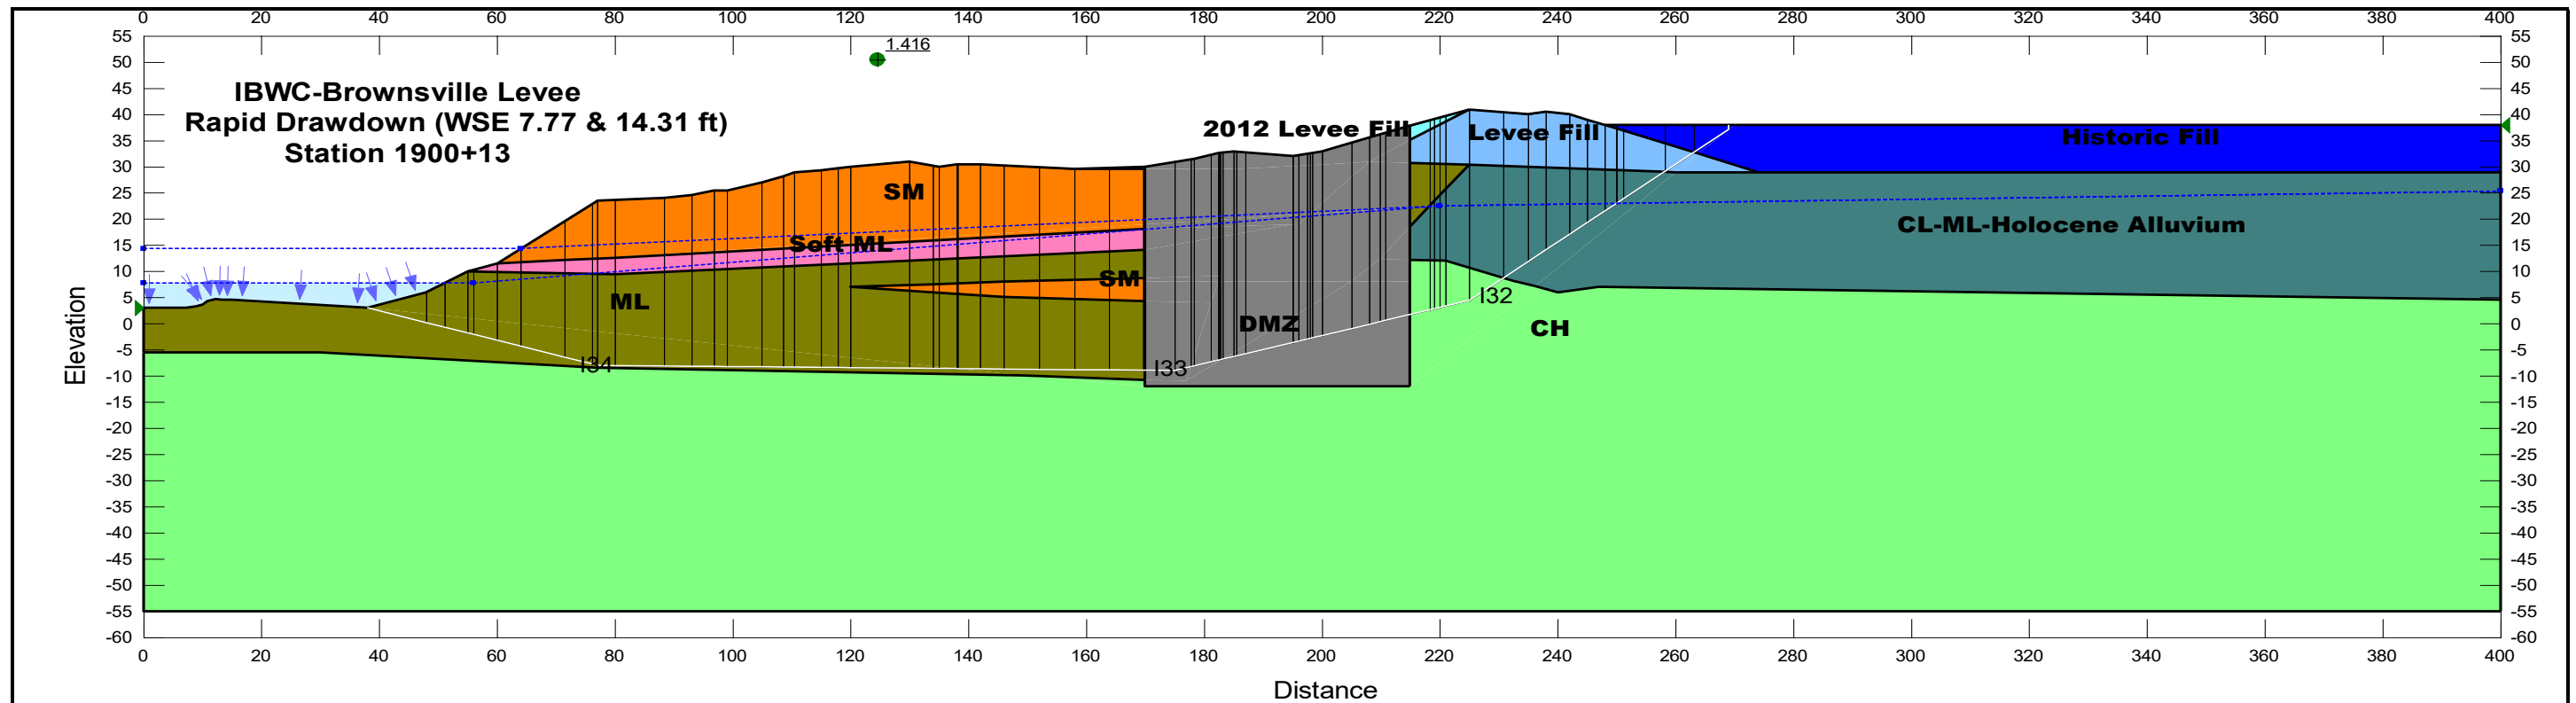
IBWC GEOTECHNICAL REPORT	
<b>REMEDIATION DESIGN OF LEVEE FLOODPLAIN FAILURE WITHIN THE UPPER BROWNSVILLE LEVEE REACH LOWER RIO GRANDE FLOOD CONTROL PROJECT</b>	
<b>SLOPE STABILITY MODEL - DEEP SOIL MIXING ASSESSMENT</b>	
<b>STEADY STATE SEEPAGE</b>	
	<b>APPENDIX</b>

Minimum Factor of Safety (FOS): 1.416

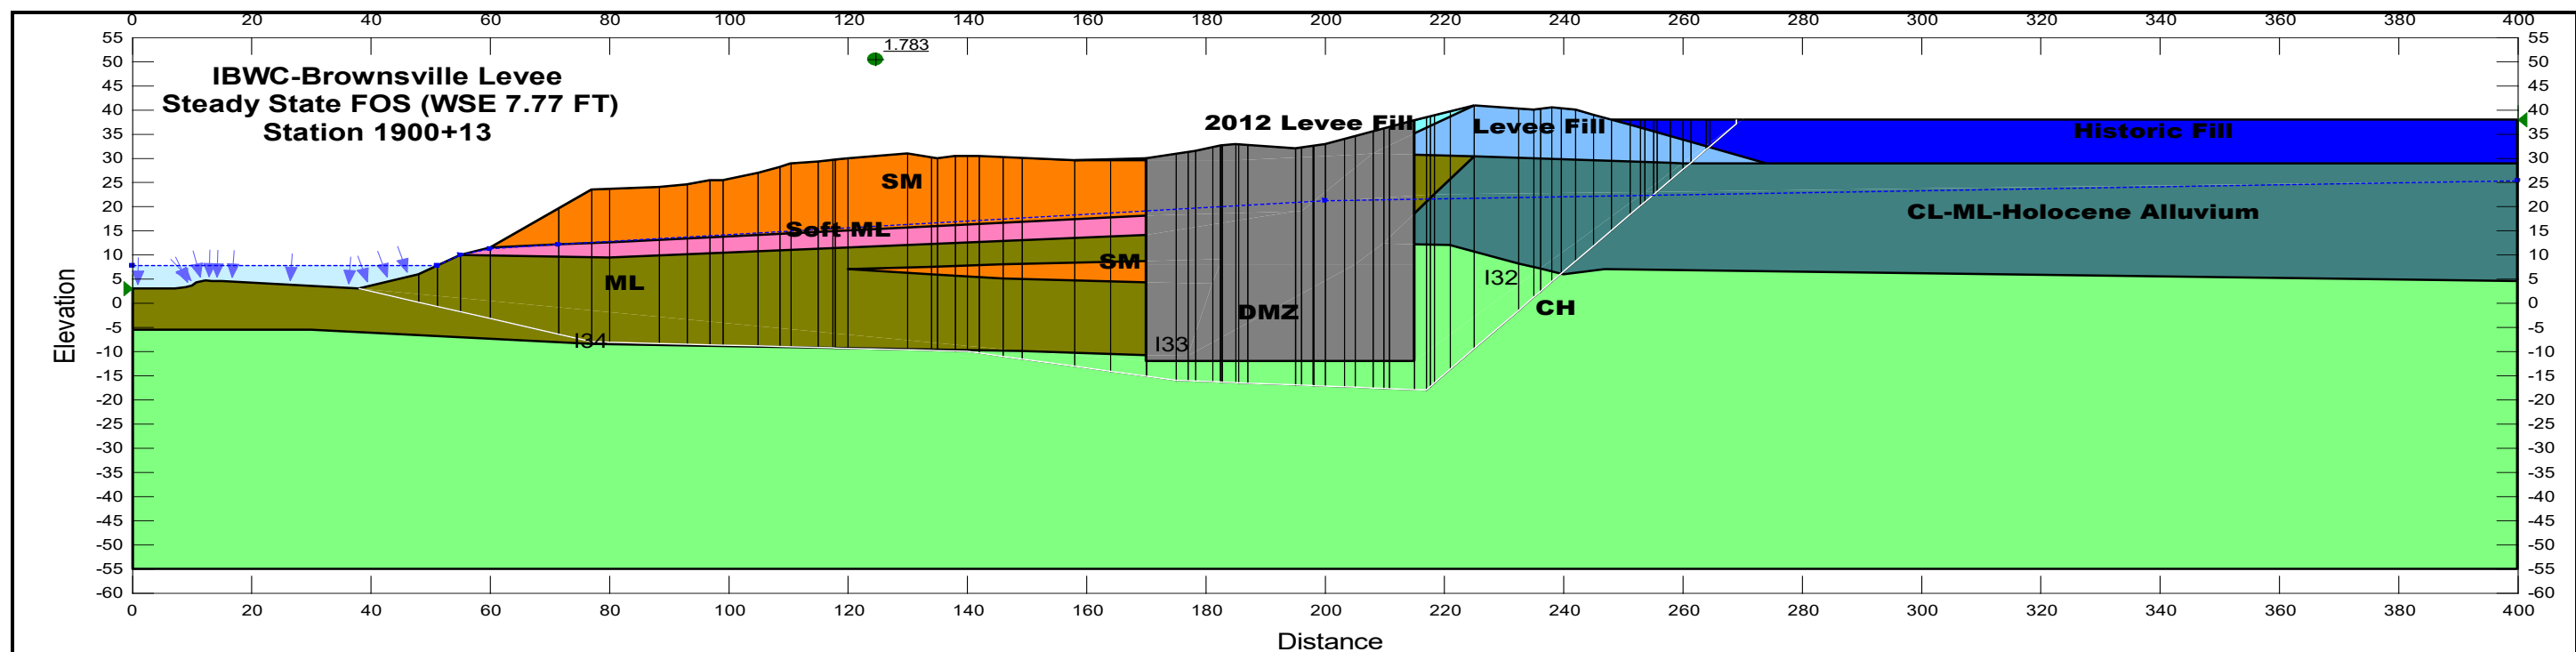
IBWC GEOTECHNICAL REPORT	
REMEDATION DESIGN OF LEVEE FLOODPLAIN FAILURE WITHIN THE UPPER BROWNSVILLE LEVEE REACH LOWER RIO GRANDE FLOOD CONTROL PROJECT SLOPE STABILITY MODEL - DEEP SOIL MIXING ASSESSMENT RAPID DRAWDOWN	
ARCADIS	APPENDIX

Minimum Factor of Safety (FOS): 1.783
