# **International Boundary and Water Commission United States Section**

## **Remediation Design of Levee and Floodplain Failure Within the Upper Brownsville Levee Reach Lower Rio Grande Flood Control Project**

### **Design Documentation Report Final Submittal**

May 2022

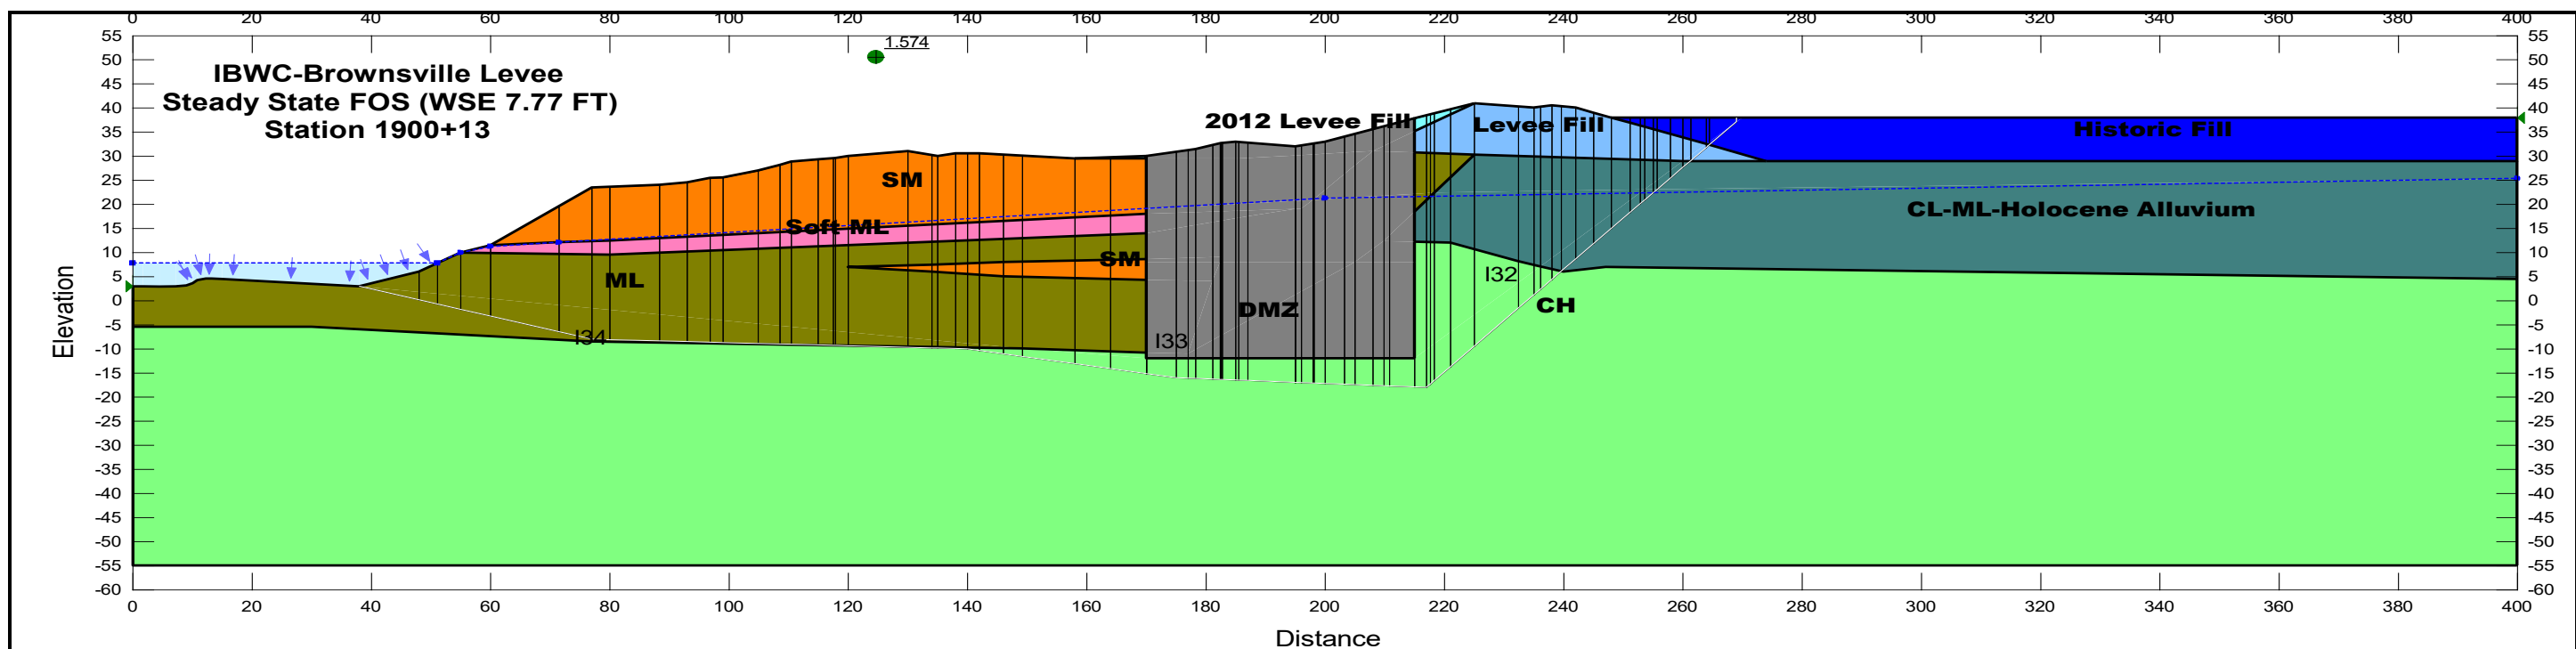
IBWC GEOTECHNICAL REPORT	
REMEDATION DESIGN OF LEVEE FLOODPLAIN FAILURE WITHIN THE UPPER BROWNSVILLE LEVEE REACH LOWER RIO GRANDE FLOOD CONTROL PROJECT	
GLOBAL STABILITY SPEC 1 - DEEP SOIL MIXING ASSESSMENT STEADY STATE SEEPAGE	
ARCADIS	APPENDIX

Minimum Factor of Safety (FOS): 1.574

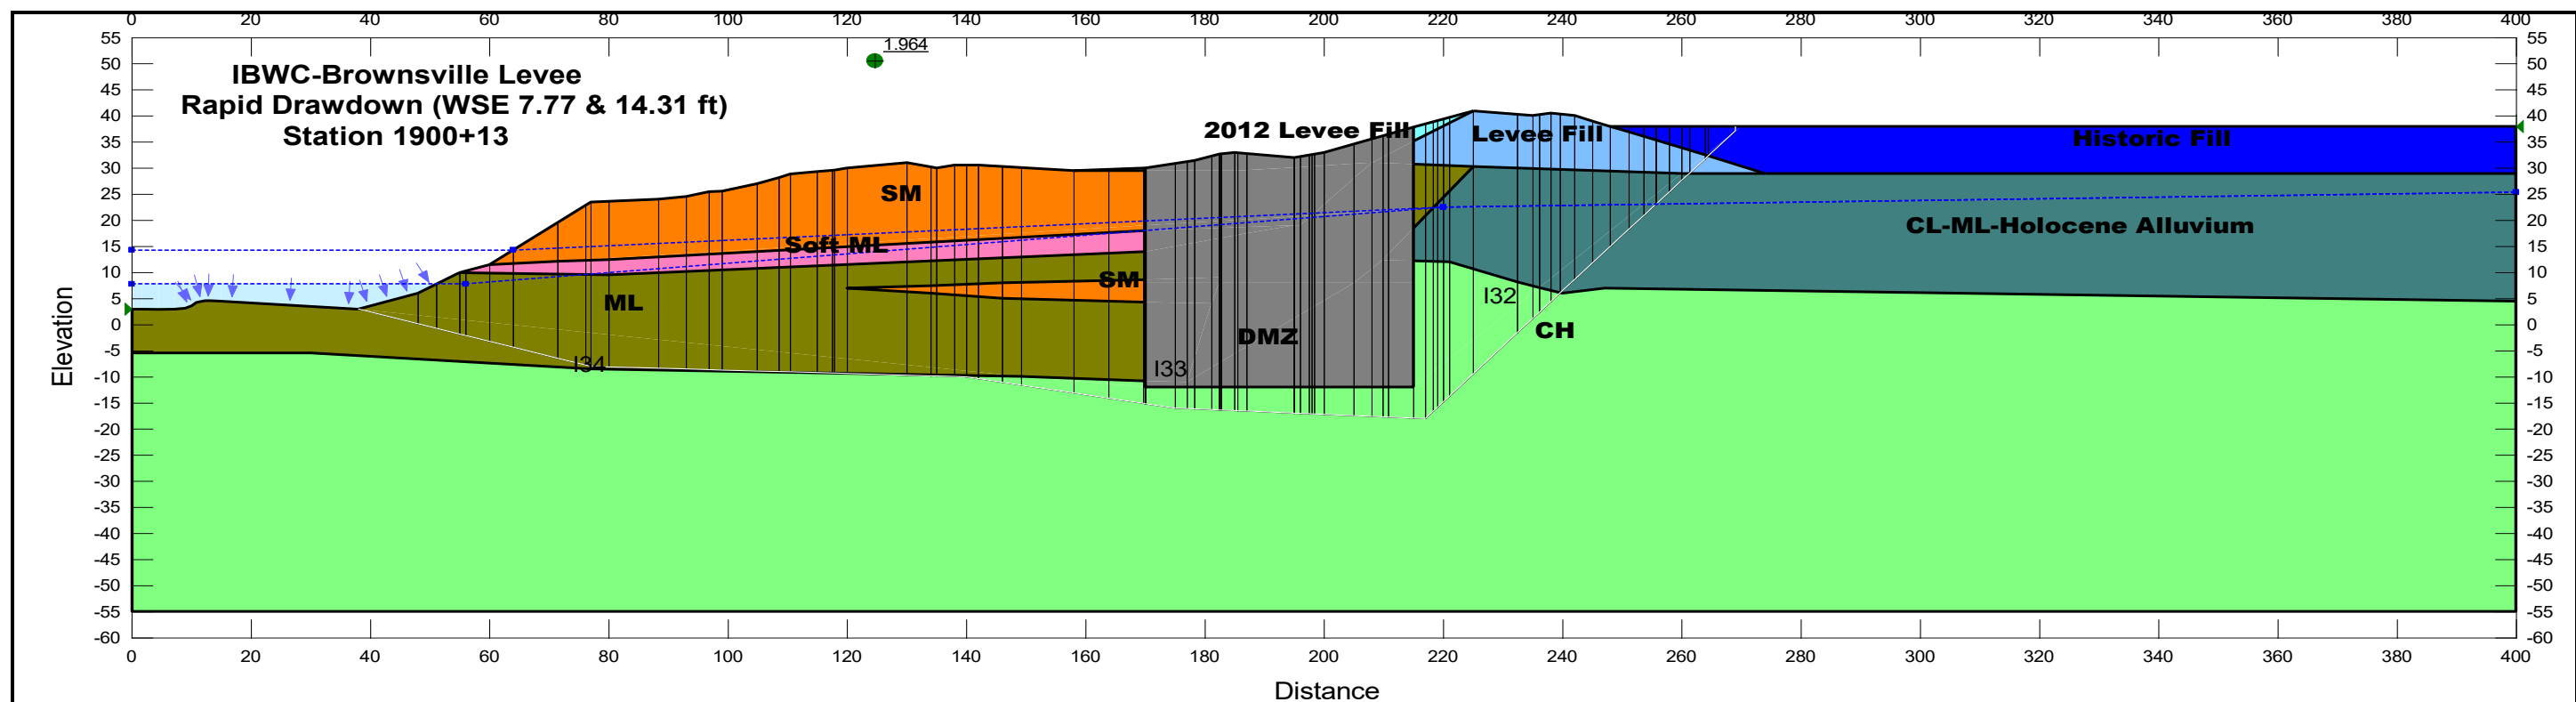
IBWC GEOTECHNICAL REPORT	
REMEDATION DESIGN OF LEVEE FLOODPLAIN FAILURE WITHIN THE UPPER BROWNSVILLE LEVEE REACH LOWER RIO GRANDE FLOOD CONTROL PROJECT	
GLOBAL STABILITY SPEC 1 - DEEP SOIL MIXING ASSESSMENT STEADY STATE SEEPAGE	
ARCADIS	APPENDIX

Minimum Factor of Safety (FOS): 1.964

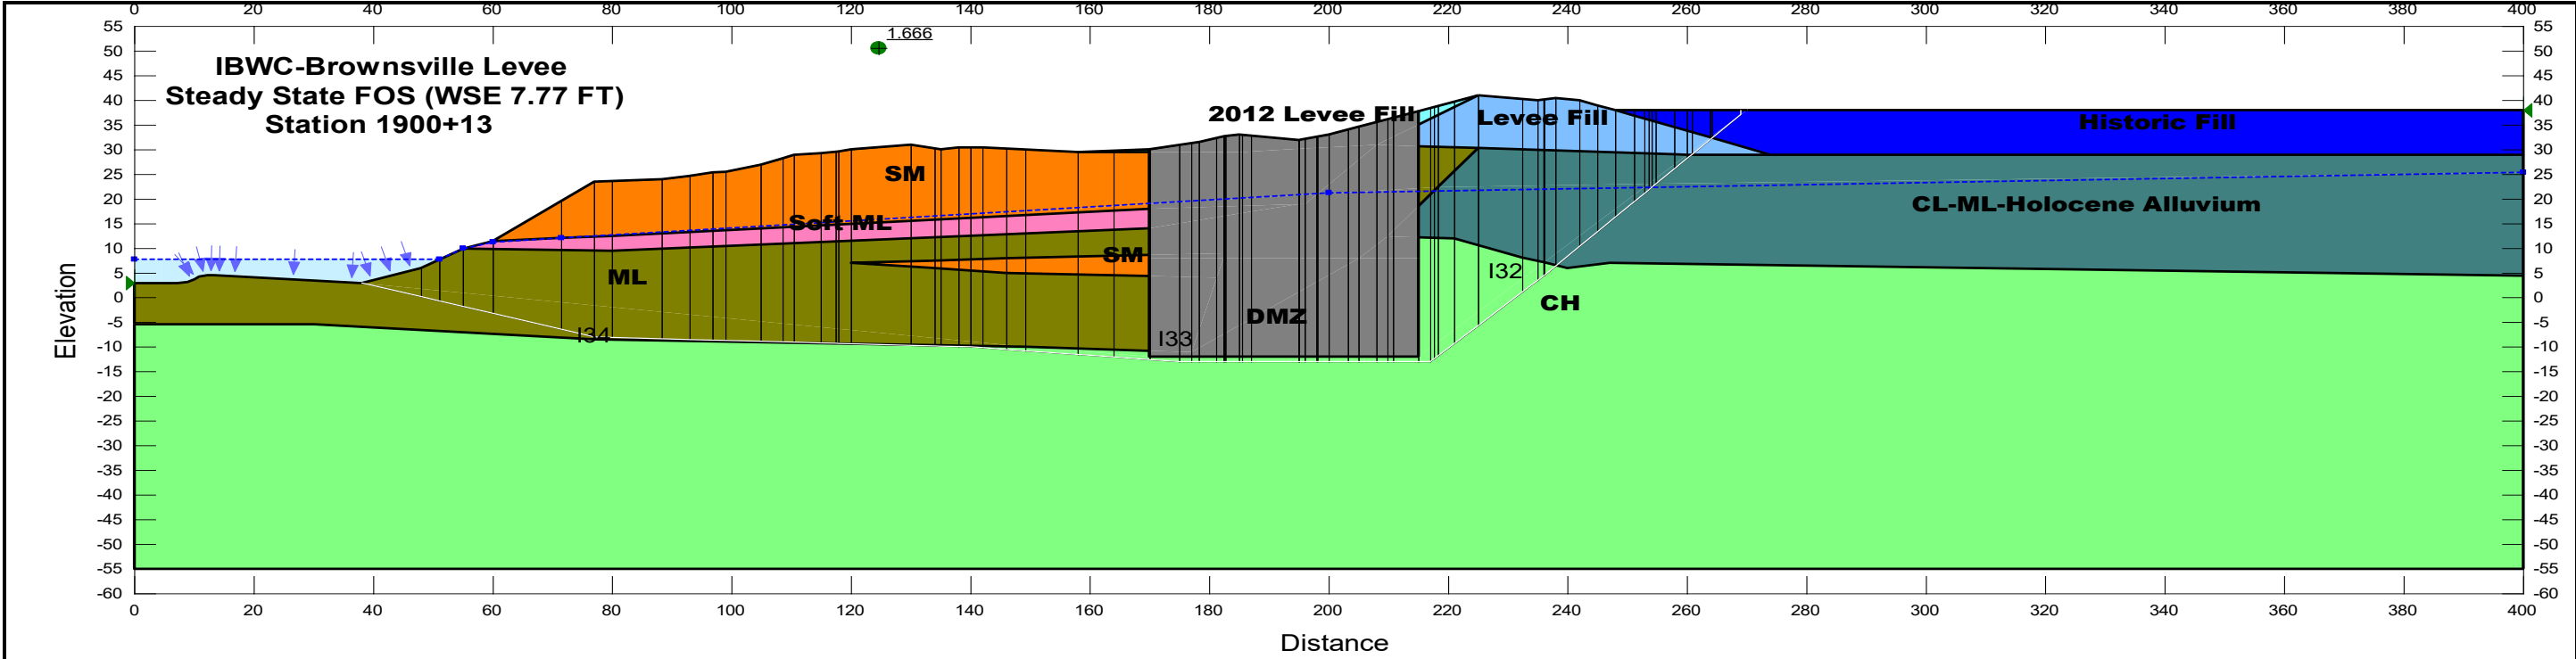
IBWC GEOTECHNICAL REPORT	
<b>REMEDIATION DESIGN OF LEVEE FLOODPLAIN FAILURE WITHIN THE UPPER BROWNSVILLE LEVEE REACH LOWER RIO GRANDE FLOOD CONTROL PROJECT</b>	
GLOBAL STABILITY SPEC 1 - DEEP SOIL MIXING ASSESSMENT	
RAPID DRAWDOWN	
	APPENDIX

Minimum Factor of Safety (FOS): 1.666

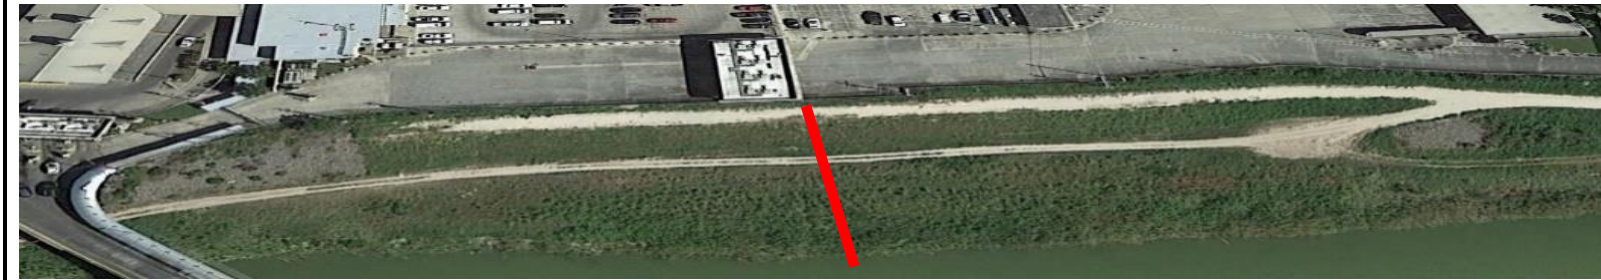
Material	Unit Weight (pcf)	c' (psf)	phi' (degree)
CH Pleistocene	121.98	200	12
CL-Holocene	123.37	460	13
SM	117	0	32
ML	119.38	230	0
2012 Levee Fill	127.34	300	12
Levee Fill	127.34	300	12
Historic Fill	127.34	200	24
Soft ML	125.98	150	0
DMZ	120	1536.8	0
Combination 1: The angle of internal friction (phi) of the silt (ML) was assessed as 0 degrees. Varied the cohesion (c) and phi of the other materials to yield a FOS of approximately 1

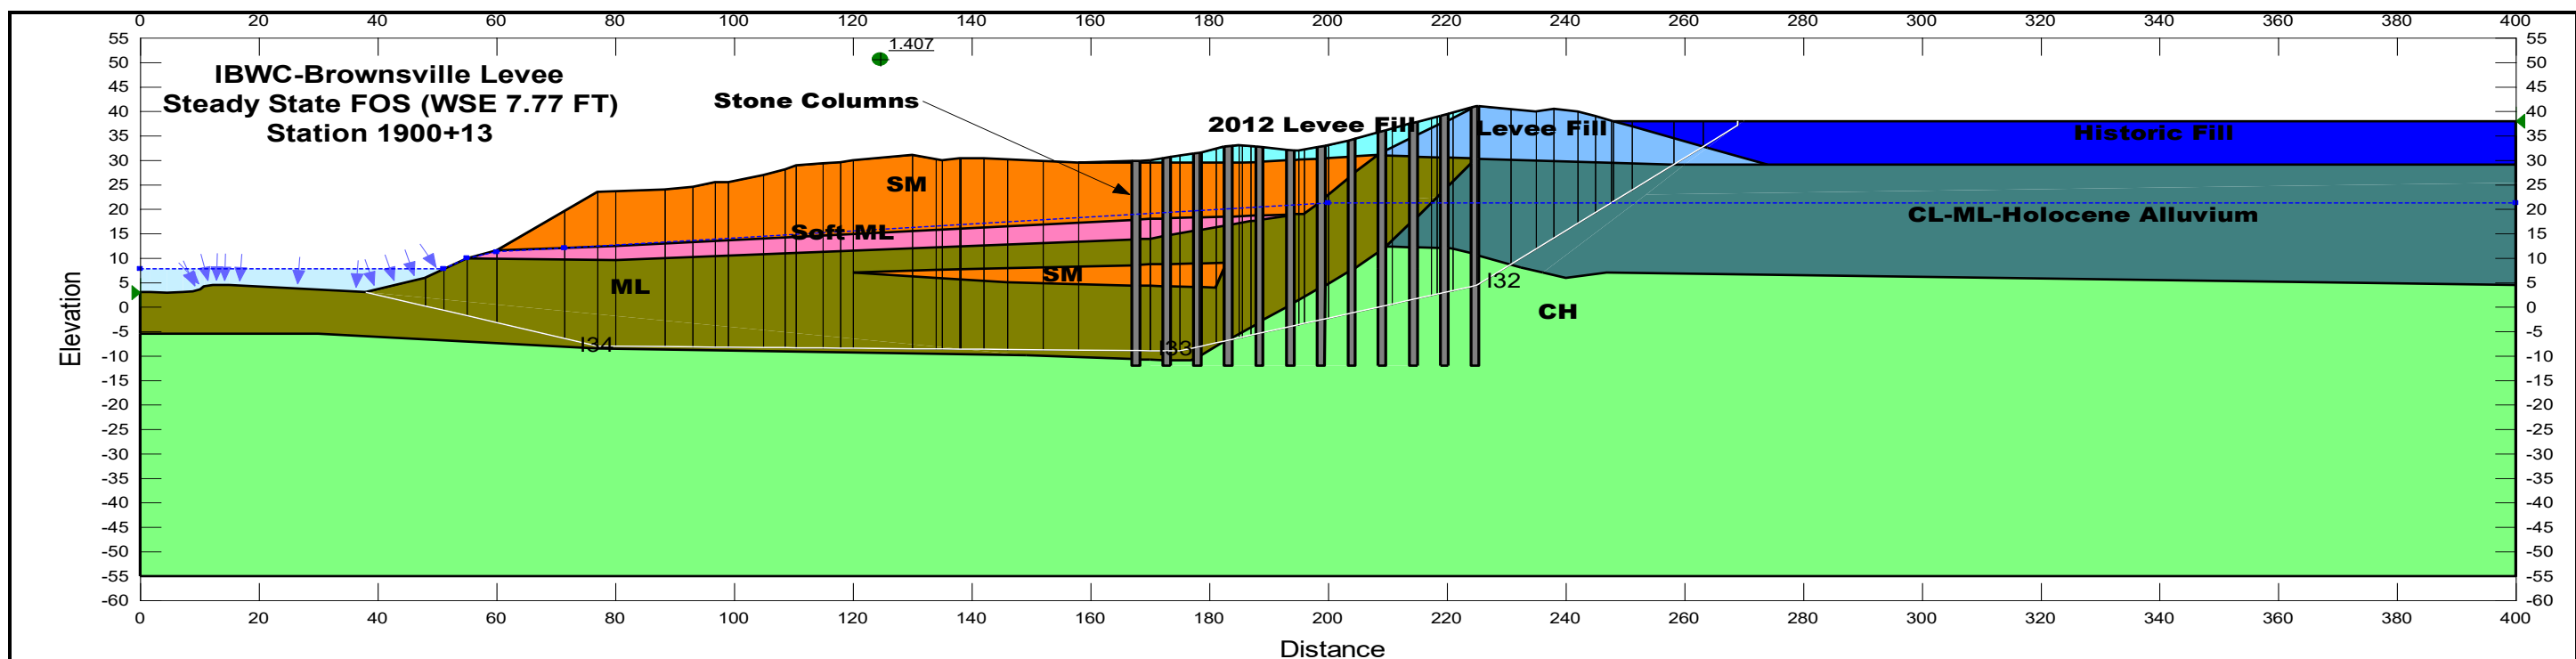
IBWC GEOTECHNICAL REPORT	
REMEDATION DESIGN OF LEVEE FLOODPLAIN FAILURE WITHIN THE UPPER BROWNSVILLE LEVEE REACH LOWER RIO GRANDE FLOOD CONTROL PROJECT  SLOPE STABILITY MODEL - STONE COLUMNS ASSESSMENT  STEADY STATE SEEPAGE	
ARCADIS	APPENDIX

Minimum Factor of Safety (FOS): 1.407

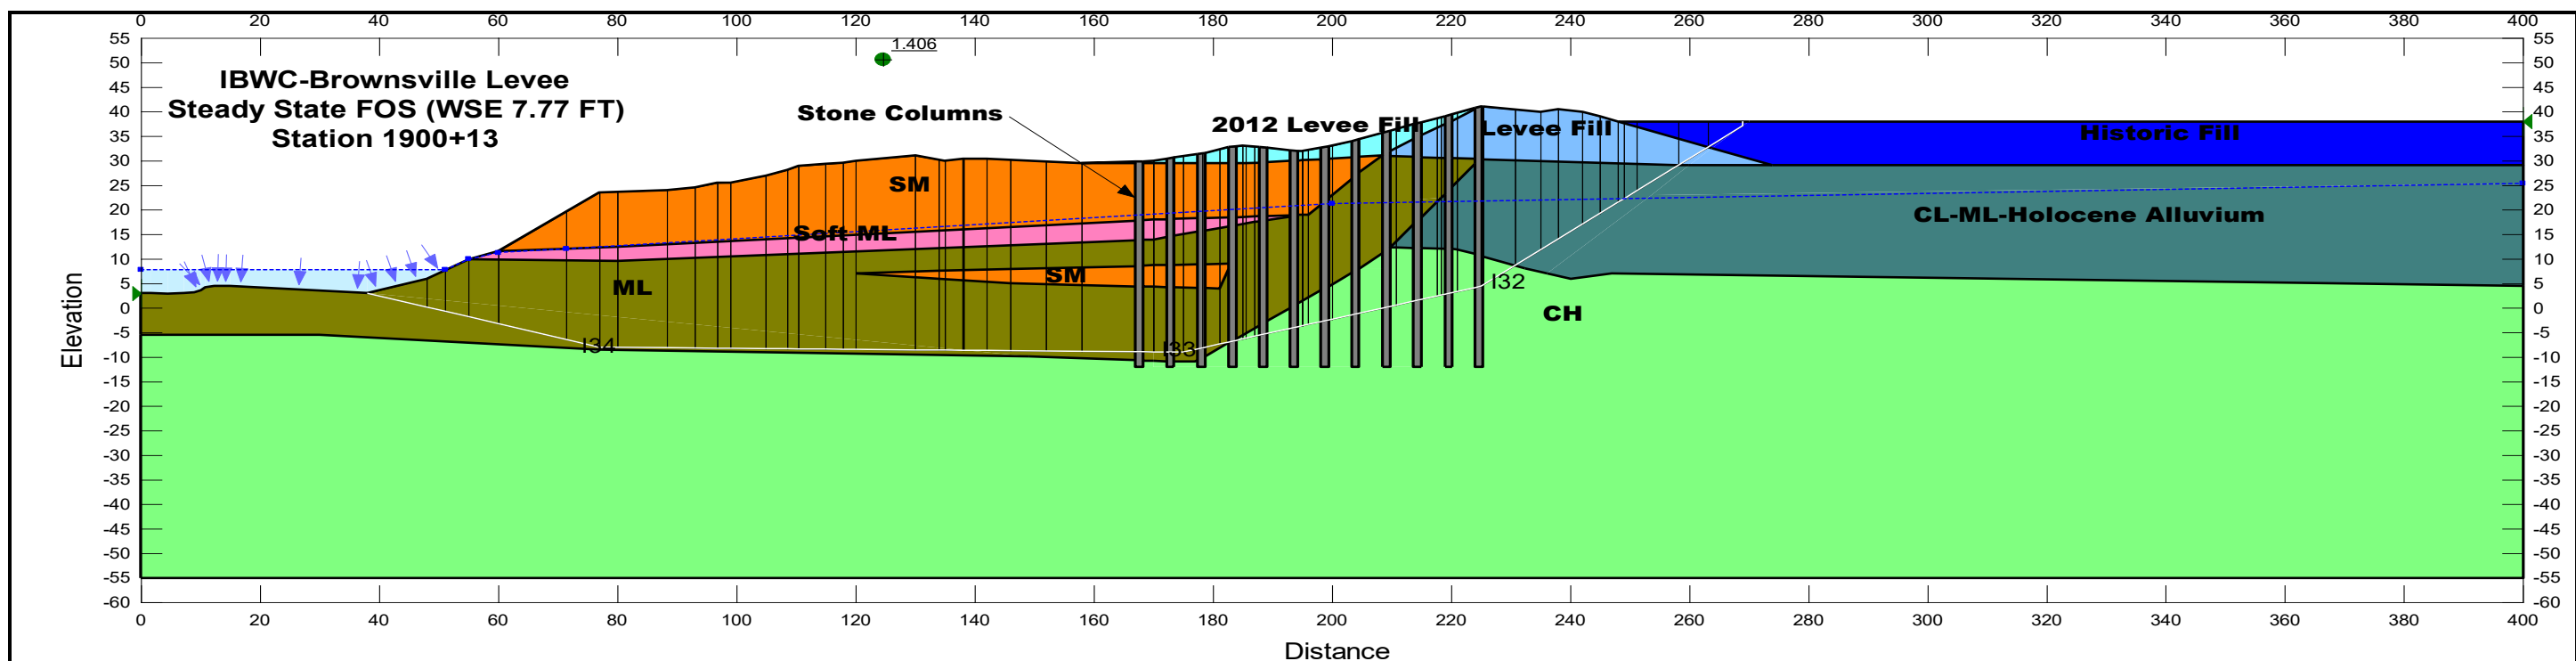
IBWC GEOTECHNICAL REPORT	
REMEDATION DESIGN OF LEVEE FLOODPLAIN FAILURE WITHIN THE UPPER BROWNSVILLE LEVEE REACH LOWER RIO GRANDE FLOOD CONTROL PROJECT	
SLOPE STABILITY MODEL - STONE COLUMNS ASSESSMENT	
STEADY STATE SEEPAGE	
ARCADIS	APPENDIX

**Minimum Factor of Safety (FOS): 1.406**

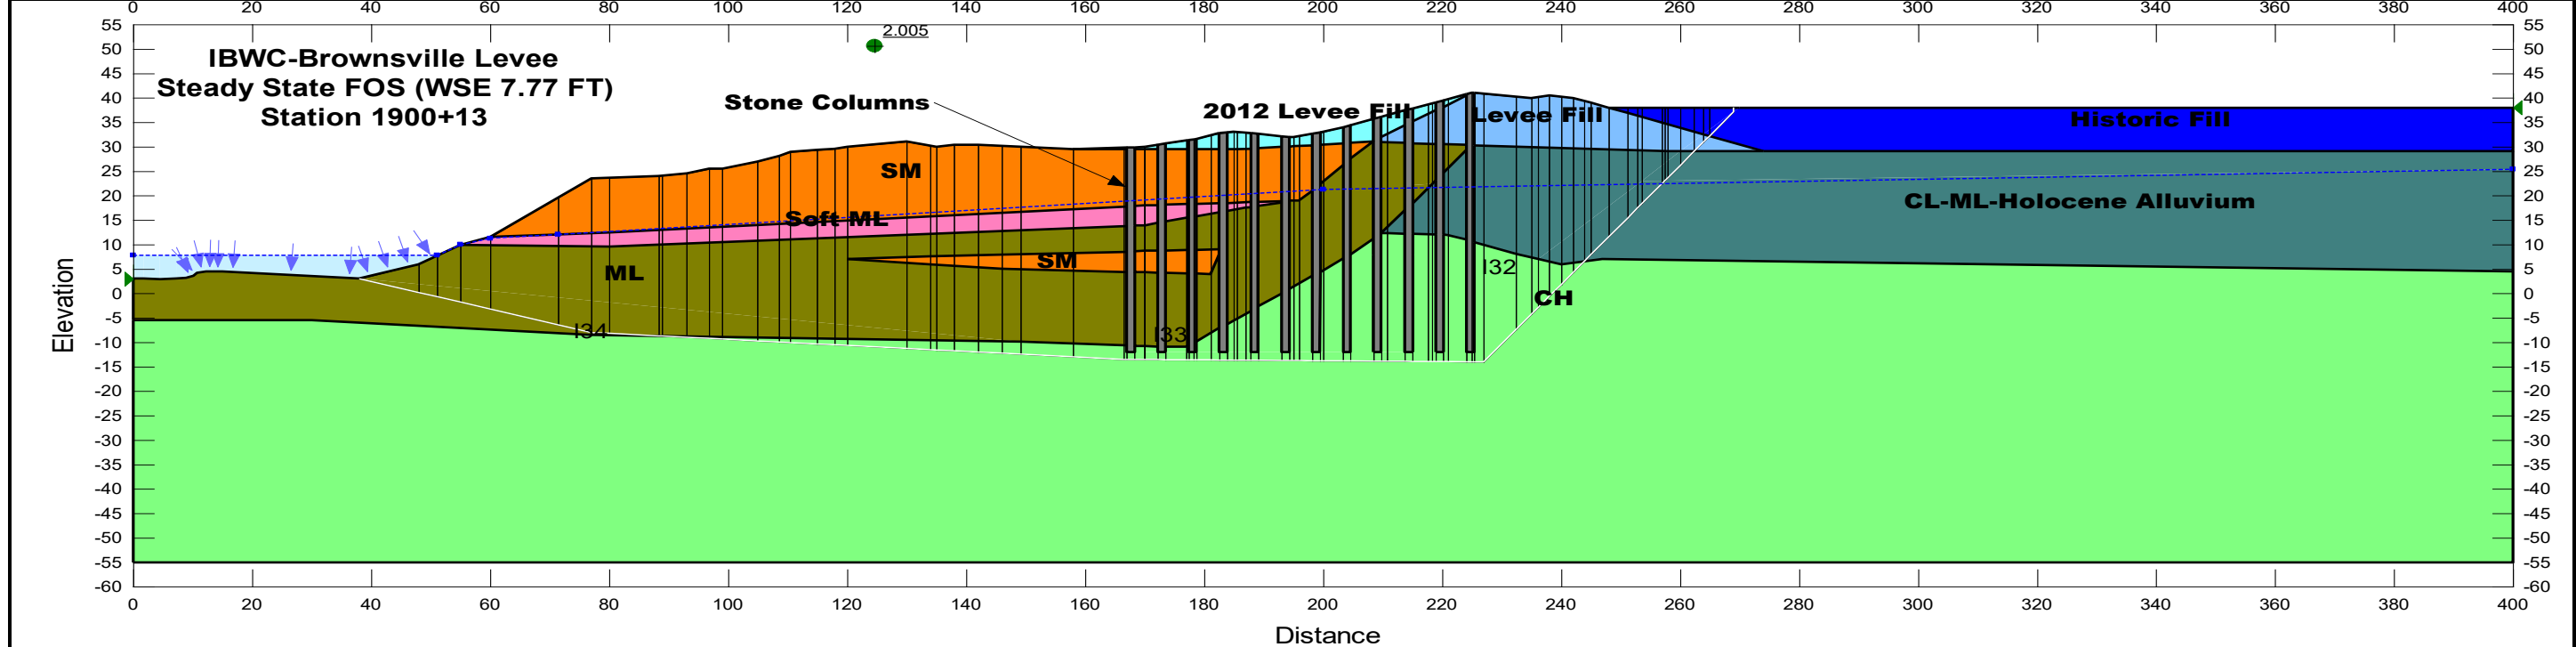
IBWC GEOTECHNICAL REPORT	
<b>REMEDIATION DESIGN OF LEVEE FLOODPLAIN FAILURE          WITHIN THE UPPER BROWNSVILLE LEVEE REACH          LOWER RIO GRANDE FLOOD CONTROL PROJECT</b>	
<b>SLOPE STABILITY MODEL - STONE COLUMNS ASSESSMENT</b>	
<b>RAPID DRAWDOWN</b>	
	<b>APPENDIX</b>

Minimum Factor of Safety (FOS): 2.005

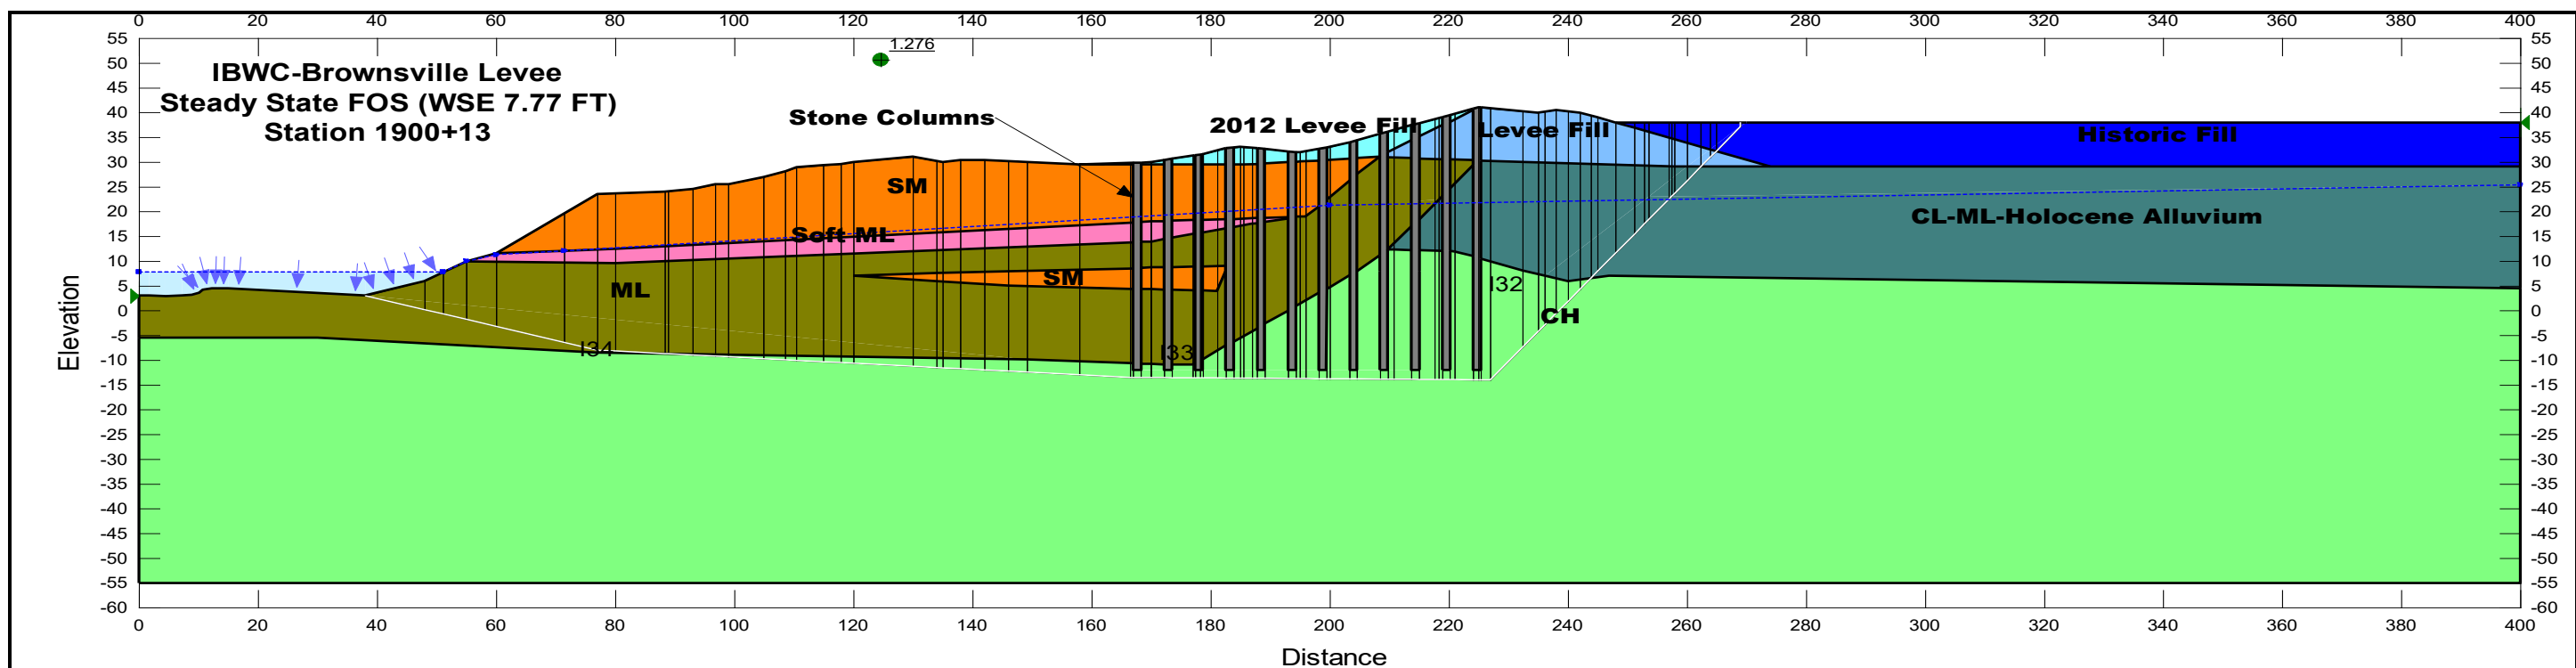
IBWC GEOTECHNICAL REPORT	
REMEDATION DESIGN OF LEVEE FLOODPLAIN FAILURE WITHIN THE UPPER BROWNSVILLE LEVEE REACH LOWER RIO GRANDE FLOOD CONTROL PROJECT  GLOBAL SHALLOW - STONE COLUMNS ASSESSMENT  STEADY STATE SEEPAGE	
ARCADIS	APPENDIX

Minimum Factor of Safety (FOS): 1.376

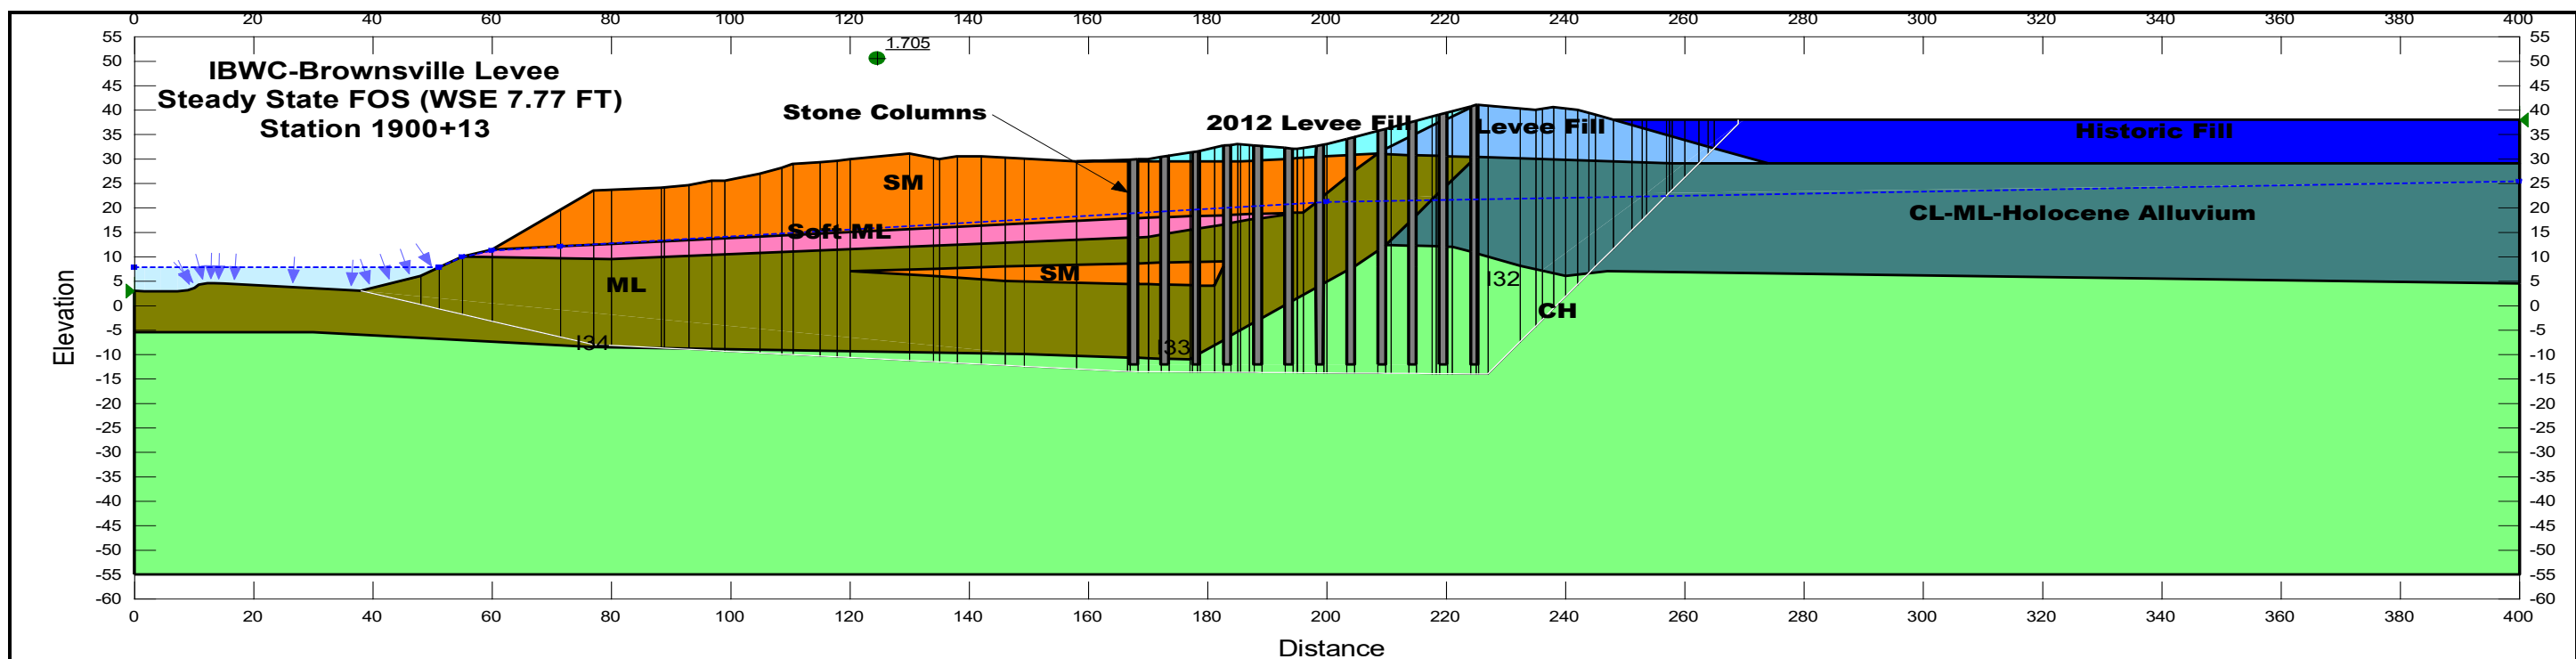
IBWC GEOTECHNICAL REPORT	
REMEDATION DESIGN OF LEVEE FLOODPLAIN FAILURE WITHIN THE UPPER BROWNSVILLE LEVEE REACH LOWER RIO GRANDE FLOOD CONTROL PROJECT  GLOBAL SHALLOW - STONE COLUMNS ASSESSMENT  STEADY STATE SEEPAGE	
ARCADIS	APPENDIX

Minimum Factor of Safety (FOS): 1.705

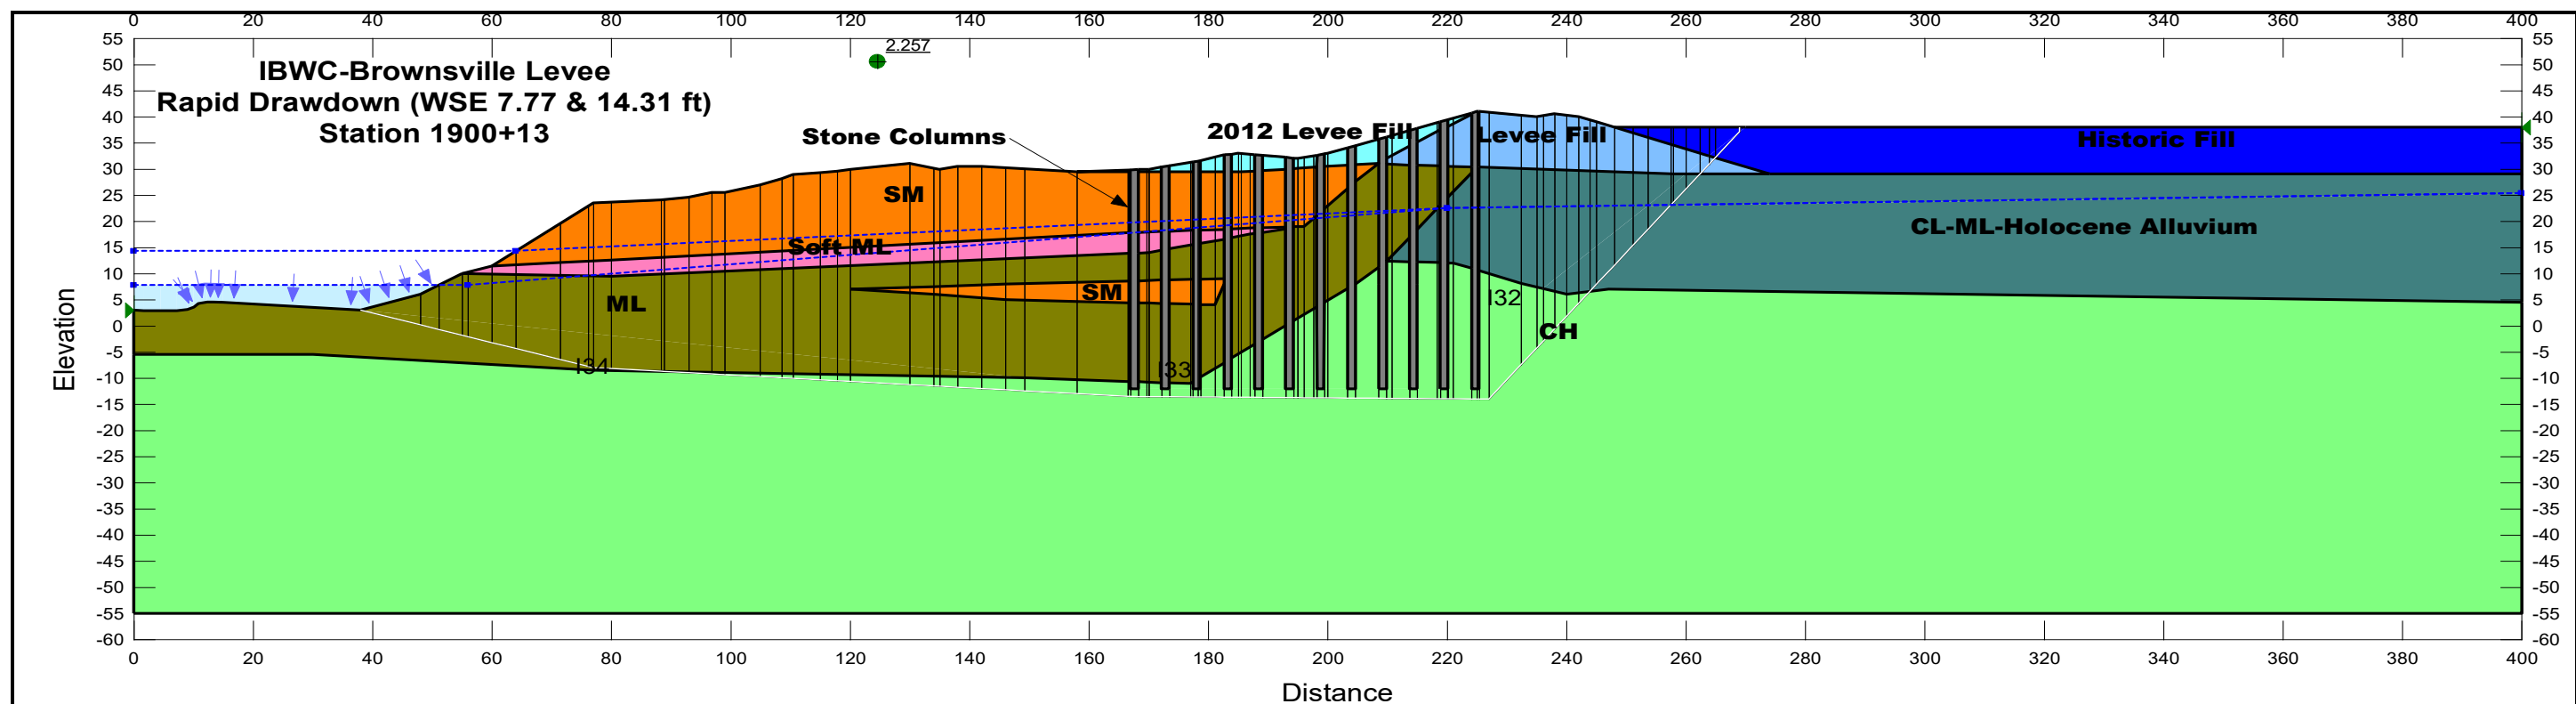
IBWC GEOTECHNICAL REPORT	
REMEDATION DESIGN OF LEVEE FLOODPLAIN FAILURE WITHIN THE UPPER BROWNSVILLE LEVEE REACH LOWER RIO GRANDE FLOOD CONTROL PROJECT  GLOBAL SHALLOW - STONE COLUMNS ASSESSMENT  STEADY STATE SEEPAGE	
	APPENDIX

Minimum Factor of Safety (FOS): 2.257

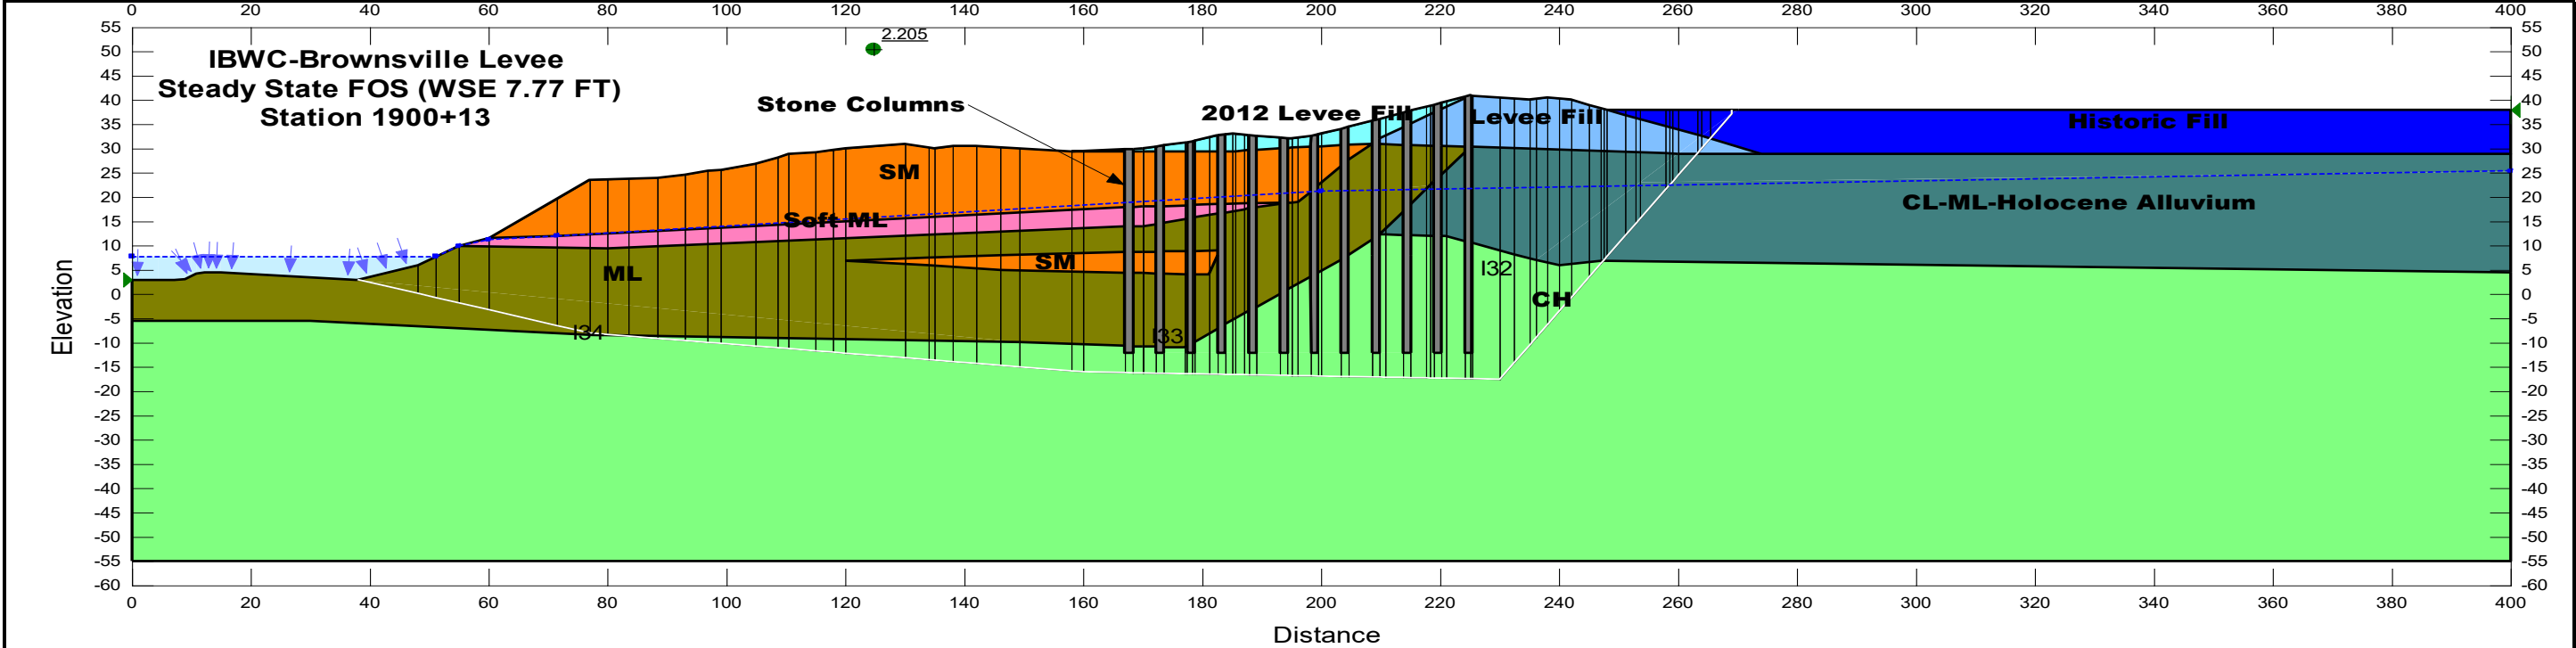
IBWC GEOTECHNICAL REPORT	
REMEDATION DESIGN OF LEVEE FLOODPLAIN FAILURE WITHIN THE UPPER BROWNSVILLE LEVEE REACH LOWER RIO GRANDE FLOOD CONTROL PROJECT GLOBAL SHALLOW - STONE COLUMNS ASSESSMENT RAPID DRAWDOWN	
ARCADIS	APPENDIX

Minimum Factor of Safety (FOS): 2.205

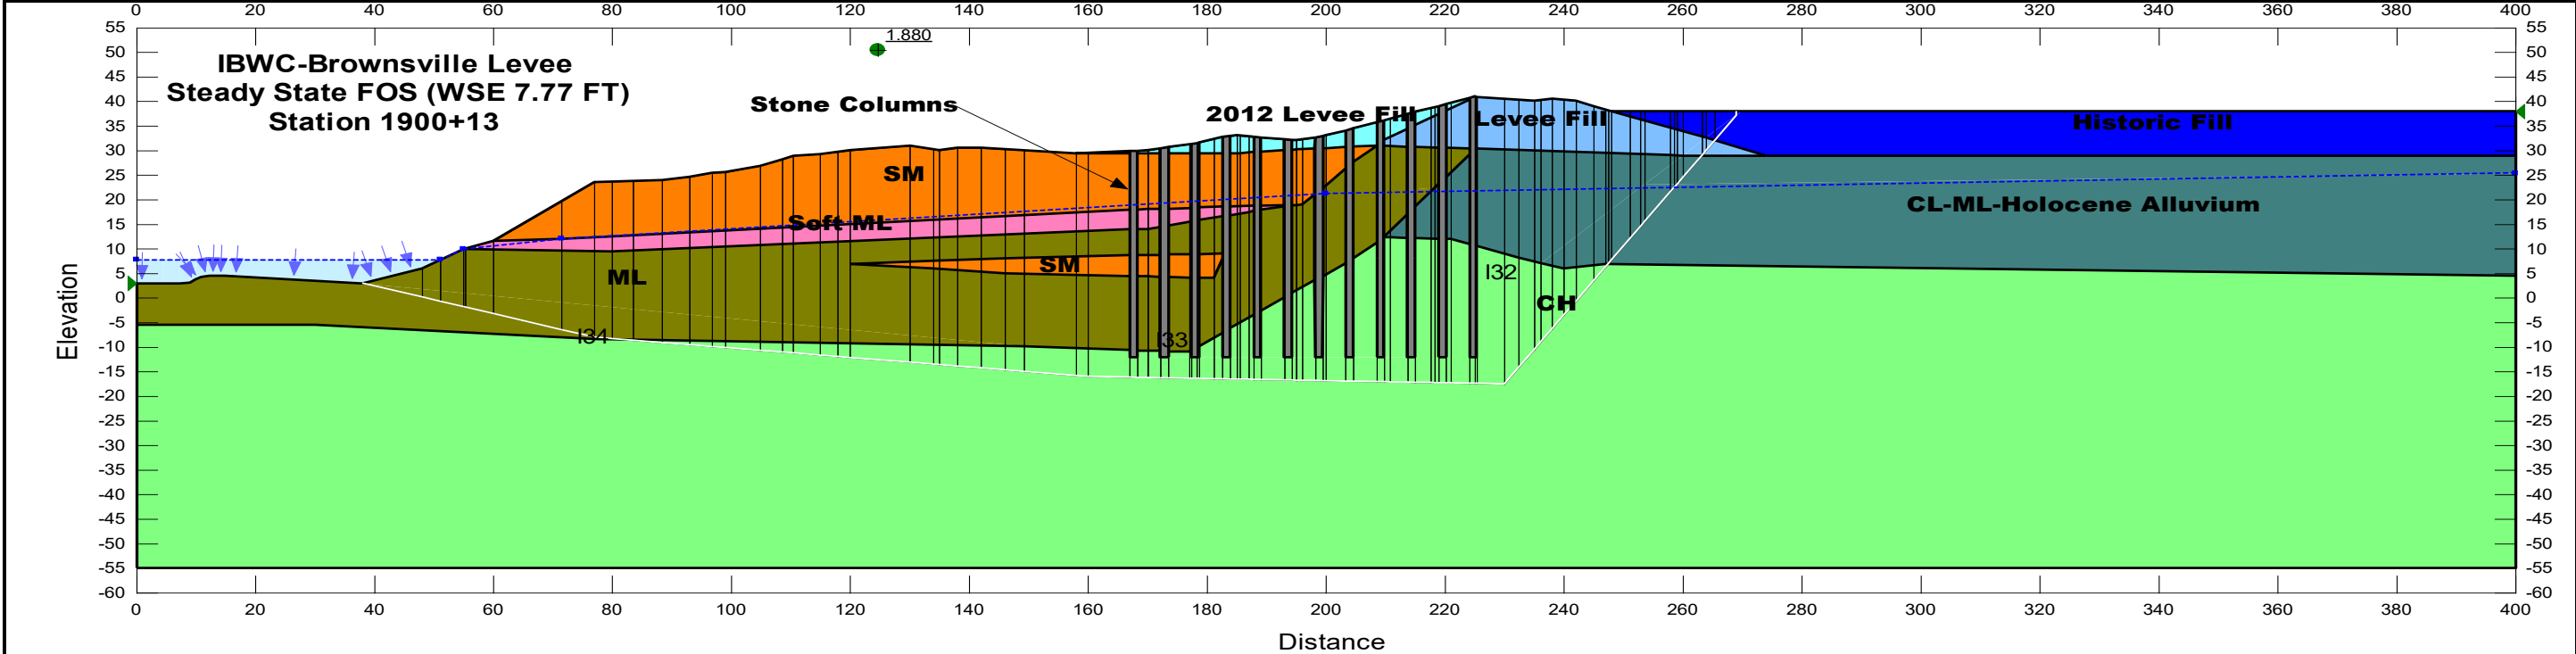
IBWC GEOTECHNICAL REPORT	
REMEDATION DESIGN OF LEVEE FLOODPLAIN FAILURE WITHIN THE UPPER BROWNSVILLE LEVEE REACH LOWER RIO GRANDE FLOOD CONTROL PROJECT  GLOBAL DEEP - STONE COLUMNS ASSESSMENT  STEADY STATE SEEPAGE	
ARCADIS	APPENDIX

Minimum Factor of Safety (FOS): 1.880

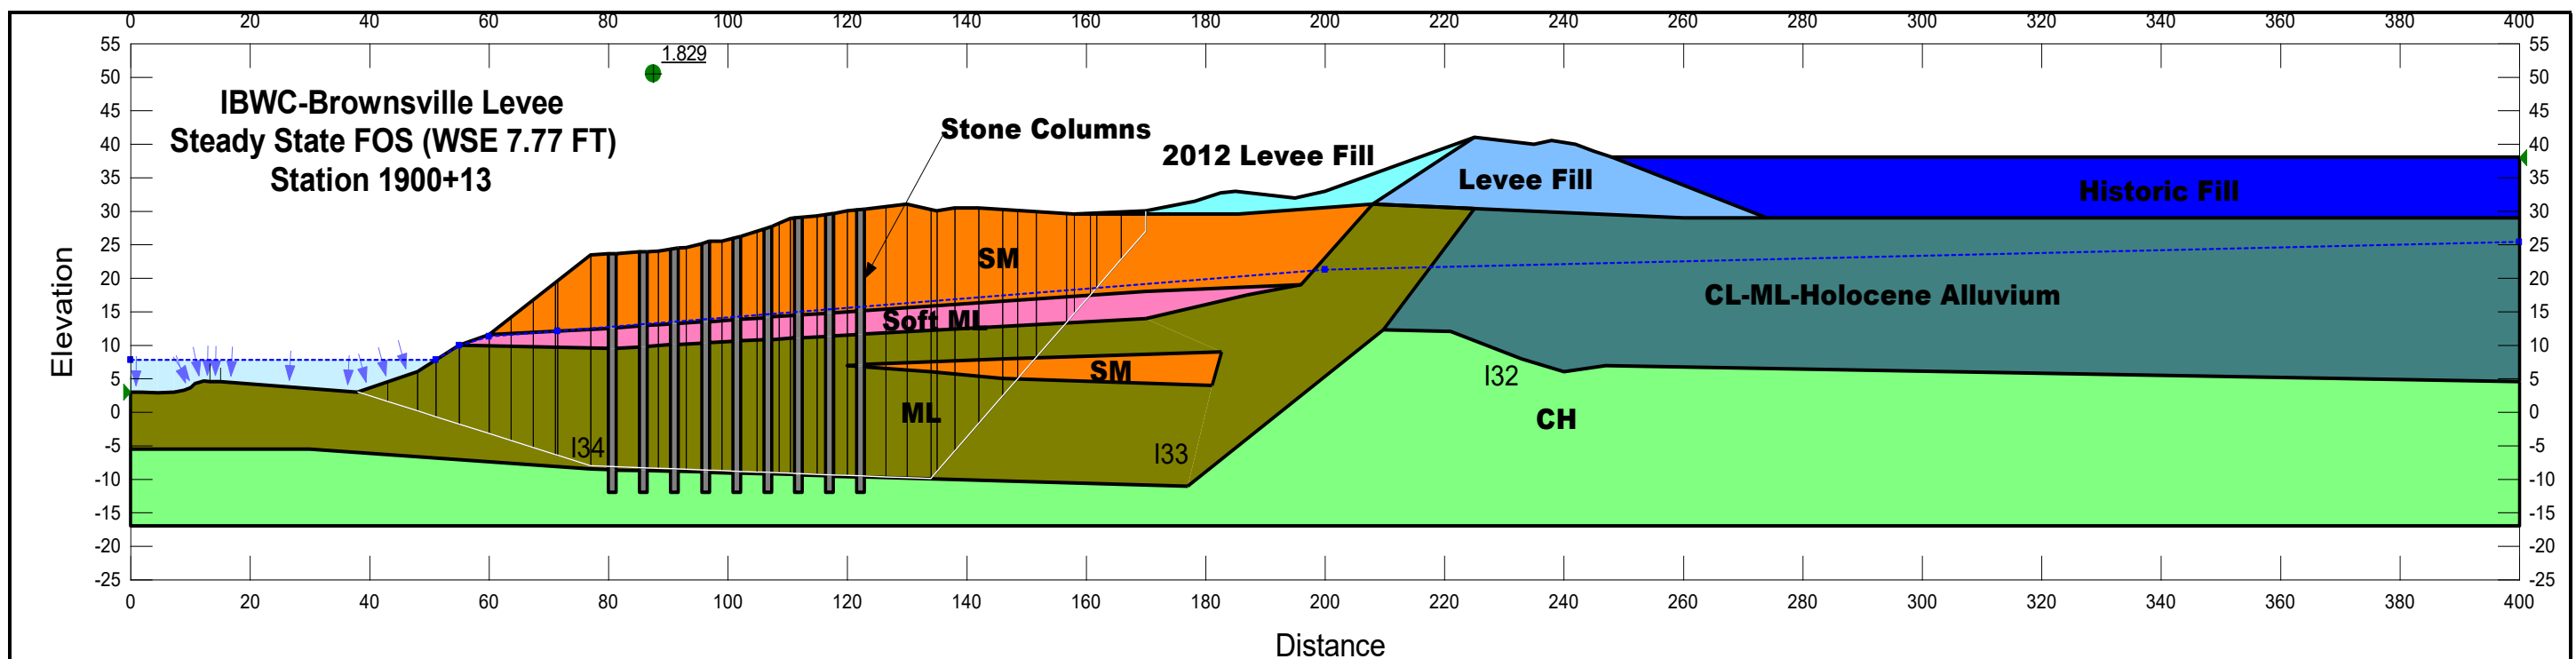
IBWC GEOTECHNICAL REPORT	
REMEDATION DESIGN OF LEVEE FLOODPLAIN FAILURE WITHIN THE UPPER BROWNSVILLE LEVEE REACH LOWER RIO GRANDE FLOOD CONTROL PROJECT	
SLOPE STABILITY MODEL - STONE COLUMNS ASSESSMENT	
STEADY STATE SEEPAGE	
ARCADIS	APPENDIX

Minimum Factor of Safety (FOS): 1.829
