# **International Boundary and Water Commission United States Section**

## **Remediation Design of Levee and Floodplain Failure Within the Upper Brownsville Levee Reach Lower Rio Grande Flood Control Project**

### **Design Documentation Report Final Submittal**

May 2022

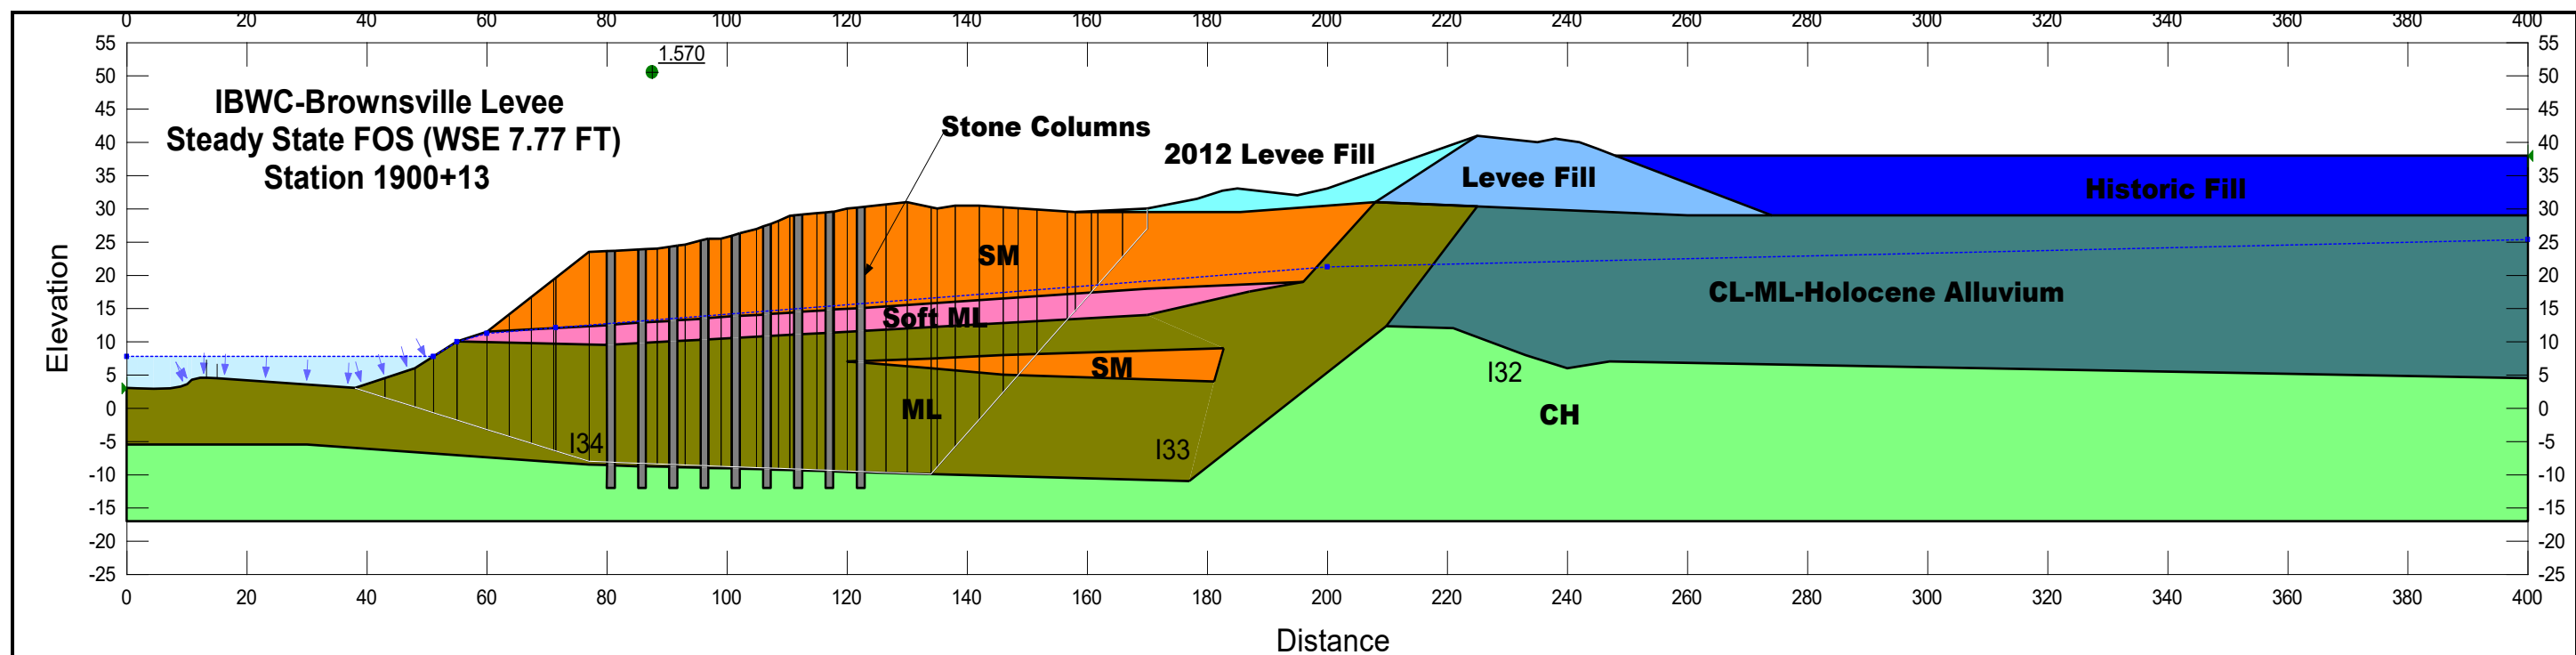
IBWC GEOTECHNICAL REPORT	
<b>REMEDIATION DESIGN OF LEVEE FLOODPLAIN FAILURE WITHIN THE UPPER BROWNSVILLE LEVEE REACH LOWER RIO GRANDE FLOOD CONTROL PROJECT</b>	
<b>SLOPE STABILITY MODEL - STONE COLUMNS ASSESSMENT</b>	
<b>STEADY STATE SEEPAGE</b>	
	APPENDIX

**Minimum Factor of Safety (FOS): 1.570**

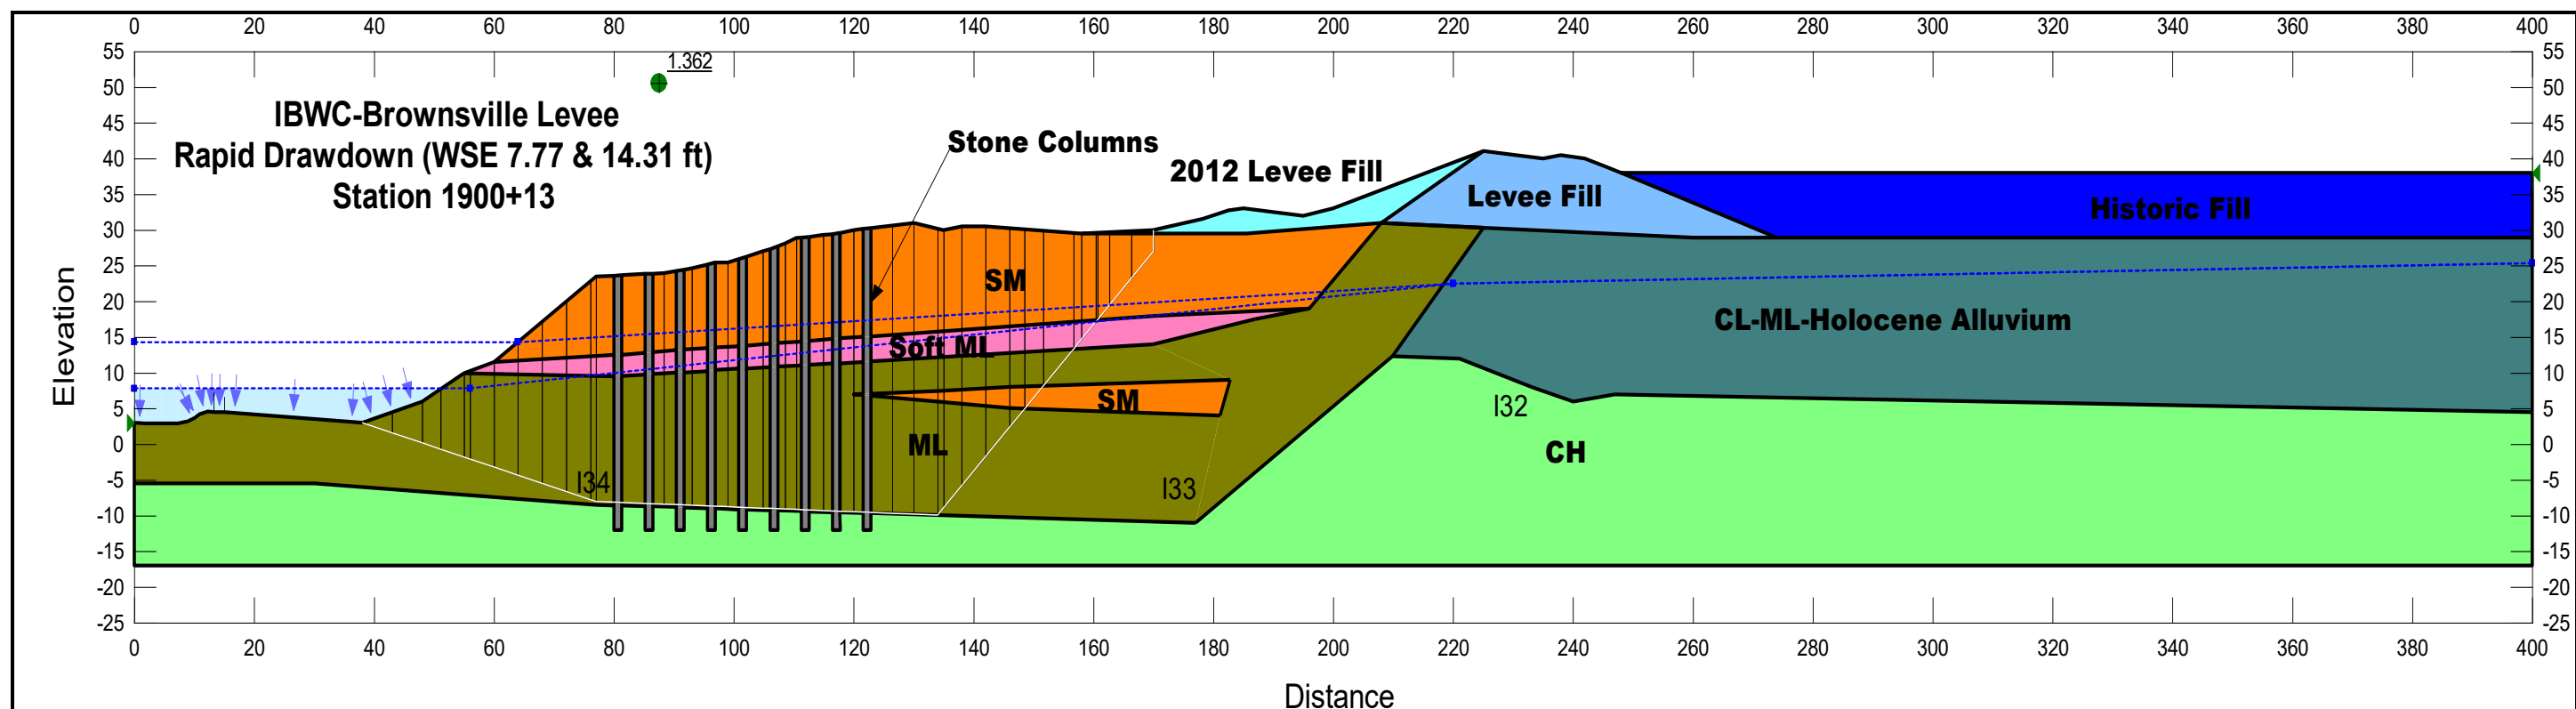
IBWC GEOTECHNICAL REPORT	
REMEDATION DESIGN OF LEVEE FLOODPLAIN FAILURE WITHIN THE UPPER BROWNSVILLE LEVEE REACH LOWER RIO GRANDE FLOOD CONTROL PROJECT	
SLOPE STABILITY MODEL - STONE COLUMNS ASSESSMENT	
STEADY STATE SEEPAGE	
ARCADIS	APPENDIX

Minimum Factor of Safety (FOS): 1.362

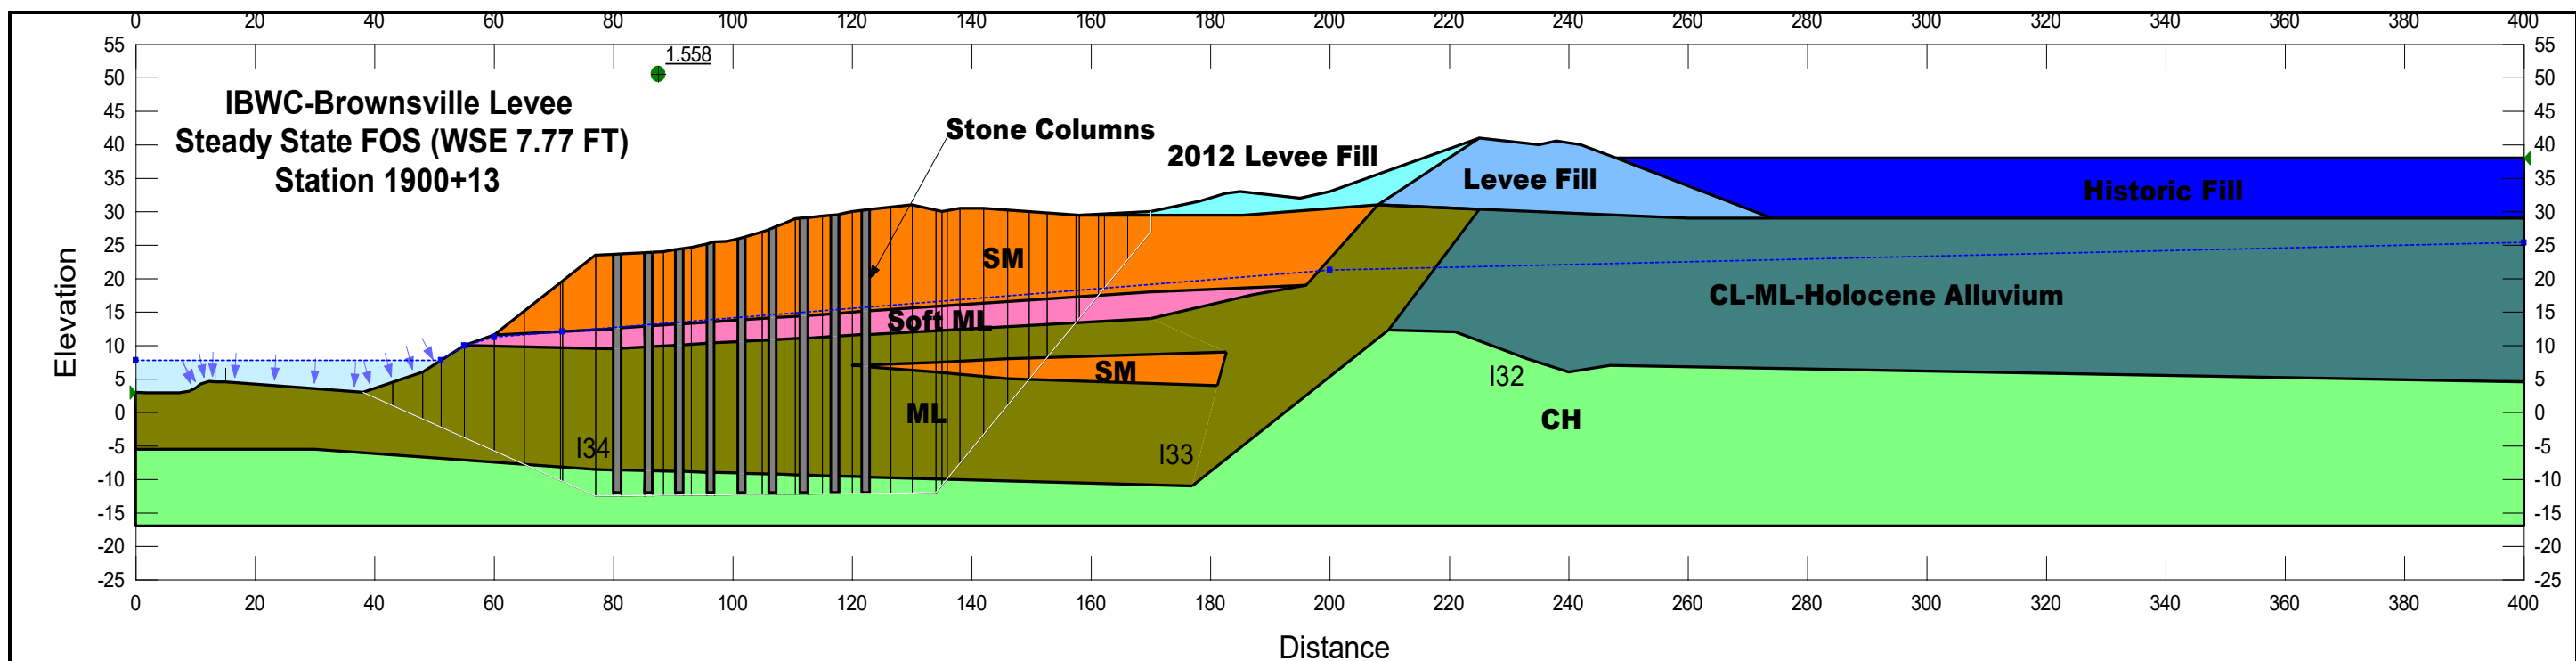
IBWC GEOTECHNICAL REPORT	
REMEDATION DESIGN OF LEVEE FLOODPLAIN FAILURE WITHIN THE UPPER BROWNSVILLE LEVEE REACH LOWER RIO GRANDE FLOOD CONTROL PROJECT SLOPE STABILITY MODEL - STONE COLUMNS ASSESSMENT RAPID DRAWDOWN	
ARCADIS	APPENDIX

Minimum Factor of Safety (FOS): 1.558

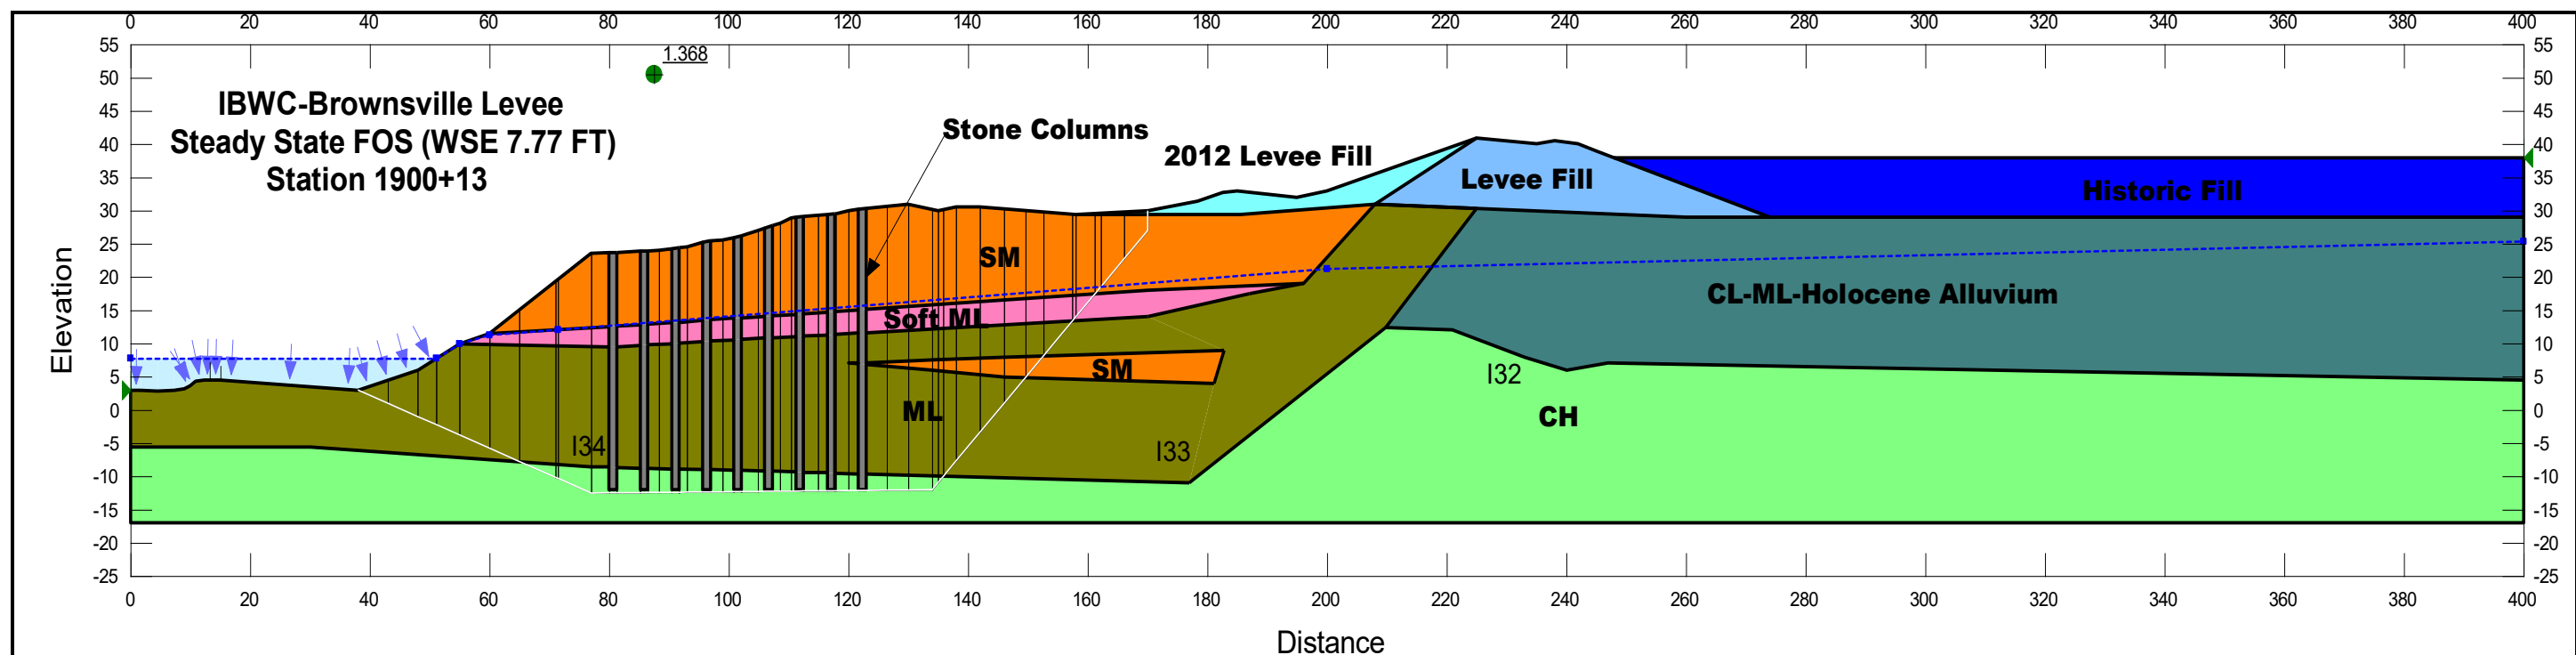
IBWC GEOTECHNICAL REPORT	
REMEDATION DESIGN OF LEVEE FLOODPLAIN FAILURE WITHIN THE UPPER BROWNSVILLE LEVEE REACH LOWER RIO GRANDE FLOOD CONTROL PROJECT GLOBAL SHALLOW - STONE COLUMNS ASSESSMENT STEADY STATE SEEPAGE	
ARCADIS	APPENDIX

Minimum Factor of Safety (FOS): 1.368

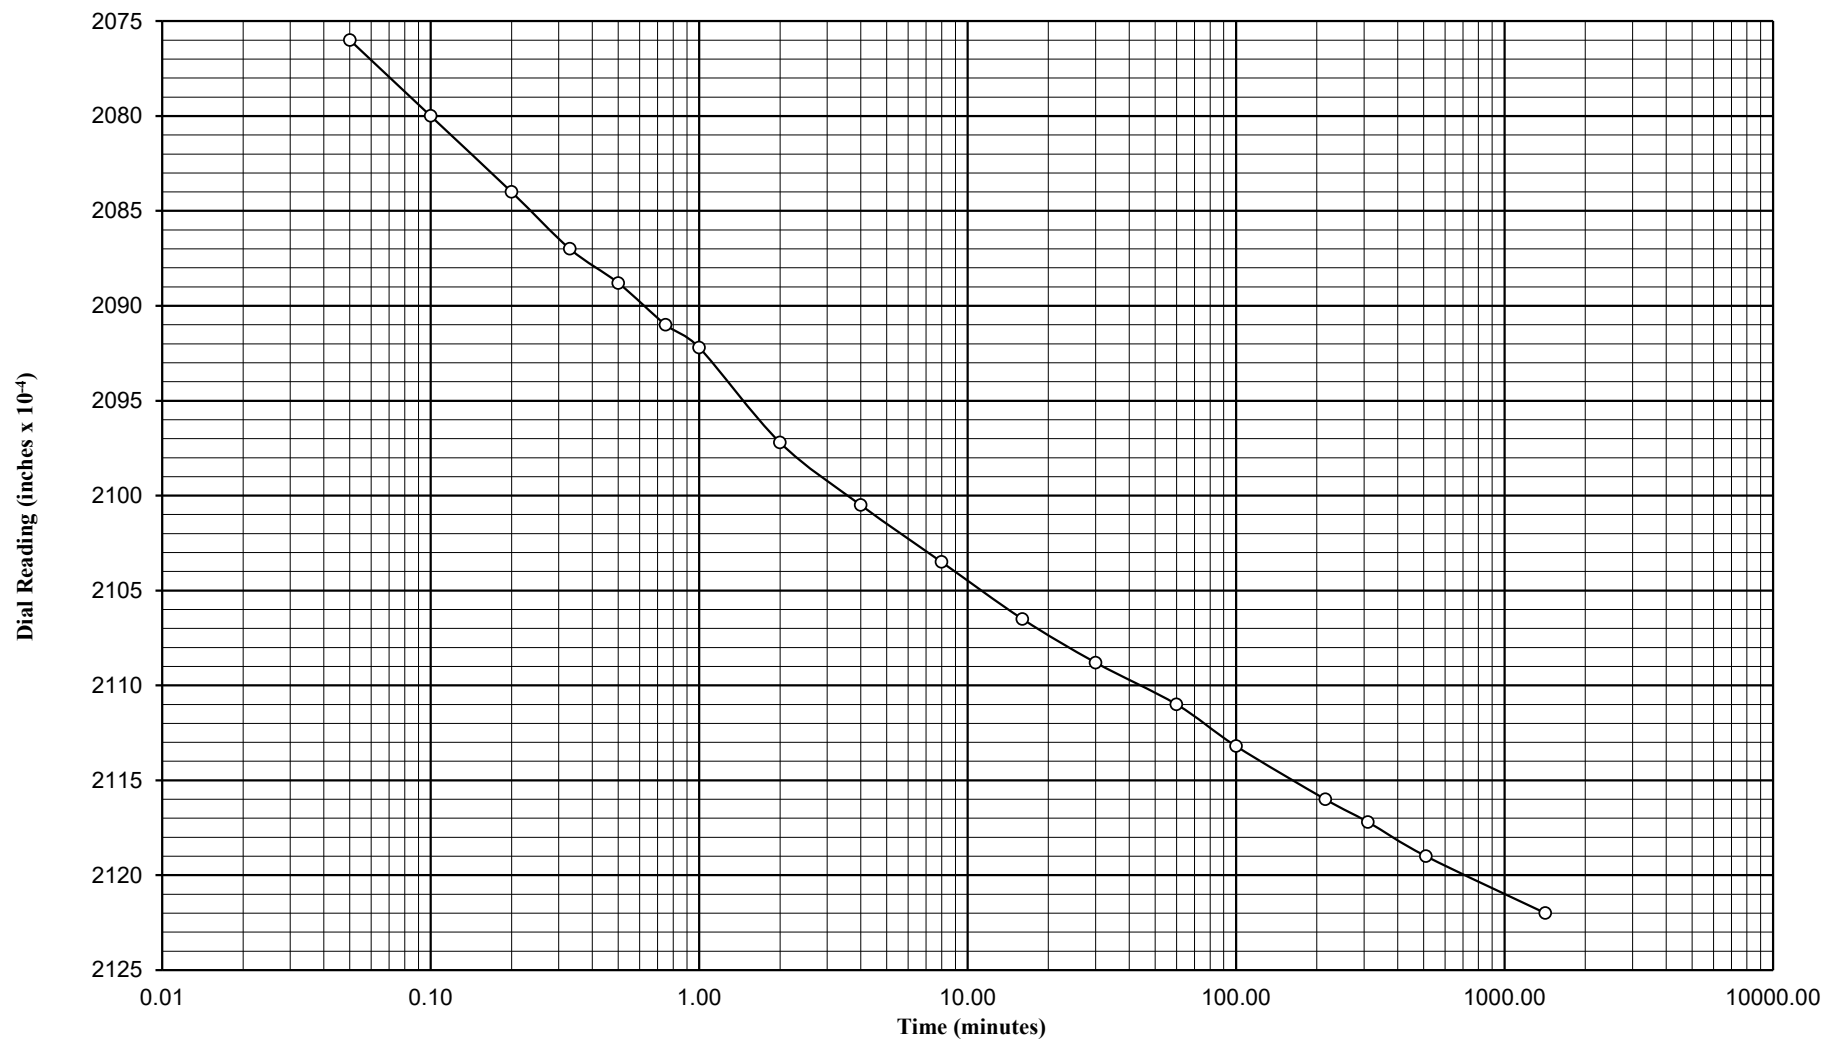
### CONSOLIDATION TEST - DIAL READING TIME CURVE

PROJECT:	Brownsville Levee Repair	Coefficient of Consolidation $C_v$	$28.2 \times 10^{-4}$ (cm <sup>2</sup> /sec)
BORING NO.:	BRN-P3-32b	$d_{50}$ (inches):	0.20885
DEPTH:	6.9-8.9	$t_{50}$ (min):	0.45
SAMPLE:	---	Load (tsf):	2
		Thickness (inches)	0.495
		TEAM Project No.:	142086
		Date:	12/19/2014
		Remarks

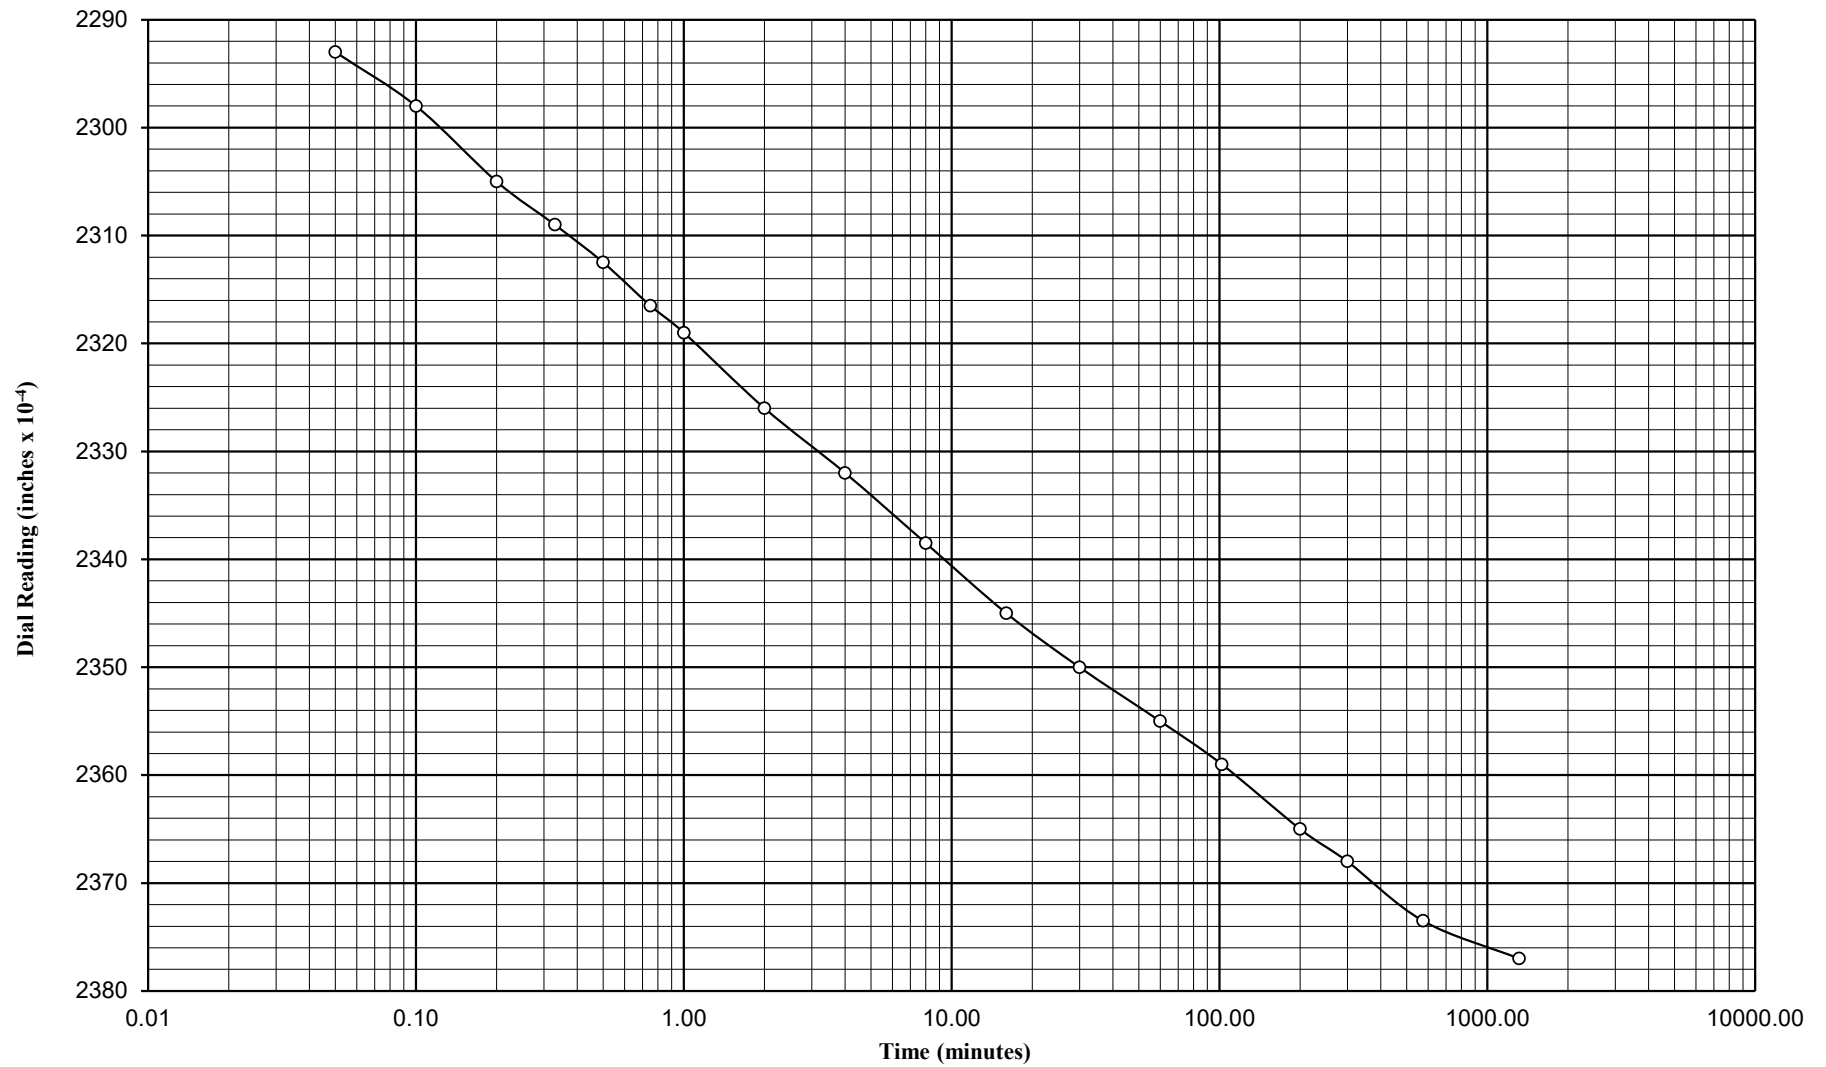
### CONSOLIDATION TEST - DIAL READING TIME CURVE

PROJECT:	Brownsville Levee Repair	Coefficient of Consolidation $C_v$	$25.6 \times 10^{-4}$ (cm <sup>2</sup> /sec)
BORING NO.:	BRN-P3-32b	$d_{50}$ (inches):	0.21855
DEPTH:	6.9-8.9	$t_{50}$ (min):	0.48
SAMPLE:	---	Load (tsf):	4
		Thickness (inches)	0.495
		TEAM Project No.:	142086
		Date:	12/19/2014
		Remarks

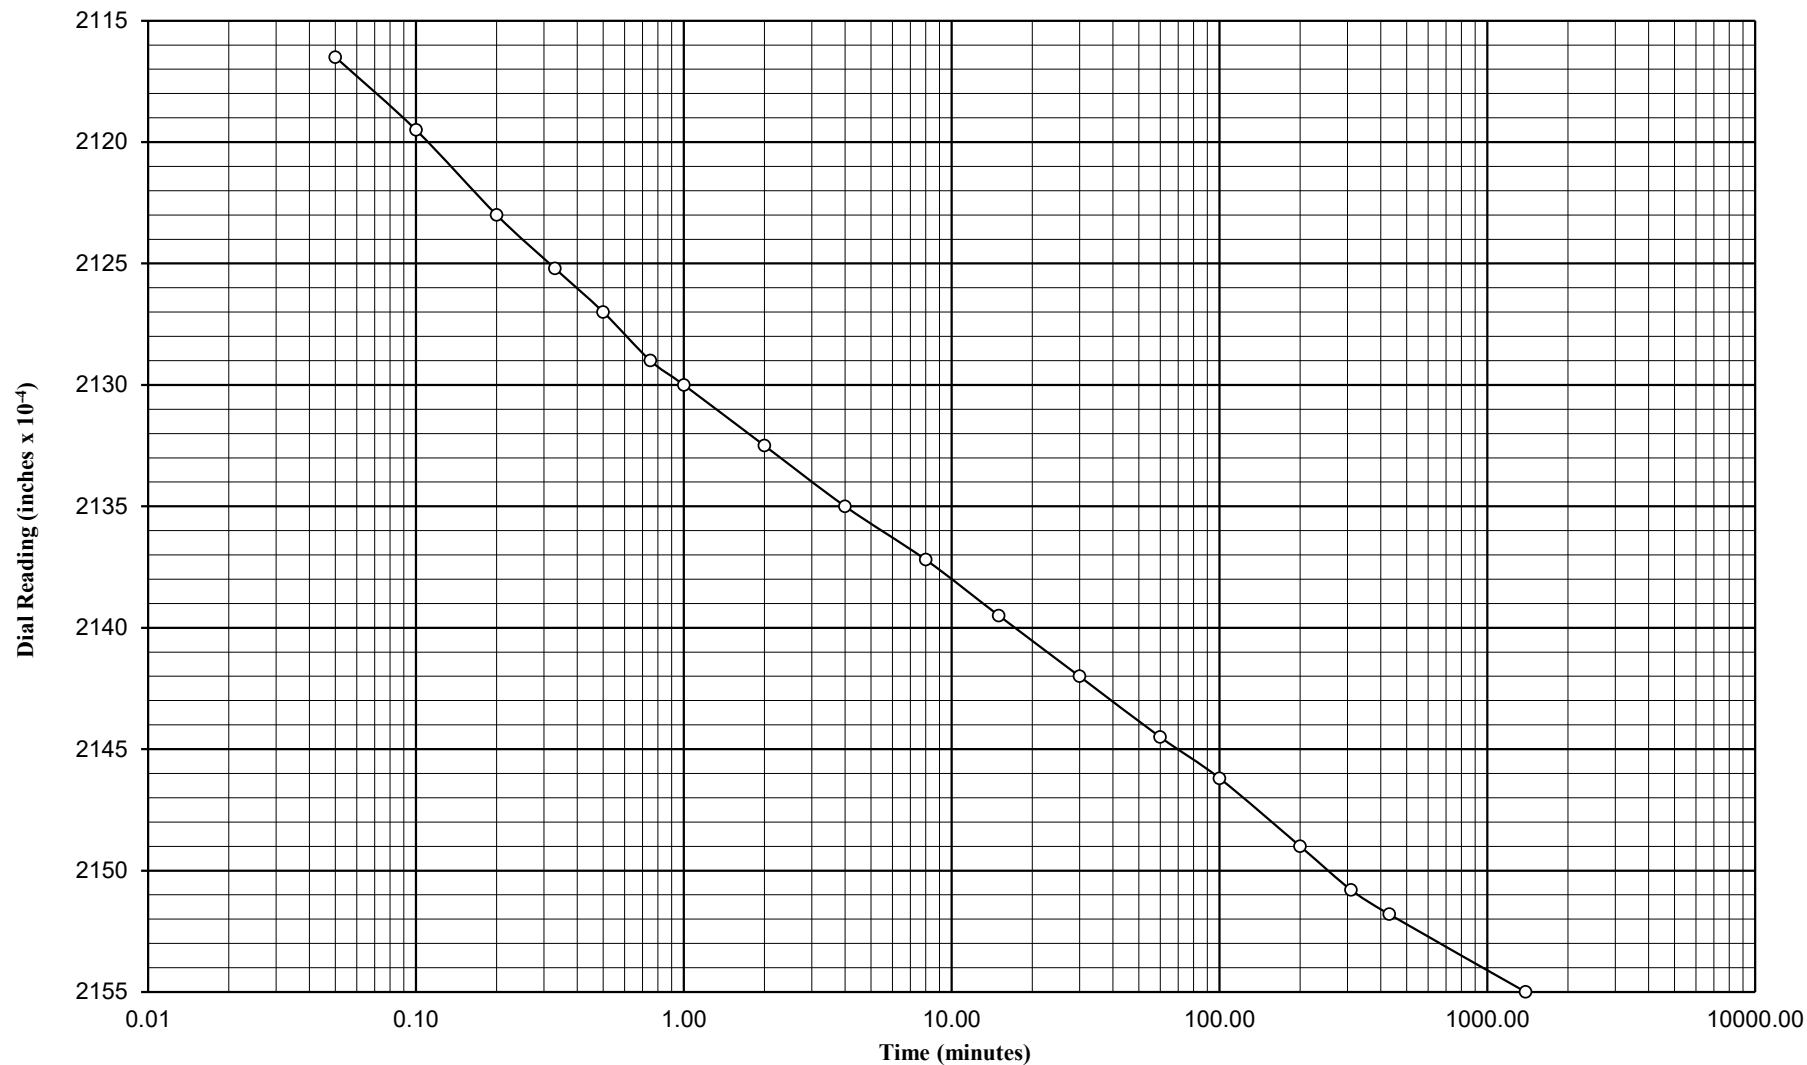
### CONSOLIDATION TEST - DIAL READING TIME CURVE

PROJECT:	Brownsville Levee Repair	Coefficient of Consolidation $C_v$	$22.0 \times 10^{-4}$ (cm <sup>2</sup> /sec)
BORING NO.:	BRN-P3-32b	$d_{50}$ (inches):	0.20620
DEPTH:	11.3-13.3'	$t_{50}$ (min):	0.58
SAMPLE:	---	Load (tsf):	1
		Thickness (inches)	0.494
		TEAM Project No.:	142086
		Date:	12/19/2014
		Remarks

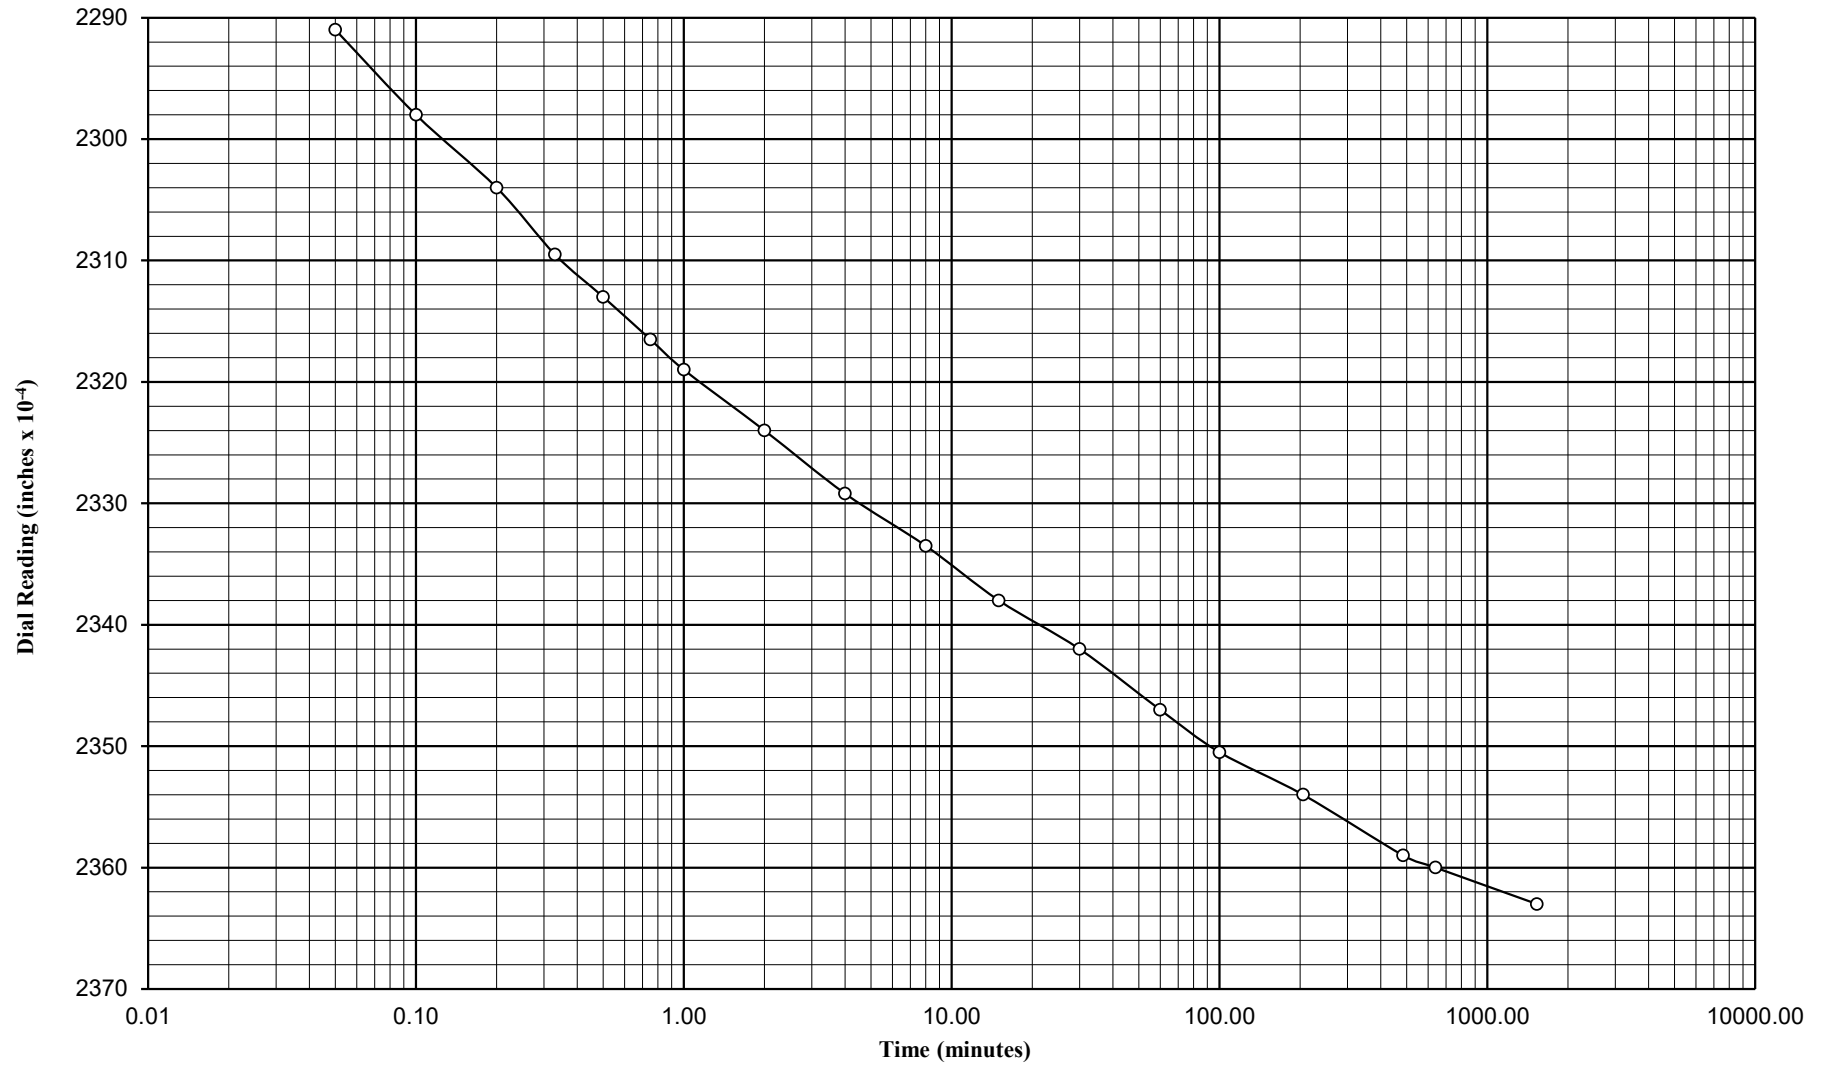
### CONSOLIDATION TEST - DIAL READING TIME CURVE

PROJECT:	Brownsville Levee Repair	Coefficient of Consolidation $C_v$	$8.09 \times 10^{-4}$ (cm <sup>2</sup> /sec)
BORING NO.:	BRN-P3-32b	$d_{50}$ (inches):	0.22118
DEPTH:	11.3-13.3'	$t_{50}$ (min):	1.5
SAMPLE:	---	Load (tsf):	4
		Thickness (inches)	0.494
		TEAM Project No.:	142086
		Date:	12/19/2014
		Remarks

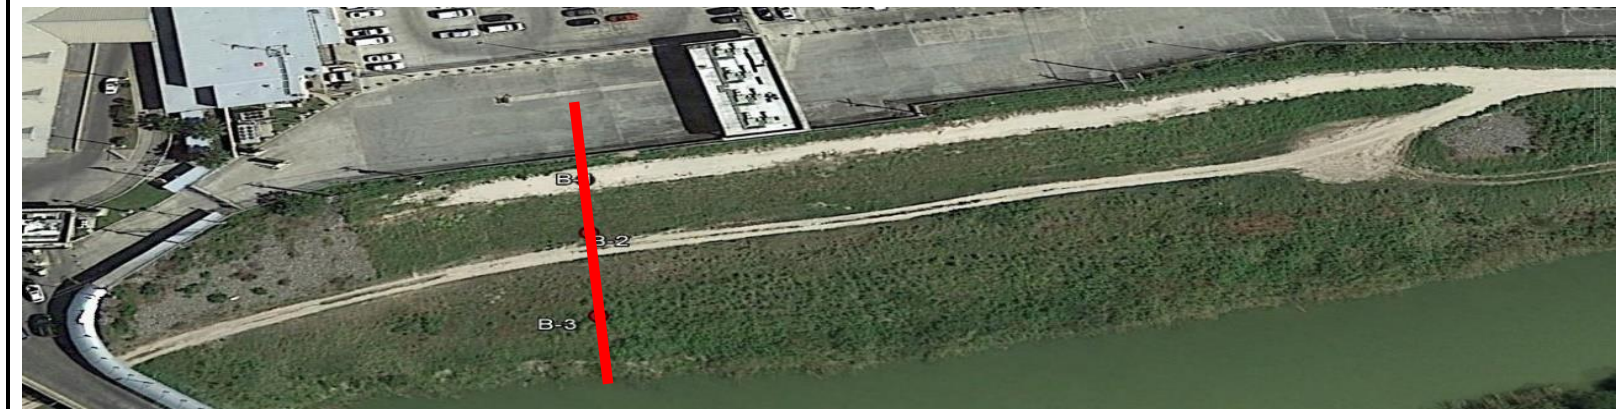
Minimum Factor of Safety (FOS): 1.097

Material	Unit Weight (pcf)	c' (psf)	phi' (degree)
CH Pleistocene	121.98	0	10
CL-Holocene	123.37	0	10
ML	119.38	0	11
Levee Fill	127.34	0	11
Historic Fill	127.34	0	11

Potential Failure Surface			
Passive Block		Active Block	
Left Block		Right Block	
Projection Angle			
Starting Angle (Degree)	Ending Angle (Degree)	Starting Angle (Degree)	Ending Angle (Degree)
140	146.17	34.26	50

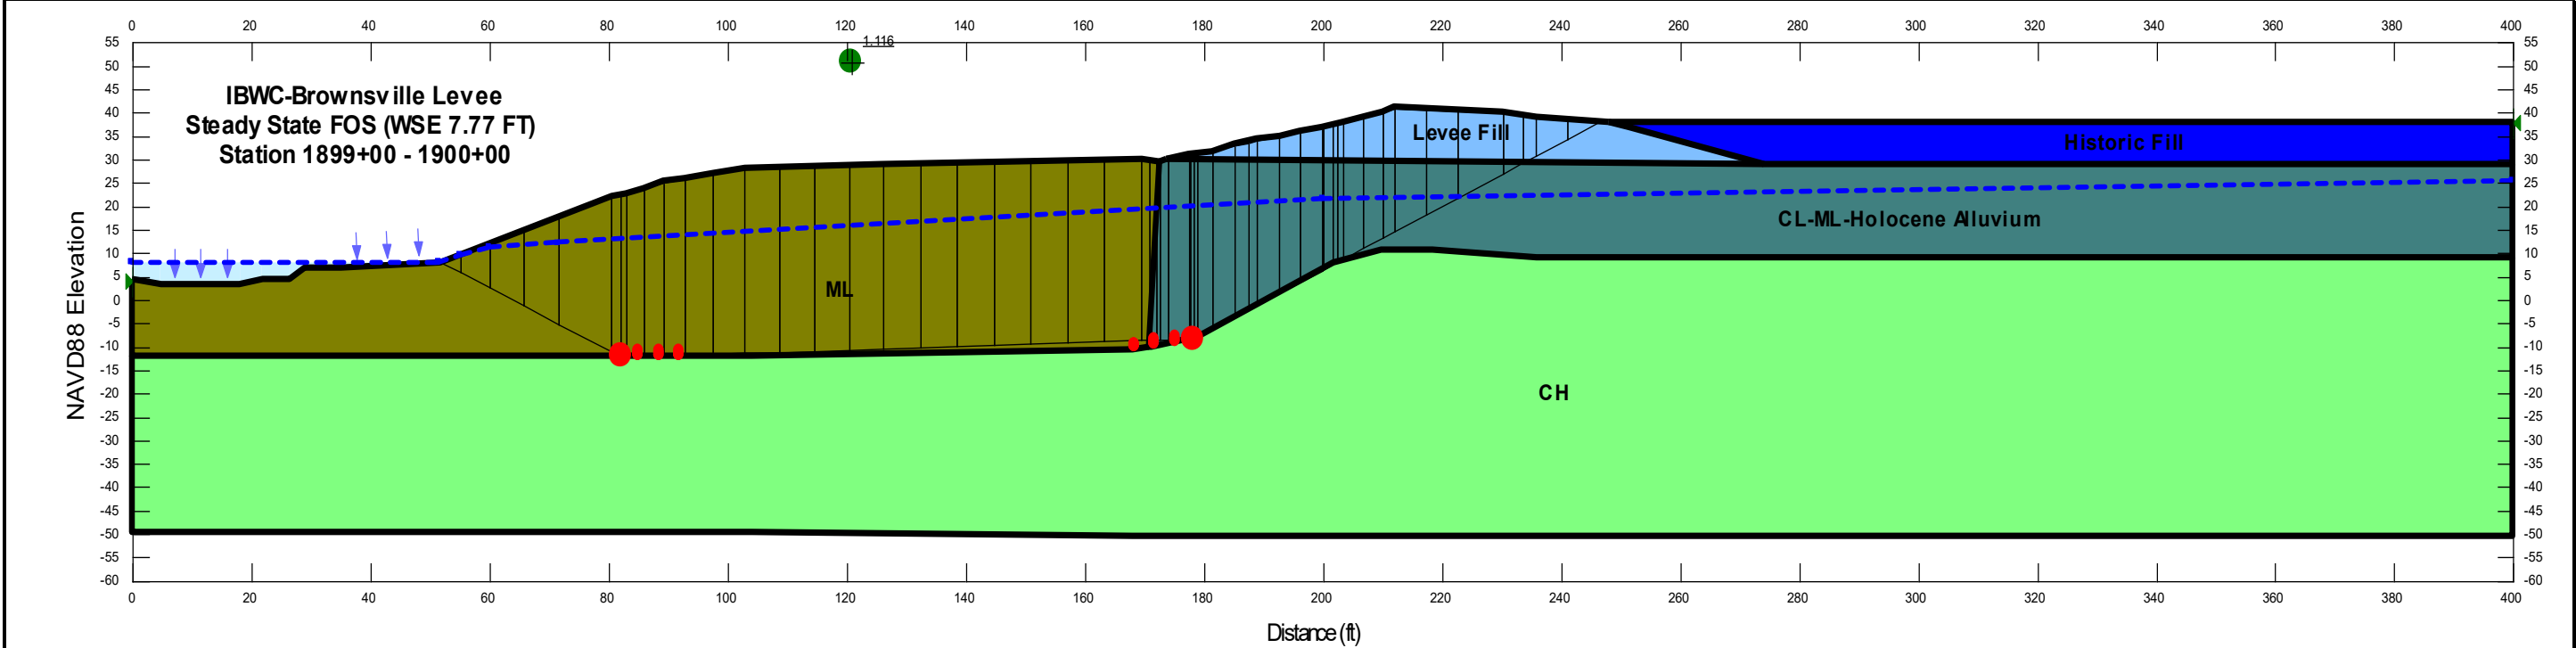
Minimum Factor of Safety (FOS): 1.116

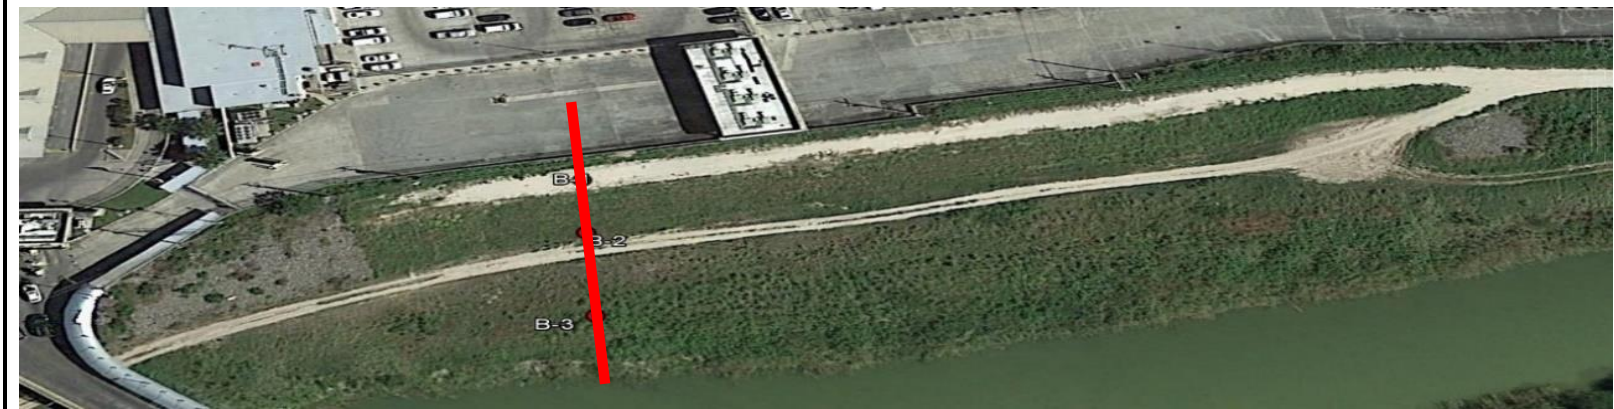
Material	Unit Weight (pcf)	c' (psf)	phi' (degree)
CH Pleistocene	121.98	90	12
CL-Holocene	123.37	225	12
ML	119.38	0	8
Levee Fill	127.34	105	12
Historic Fill	127.34	95	12

Potential Failure Surface			
Passive Block		Active Block	
Left Block		Right Block	
Projection Angle			
Starting Angle (Degree)	Ending Angle (Degree)	Starting Angle (Degree)	Ending Angle (Degree)
139	146.17	34.26	49

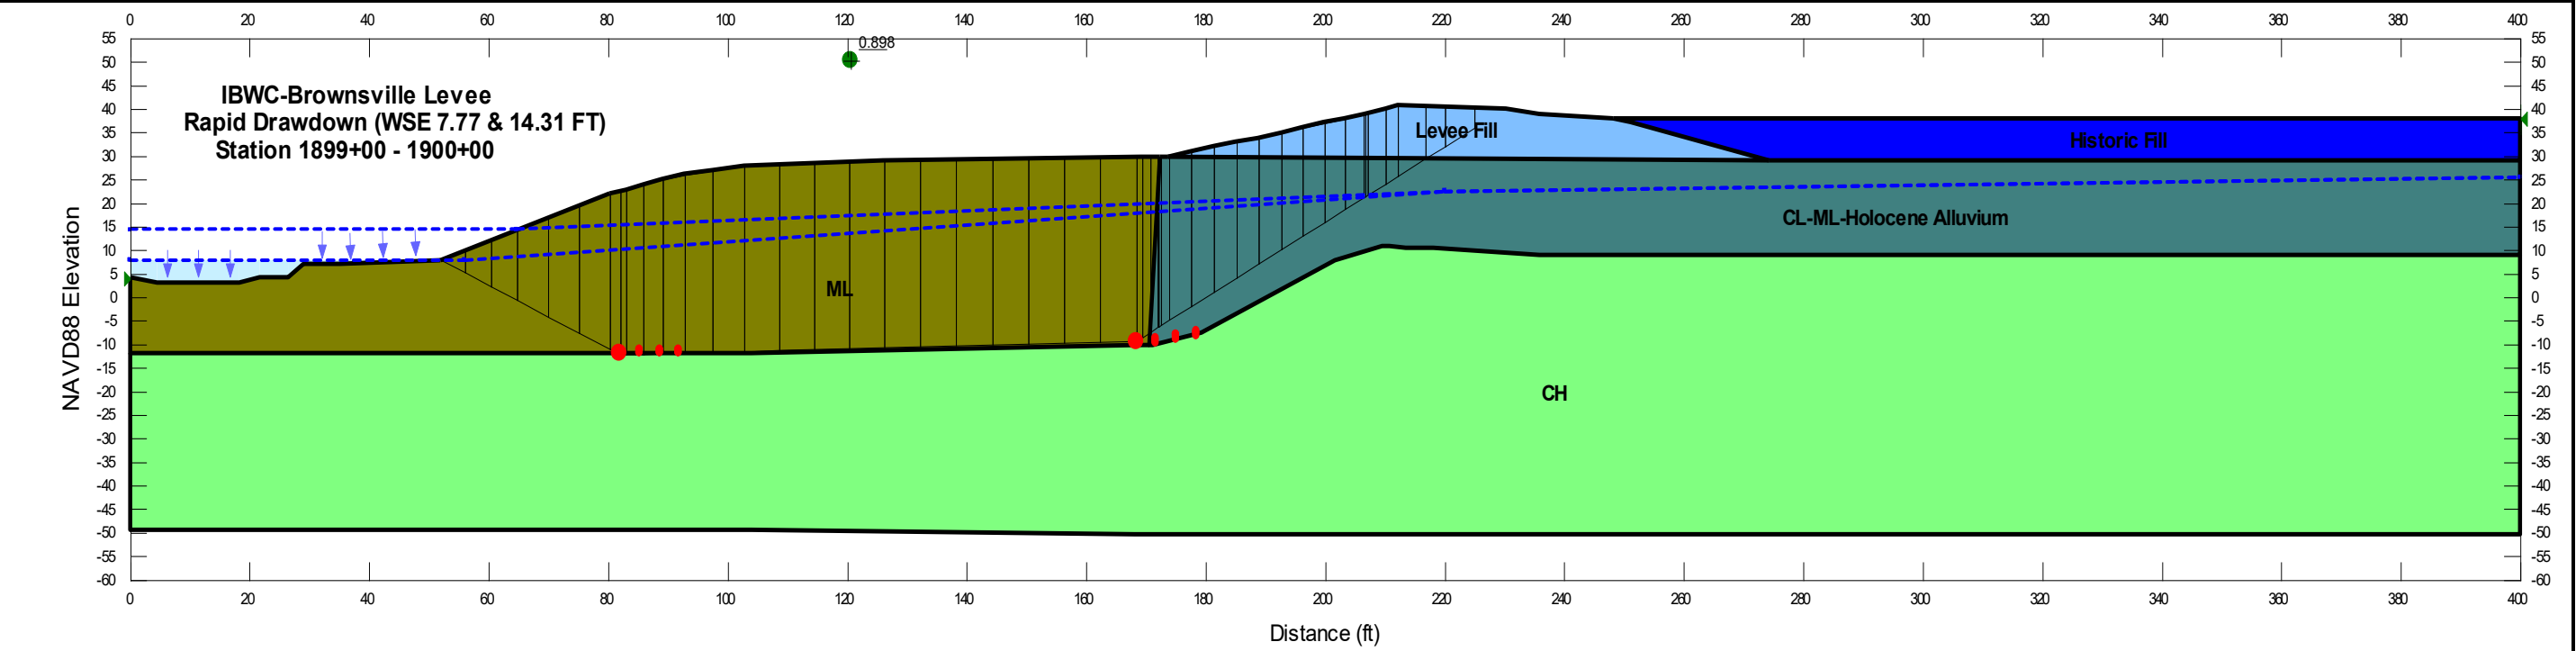
Minimum Factor of Safety (FOS): 0.898

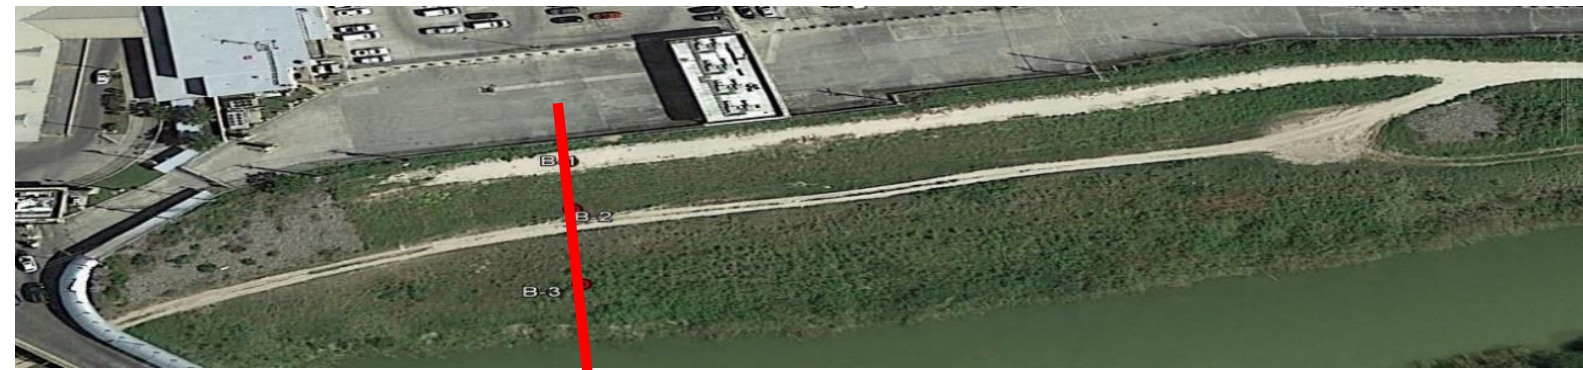
Material	Unit Weight (pcf)	c' (psf)	phi' (degree)	Total Stress	
				c (psf)	phi (degree)
CH Pleistocene	121.98	150	16	2320	0
CL-Holocene	123.37	200	14	400	0
ML	119.38	190	0	0	29
Levee Fill	127.34	400	20	5000	0
Historic Fill	127.34	200	20	400	15

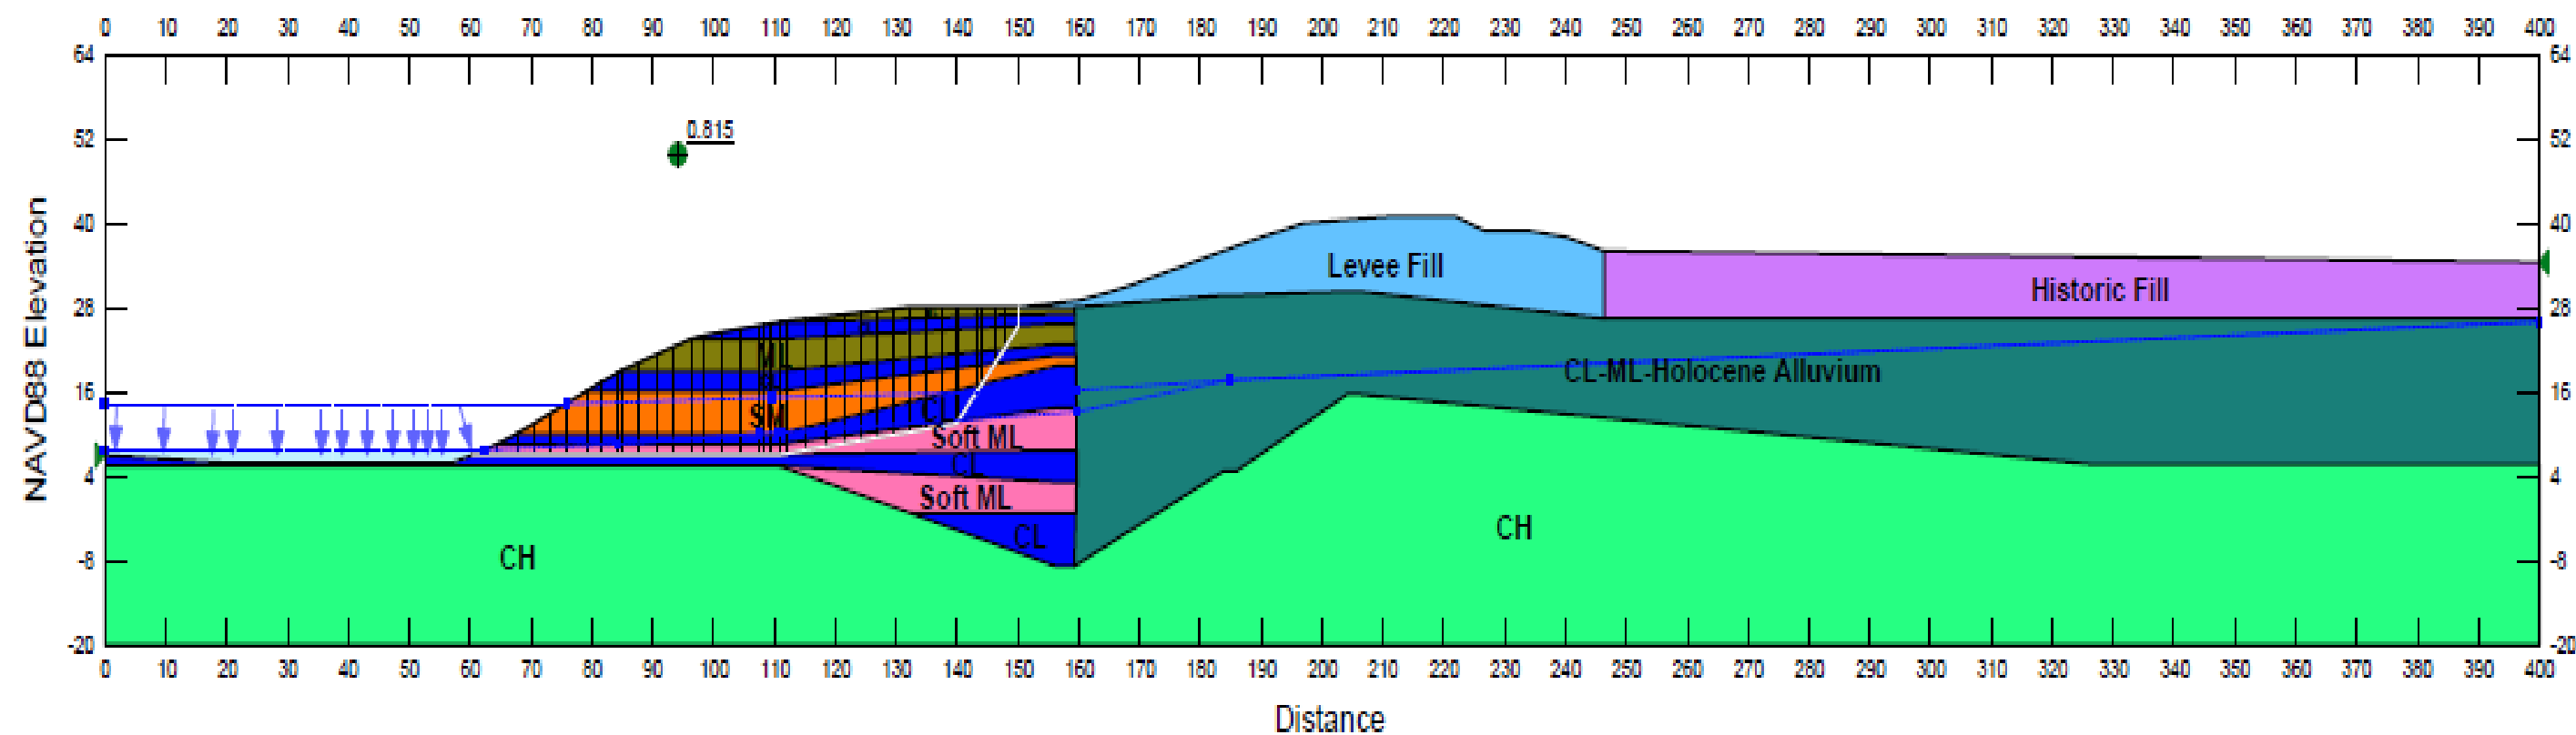
Minimum Factor of Safety (FOS): 0.815
