# **International Boundary and Water Commission United States Section**

## **Remediation Design of Levee and Floodplain Failure Within the Upper Brownsville Levee Reach Lower Rio Grande Flood Control Project**

### **Design Documentation Report Final Submittal**

May 2022

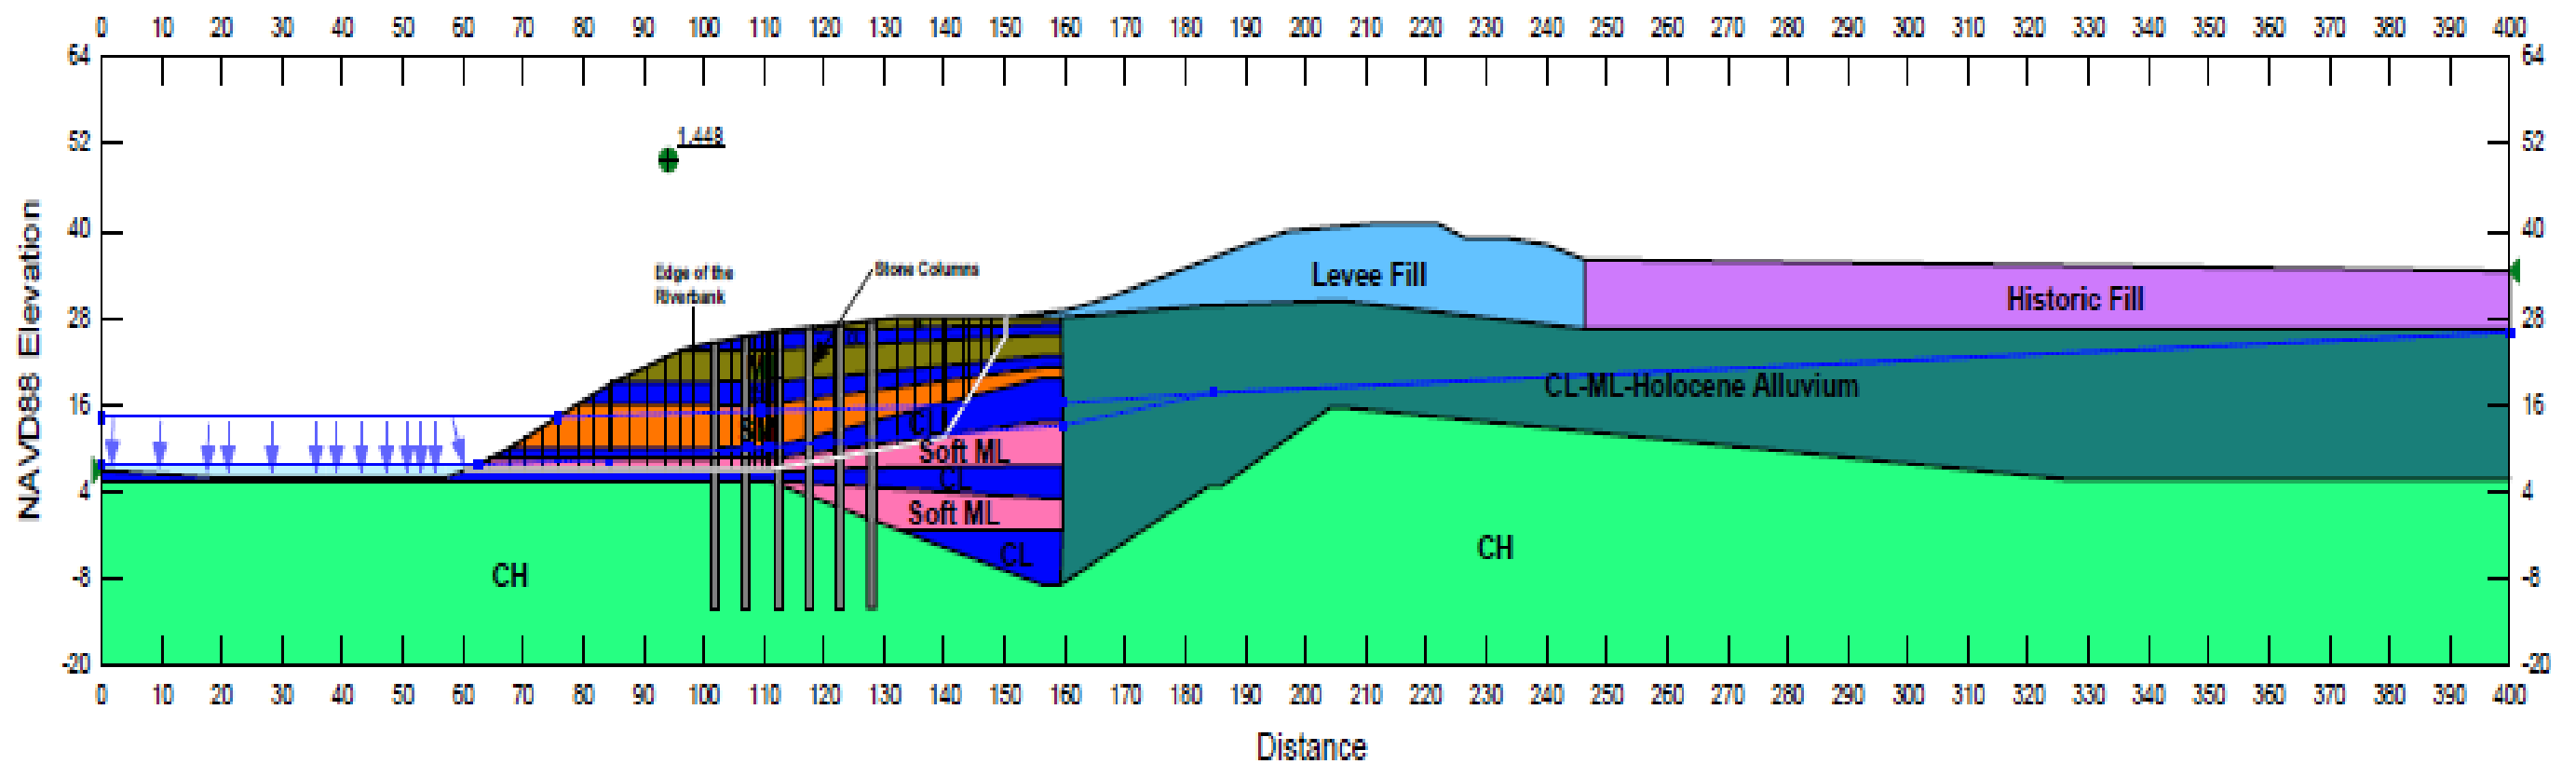
Minimum Factor of Safety (FOS): 1.448

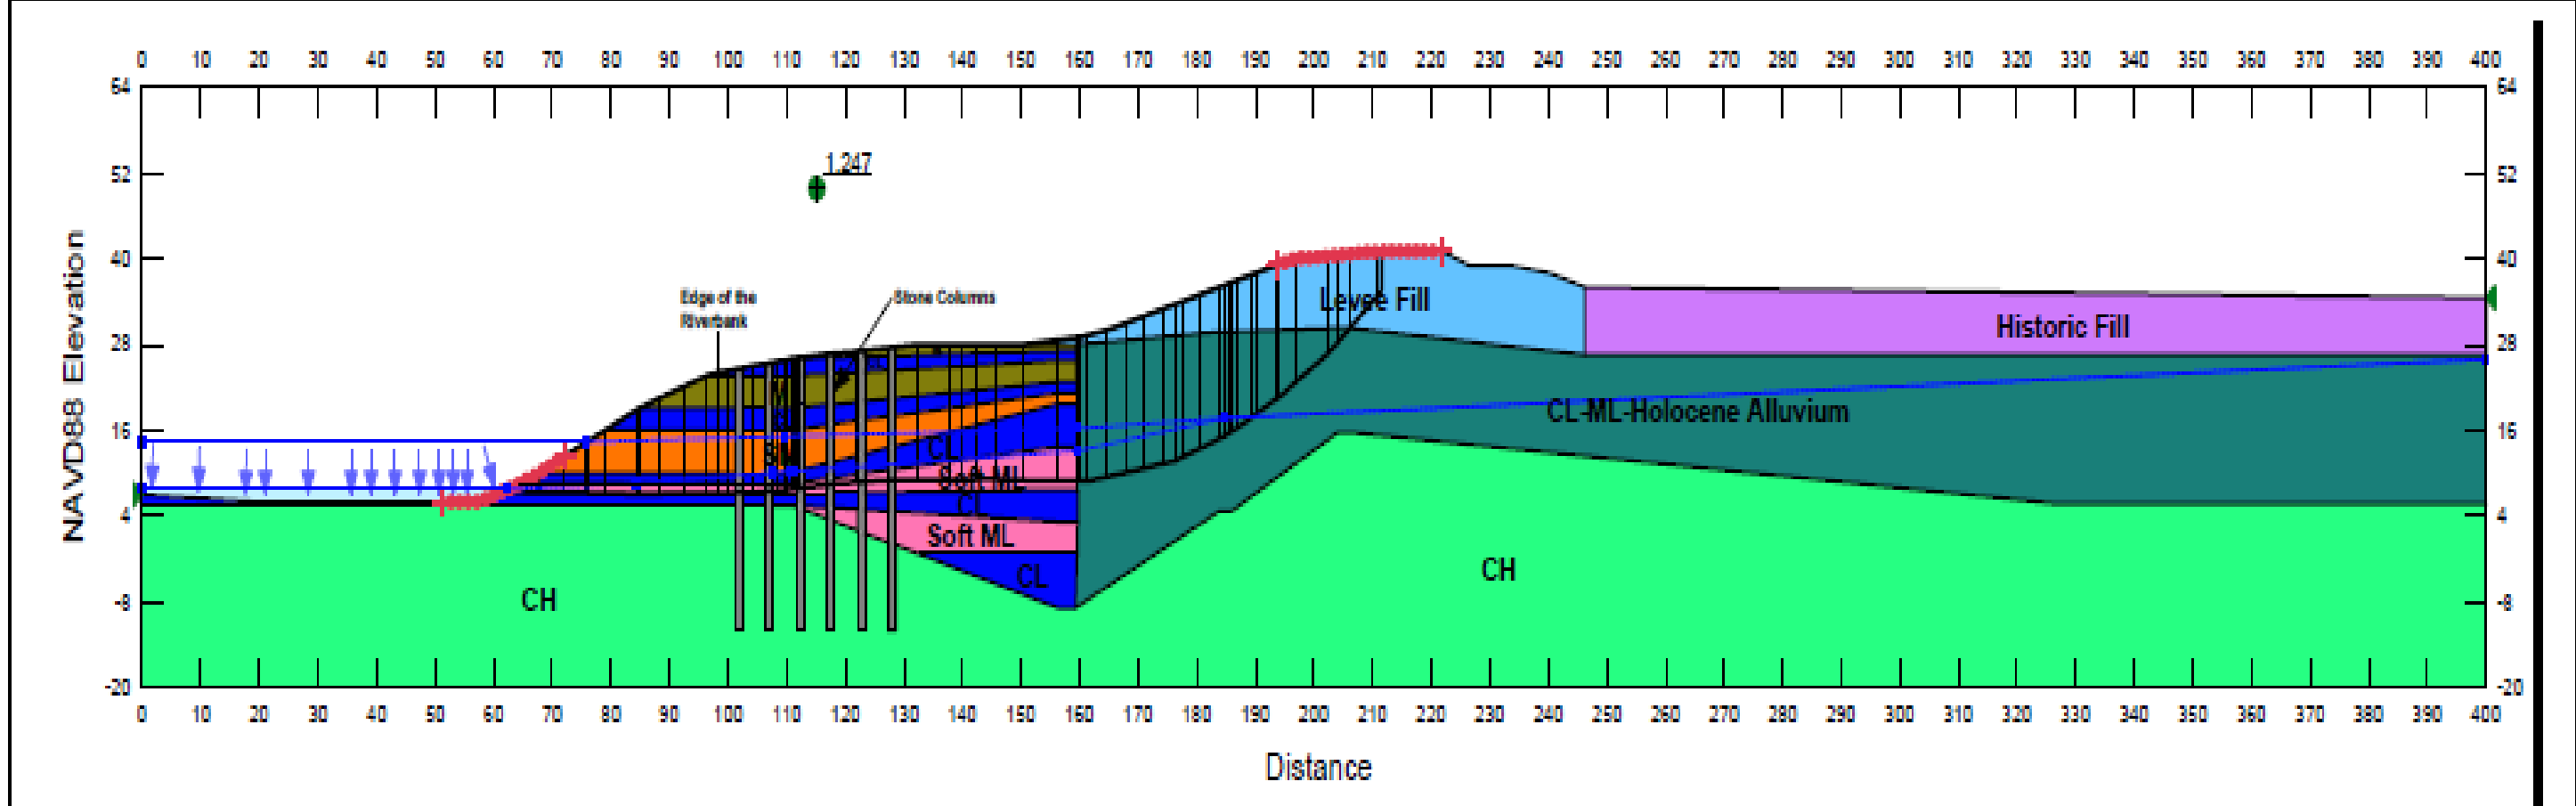
Minimum Factor of Safety (FOS): 1.247

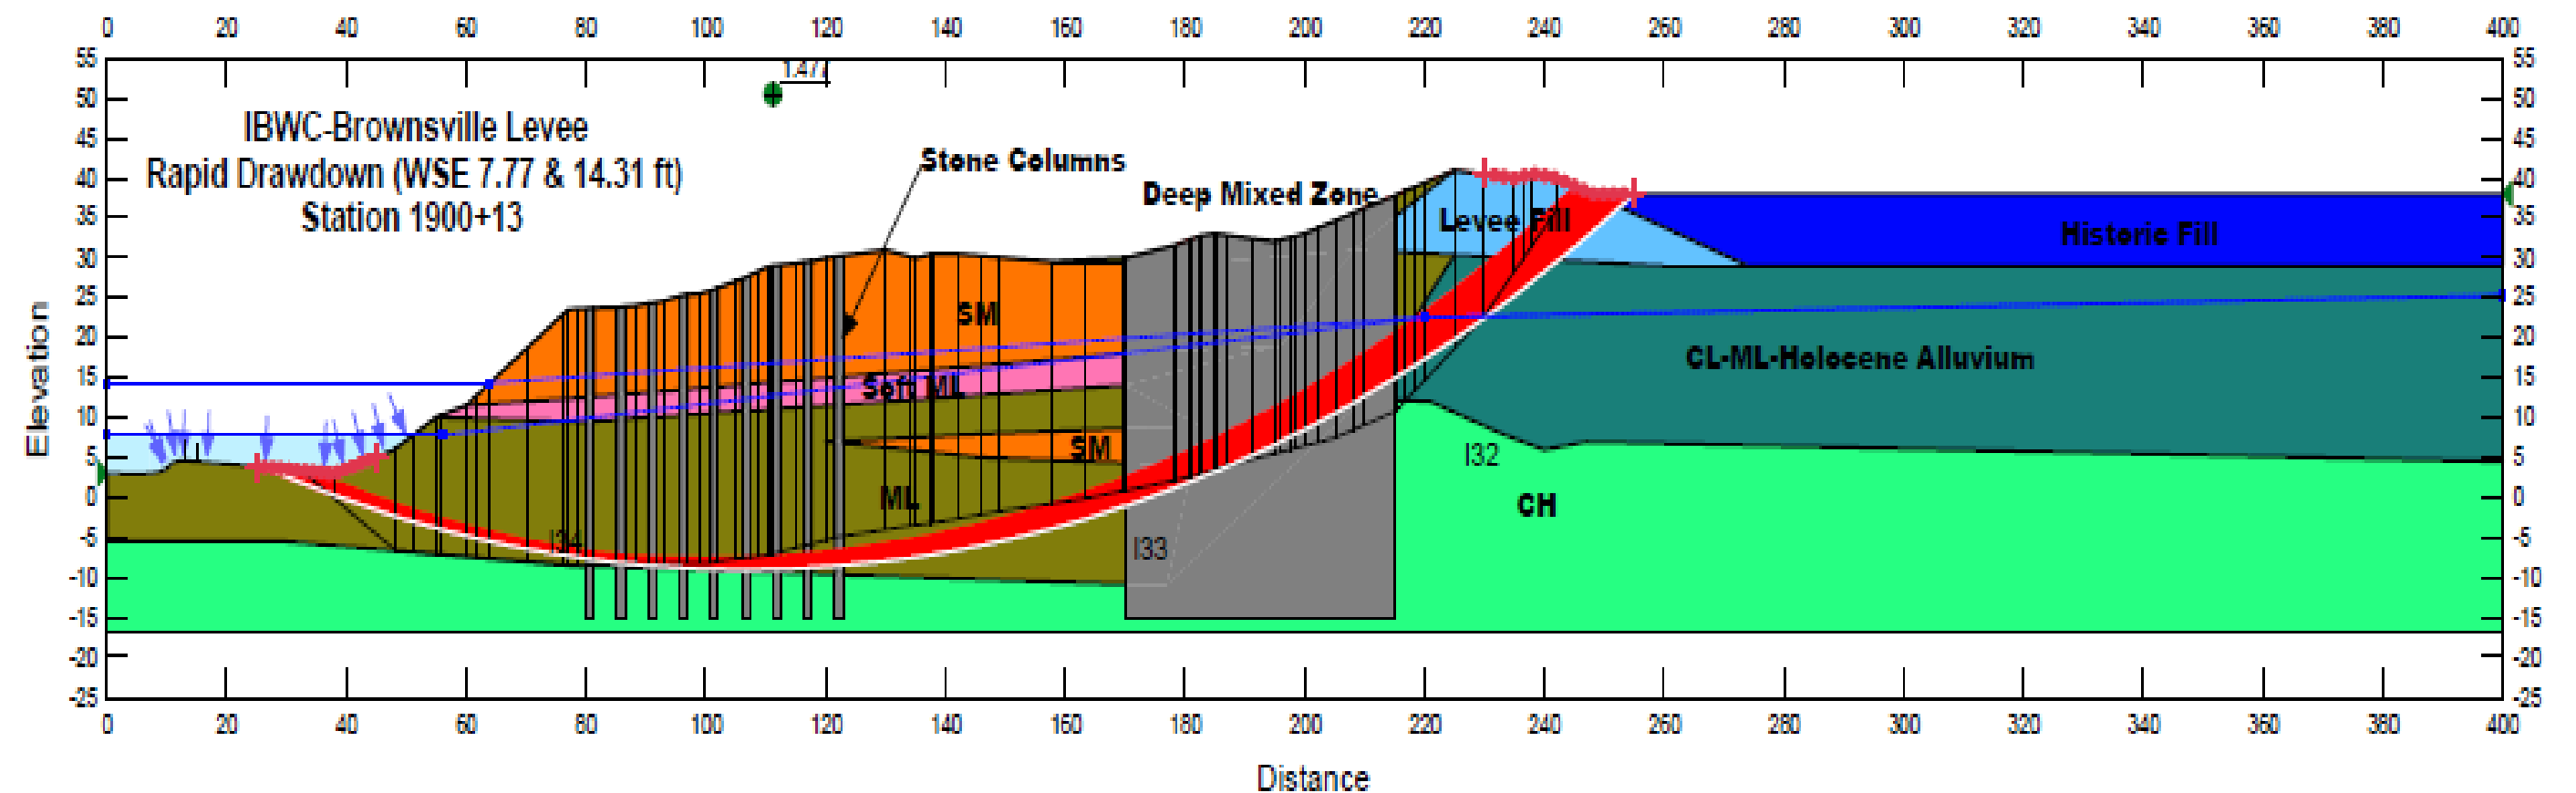
Minimum Factor of Safety (FOS): 1.477

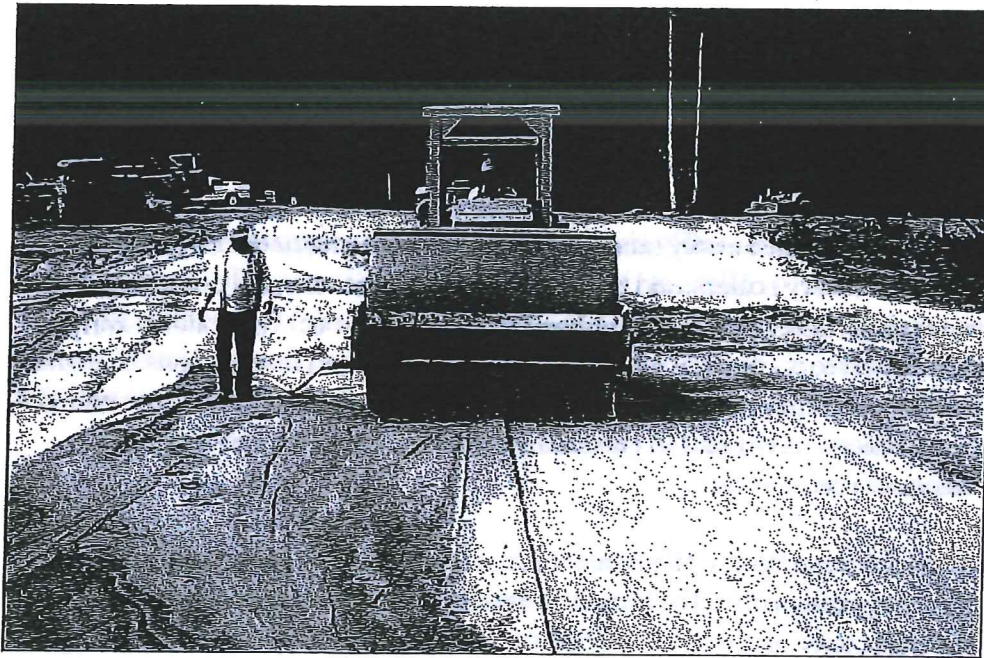
Figure 7-24. Compacting a joint between two zones by a vibratory roller.

Proper compaction of the contacts is accomplished by overlapping the vibratory roller onto the adjacent material rather than overlapping the tamping roller onto the filter/drain. However, roller operators and inspectors should be taught that a minor amount of mixing of the two adjacent materials is less a detriment than leaving the contact uncompacted. An overlap of 1 ft is usually specified. To facilitate compaction of contacts, all grade stakes used to mark zonal contacts prior to compaction should be removed so that operators do not drive around the stakes. Density testing should be conducted at or near zonal boundaries to verify that adequate compaction is being achieved in these critical areas. An example of rolling a sand filter/drain contact is shown in Figure 7-24 (Hammer 2003).
