From:
Kirk Lowery, P.E.

Date:
October 31, 2016

Subject:
October 2016 Summary Report of Inclinator Readings
Remediation Design of Levee Floodplain Failure within the
Upper Brownsville Levee Reach Lower Rio Grande Flood
Control Project – IBM15D0001 – IBM15T0015

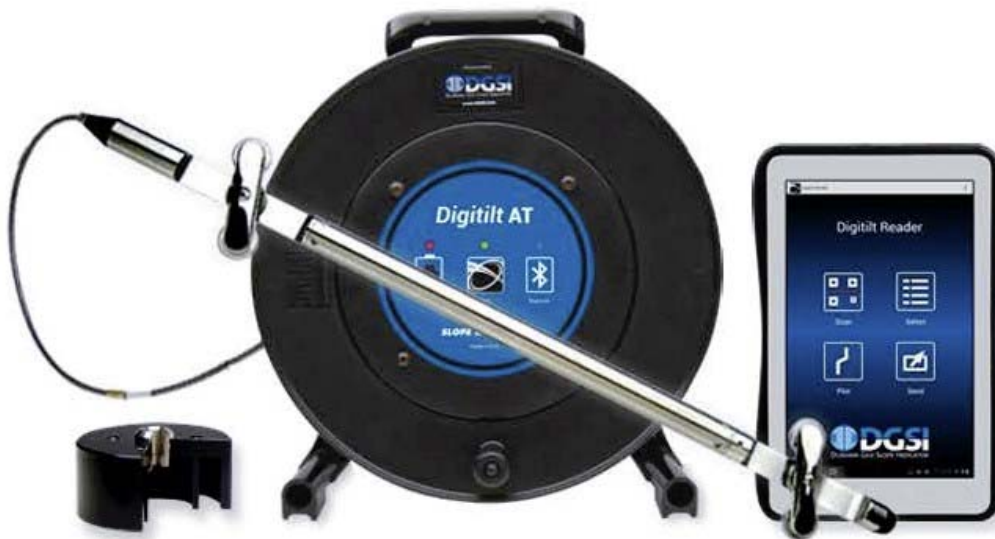
Digitilt AT system was used to survey the inclinometers. The system components include an inclinometer probe, control cable, a Bluetooth reel and the Digitilt Reader app for certified Android-based tablet computer. The equipment is shown in Figure 1.

Figure 1: Digitilt AT System Components.
