Arcadis Project No.:
LA003315.0000

Subject:
November 2016 Summary Report of Inclinator Readings
Remediation Design of Levee Floodplain Failure within the
Upper Brownsville Levee Reach Lower Rio Grande Flood
Control Project – IBM15D0001 – IBM15T0015

IBWC
SUMMARY REPORT OF INCLINOMETER READINGS

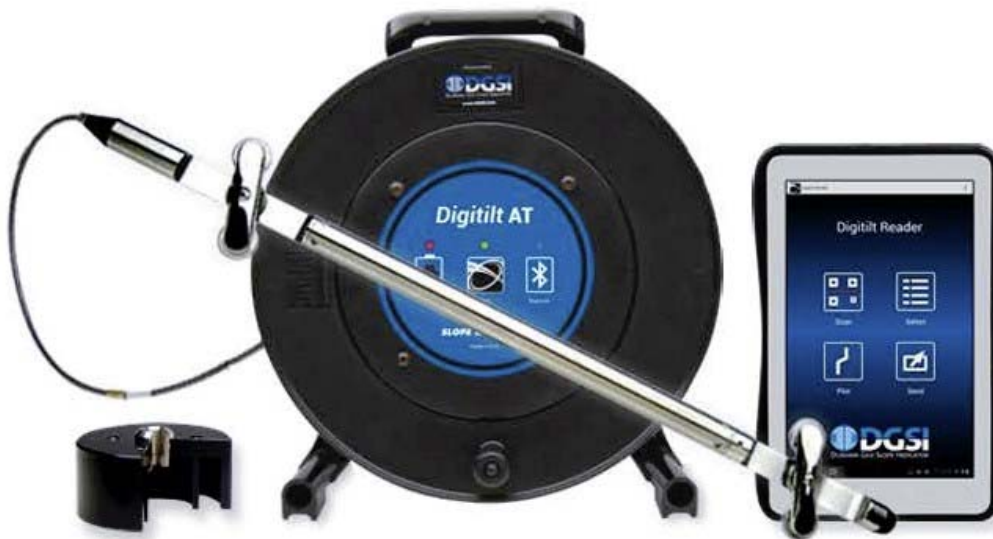
Digitilt AT system was used to survey the inclinometers. The system components include an inclinometer probe, control cable, a Bluetooth reel and the Digitilt Reader app for certified Android-based tablet computer. The equipment is shown in Figure 1.

Figure 1: Digitilt AT System Components.
