Subject:
February 2017 Summary Report of Inclinator Readings
Remediation Design of Levee Floodplain Failure within the
Upper Brownsville Levee Reach Lower Rio Grande Flood
Control Project – IBM15D0001 – IBM15T0015

IBWC
SUMMARY REPORT OF INCLINOMETER READINGS

REMEDATION DESIGN OF LEVEE FLOODPLAIN FAILURE
WITHIN THE UPPER BROWNSVILLE LEVEE REACH
LOWER RIO GRANDE FLOOD CONTROL PROJECT

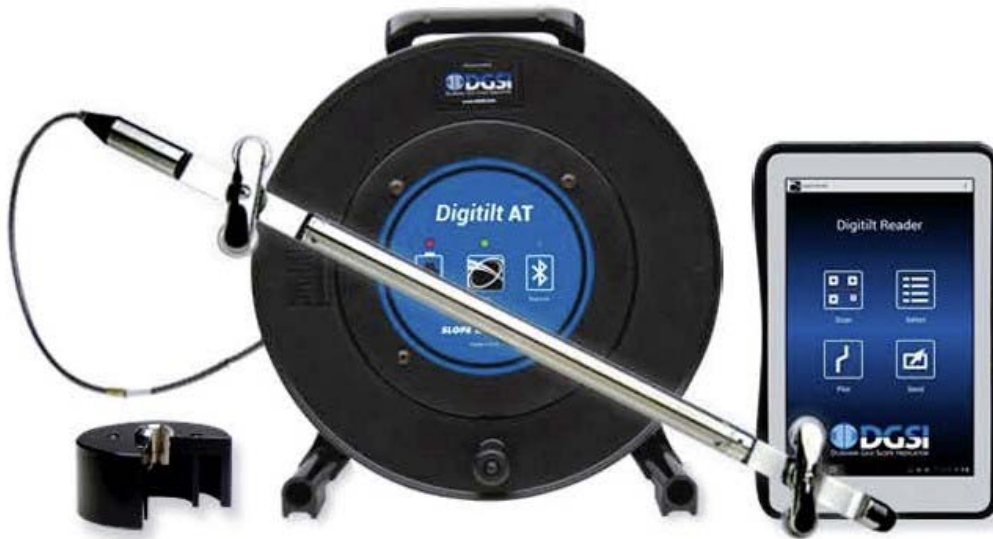
Figure 1: Digitilt AT System Components.

Digitilt AT system was used to survey the inclinometers. The system components include an inclinometer probe, control cable, a Bluetooth reel and the Digitilt Reader app for certified Android-based tablet computer. The equipment is shown in Figure 1.

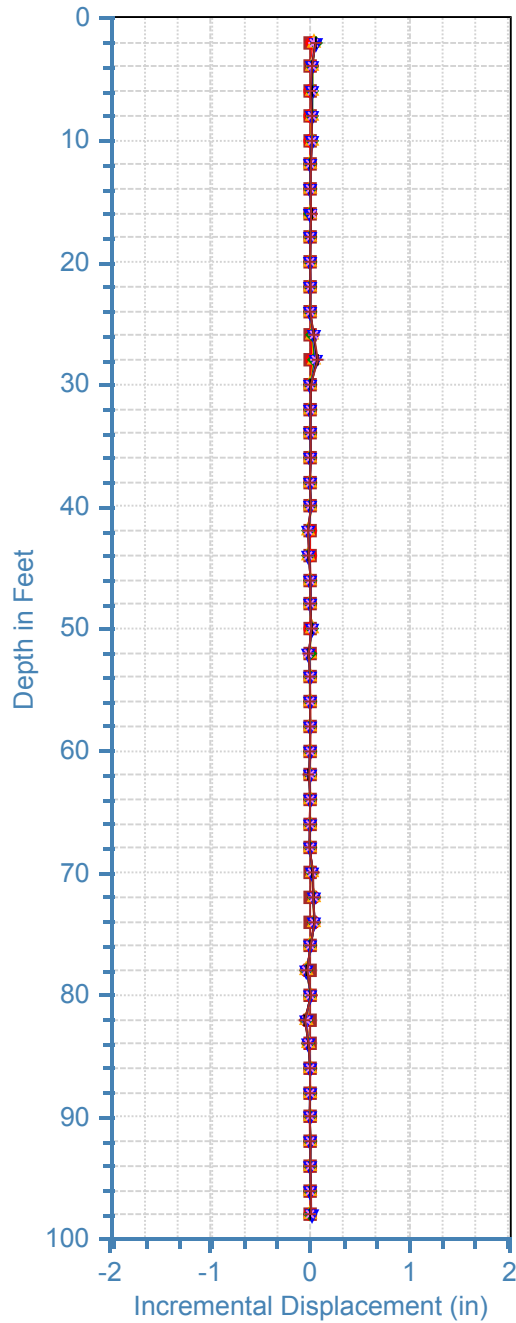
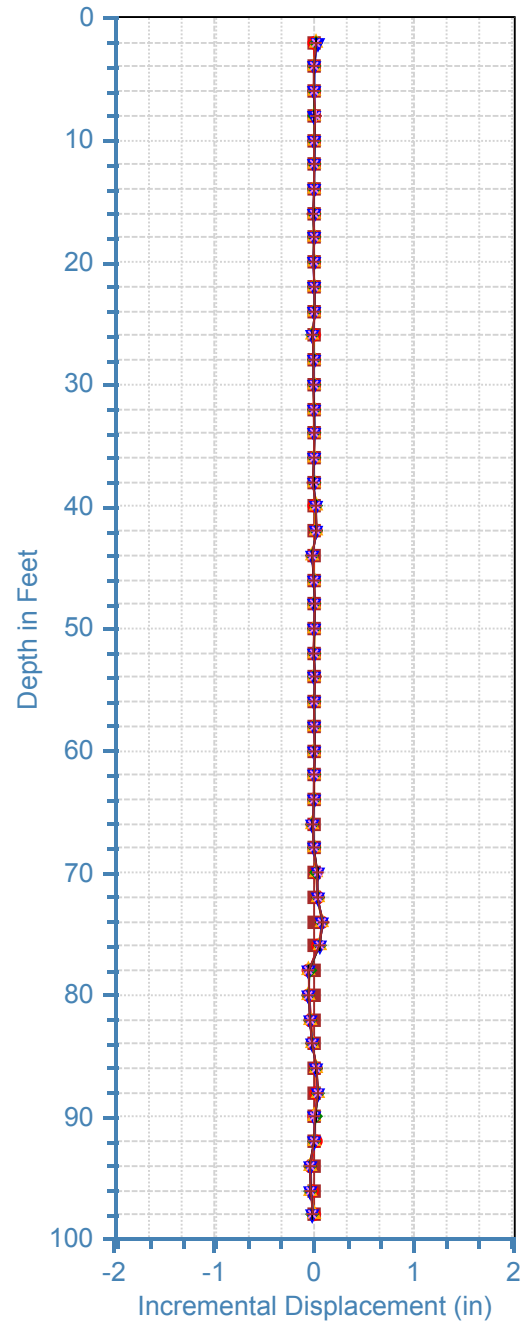
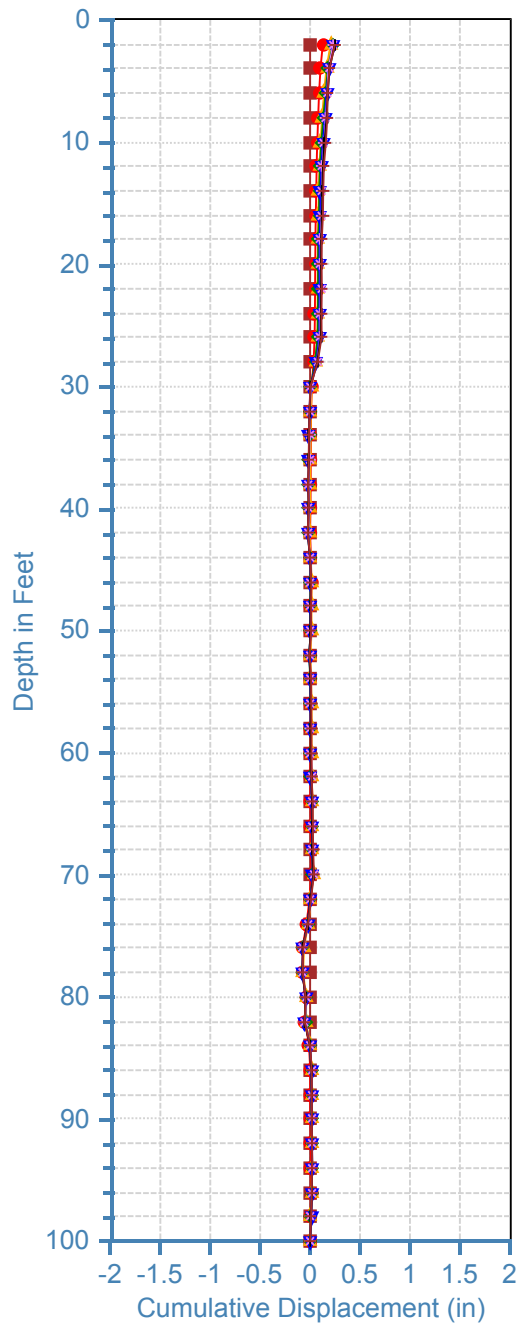
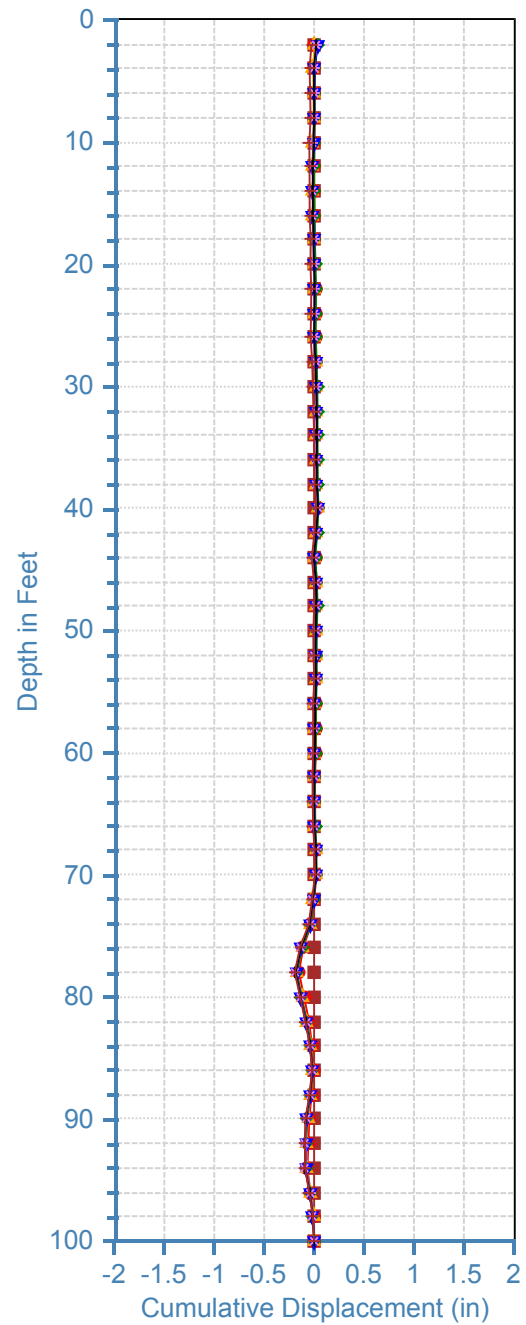
IBWC Arc-1 A - Axis

Inclinometer Arc-1: The base readings for inclinometer Arc-1 were collected on June 22, 2016. The Arc-1 cumulative plot in the A-Axis direction shows a slight progressive movement starting at depths between 28 and 30 feet. This depth corresponds with the interpreted Alluvium/Pleistocene interface presented in Figure 2 of Arcadis' December 2, 2016 *Draft Geotechnical Assessment Report*. This inclinometer will continue to be monitored on the normally scheduled frequency to determine if there is any increase in cumulative displacements.

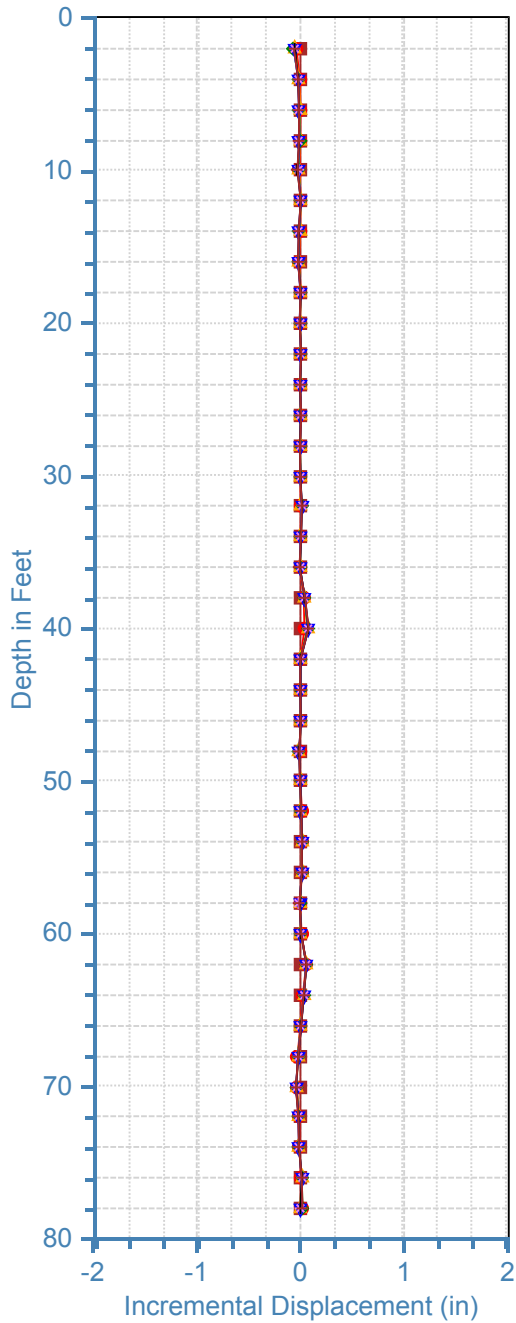
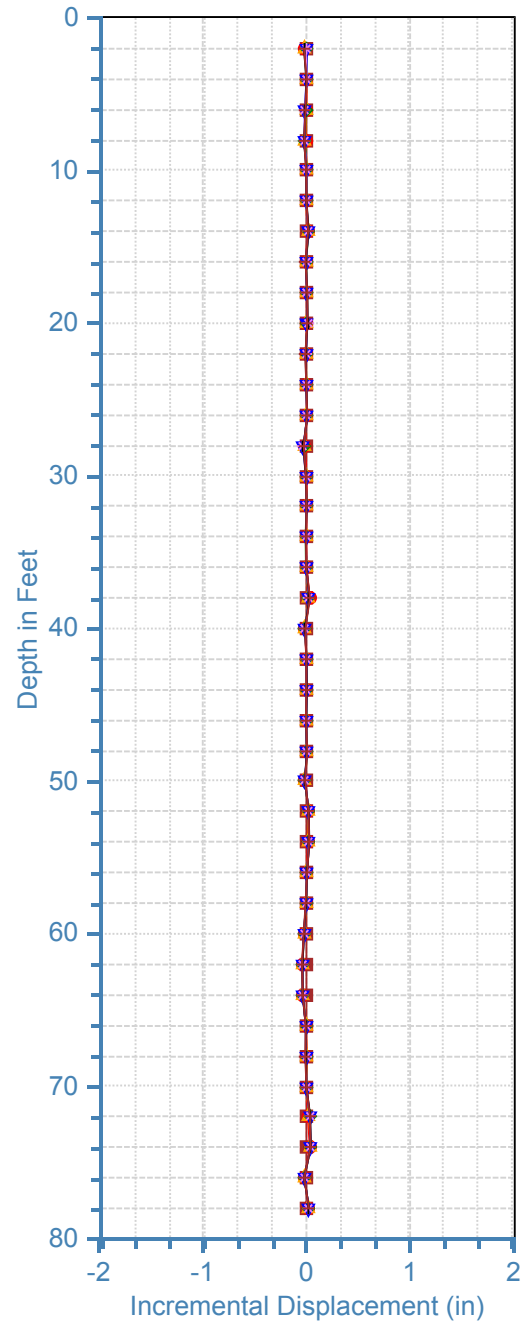
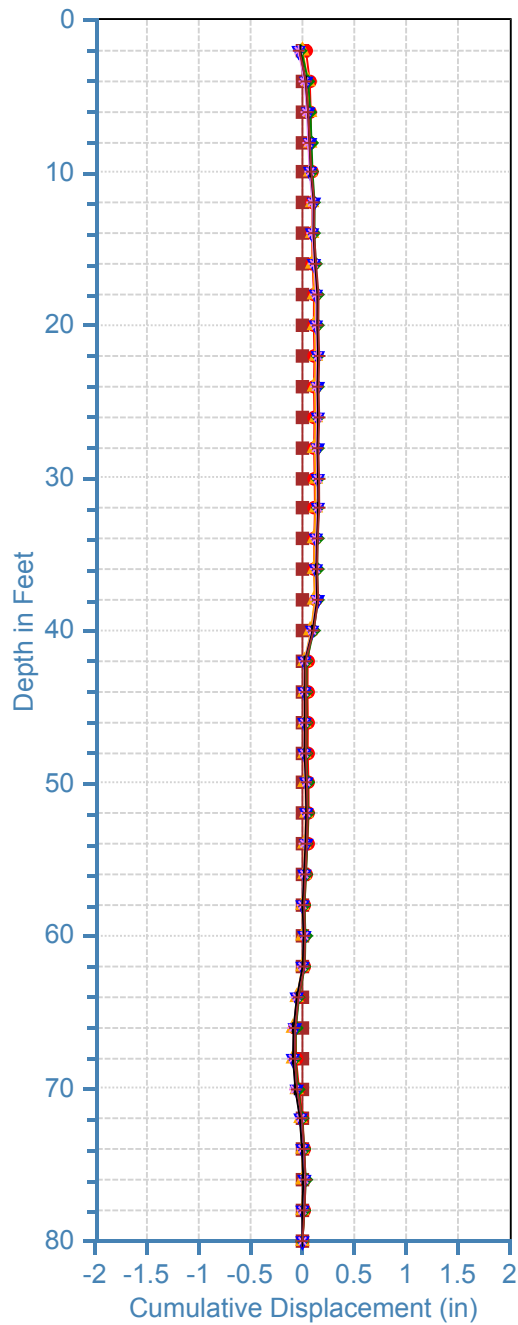
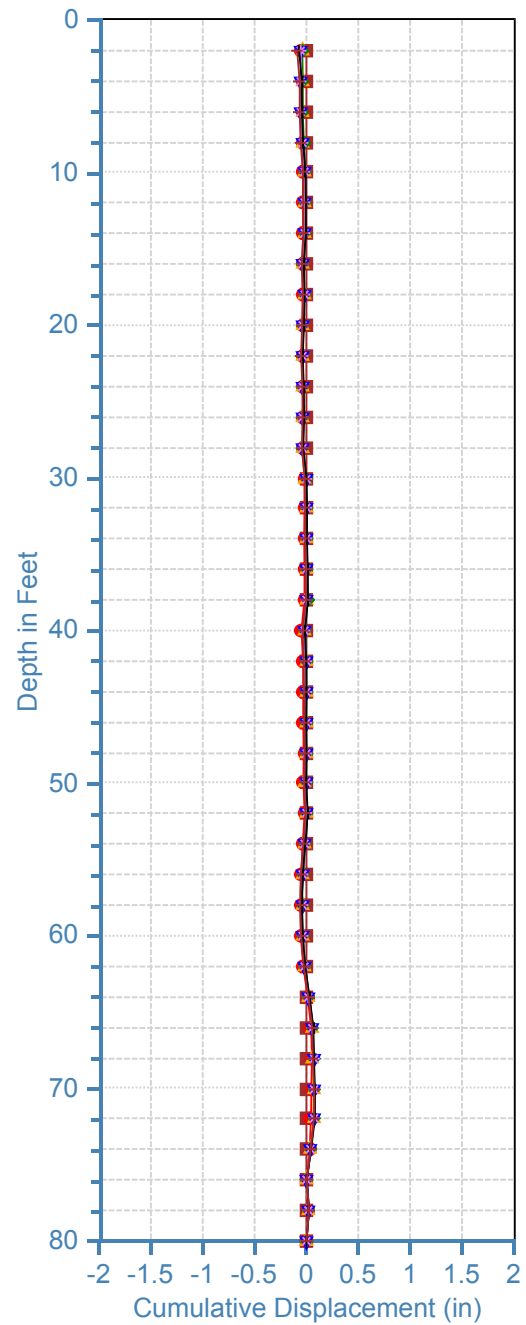
IBWC Arc-2 A - Axis

Inclinometer Arc-2: The base readings for inclinometer Arc-2 were collected on June 17, 2016. The Arc-2 cumulative and incremental displacement does not show any sign of movement on the plane perpendicular to the levee nor on the plane parallel to the levee. Although the cumulative plot in the A-Axis direction shows a slight displacement at depths between 40 and 42 feet, this displacement is not progressive. This displacement could have been caused during the curing of the grout or some other environmental factor after the initial reading.

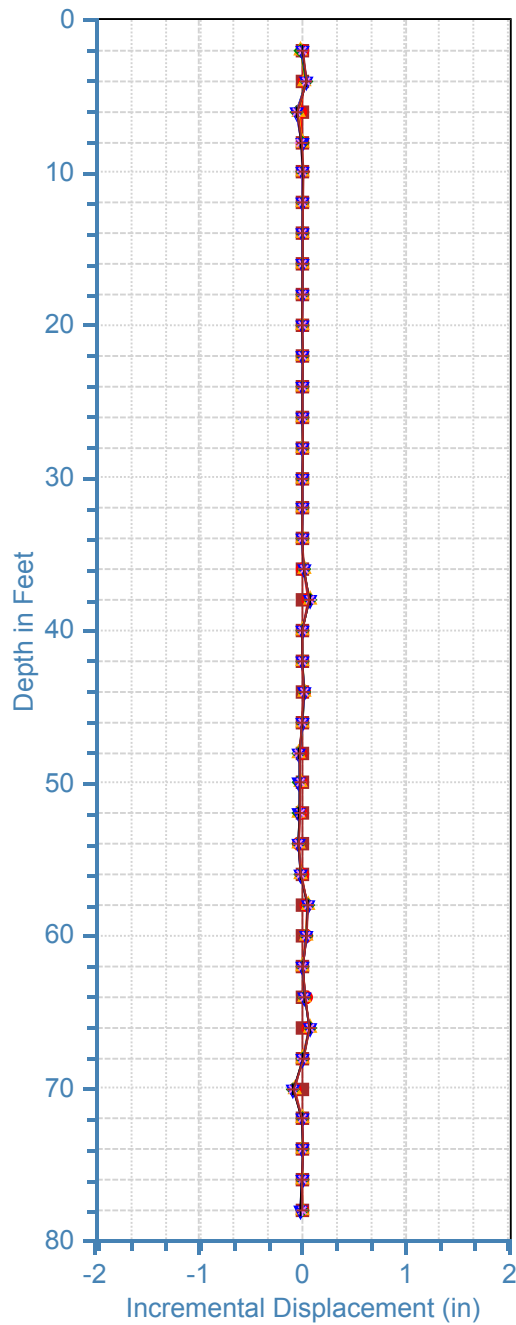
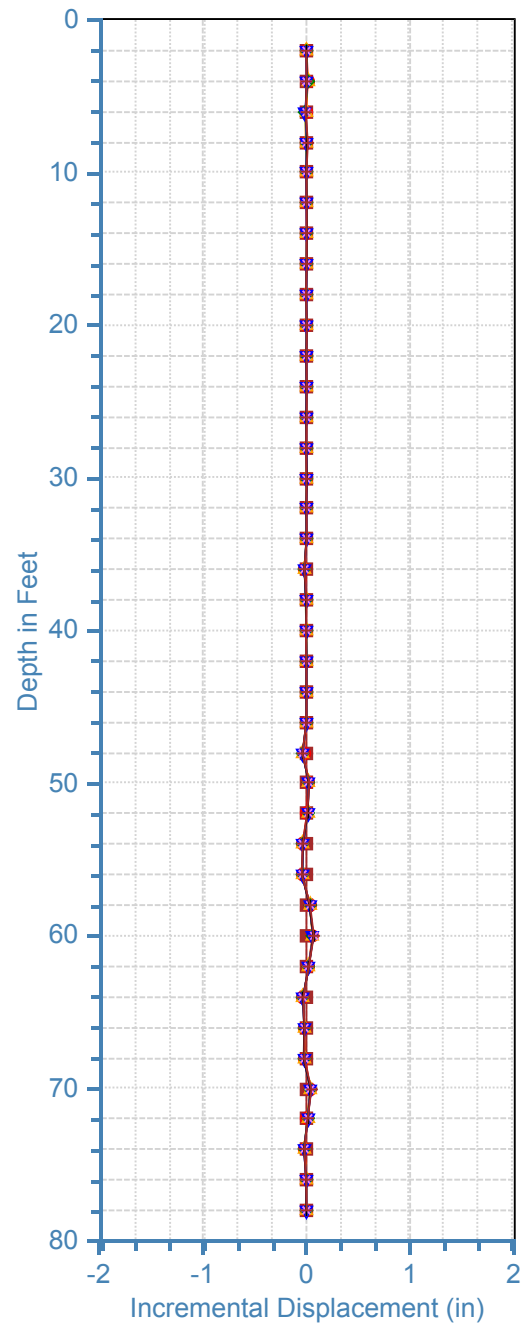
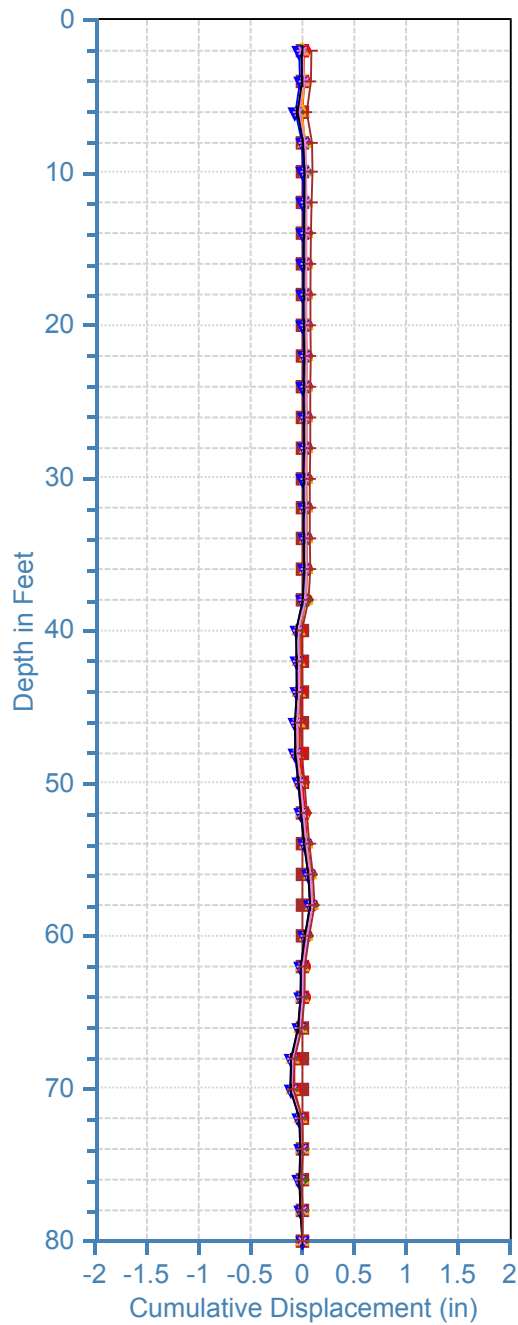
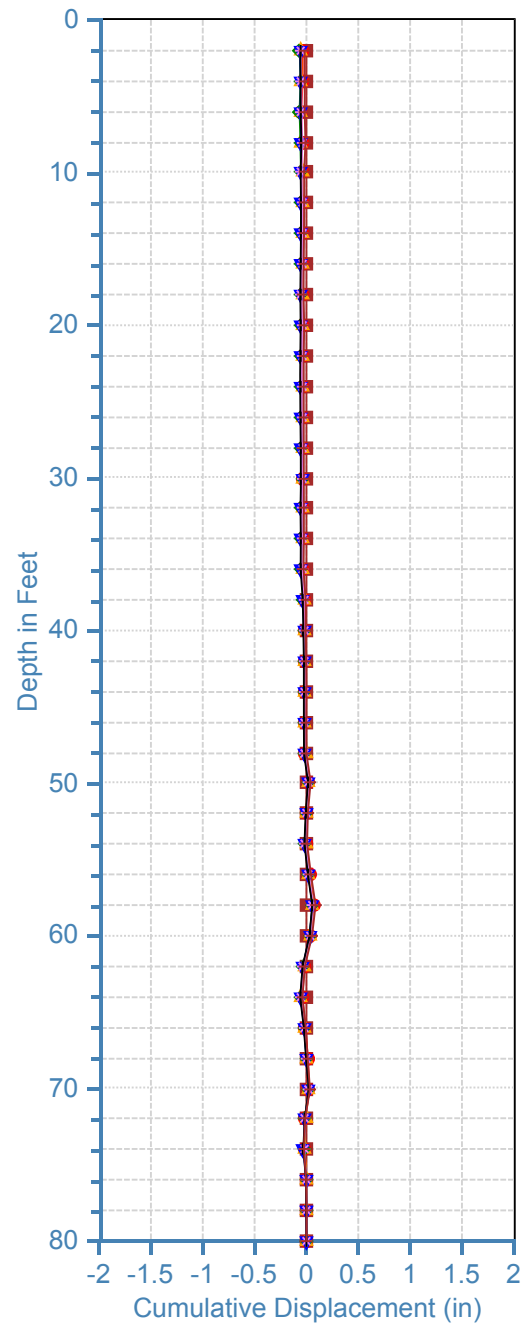
IBWC Arc-3 A - Axis

Inclinometer Arc-3: The base readings for inclinometer Arc-3 were collected on June 17, 2016. The Arc-3 cumulative and incremental displacement does not show any sign of movement on the plane perpendicular to the levee nor on the plane parallel to the levee.

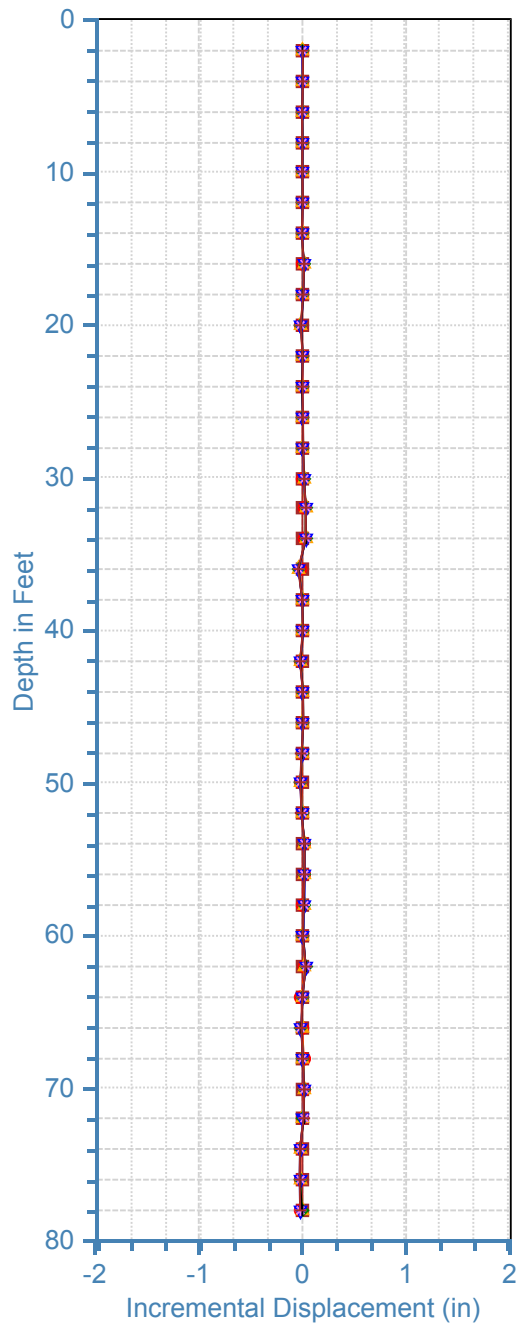
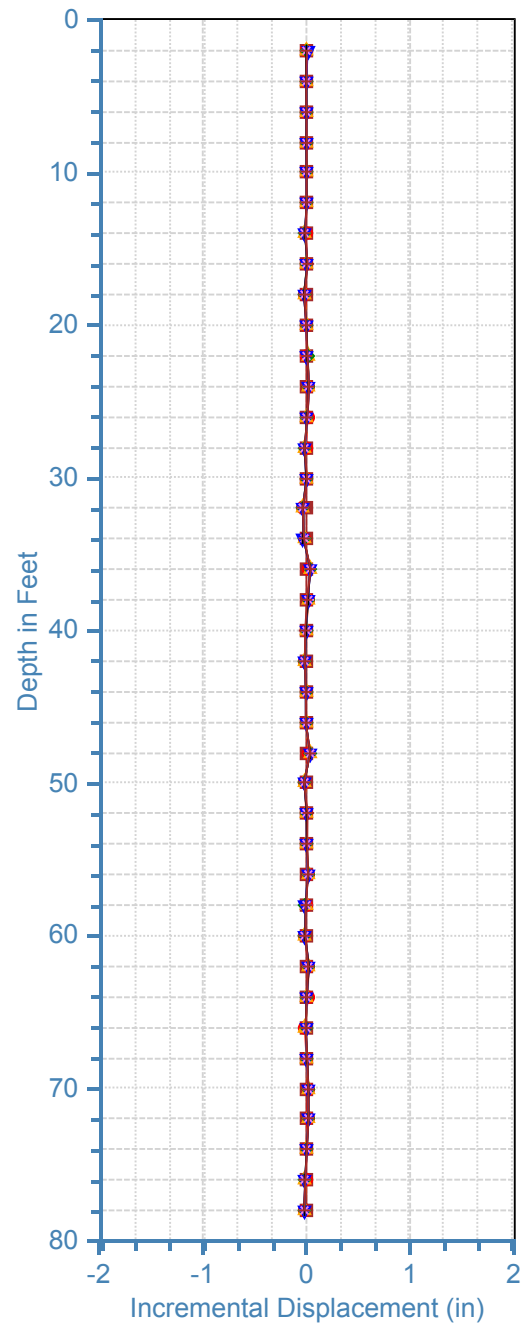
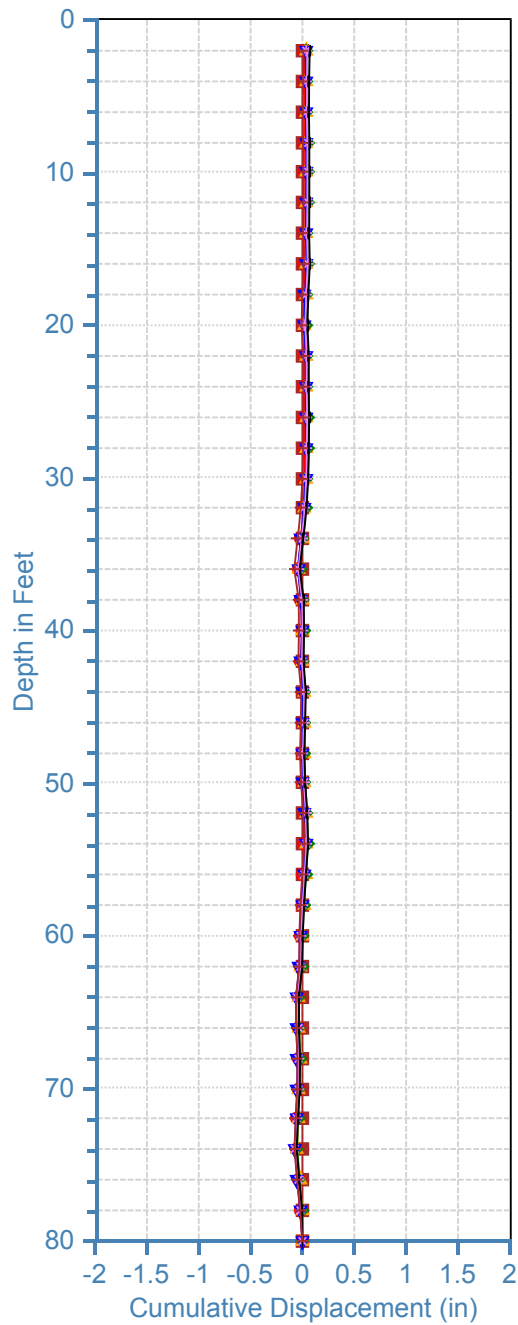
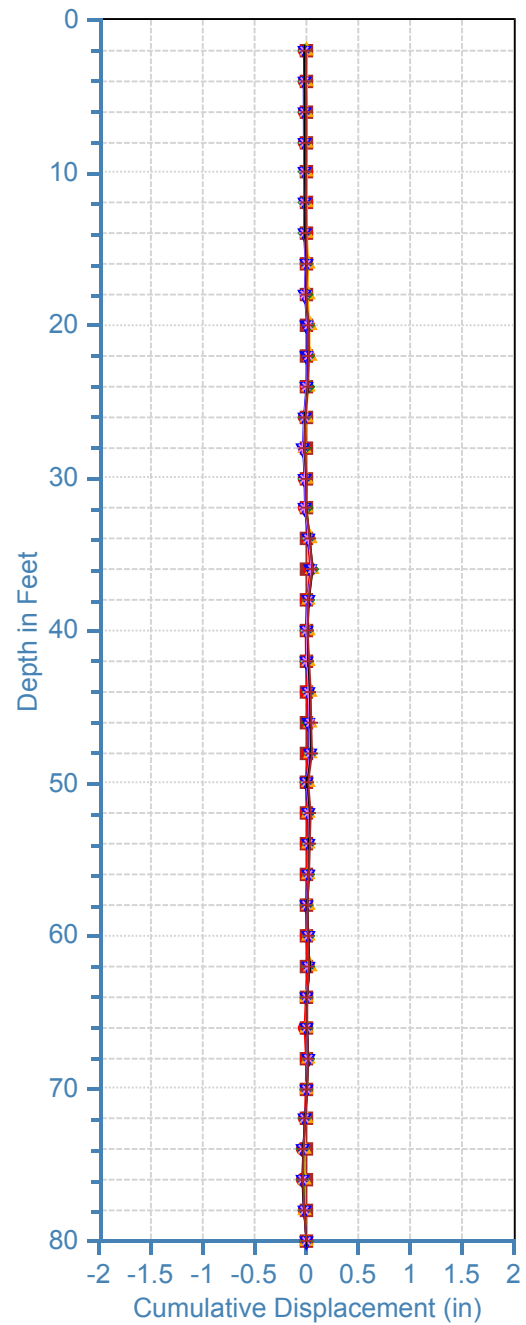
IBWC Arc-4 A - Axis

Inclinometer Arc-4: The base readings for inclinometer Arc-4 were collected on June 22, 2016. The Arc-4 cumulative and incremental displacement does not show any sign of movement on the plane perpendicular to the levee nor on the plane parallel to the levee.

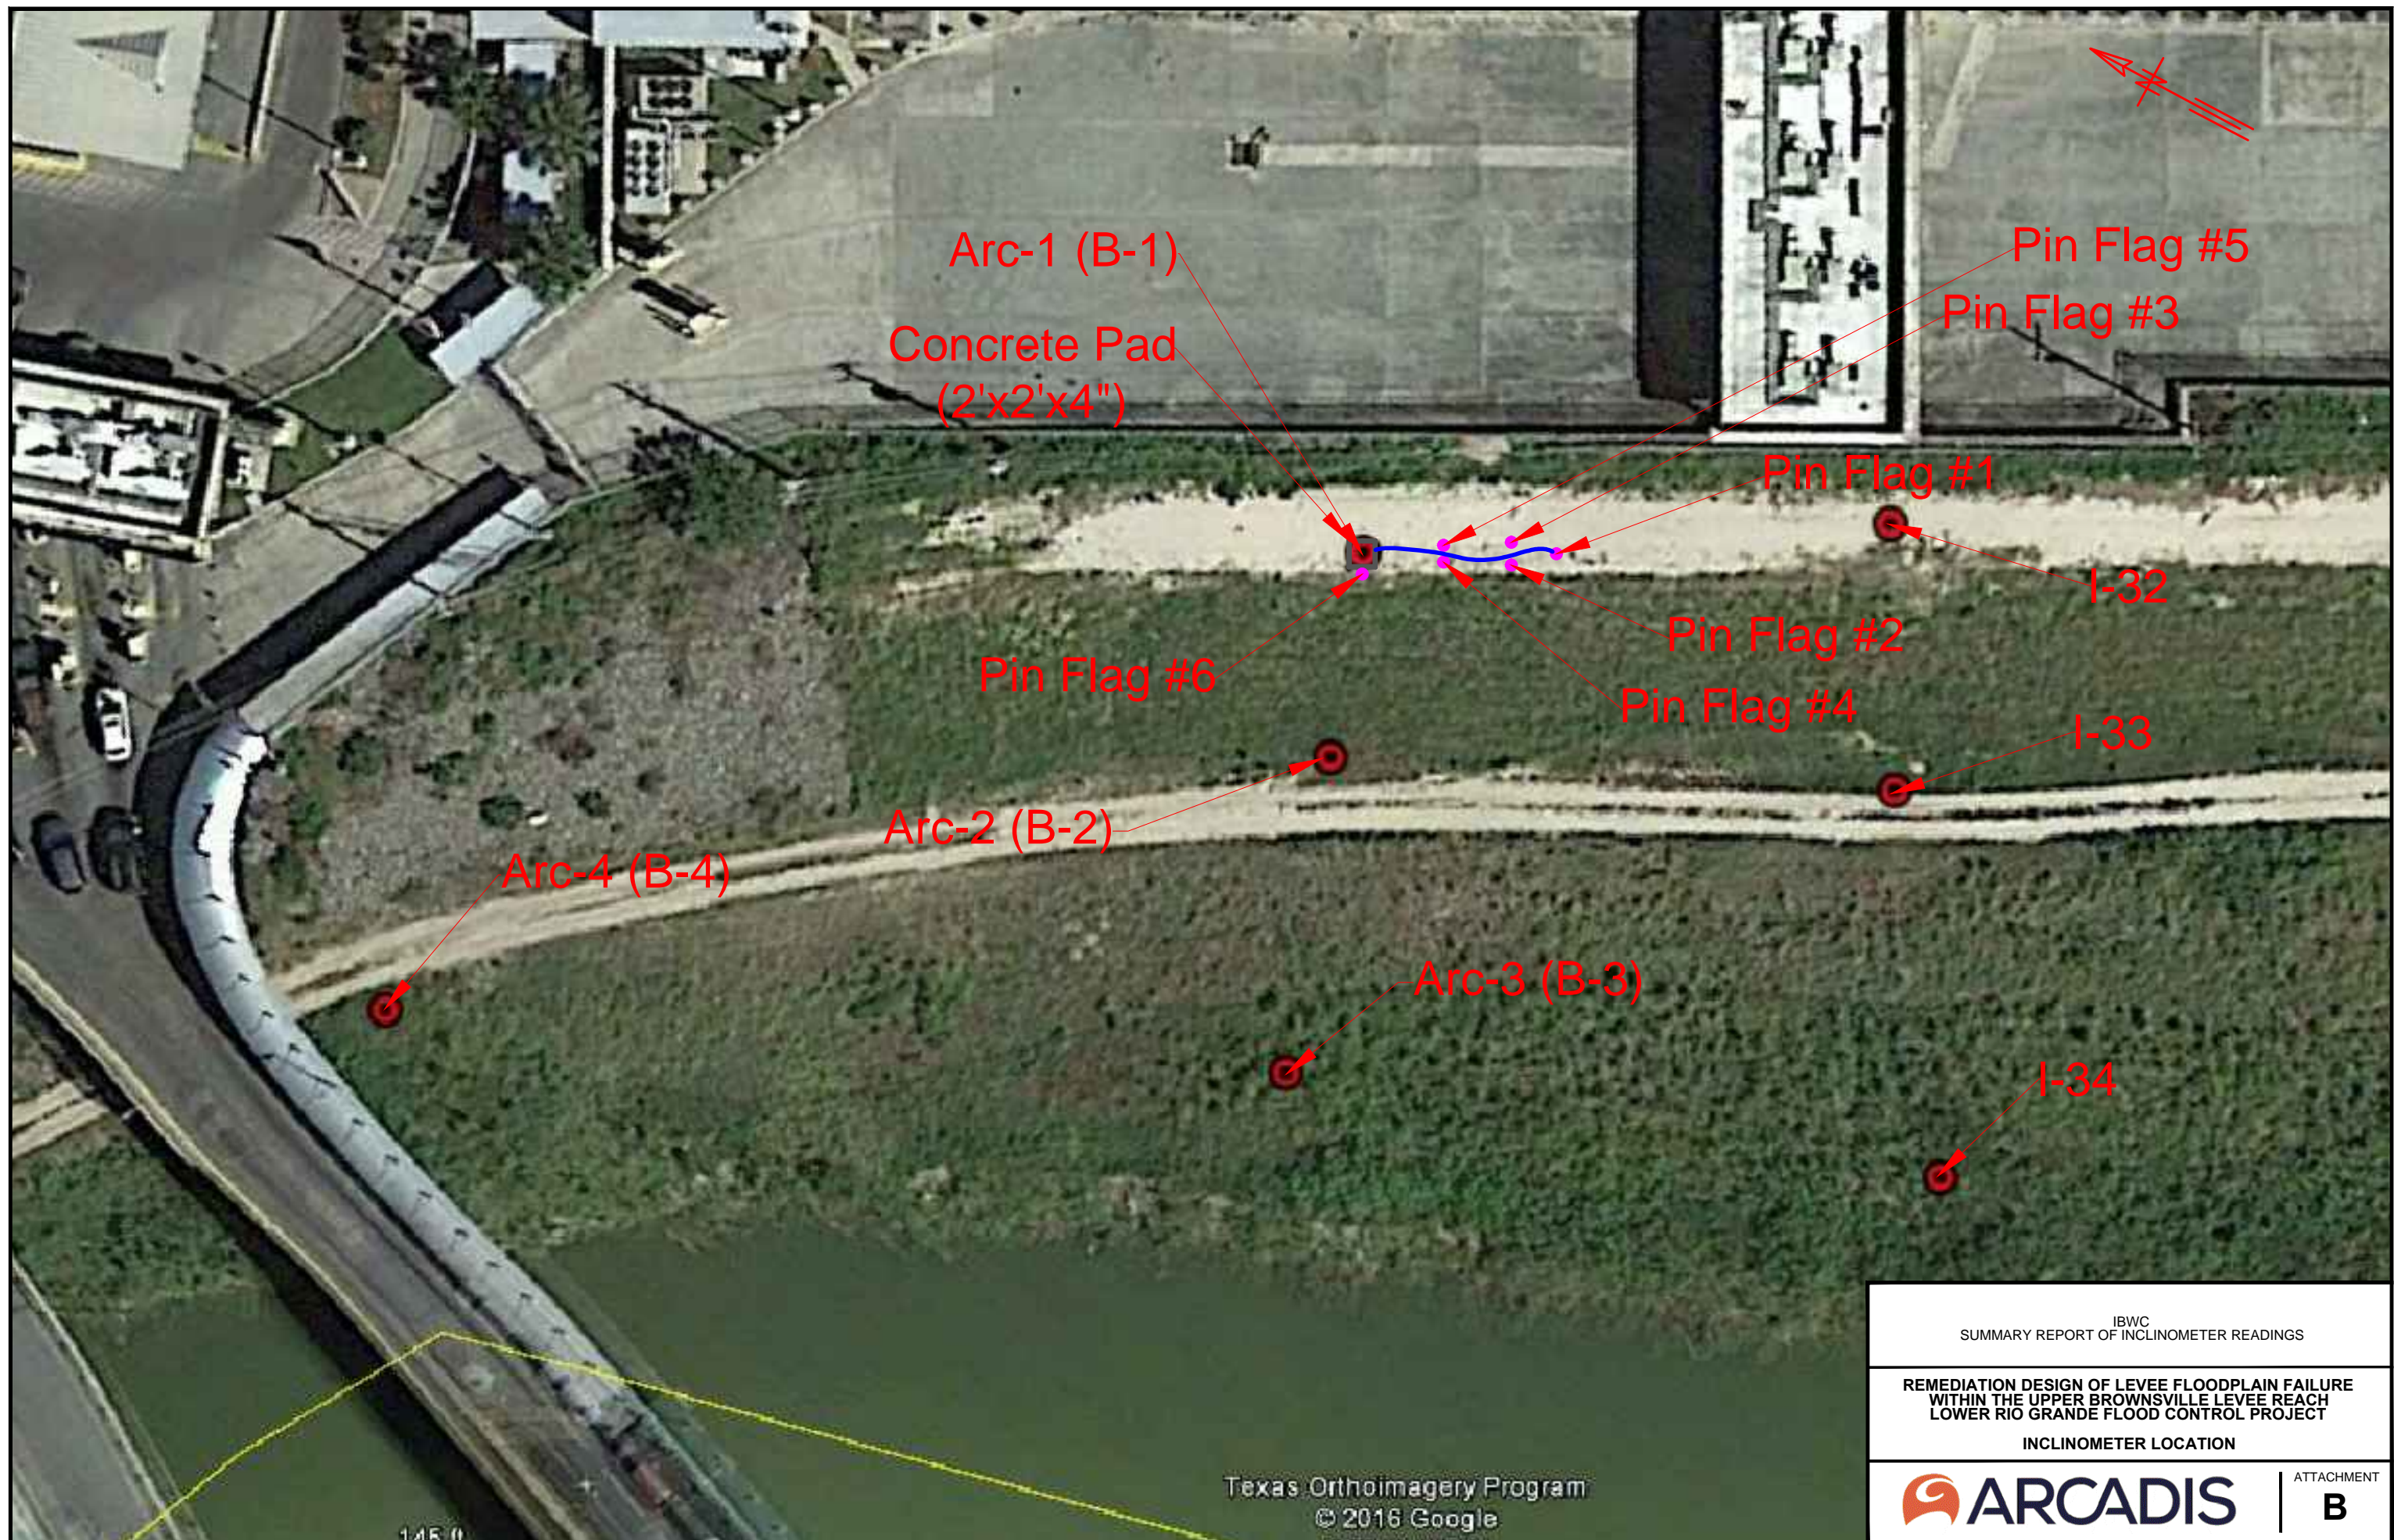
INCLINOMETER LOCATION

In addition, tension cracks were observed on top of the levee near inclinometer ARC-1. The cracks begin at the northern edge of the 2-foot by 2-foot concrete pad and ends approximately 14 feet and four inches south from the center of the inclinometer casing along the top edge of the levee. Arcadis installed six pin

flags along the crack as shown in Attachment B. These pin flags will be used as a reference to measure over the next five months to observe if the crack widens or extends either south or north. Table 1 summarized the pin flags location along the cracks.

The readings for each inclinometer are reflected in the graphical displays provided in Attachment A. Attachment A includes both incremental and cumulative displacement plots. Attachment B shows the inclinometer locations on a Google Map.
