Date:
March 20, 2017

Arcadis Project No.:
LA003315.0000

Subject:
March 2017 Summary Report of Inclinator Readings
Remediation Design of Levee Floodplain Failure within the
Upper Brownsville Levee Reach Lower Rio Grande Flood
Control Project – IBM15D0001 – IBM15T0015

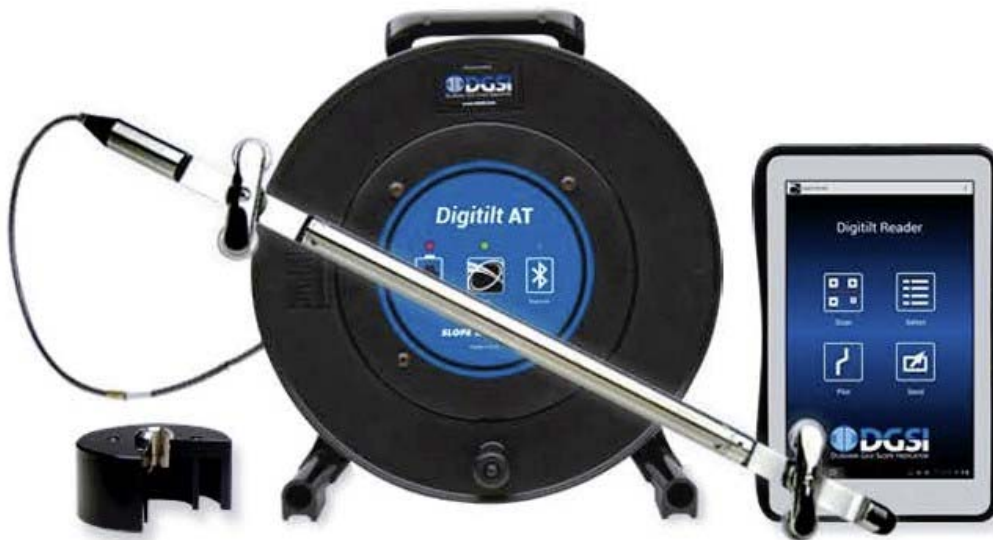
Figure 1: Digitilt AT System Components.

Digitilt AT system was used to survey the inclinometers. The system components include an inclinometer probe, control cable, a Bluetooth reel and the Digitilt Reader app for certified Android-based tablet computer. The equipment is shown in Figure 1.

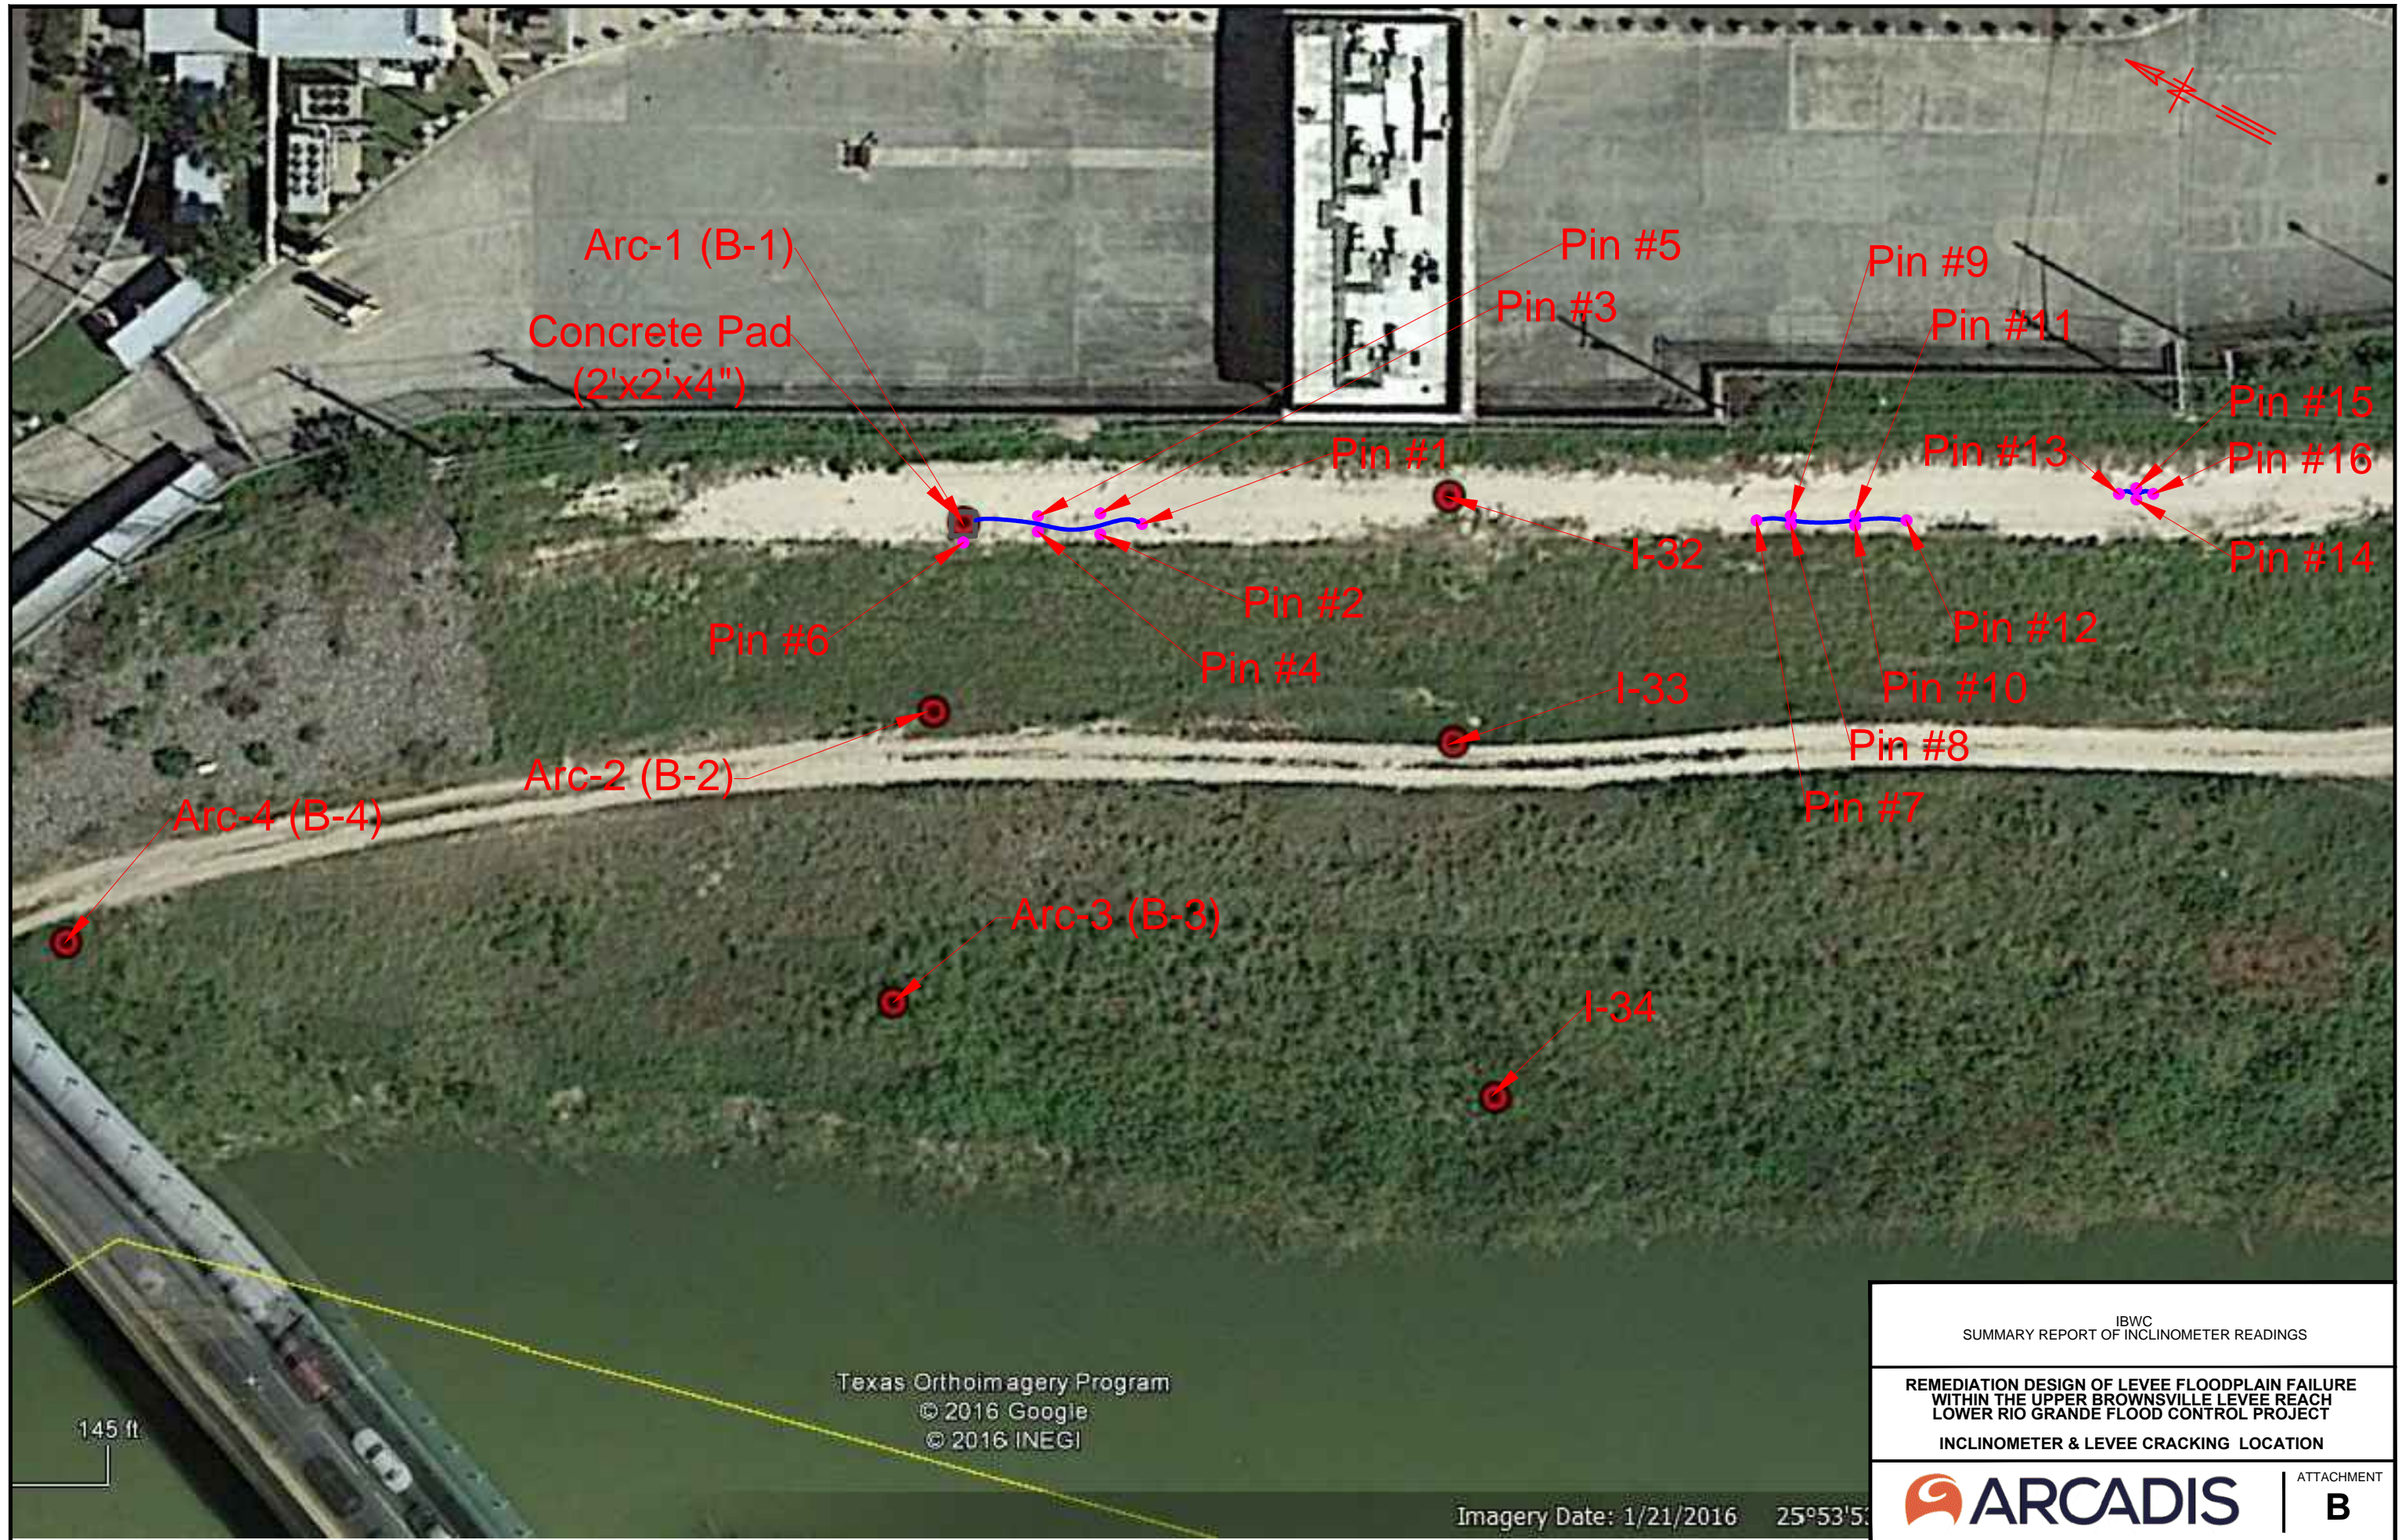
ATTACHMENT B
INCLINOMETER LOCATION MAP

In this month's visit to the IBWC site, tension cracks were observed on top of the levee near inclinometer ARC-1 and new cracks were discovered south of the existing retaining wall in two sections as shown in Attachment B. At the known surface cracks near ARC-1, there was no displacement with respect to the

The readings for each inclinometer are reflected in the graphical displays provided in Attachment A. Attachment A includes both incremental and cumulative displacement plots. Attachment B shows the inclinometer locations on a Google Map.
