Subject:
May 2017 Summary Report of Inclinometer Readings - **Revised**
Remediation Design of Levee Floodplain Failure within the
Upper Brownsville Levee Reach Lower Rio Grande Flood
Control Project – IBM15D0001 – IBM15T0015

IBWC
SUMMARY REPORT OF INCLINOMETER READINGS

REMEDATION DESIGN OF LEVEE FLOODPLAIN FAILURE
WITHIN THE UPPER BROWNSVILLE LEVEE REACH
LOWER RIO GRANDE FLOOD CONTROL PROJECT

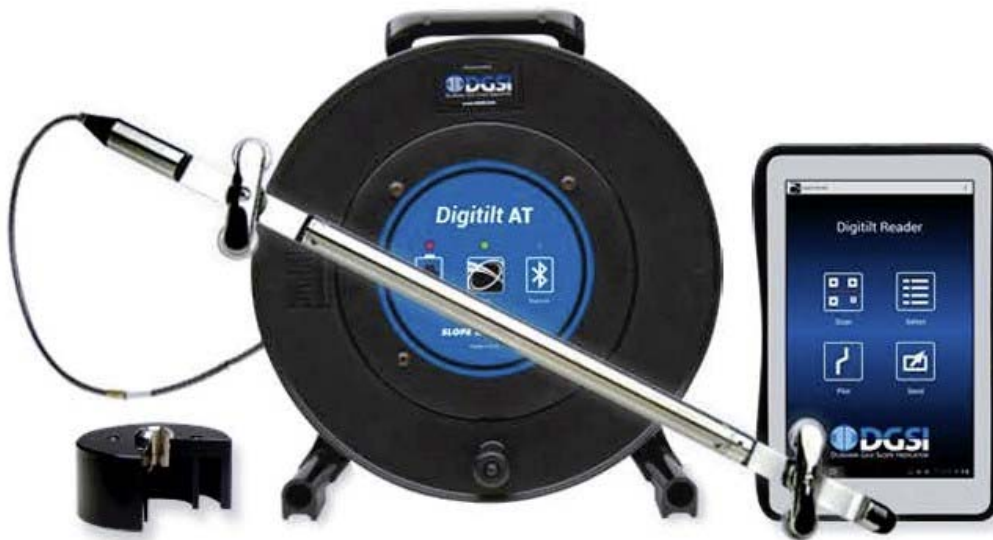
Figure 1: Digitilt AT System Components.

Digitilt AT system was used to survey the inclinometers. The system components include an inclinometer probe, control cable, a Bluetooth reel and the Digitilt Reader app for certified Android-based tablet computer. The equipment is shown in Figure 1.

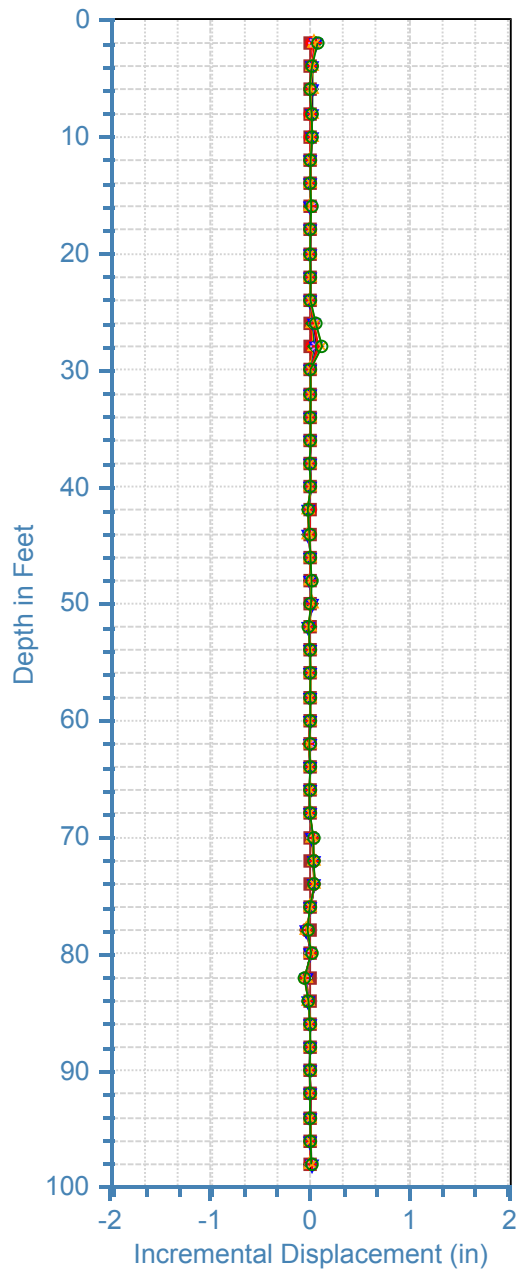
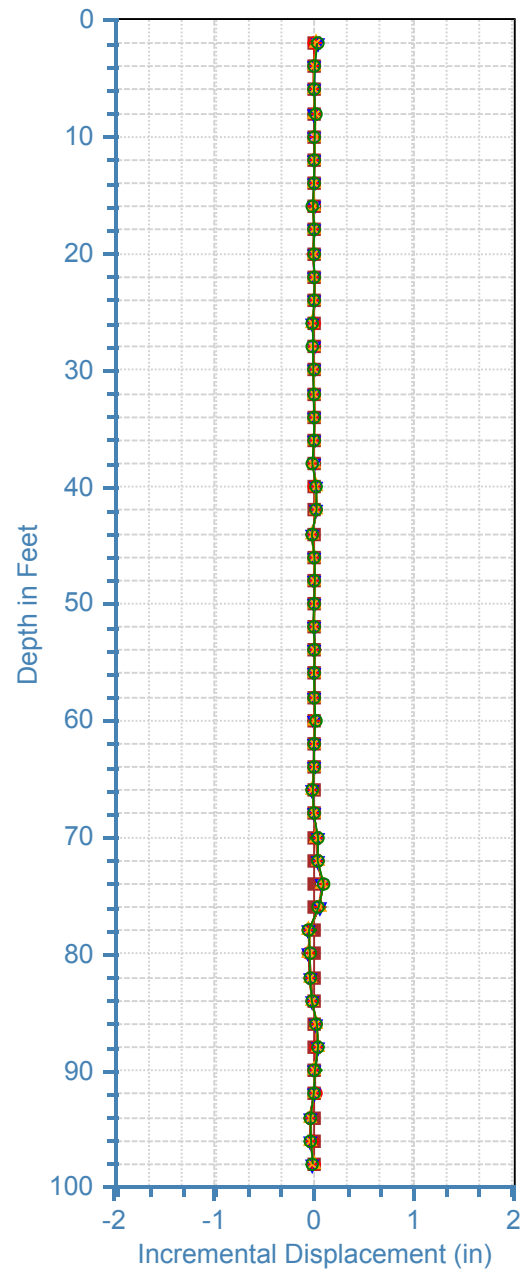
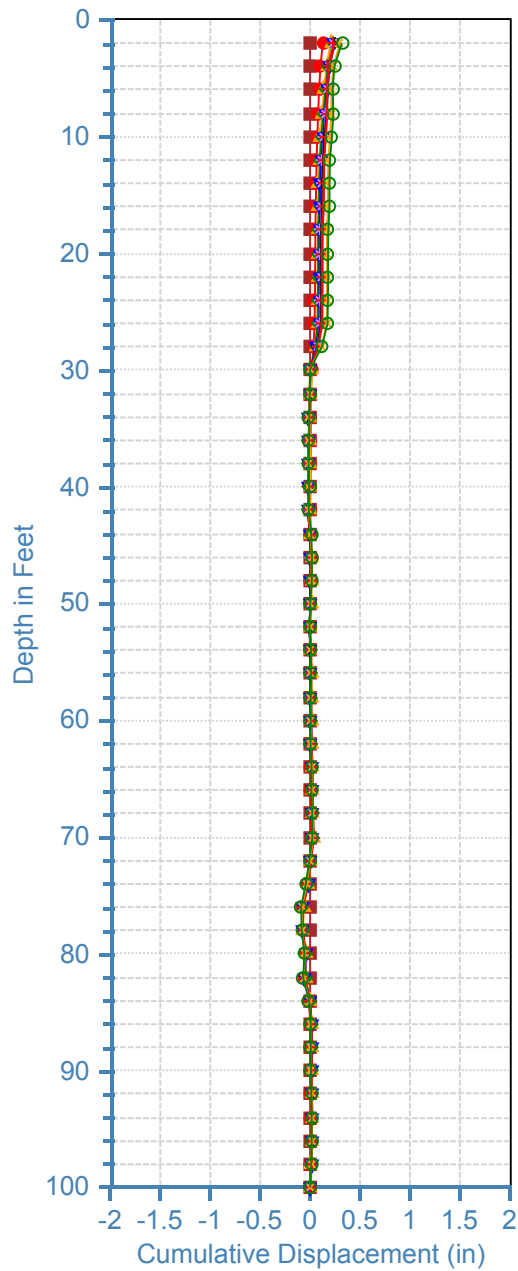
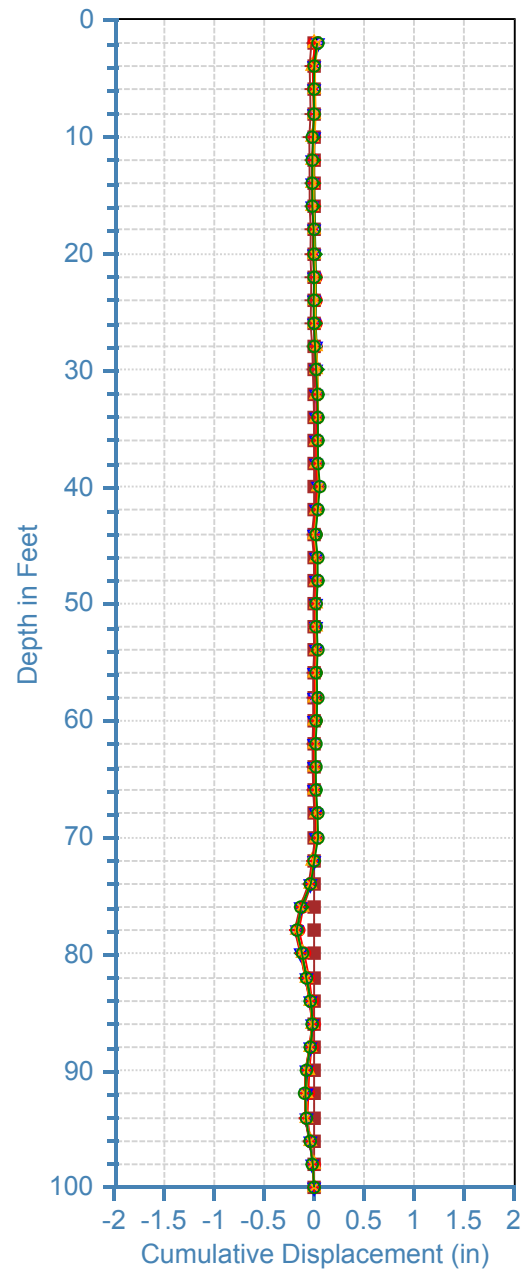
IBWC Arc-1 A - Axis

Inclinometer ARC-1: The base readings for inclinometer ARC-1 were collected on June 22, 2016. The ARC-1 cumulative plot in the A-Axis direction shows a slight progressive movement starting at depths between 28 and 30 feet. This depth corresponds with the interpreted Alluvium/Pleistocene interface presented in Figure 2 of Arcadis' December 2, 2016 *Draft Geotechnical Assessment Report*. Comparing the measurements taken in April 2017 to May 2017, the displacement increases 0.02 inches towards the Rio Grande (A-Axis) at a depth of 28 feet. This inclinometer will continue to be monitored on the normally scheduled frequency to determine if there is any increase in cumulative displacements. The displacement

parallel to the levee are comparatively smaller and does not show any sign of movement in this month's readings.

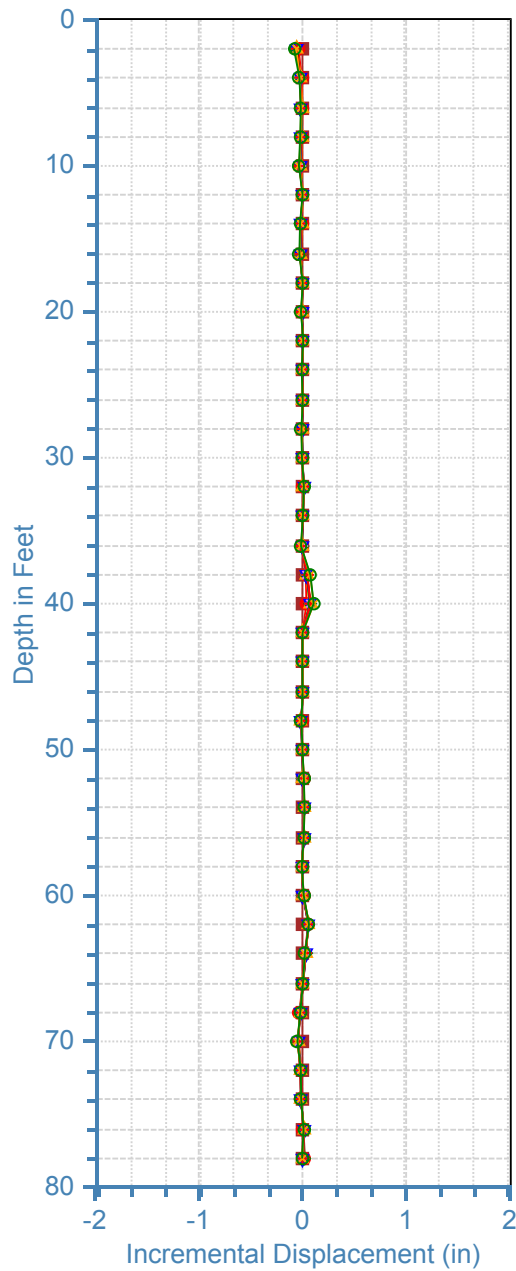
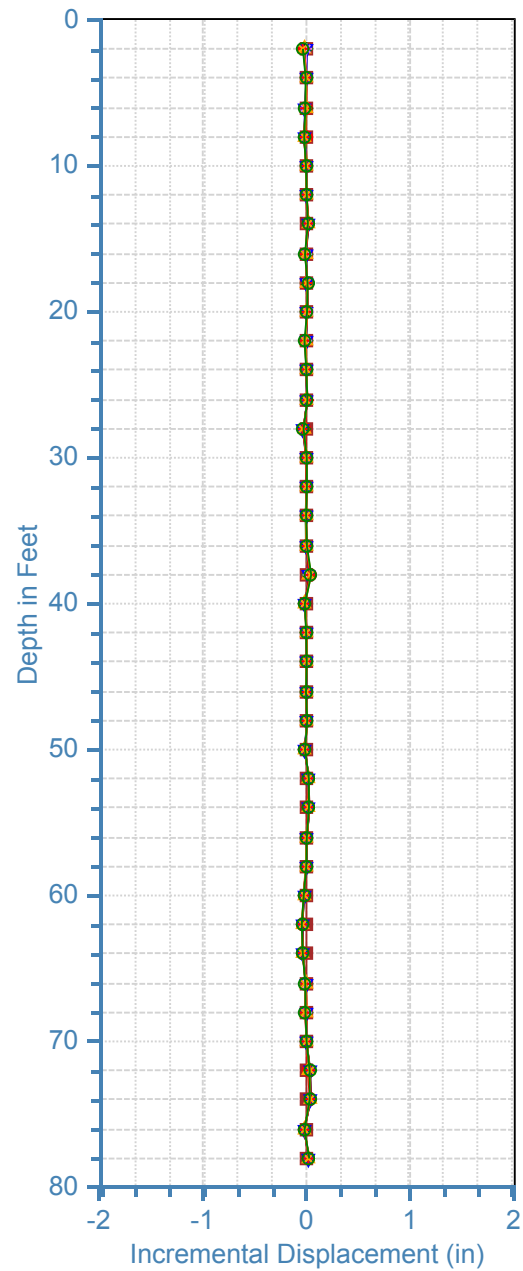
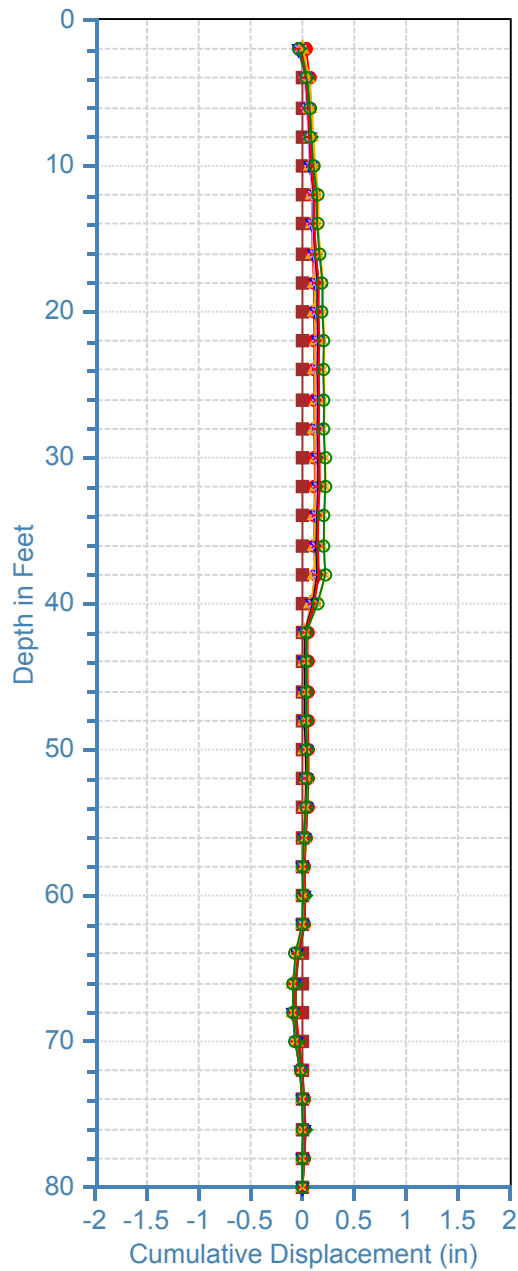
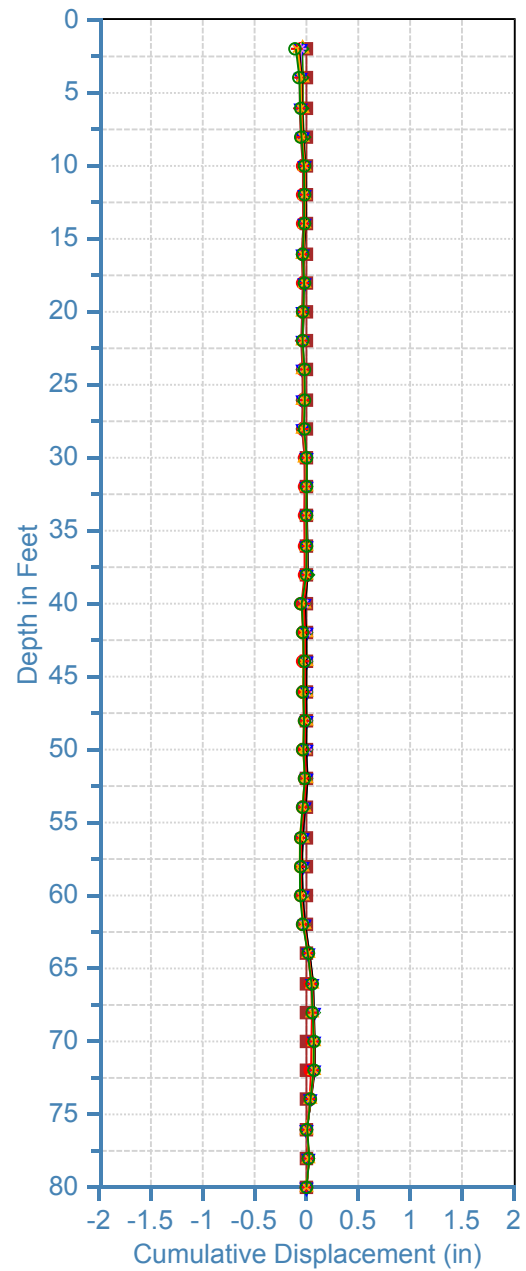
IBWC Arc-2 A - Axis

Inclinometer Arc-2: The base readings for inclinometer ARC-2 were collected on June 17, 2016. The ARC-2 cumulative displacement plot in the A-Axis direction shows a slight displacement between the depths of 38 feet to 40 feet. This depth corresponds with the interpreted Alluvium/Pleistocene interface presented in Figure 2 of Arcadis' December 2, 2016 *Draft Geotechnical Assessment Report*. Comparing the measurements taken in April 2017 to May 2017, the displacement increases 0.03 inches towards the Rio Grande (A-Axis) at a depth of 38 feet. This inclinometer will continue to be monitored on the normally scheduled frequency to determine if there is any increase in cumulative displacements. The displacement parallel to the levee are comparatively smaller and does not show any sign of movement in this month's readings.

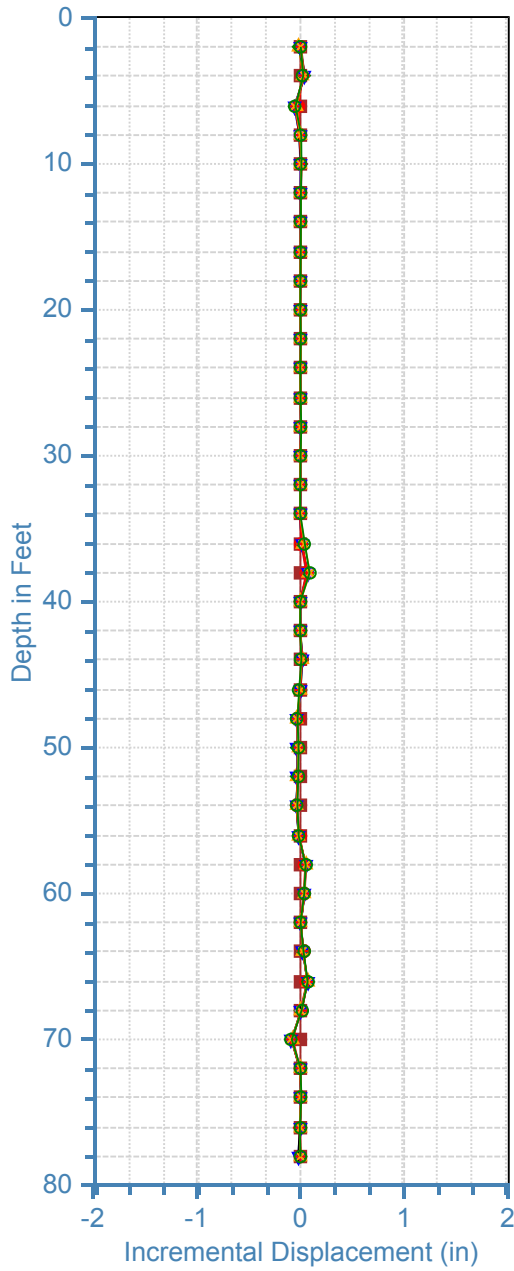
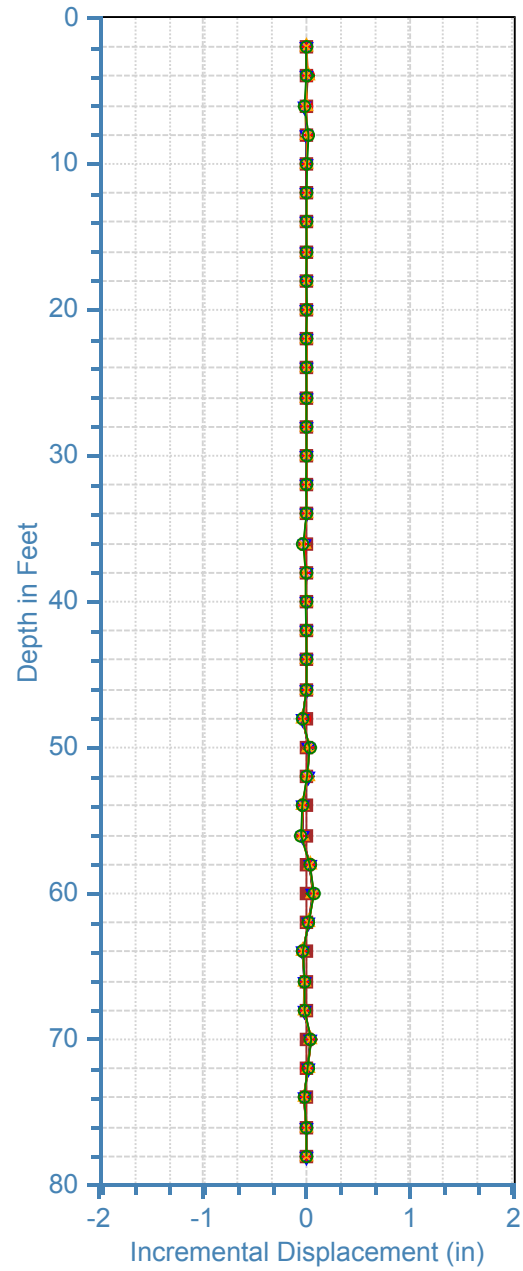
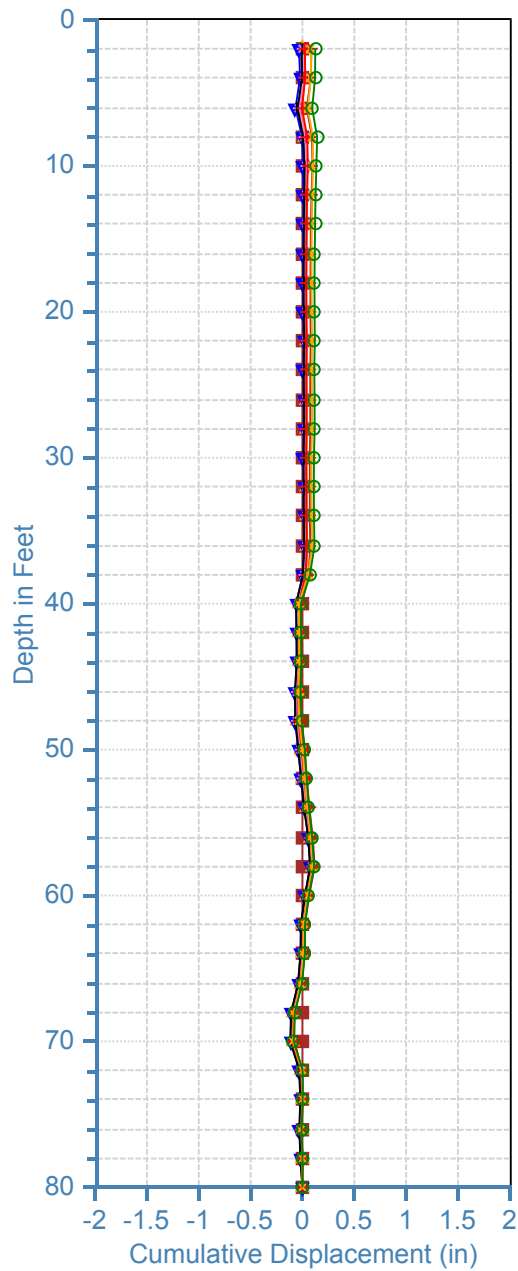
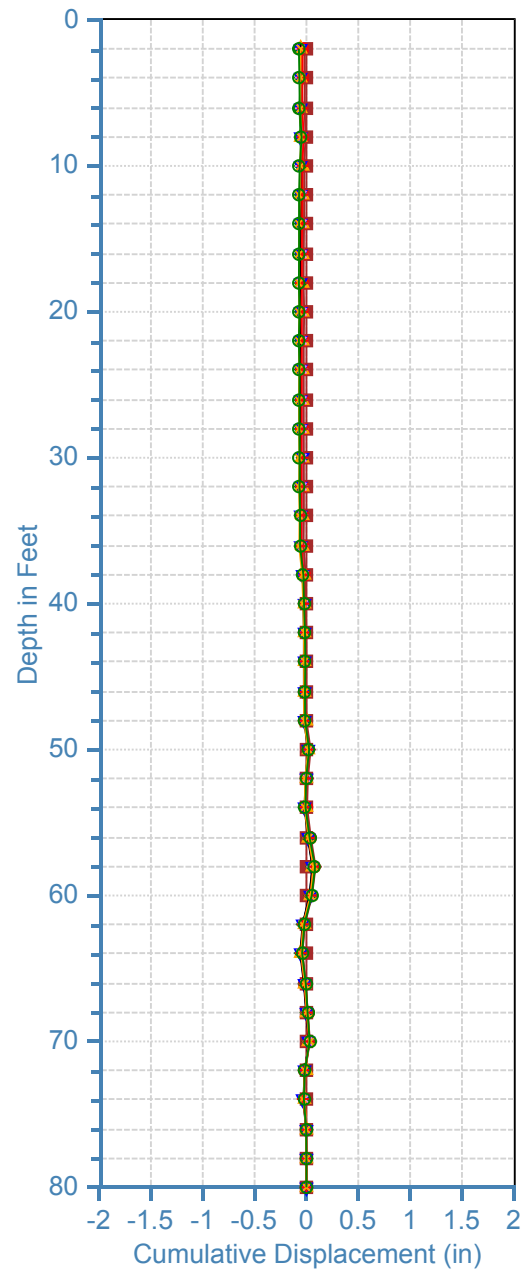
IBWC Arc-3 A - Axis

Inclinometer ARC-3: The base readings for inclinometer ARC-3 were collected on June 17, 2016. The ARC-3 cumulative and incremental displacement does not show any sign of movement on the plane perpendicular to the levee nor on the plane parallel to the levee.

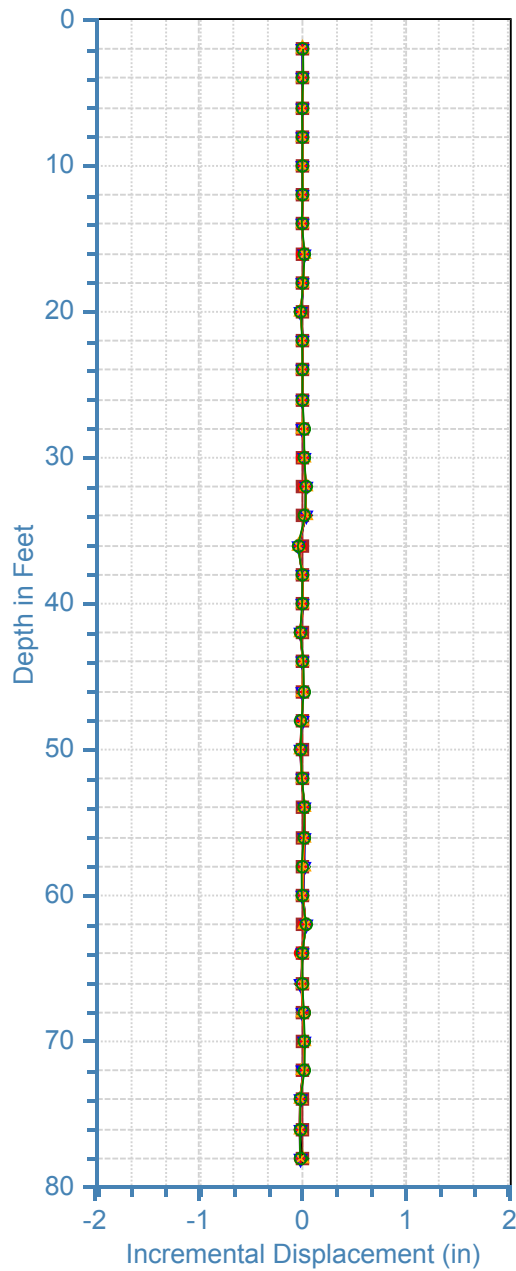
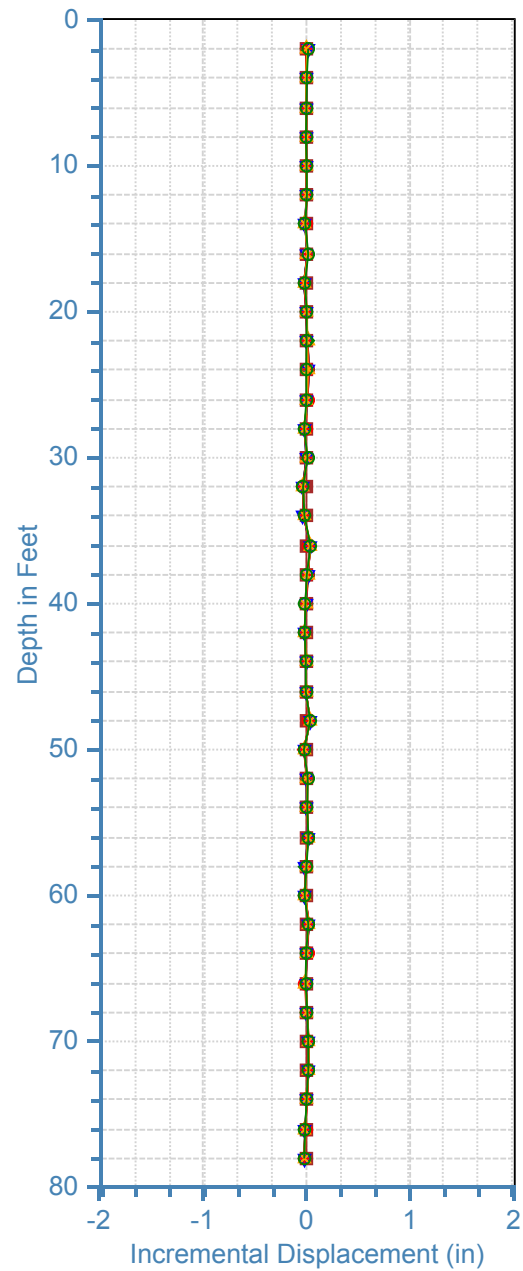
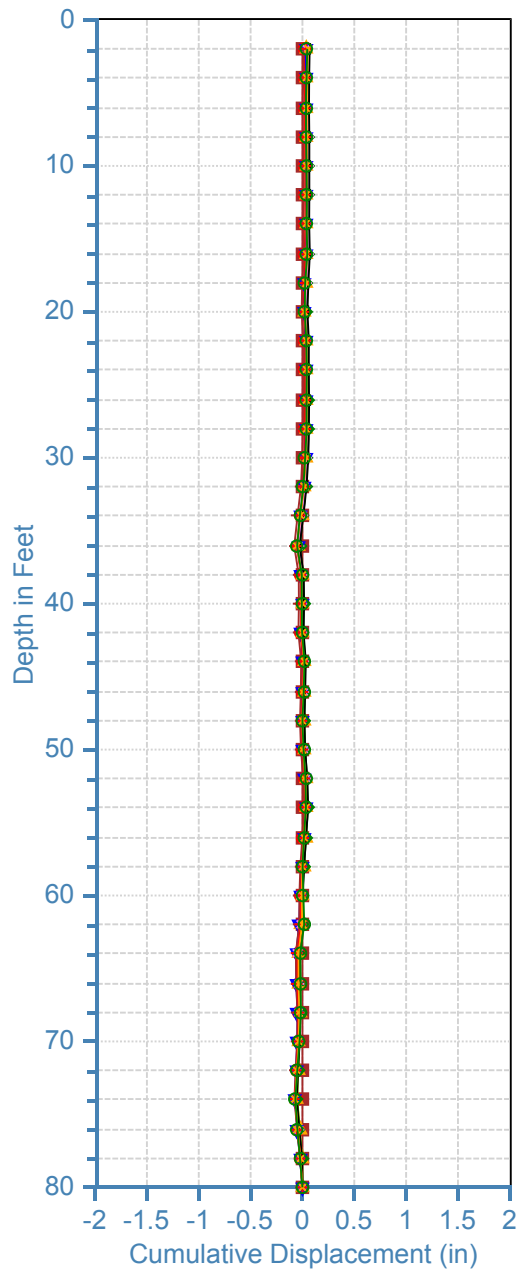
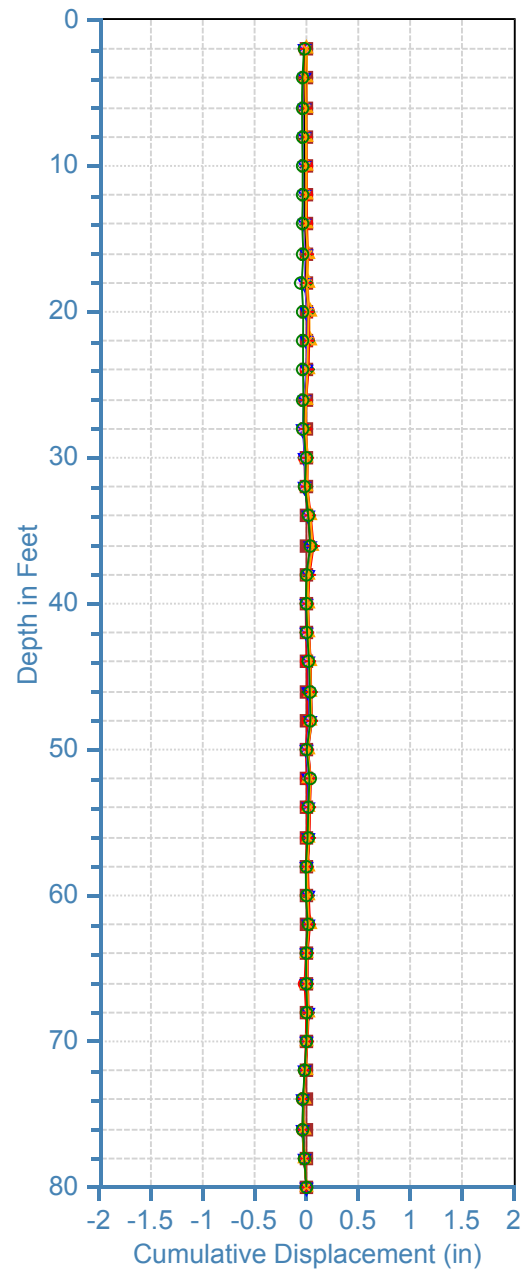
IBWC Arc-4 A - Axis

Inclinometer ARC-4: The base readings for inclinometer ARC-4 were collected on June 22, 2016. The ARC-4 cumulative and incremental displacement does not show any sign of movement on the plane perpendicular to the levee nor on the plane parallel to the levee.

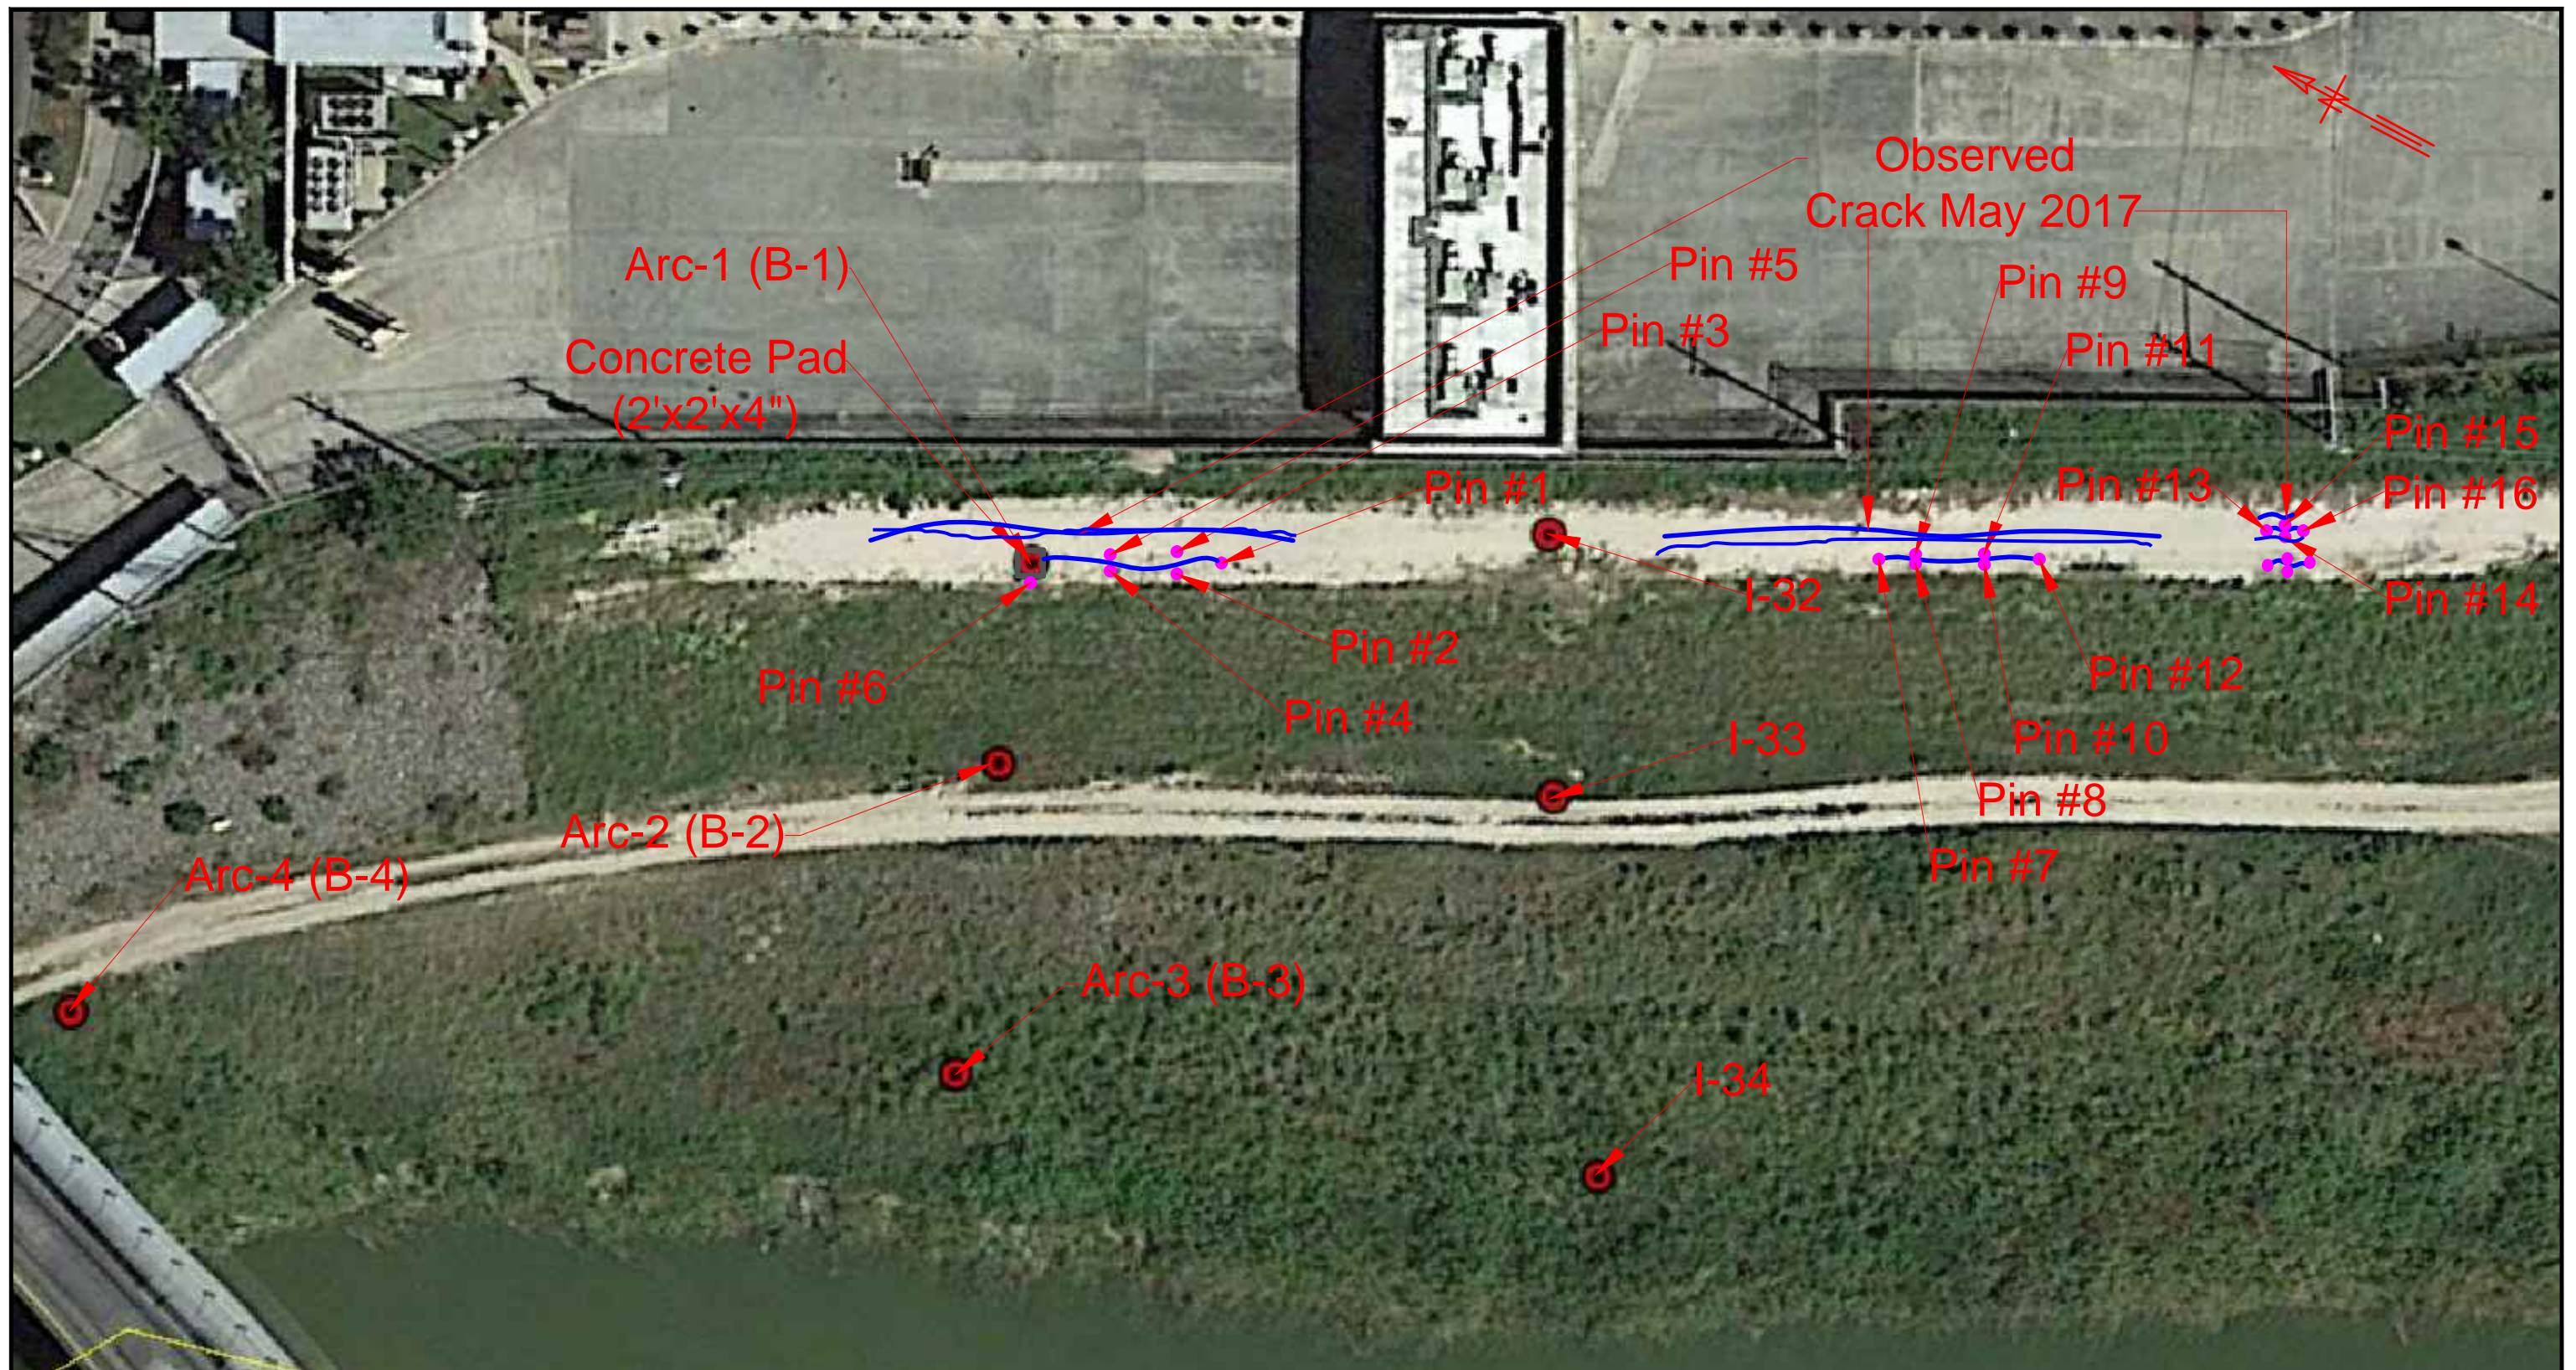
INCLINOMETER & LEVEE CRACKING LOCATION

In this month's visit to the IBWC site, tension cracks were observed on top of the levee near inclinometer ARC-1, south of the existing retaining wall in two sections and new cracks were discovered east of the existing cracks as shown in Attachment B. Attachment C presents photos of the new surface tension cracks. At the known surface cracks near ARC-1, there was no displacement with respect to the April 10, 2017 measurements for Pin 1 through Pin 5. The west outer edge of the wood frame to Pin 6 crack has increased

The readings for each inclinometer are reflected in the graphical displays provided in Attachment A. Attachment A includes both incremental and cumulative displacement plots. Attachment B shows the inclinometer locations on a Google Map.

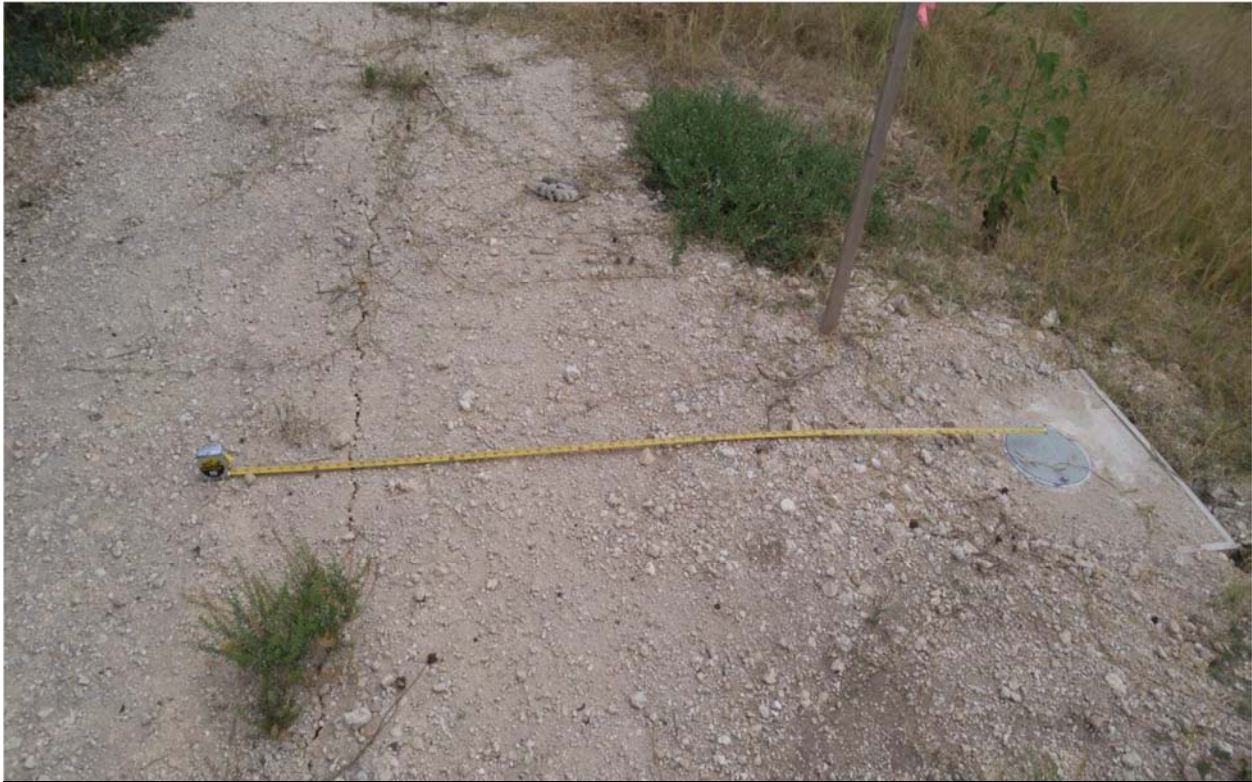
Photo 1 - Looking South - New Surface Tension Crack 5.75 Feet East of ARC-1

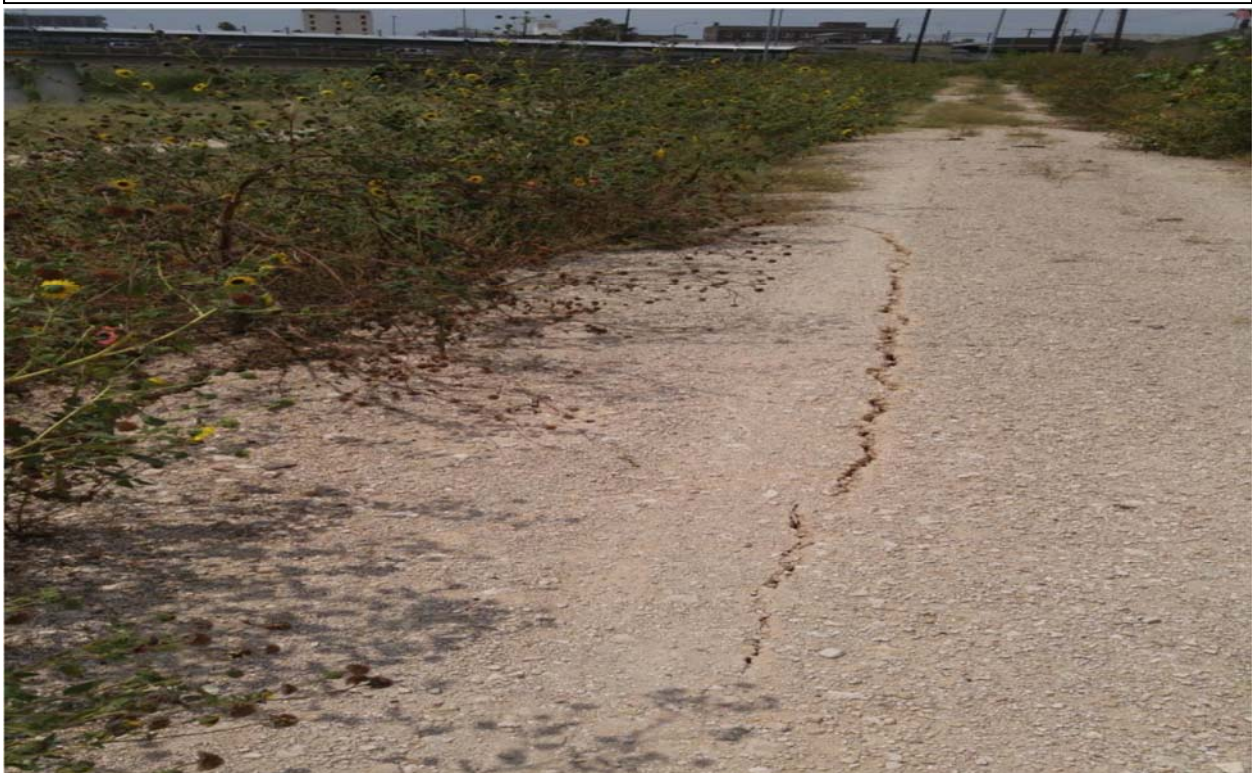
Photo 2 - Looking North – New Surface Tension Crack East of Pins 8 through 11

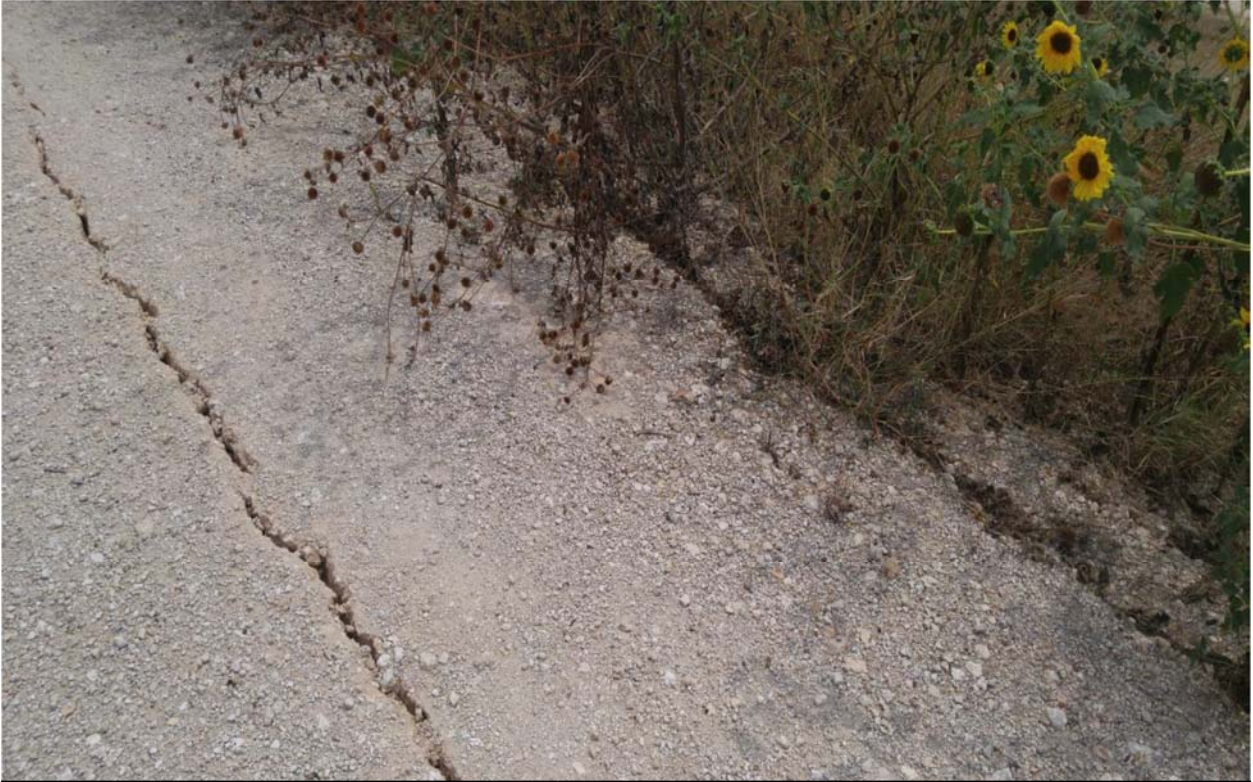
Photo 3 - Looking South - New Surface Tension Crack East of Pins 8 and 9

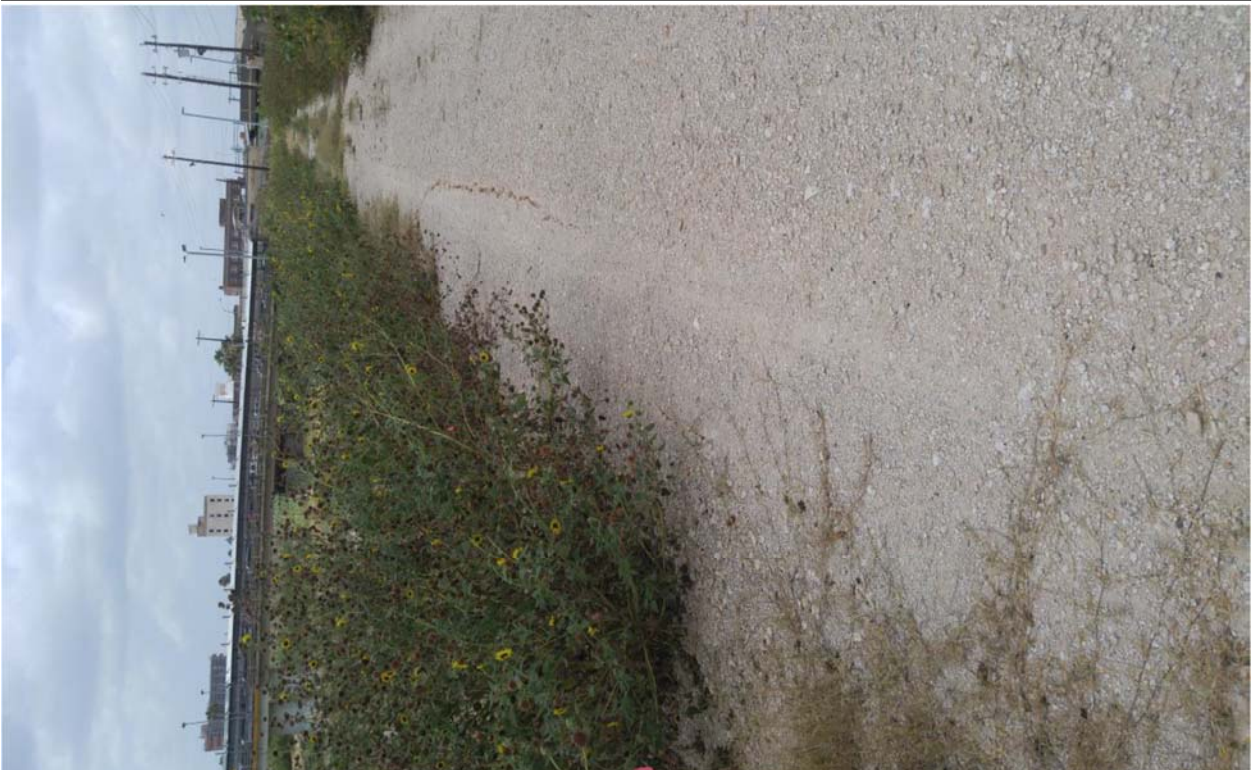
Photo 4 - Looking North - New Surface Tension Crack East of Pins 14 and 15
