Date:  
July 18, 2017

Arcadis Project No.:  
LA003315.0000

Subject:  
July 2017 Final Summary Report of Inclinometer Readings  
Remediation Design of Levee Floodplain Failure within the  
Upper Brownsville Levee Reach Lower Rio Grande Flood  
Control Project – IBM15D0001 – IBM15T0015

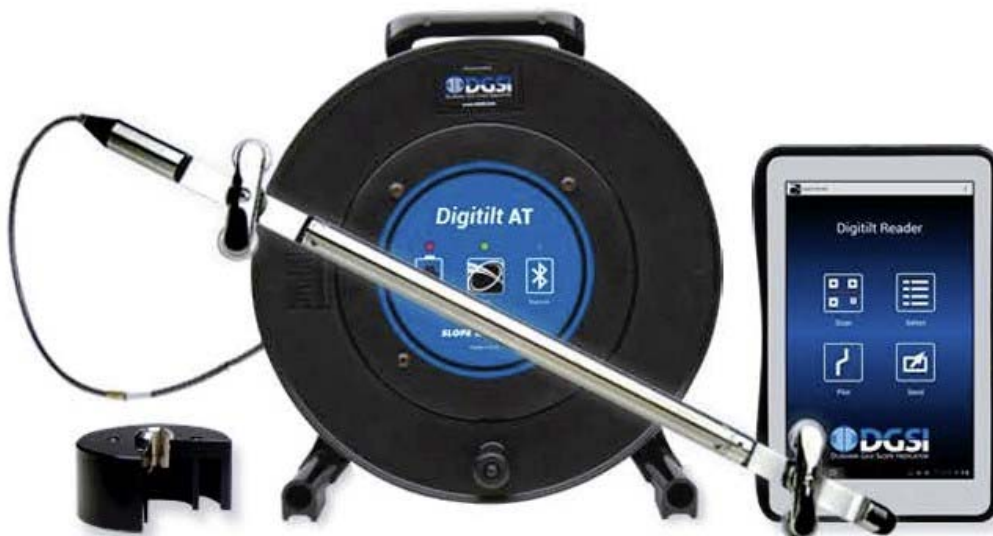
Digitilt AT system was used to survey the inclinometers. The system components include an inclinometer probe, control cable, a Bluetooth reel and the Digitilt Reader app for certified Android-based tablet computer. The equipment is shown in Figure 1.

Figure 1: Digitilt AT System Components.

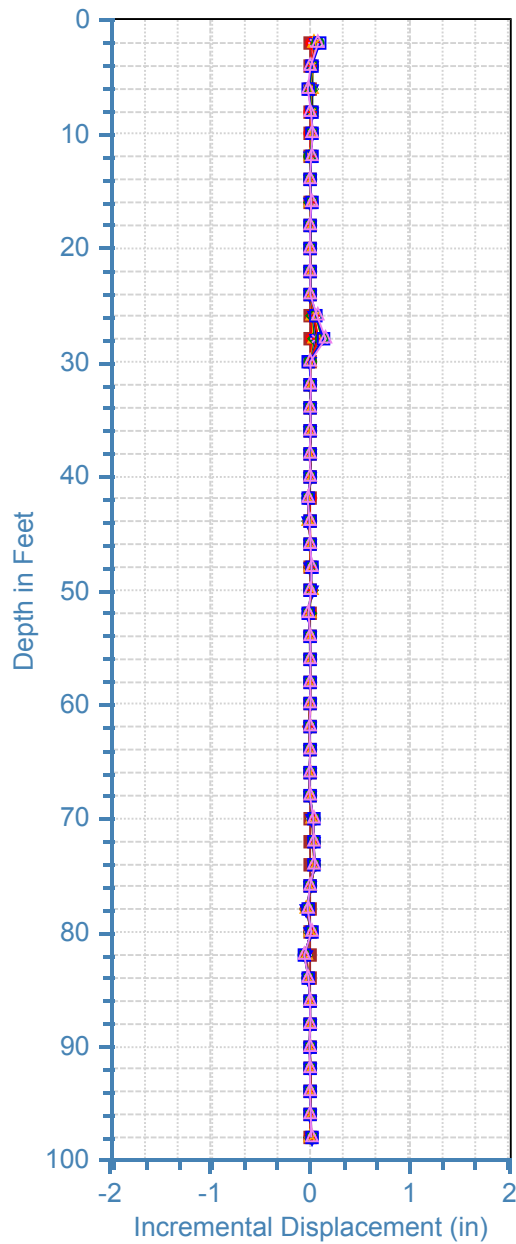
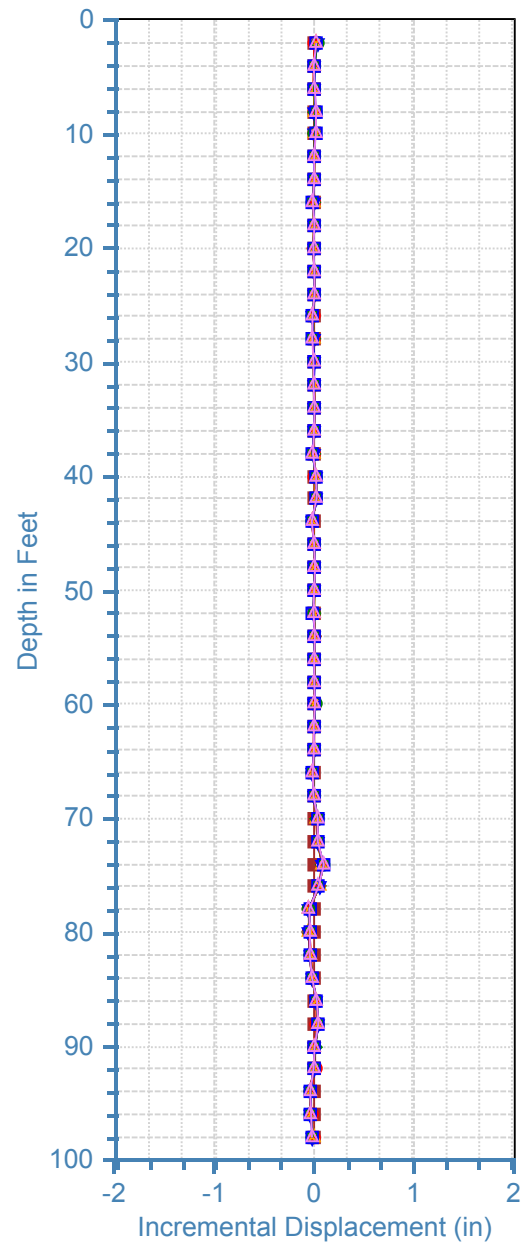
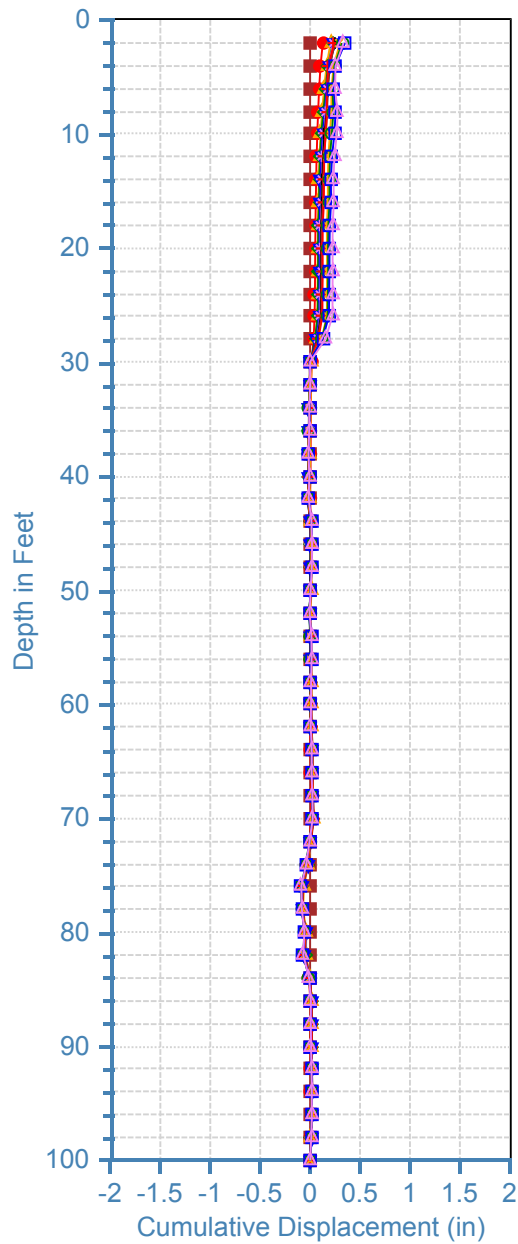
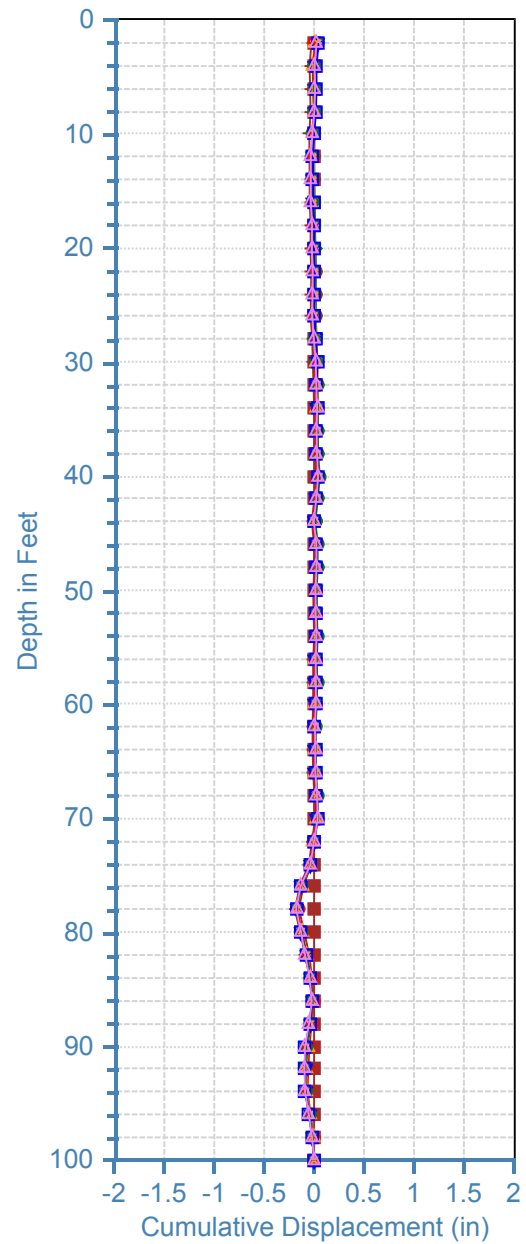
IBWC Arc-1 A - Axis

Inclinometer ARC-1: The base readings for inclinometer ARC-1 were collected on June 22, 2016. The ARC-1 cumulative plot in the A-Axis direction shows a slight progressive movement starting at depths between 28 and 30 feet. This depth corresponds with the interpreted Alluvium/Pleistocene interface presented in Figure 2 of Arcadis' December 2, 2016 *Draft Geotechnical Assessment Report*. Comparing the measurements taken in July 2016 to July 2017, the displacement is 0.12 inches towards the Rio Grande (A-Axis) at a depth of 28 feet. The displacement parallel to the levee does not show any sign of movement in this month's readings.

After critically reviewing the cumulative displacement plots, the graphical displays in Attachment A shows that in each month there is an increase in movement towards the Rio Grande (A-Axis direction) for the inclinometers ARC-1 and ARC-2. The displacement for these inclinometers are progressive but moving at a slow rate. This information will be summarized and used to finalize the *Draft Geotechnical Assessment Report*.

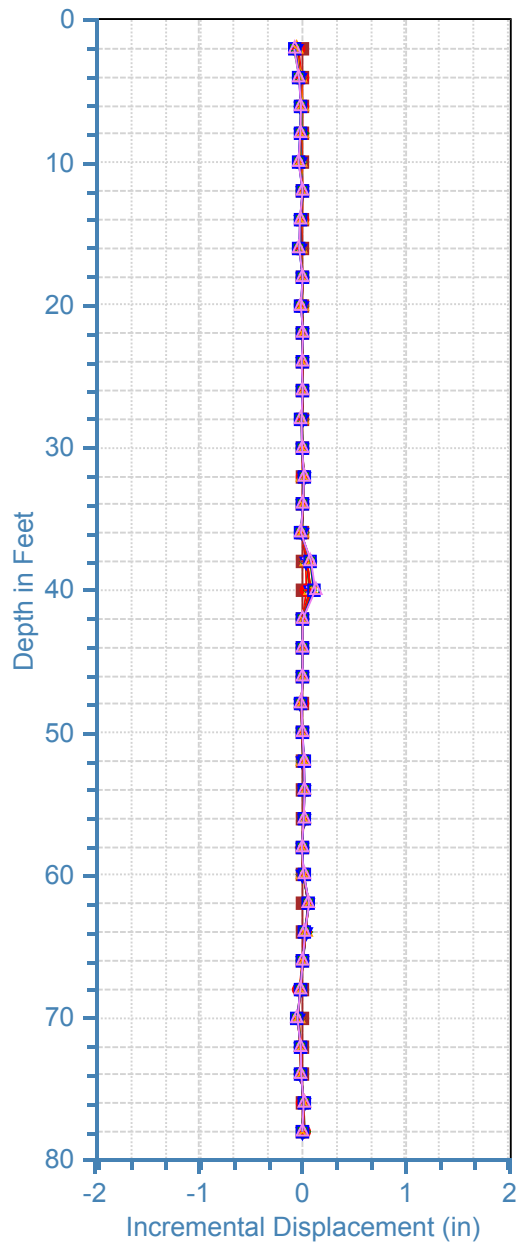
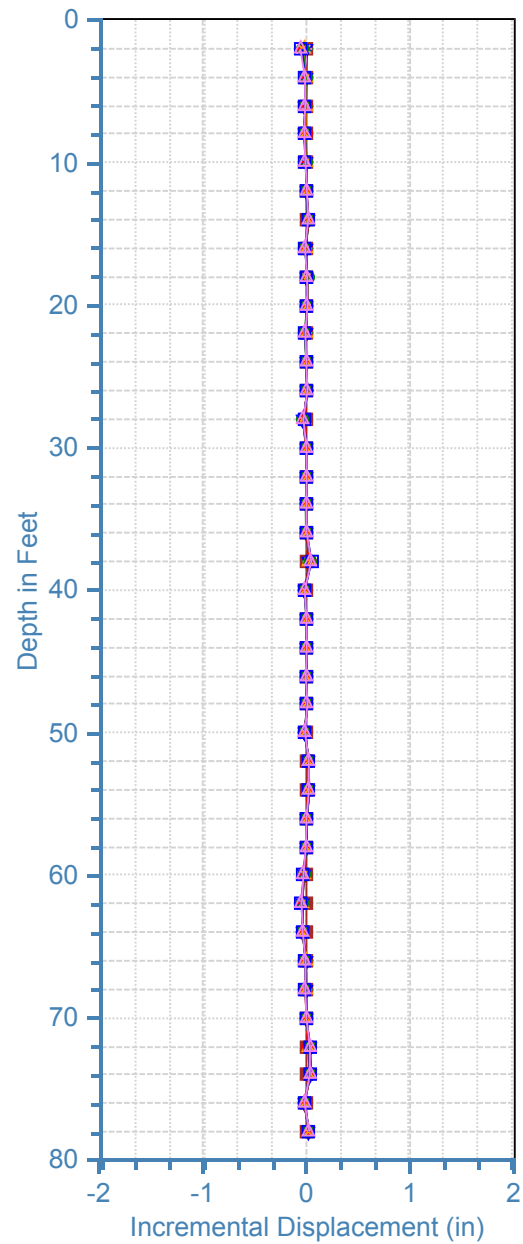
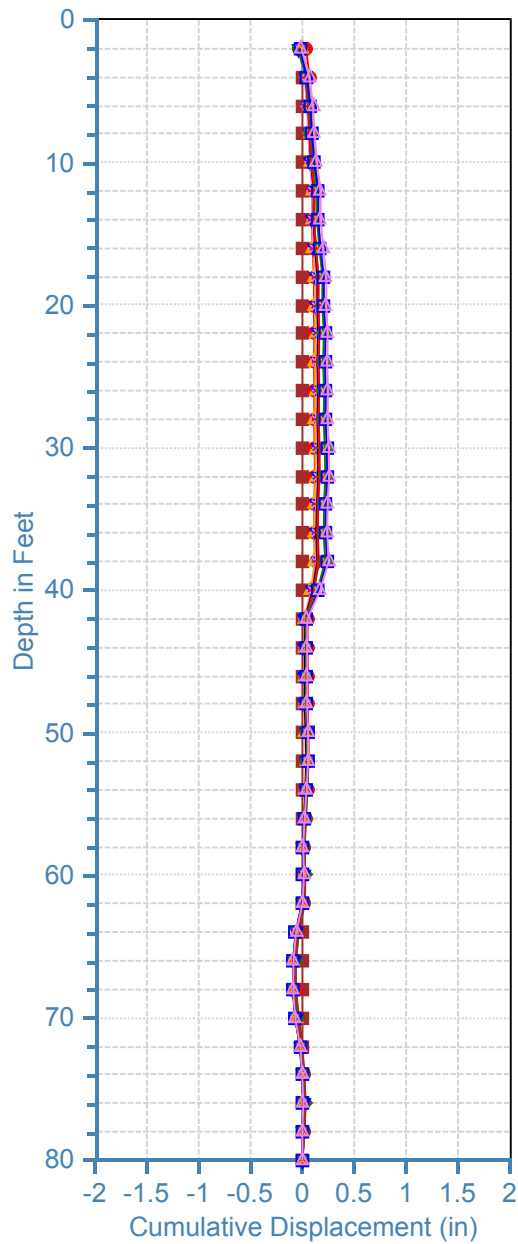
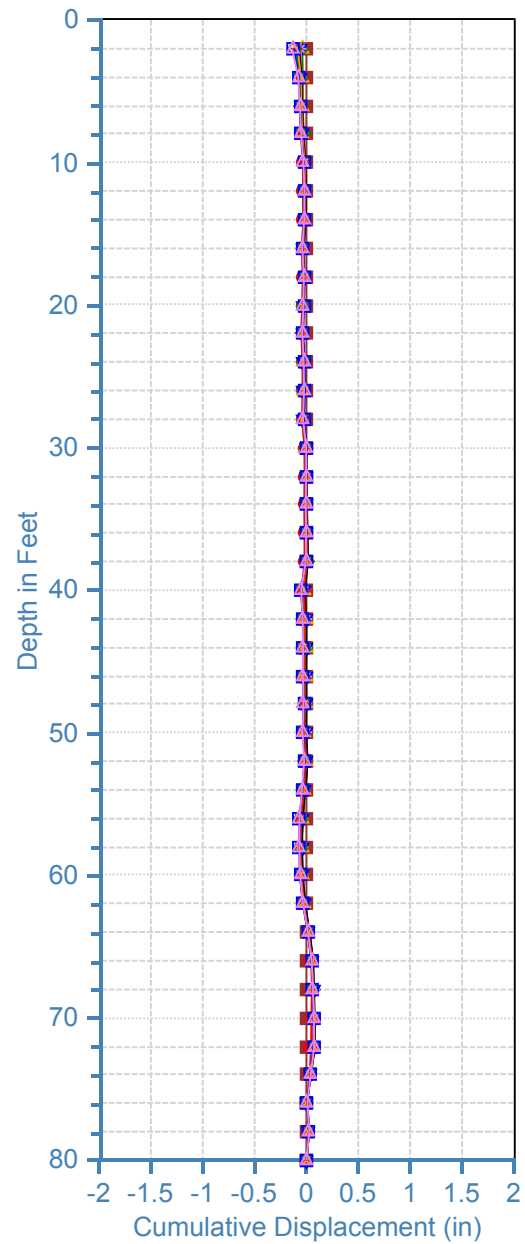
IBWC Arc-2 A - Axis

Inclinometer Arc-2: The base readings for inclinometer ARC-2 were collected on June 17, 2016. The ARC-2 cumulative displacement plot in the A-Axis direction shows a slight displacement between the depths of 38 feet to 40 feet. This depth corresponds with the interpreted Alluvium/Pleistocene interface presented in Figure 2 of Arcadis' December 2, 2016 *Draft Geotechnical Assessment Report*. Comparing the measurements taken in July 2016 to July 2017, the displacement is 0.13 inches towards the Rio Grande (A-Axis) at a depth of 38 feet. The displacement parallel to the levee does not show any sign of movement in this month's readings.

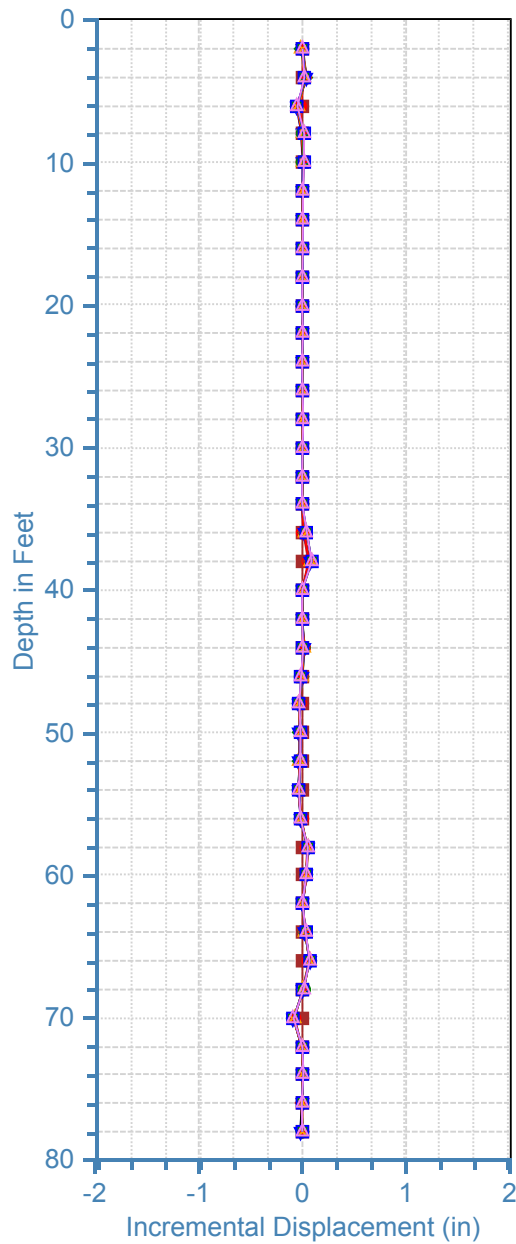
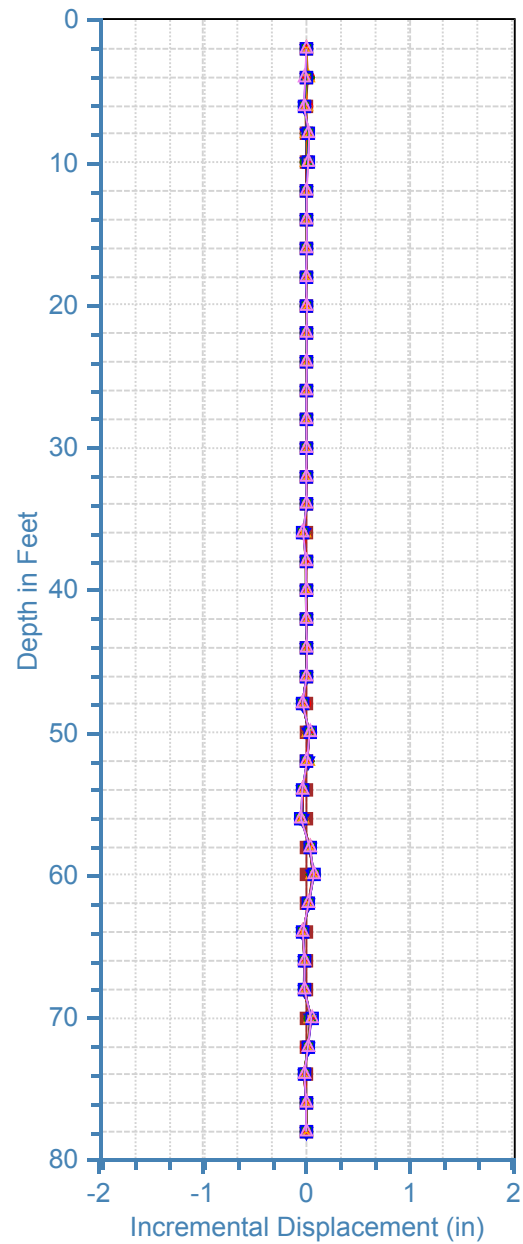
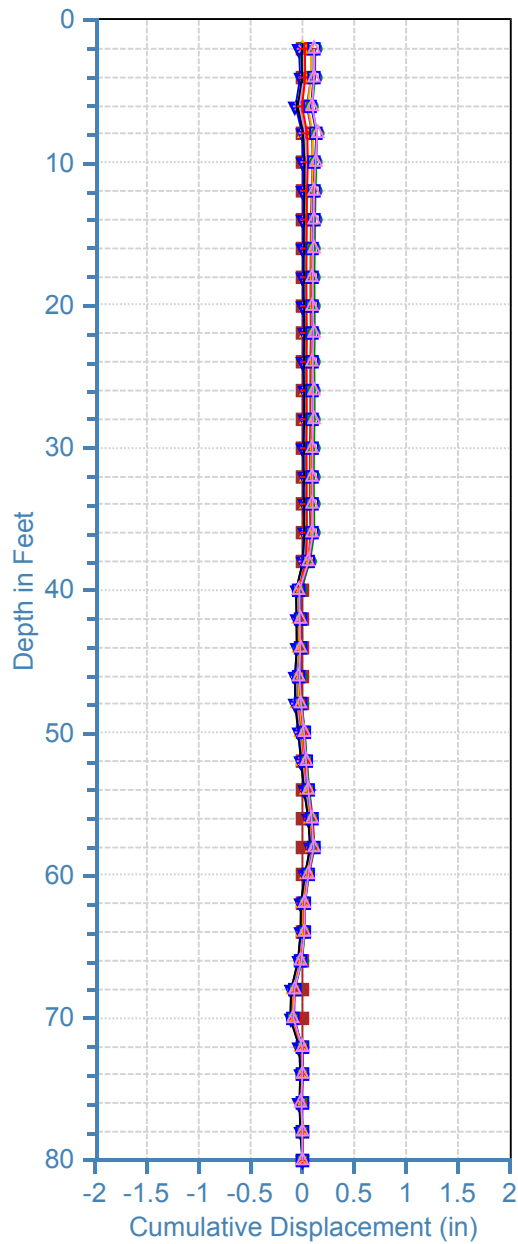
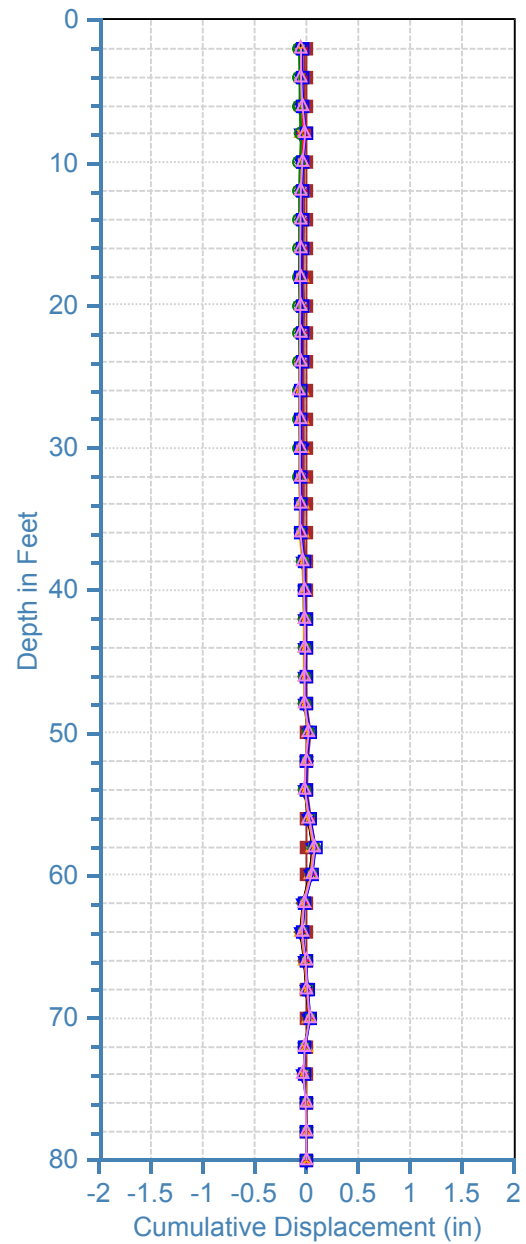
IBWC Arc-3 A - Axis

Inclinometer ARC-3: The base readings for inclinometer ARC-3 were collected on June 17, 2016. The ARC-3 cumulative and incremental displacement does not show any sign of movement on the plane perpendicular to the levee nor on the plane parallel to the levee.

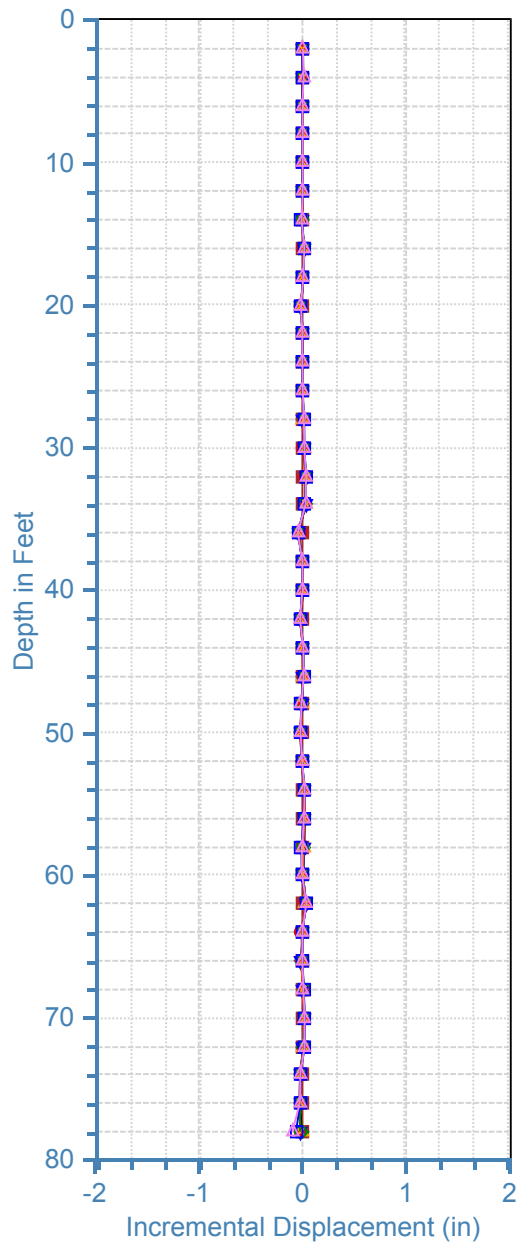
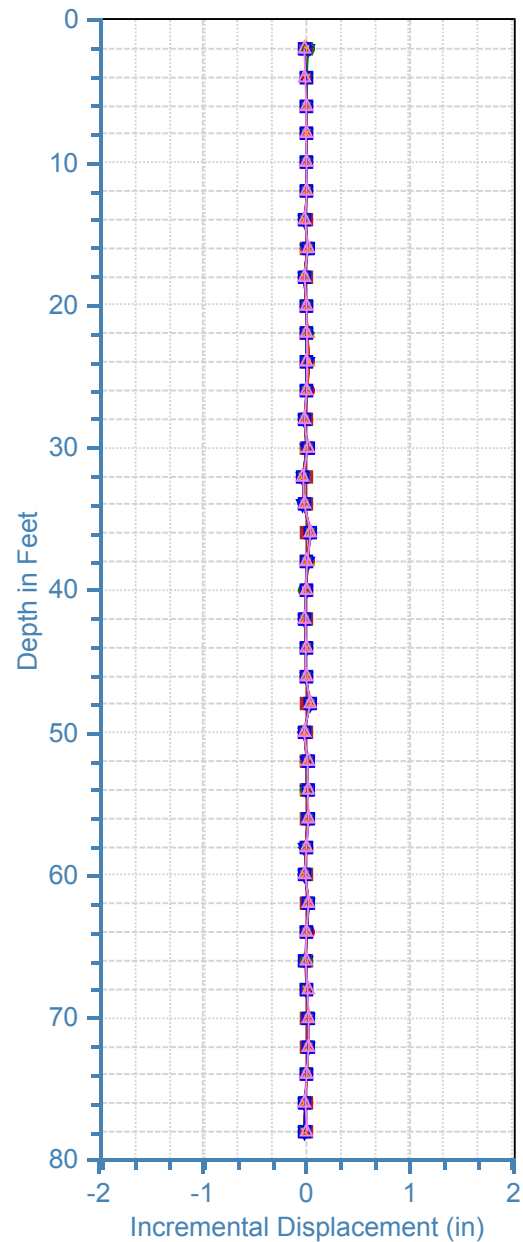
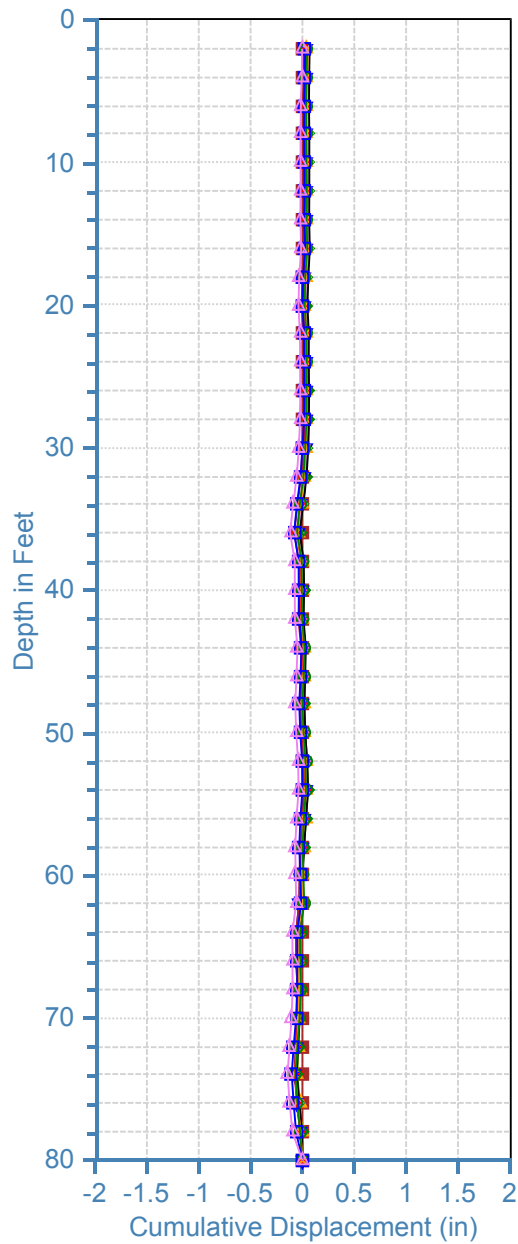
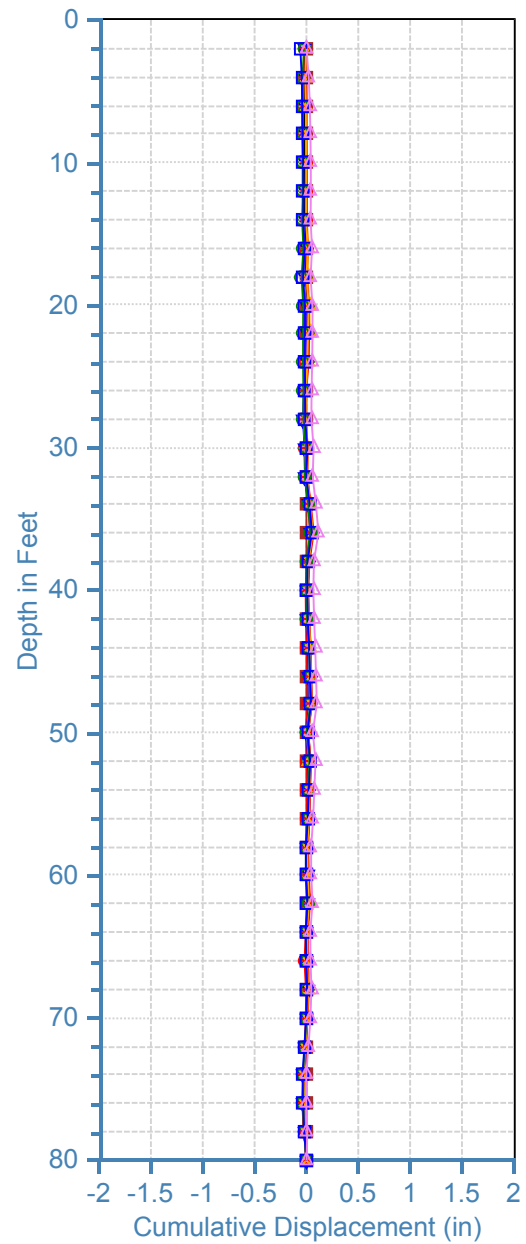
IBWC Arc-4 A - Axis

Inclinometer ARC-4: The base readings for inclinometer ARC-4 were collected on June 22, 2016. The ARC-4 cumulative and incremental displacement does not show any sign of movement on the plane perpendicular to the levee nor on the plane parallel to the levee.

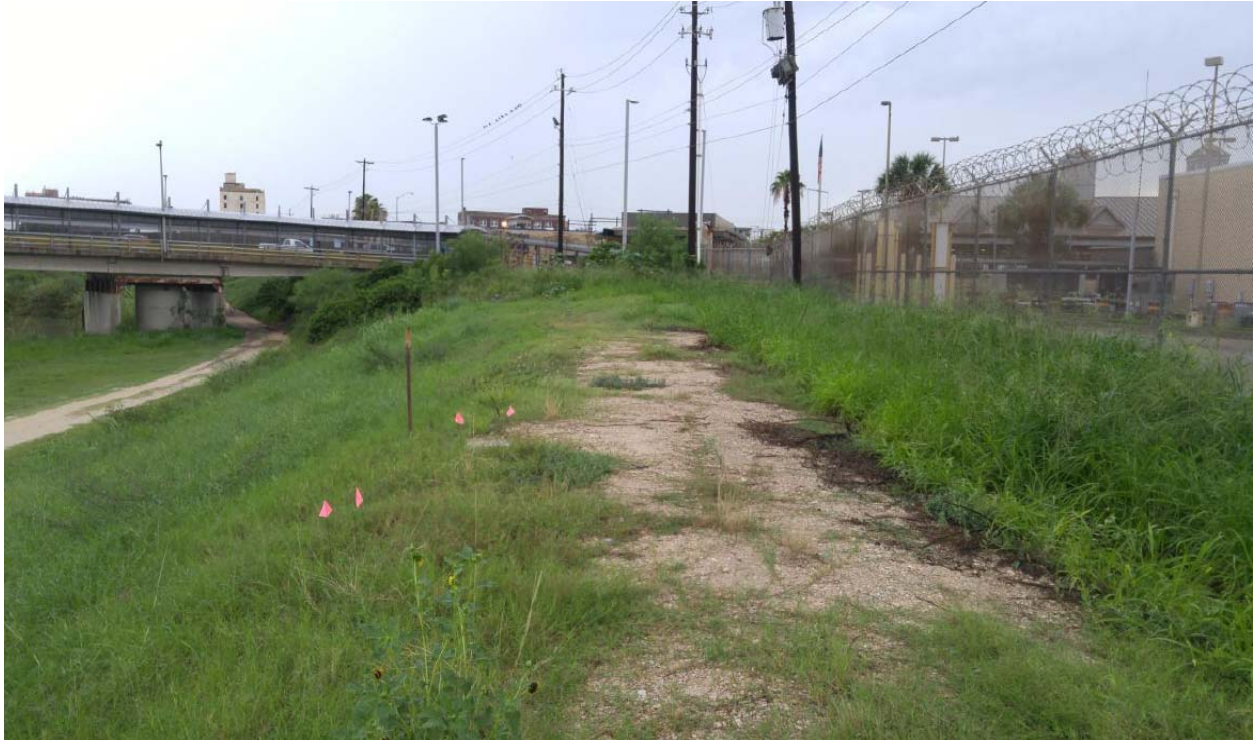
Photo 1 - Looking North - Surface Tension Crack of Pin Flags 1B through 4B.

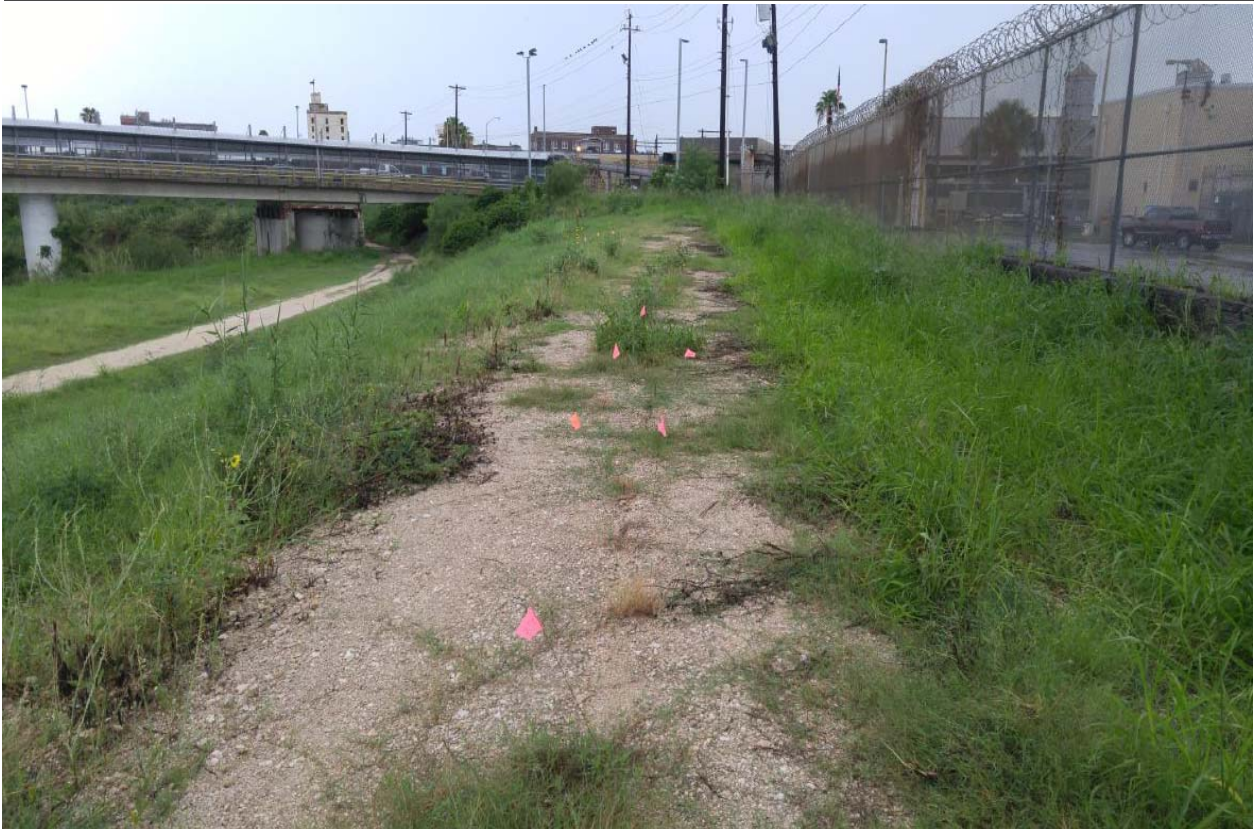
Photo 2 - Looking North - Surface Tension Crack of Pin Flags 5B through 10B.

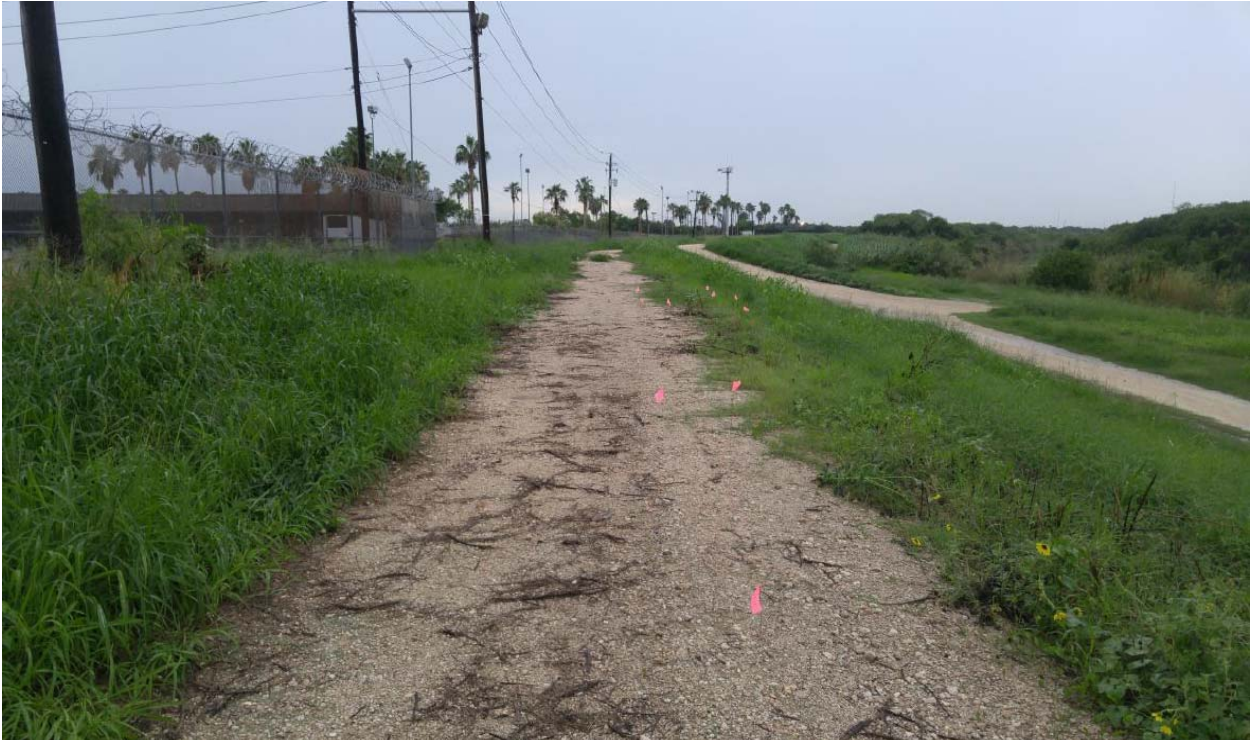
to take this month's measurements. Over the last month, the tension cracks appear to have not changed except for the cracks that are located between the pins 18B and 19B. For those pins, there was a slight increase in width of 0.5 inch. The locations of the cracks and the pins are shown in Attachment B while Attachment C presents photos of the tension cracks.

Photo 3 - Looking South - Surface Tension Crack of Pin Flags 11B through 20B.

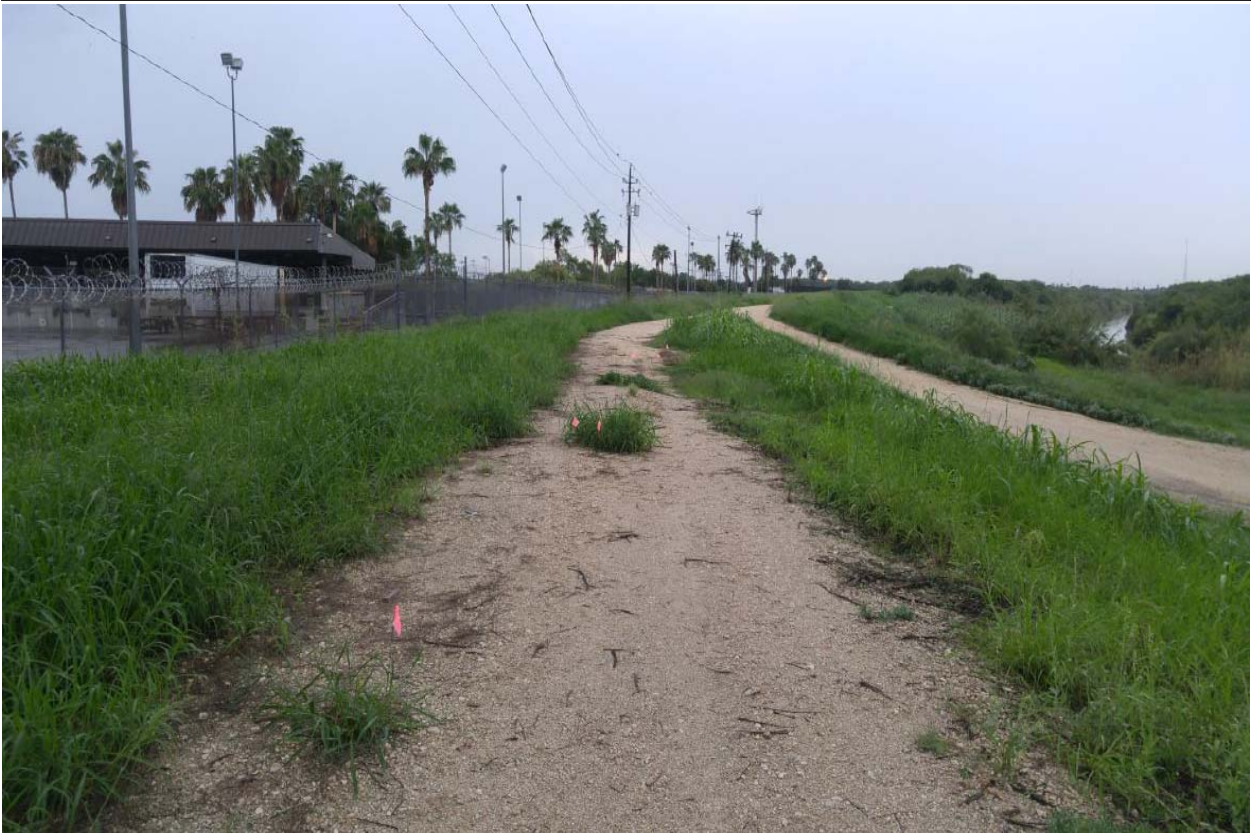
Photo 4 - Looking South - Surface Tension Crack of Pin Flags 21B through 26B.
