Subject:  
March 2020 Summary Report of Inclinator Readings  
Remediation Design of Levee Floodplain Failure within the  
Upper Brownsville Levee Reach Lower Rio Grande Flood  
Control Project – IBM15D0001 – IBM15T0015

IBWC  
SUMMARY REPORT OF INCLINOMETER READINGS

REMEDATION DESIGN OF LEVEE FLOODPLAIN FAILURE  
WITHIN THE UPPER BROWNSVILLE LEVEE REACH  
LOWER RIO GRANDE FLOOD CONTROL PROJECT

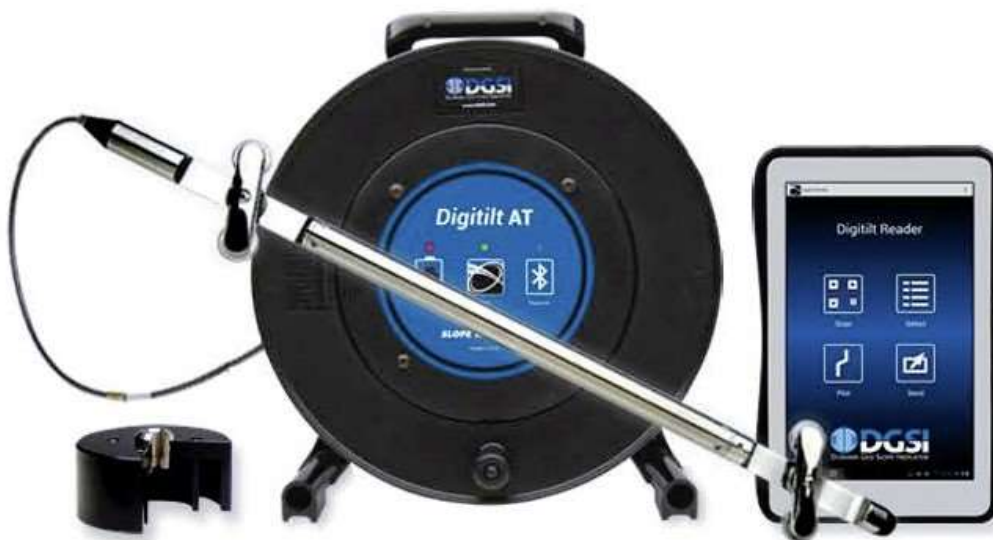
Figure 1: Digitilt AT System Components.

Digitilt AT system was used to survey the inclinometers. The system components include an inclinometer probe, control cable, a Bluetooth reel and the Digitilt Reader app for certified Android-based tablet computer. The equipment is shown in Figure 1.

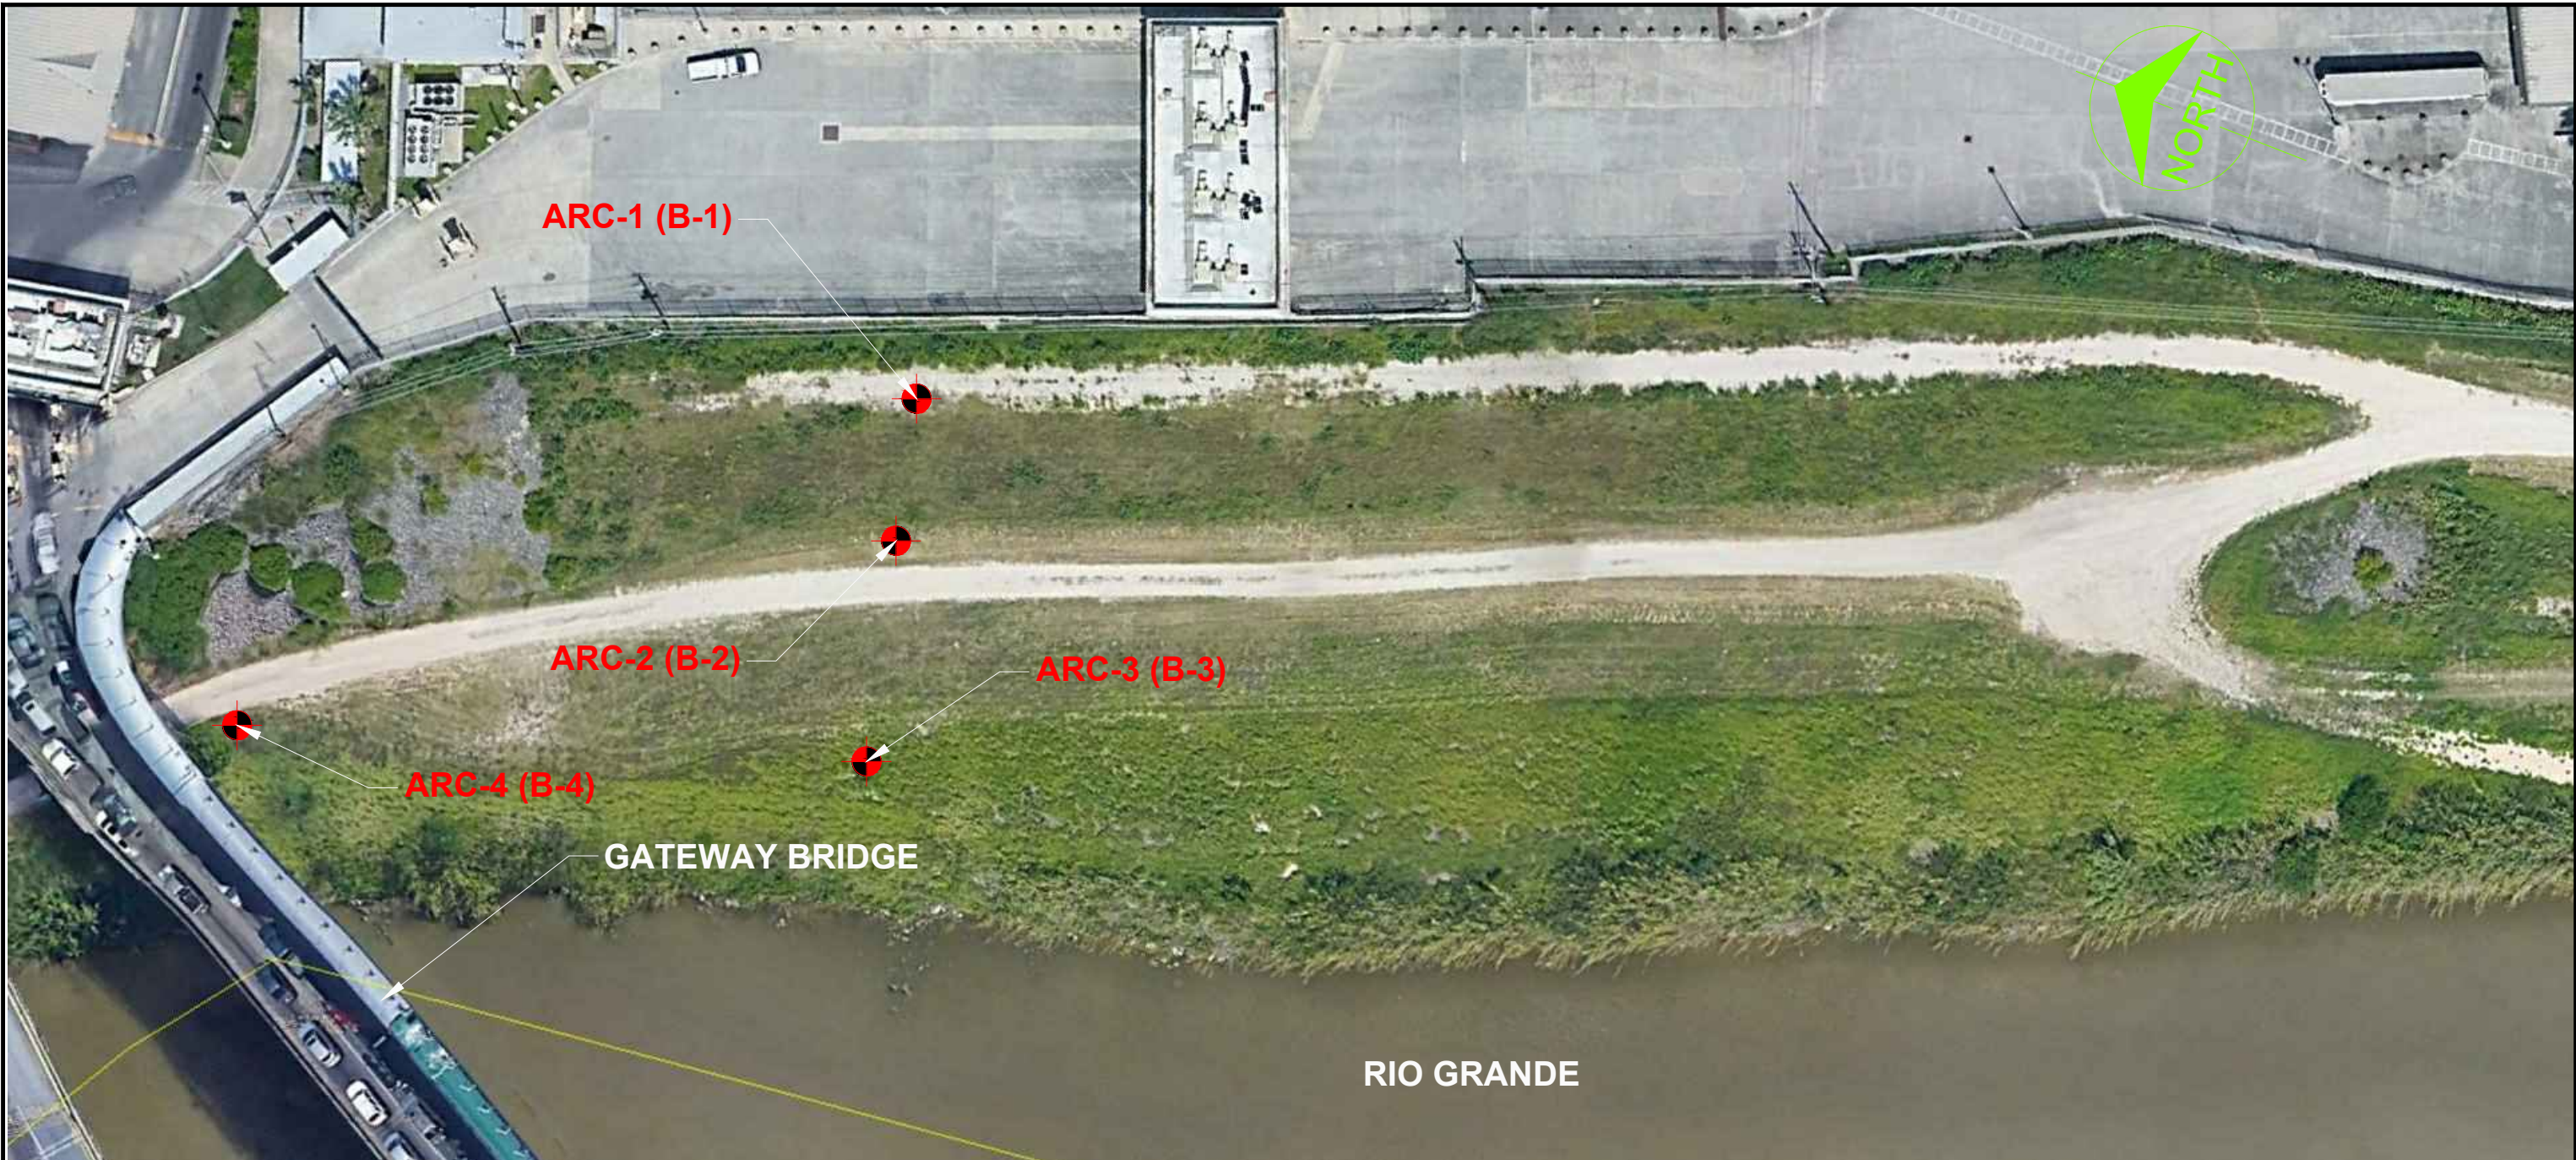
INCLINOMETER LOCATION MAP

The readings for each inclinometer are reflected in the graphical displays provided in Attachment A. Attachment A includes both incremental and cumulative displacement plots. Attachment B shows the inclinometer locations on a Google Map.

| <b>B-1:</b> 100 FEET BOREHOLE DRILLED AT THE TOP OF THE LEVEE | <b>B-3:</b> 80 FEET BOREHOLE DRILLED AT THE EDGE OF THE RIVERBANK |
| <b>ARC-1:</b> 98 FEET INCLINOMETER CASING INSTALLED WITHIN BORING B-1 | <b>ARC-3:</b> 78 FEET INCLINOMETER CASING INSTALLED WITHIN BORING B-3 |
| <b>B-2:</b> 80 FEET BOREHOLE DRILLED AT THE TOE OF THE LEVEE | <b>B-4:</b> 80 FEET BOREHOLE DRILLED NEAR THE NORTH ABUTMENT OF THE GATEWAY BRIDGE |
| <b>ARC-2:</b> 78 FEET INCLINOMETER CASING INSTALLED WITHIN BORING B-2 | <b>ARC-4:</b> 78 FEET INCLINOMETER CASING INSTALLED WITHIN BORING B-4 |

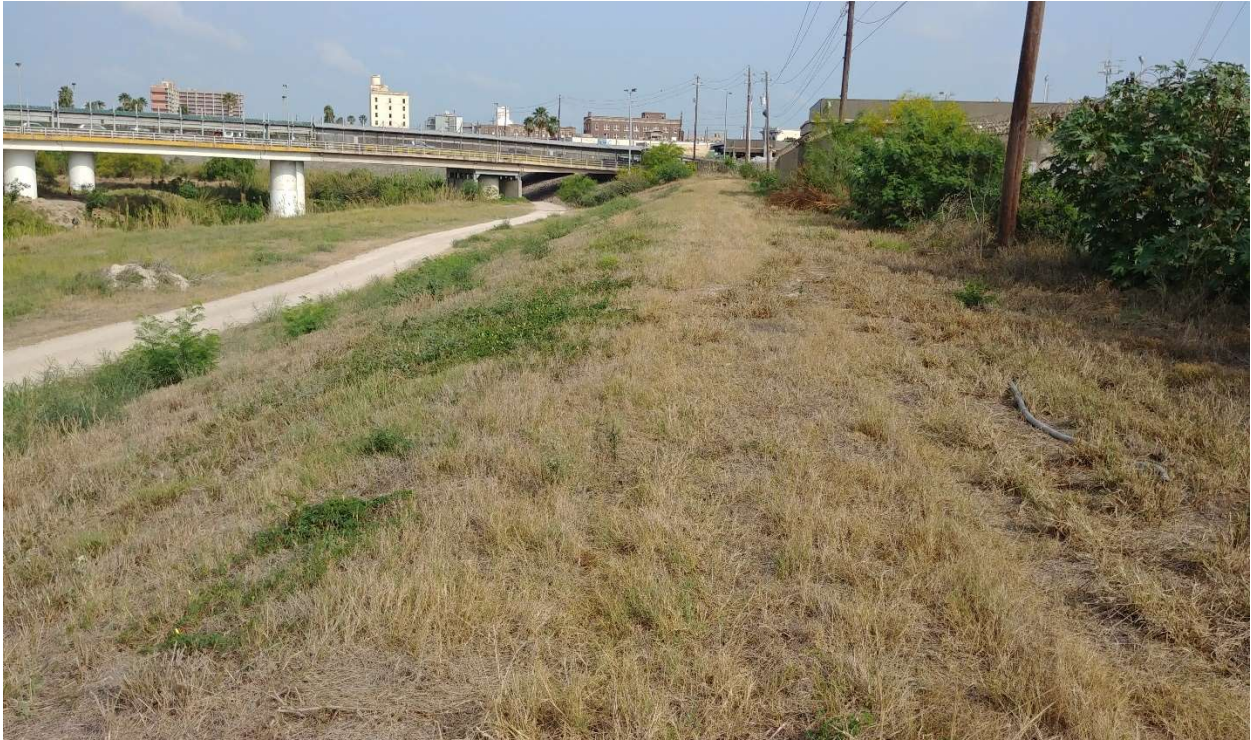
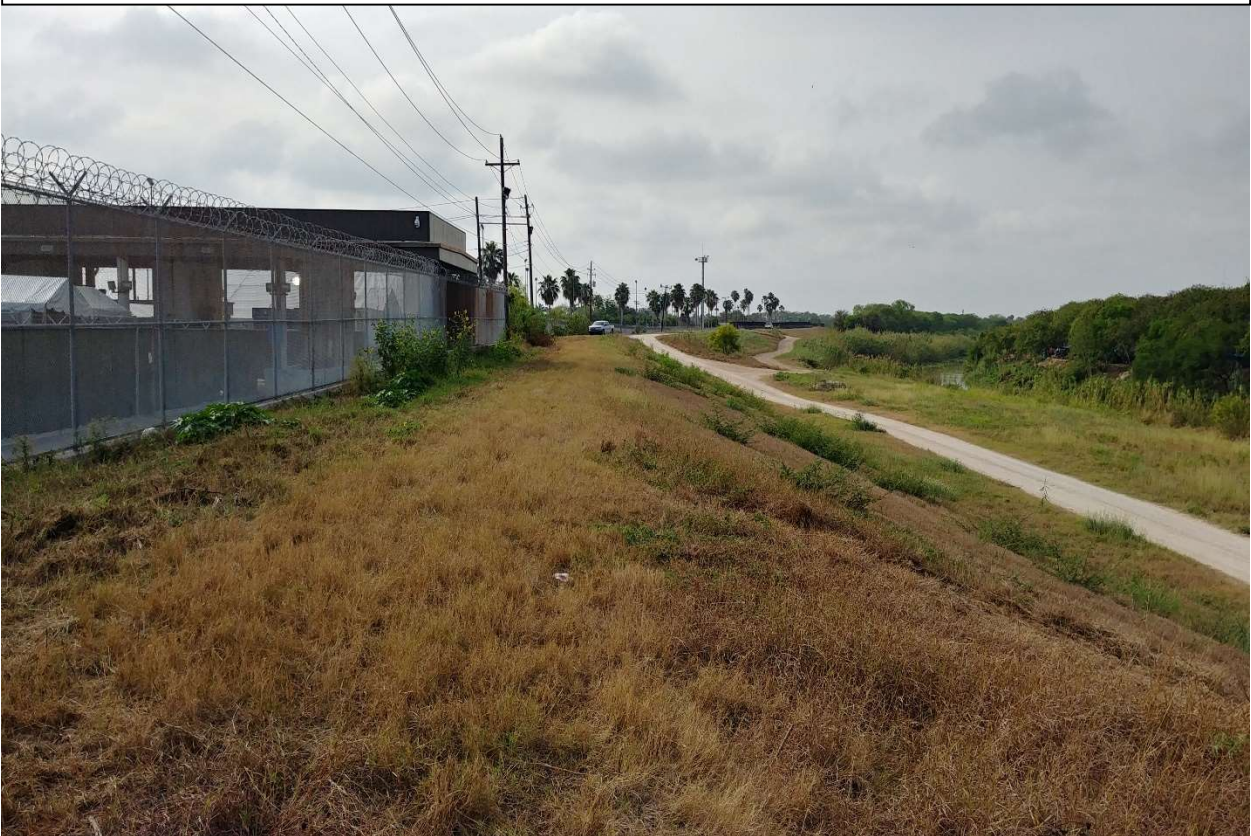
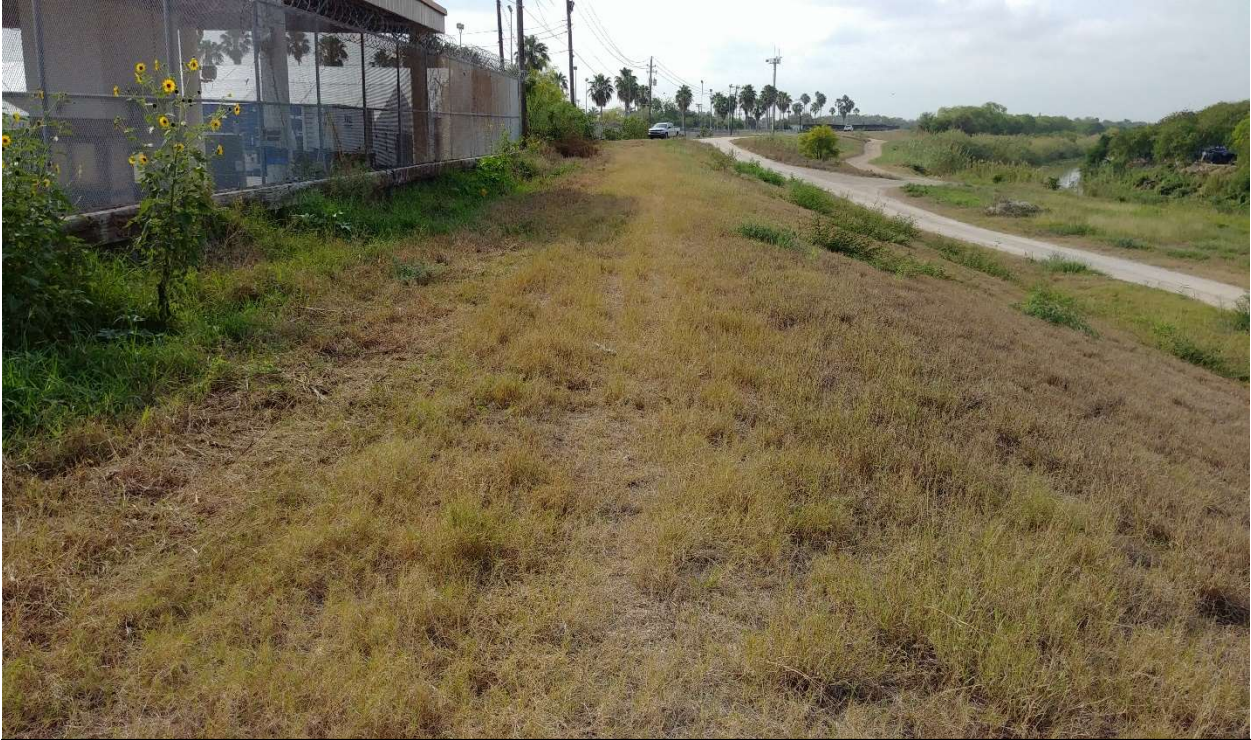
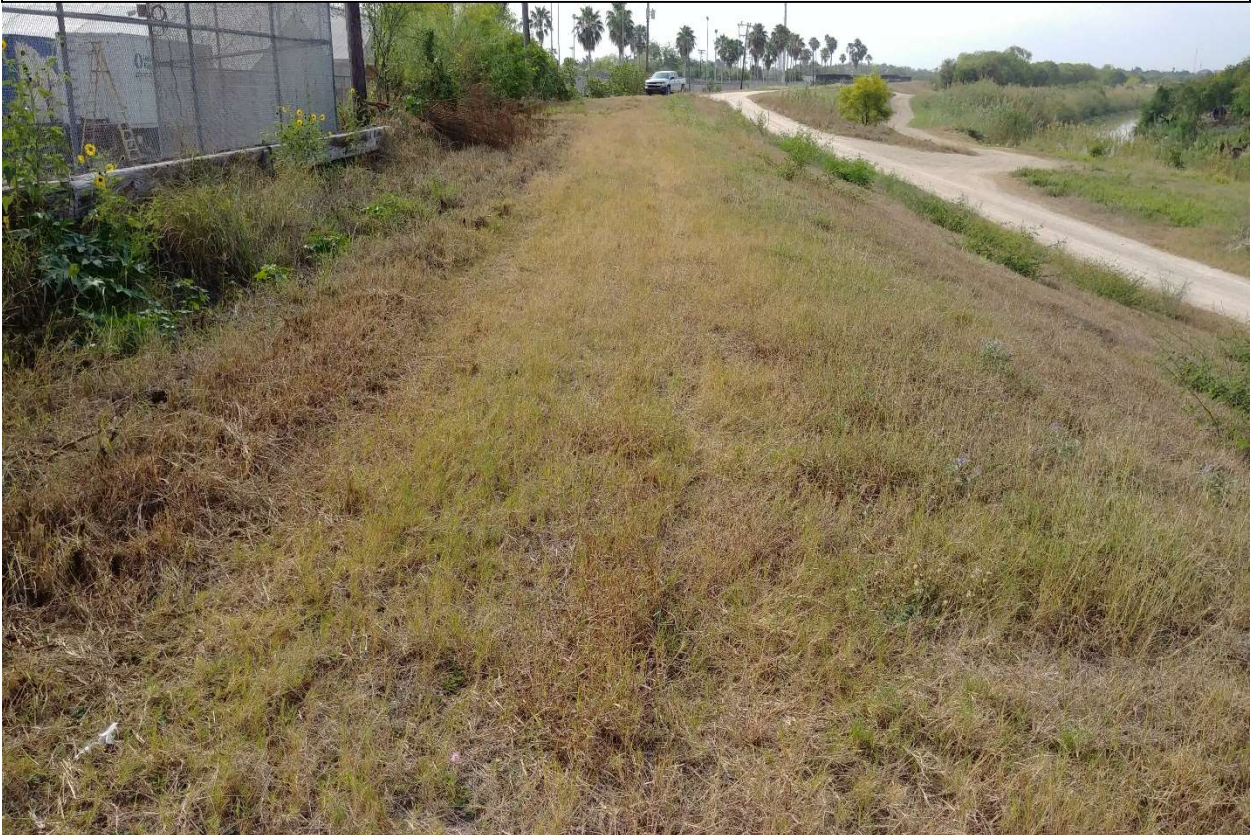
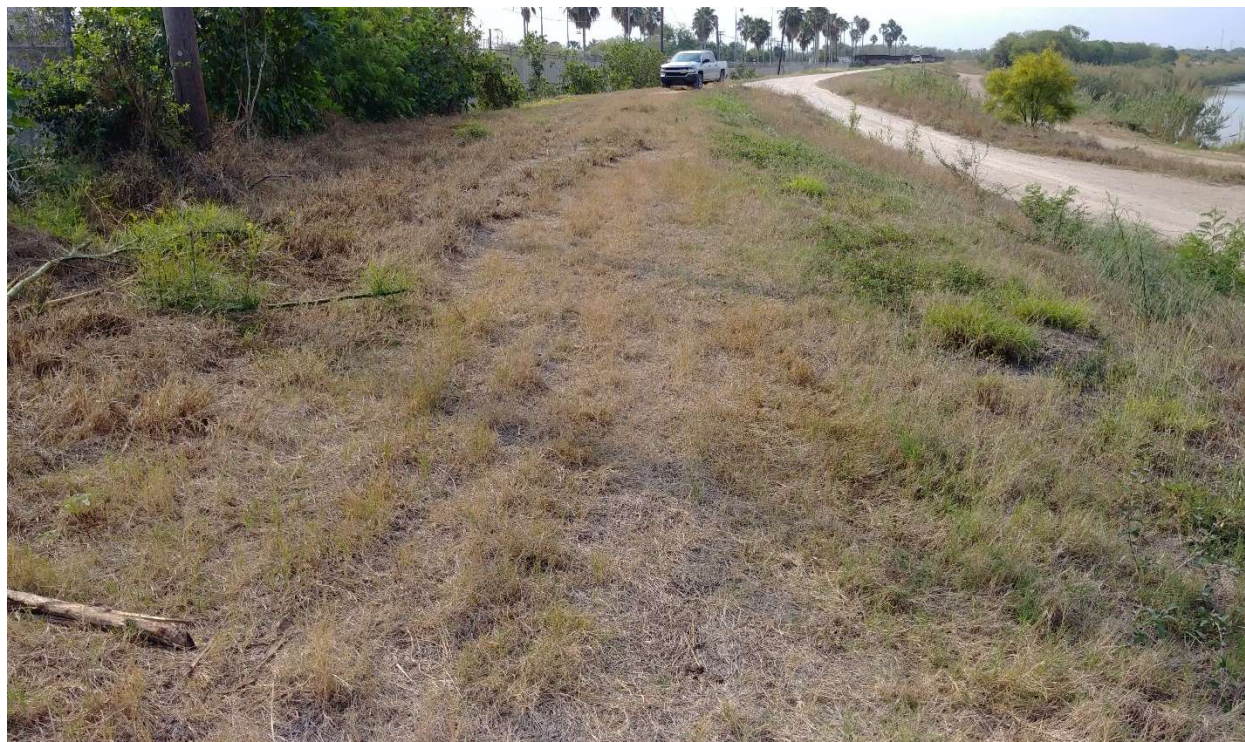
During the March 31, 2020 site visit, several pins that were installed June 14, 2017 have been removed. The removed pins were predominantly on top of the levee near inclinometer ARC-1 and south of the existing retaining wall. It is assumed that pins were removed by active traffic on the levee roadway and by grass mowing activities. In addition, vegetation at the top of the levee as covered the caliche base road. For these reasons, the longitudinal cracks noted in July 2017 could not be observed or measured during the March 2020 visit. Attachment C shows photos of the top of the levee where tension cracks were present in July 2017.

Photo 1 – Looking North – Top of the Levee.

Photo 2 – Looking South – Top of the Levee.

Photo 3 – Looking South – Top of the Levee.

Photo 4 – Looking South – Top of the Levee.

Photo 5 – Looking South – Top of the Levee.
