Arcadis Project No.:  
LA003315.0000

Subject:  
July 2020 Summary Report of Inclinator Readings  
Remediation Design of Levee Floodplain Failure within the  
Upper Brownsville Levee Reach Lower Rio Grande Flood  
Control Project – IBM15D0001 – IBM15T0015

IBWC  
SUMMARY REPORT OF INCLINOMETER READINGS

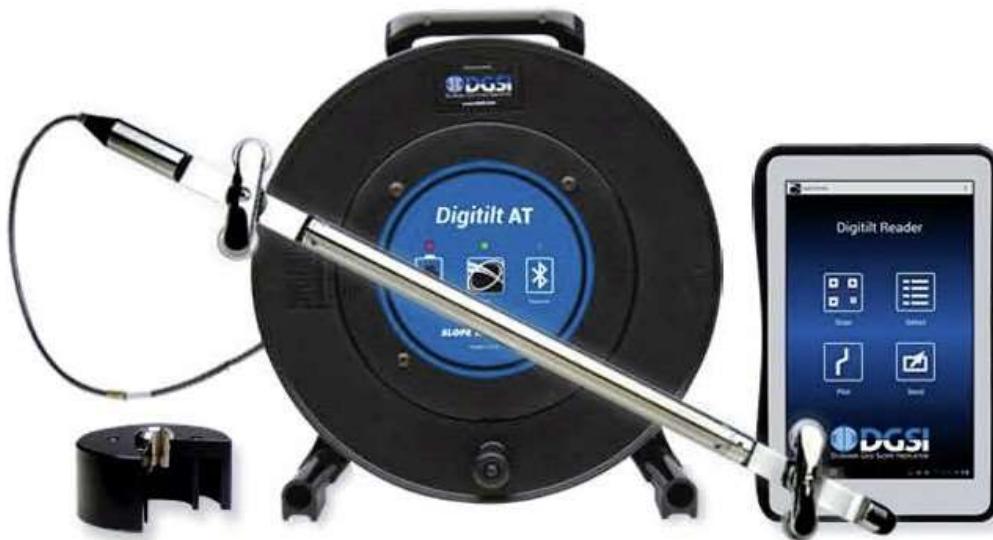
Figure 1: Digitilt AT System Components.

Digitilt AT system was used to survey the inclinometers. The system components include an inclinometer probe, control cable, a Bluetooth reel and the Digitilt Reader app for certified Android-based tablet computer. The equipment is shown in Figure 1.

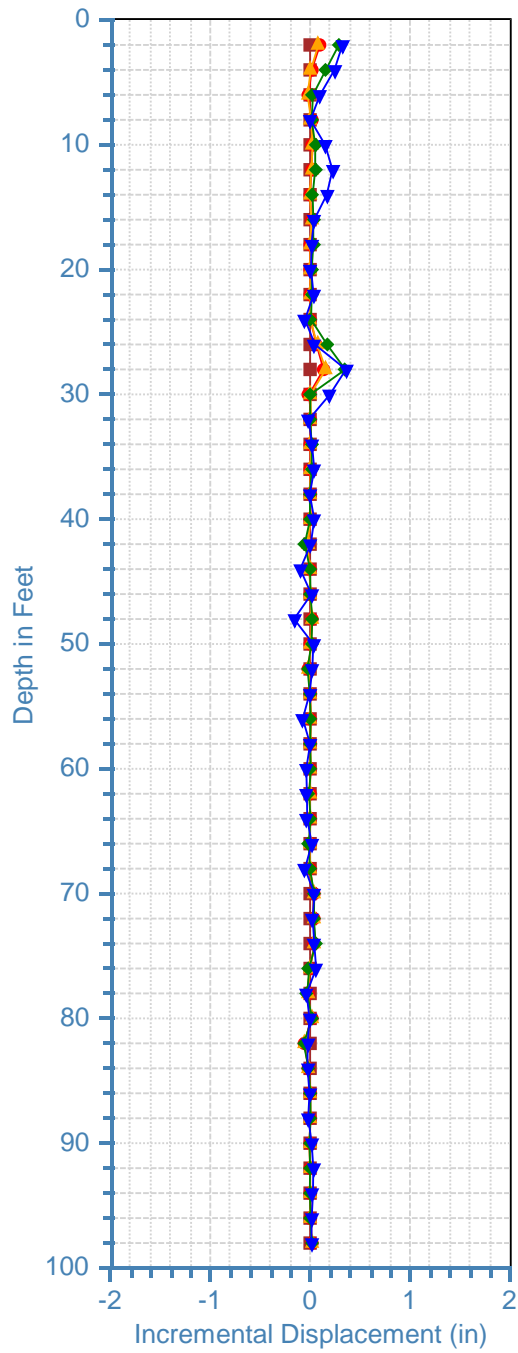
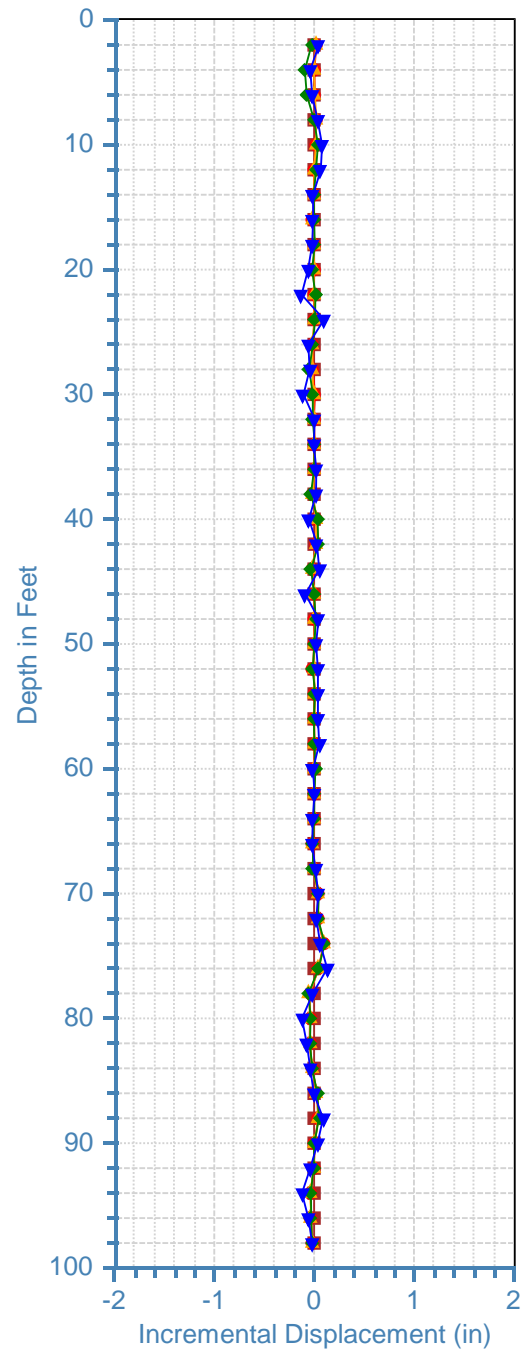
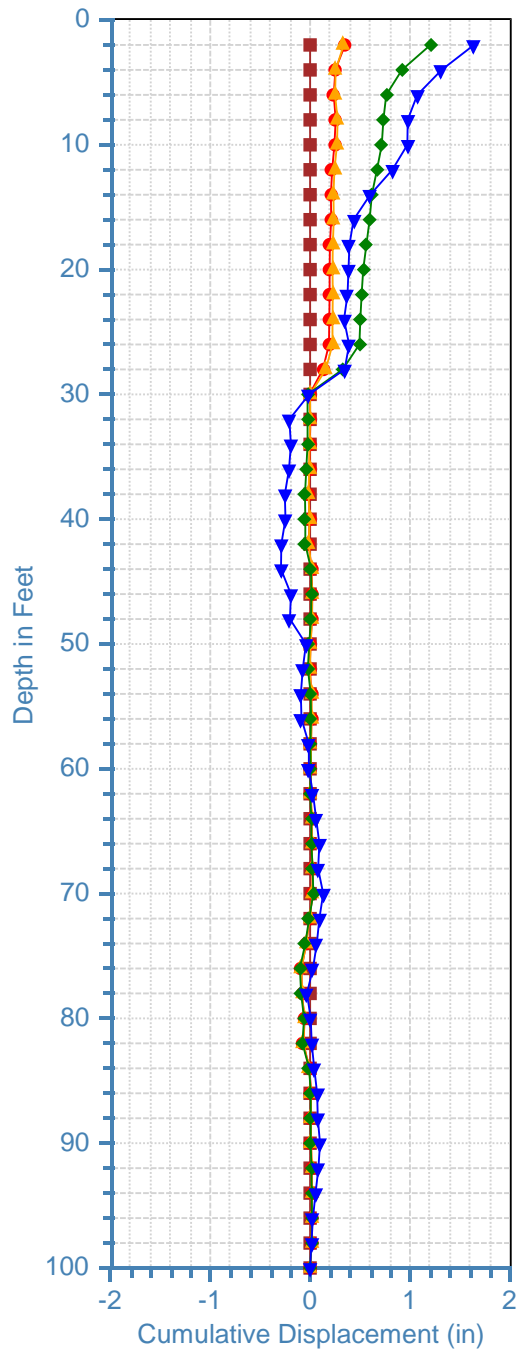
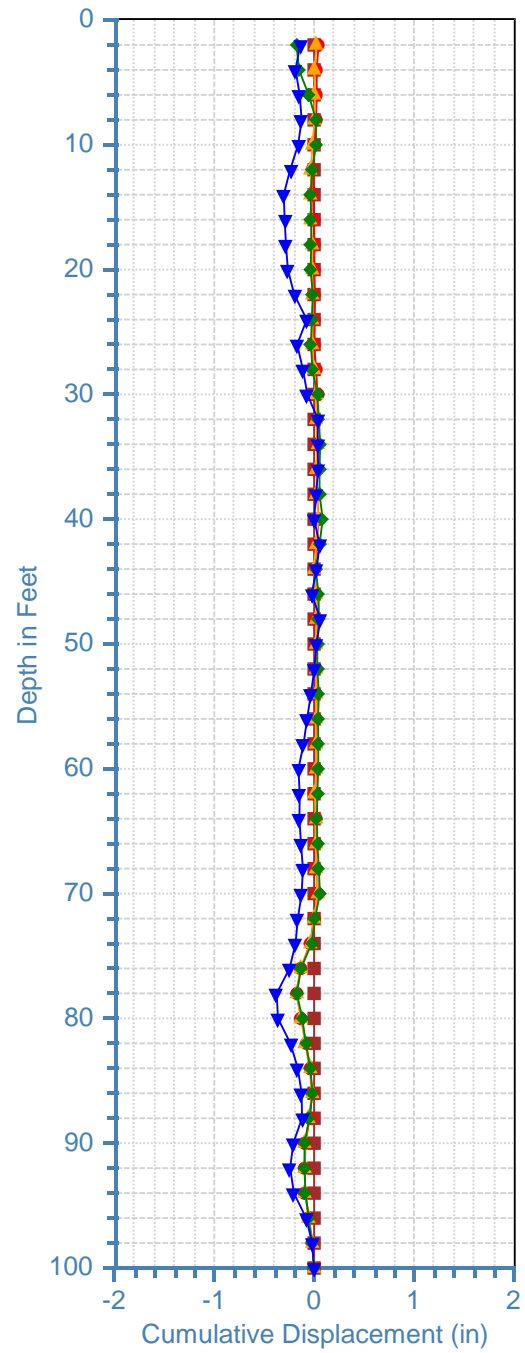
IBWC Arc-1 A - Axis

Inclinometer ARC-1: The base readings for inclinometer ARC-1 were collected on June 22, 2016. The ARC-1 cumulative plot in the A-Axis direction shows a slight progressive movement starting at depths between 28 and 30 feet. This depth corresponds with the interpreted Alluvium/Pleistocene interface presented in Figure 2 of Arcadis' July 31, 2017 *Final Geotechnical Assessment Report*. After reviewing the cumulative displacement plots, there was a slight increase in displacement between the dates of September 2016 and March 2017. After March 2017, the displacement towards the Rio Grande (A-Axis) started to increase at a slow rate. Comparing the measurements taken in July 2017 to July 2020, the displacement is 0.19 inch towards the Rio Grande (A-Axis) at a depth of 28 feet. The overall displacement at a depth of 28 feet is 0.35 inch.

The displacement parallel to the levee does not show any sign of movement in this month's readings.

After reviewing the cumulative displacement plots in Attachment A, the readings exhibit increasing displacement towards the Rio Grande (A-Axis direction) for inclinometer ARC-1. The displacement for these inclinometers demonstrates a trend that will increase over time due to fluctuations of the water level in the Rio Grande. After critically reviewing the cumulative displacement plots, the graphical displays in Attachment A shows that there is an increase in movement towards the Rio Grande (A-Axis direction) for the

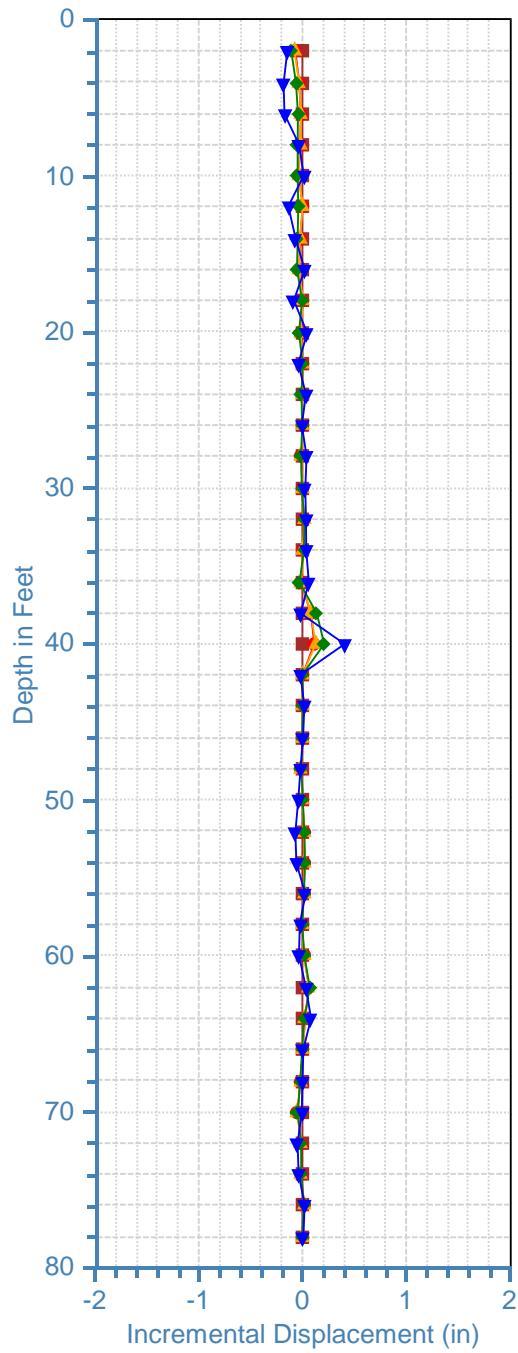
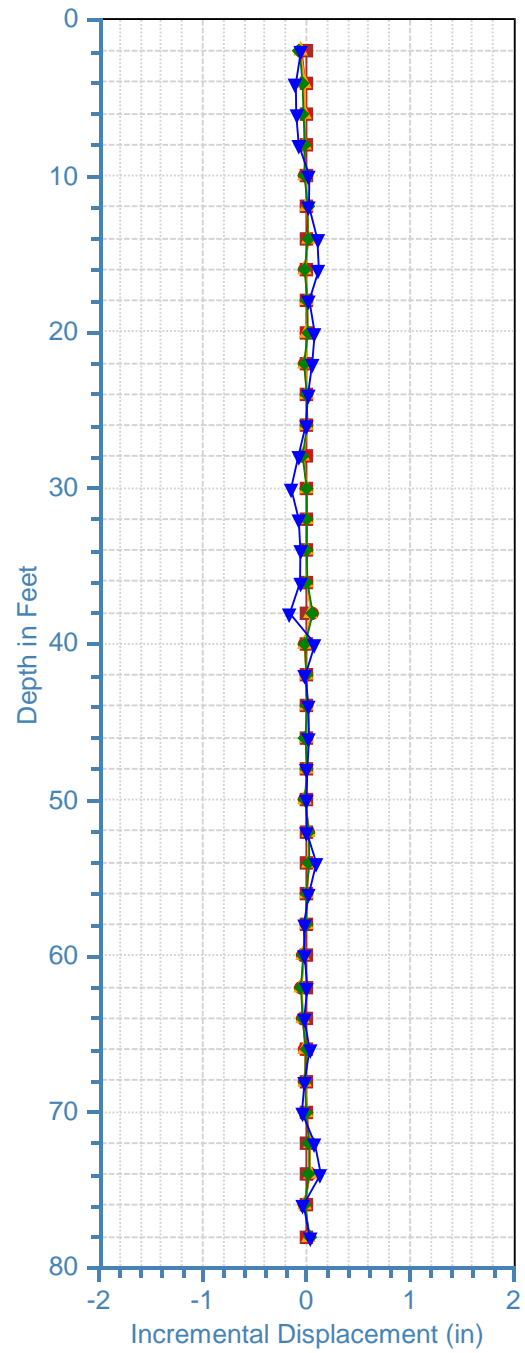
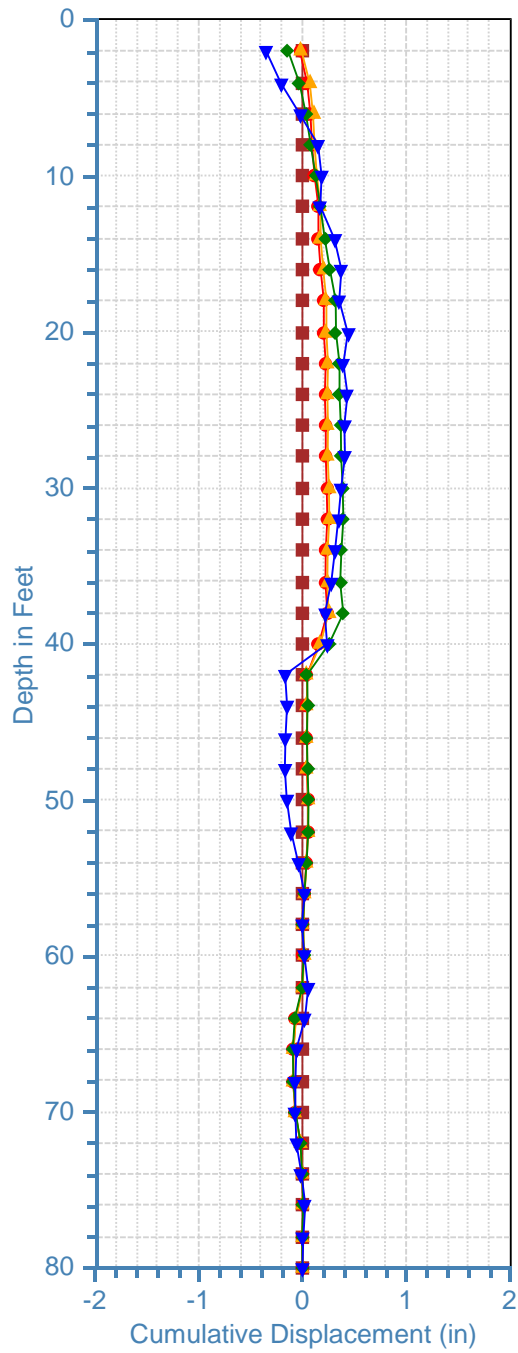
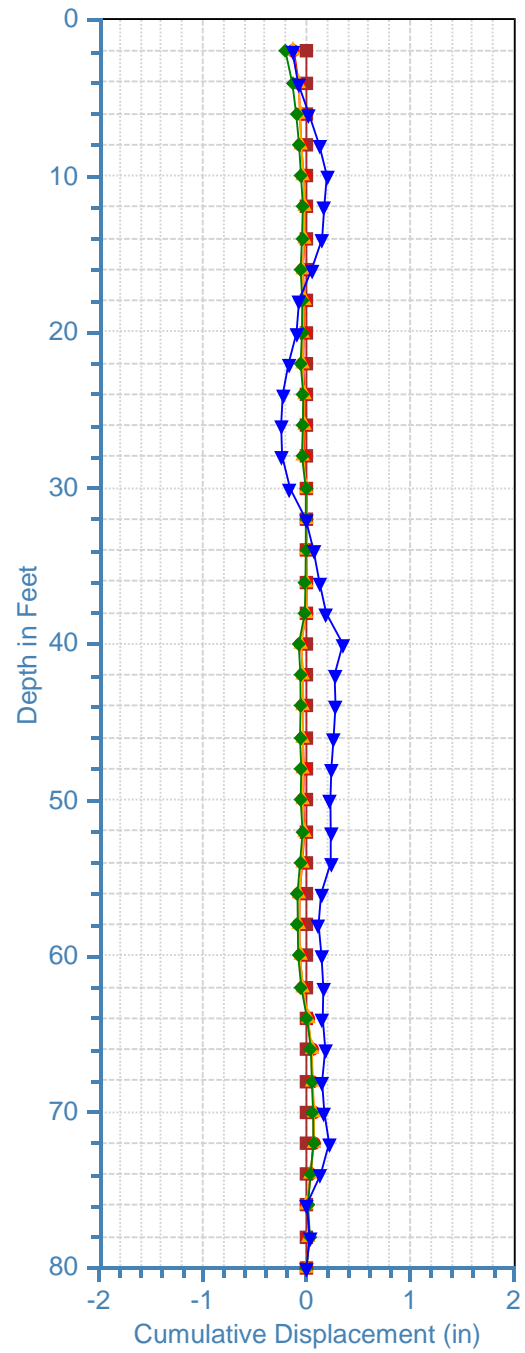
IBWC Arc-2 A - Axis

Inclinometer Arc-2: The base readings for inclinometer ARC-2 were collected on June 17, 2016. The ARC-2 cumulative displacement plot in the A-Axis direction shows displacement between the depths of 38 feet to 40 feet. This depth corresponds with the interpreted Alluvium/Pleistocene interface presented in Figure 2 of Arcadis' July 31, 2017 *Final Geotechnical Assessment Report*. The cumulative displacement plots show a slight increase in displacement in September 2016 and a decrease in movement in December 2016. After December 2016, the movement towards the Rio Grande (A-Axis) started to increase at a slow rate. Comparing the measurements taken in July 2017 to July 2020, the displacement is 0.08 inches towards the Rio Grande (A-Axis) at a depth of 40 feet. The overall displacement at a depth of 40 feet is 0.25 inch.

The displacement parallel to the levee does not show any sign of movement in this month's readings.

inclinometers ARC-1, ARC-2, and ARC-3. The displacement for these inclinometers is progressive but moving at a very slow rate.

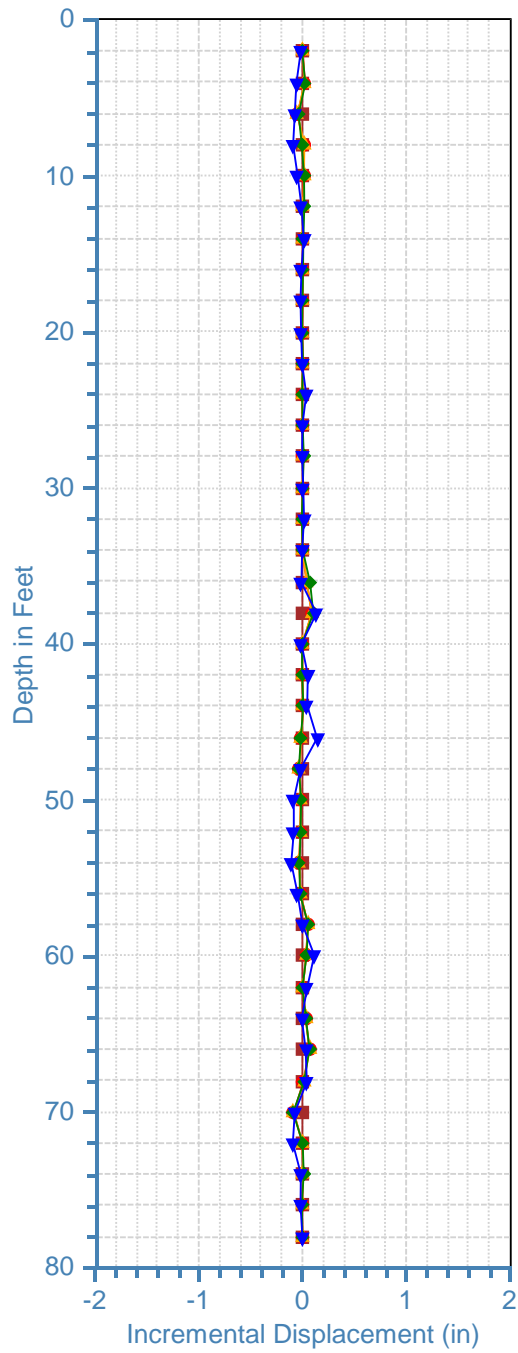
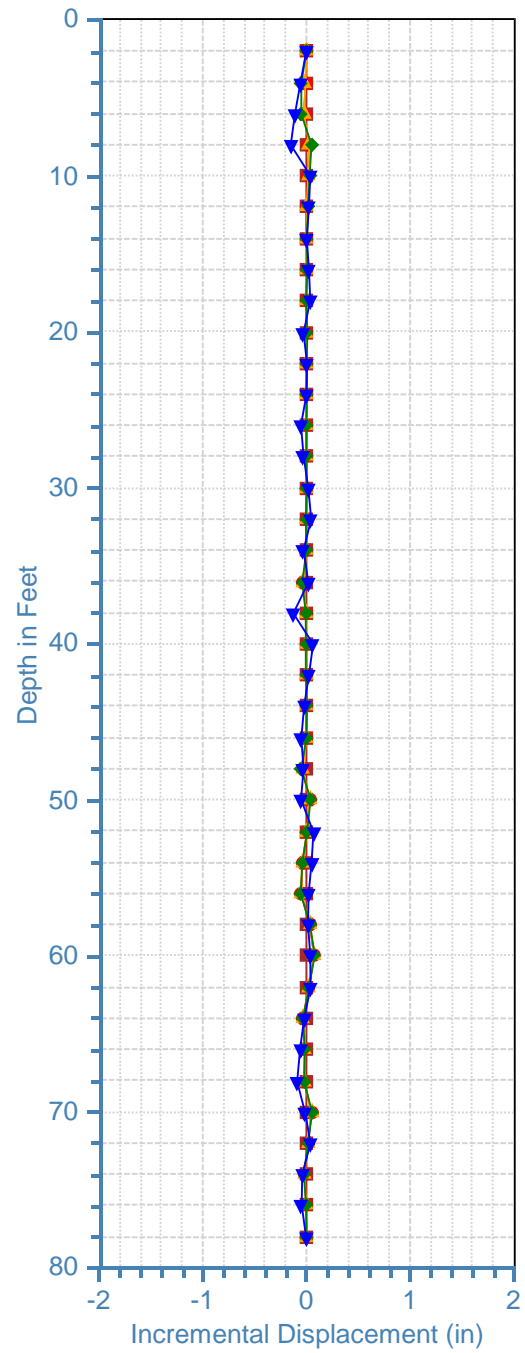
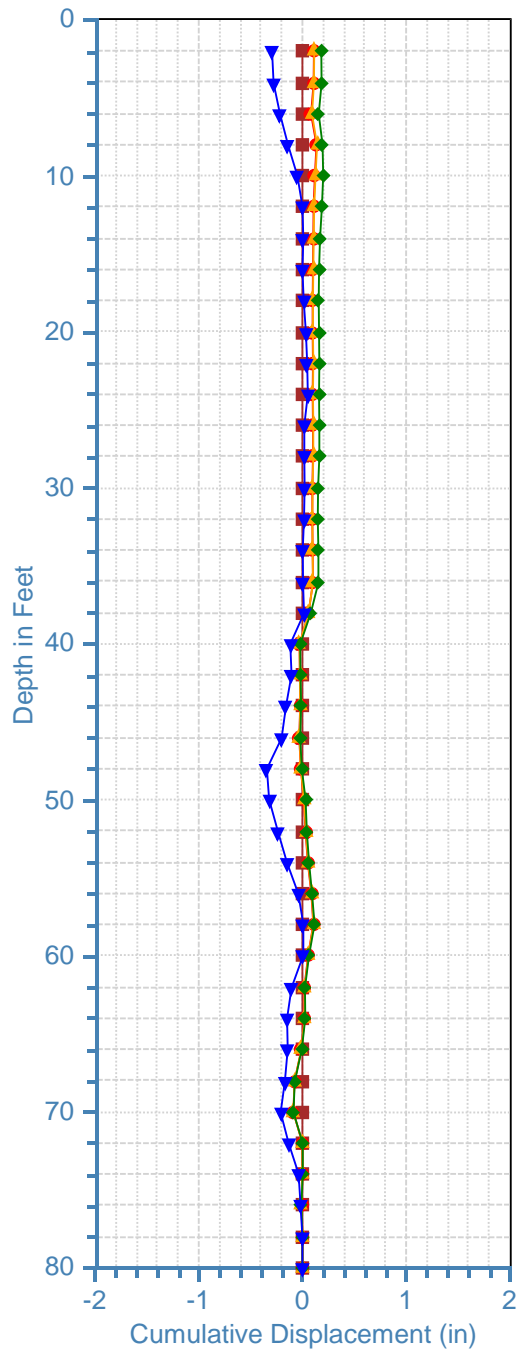
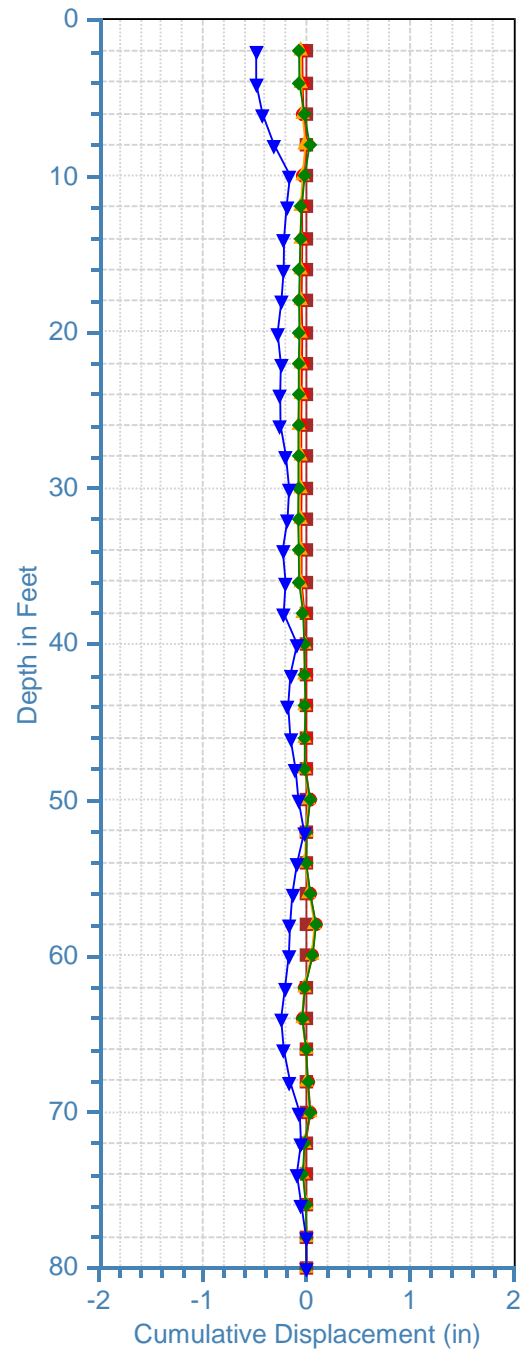
IBWC Arc-3 A - Axis

Inclinometer ARC-3: The base readings for inclinometer ARC-3 were collected on June 17, 2016. The ARC-3 cumulative displacement plot in the A-Axis direction shows displacement between the depths of 36 feet to 38 feet. This depth corresponds with the interpreted Alluvium/Pleistocene interface presented in Figure 2 of Arcadis' July 31, 2017 *Final Geotechnical Assessment Report*. Previous readings showed less than 0.1 inch movement at this depth that now shows an overall displacement of 0.15 inch.

The displacement parallel to the levee does not show any sign of movement in this month's readings.

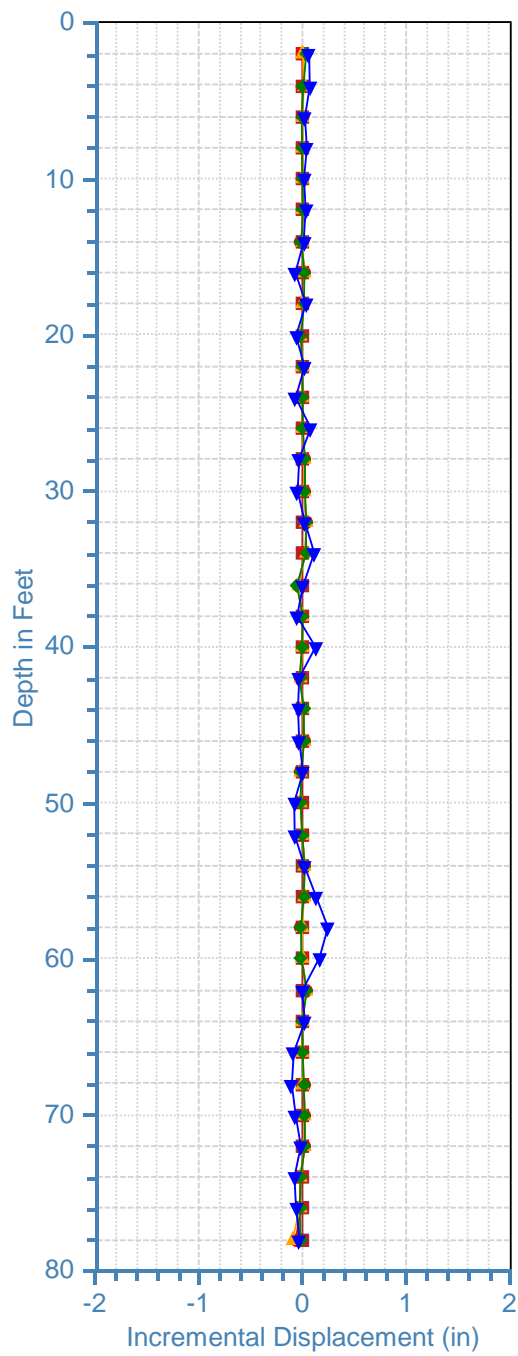
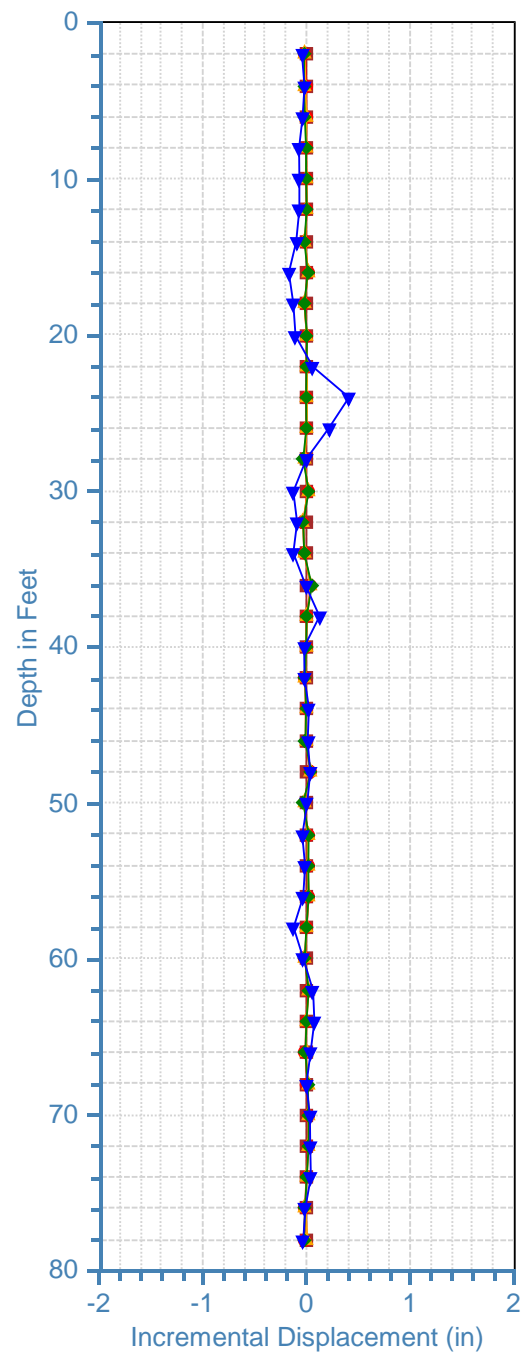
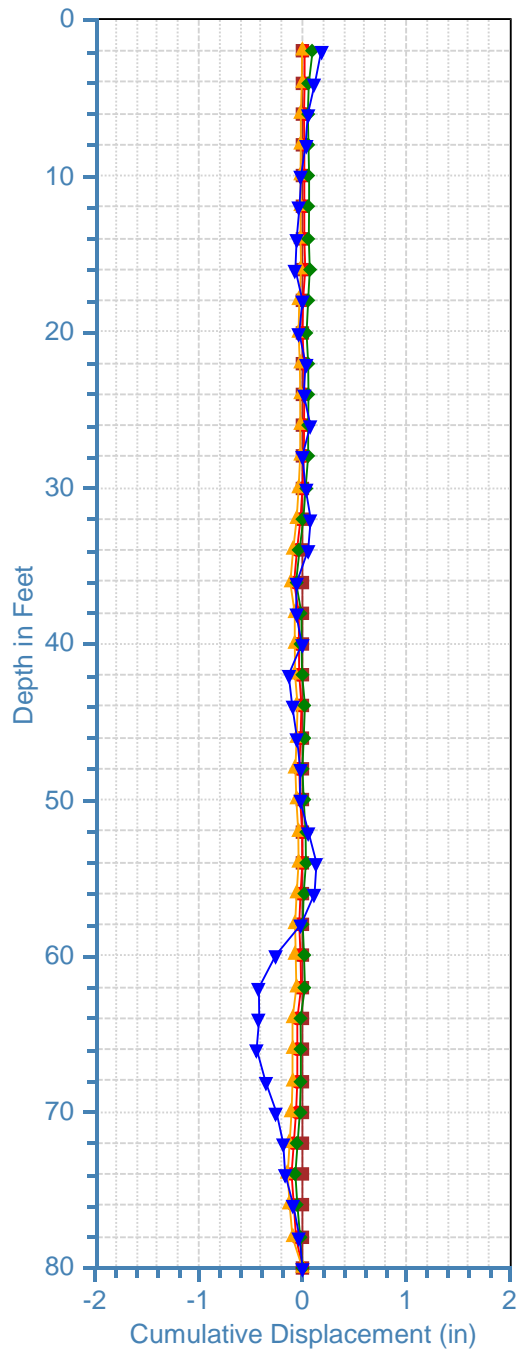
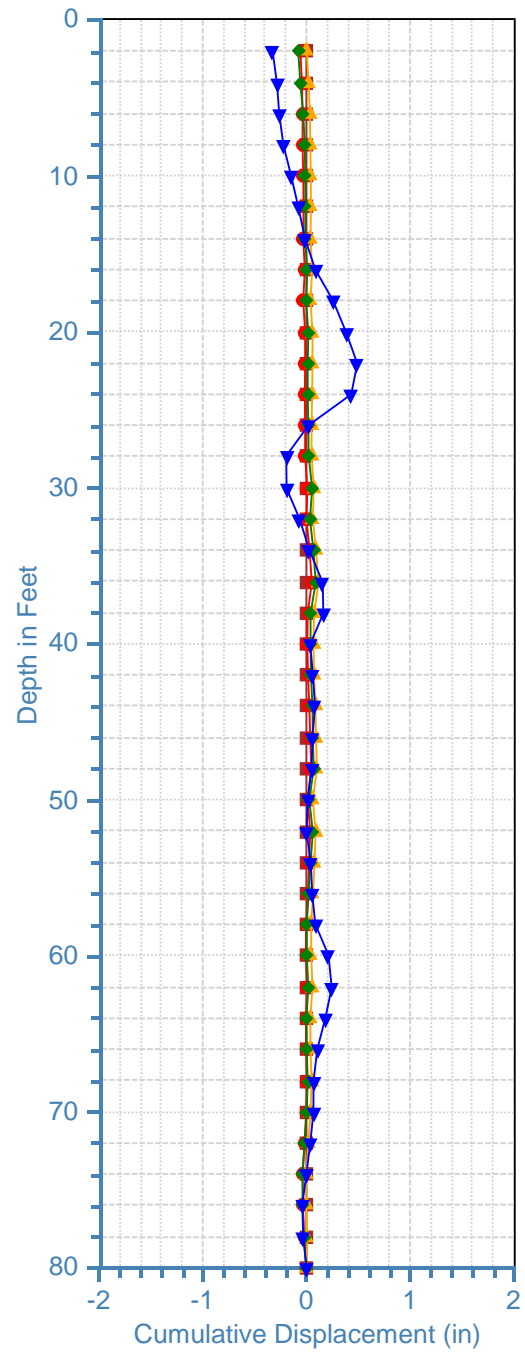
IBWC Arc-4 A - Axis

Inclinometer ARC-4: The base readings for inclinometer ARC-4 were collected on June 22, 2016. The ARC-4 cumulative and incremental displacement does not show any sign of movement on the plane perpendicular to the levee nor on the plane parallel to the levee.

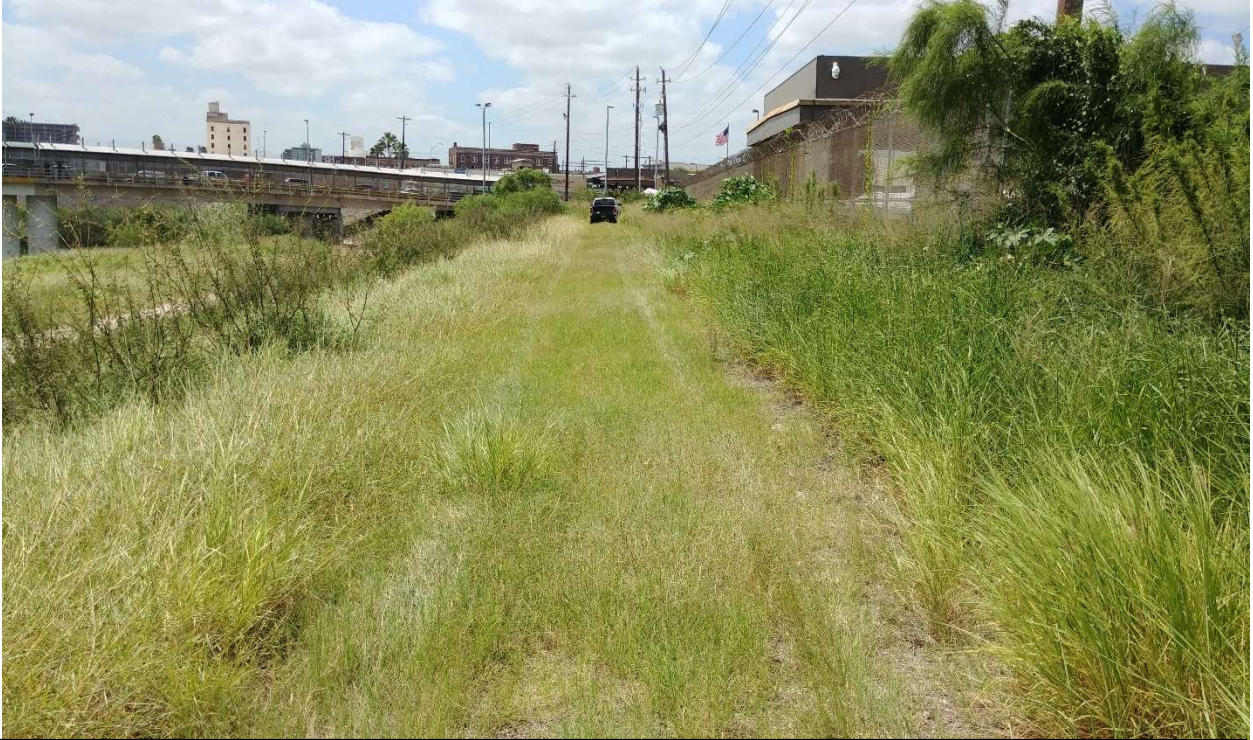
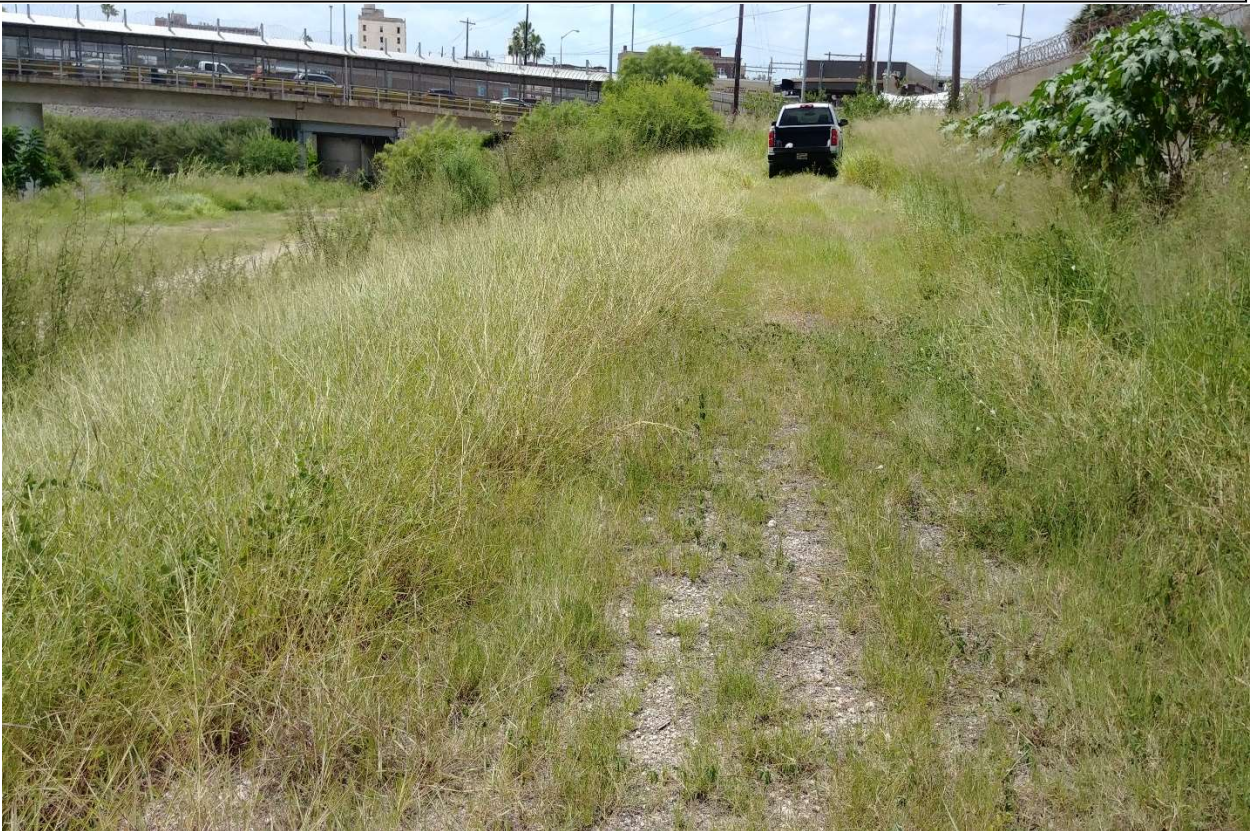
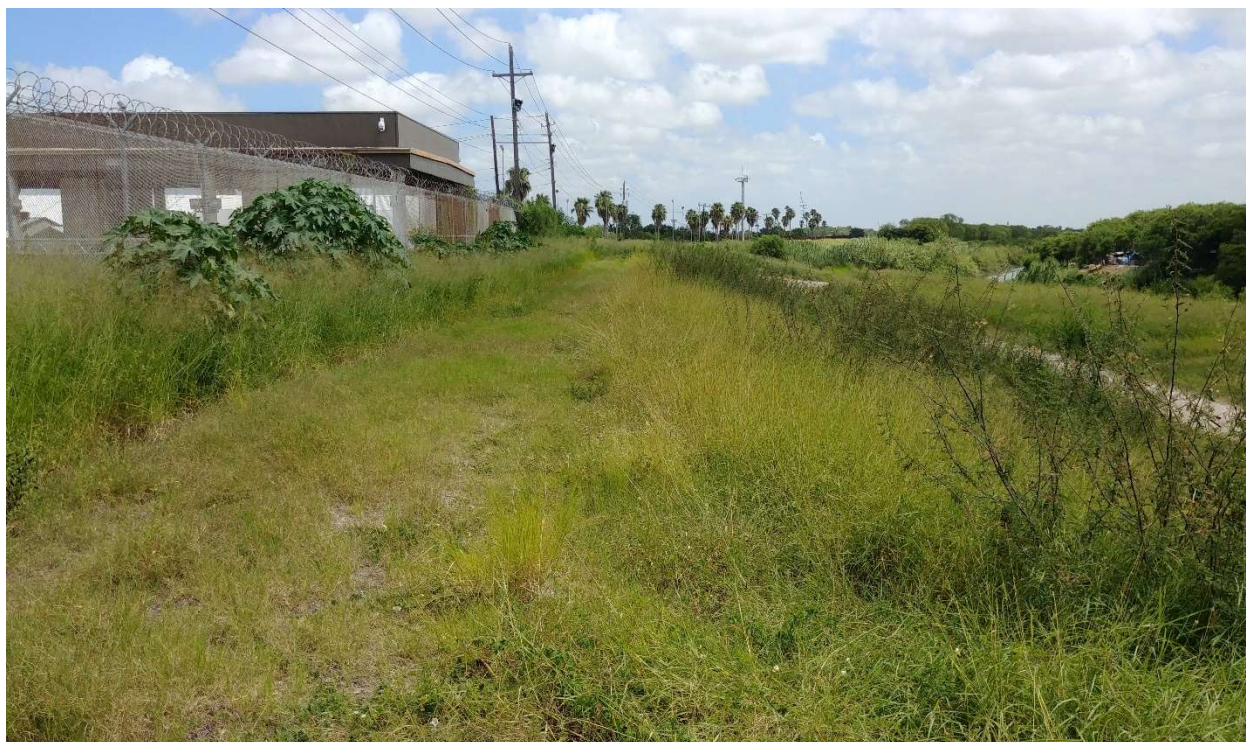
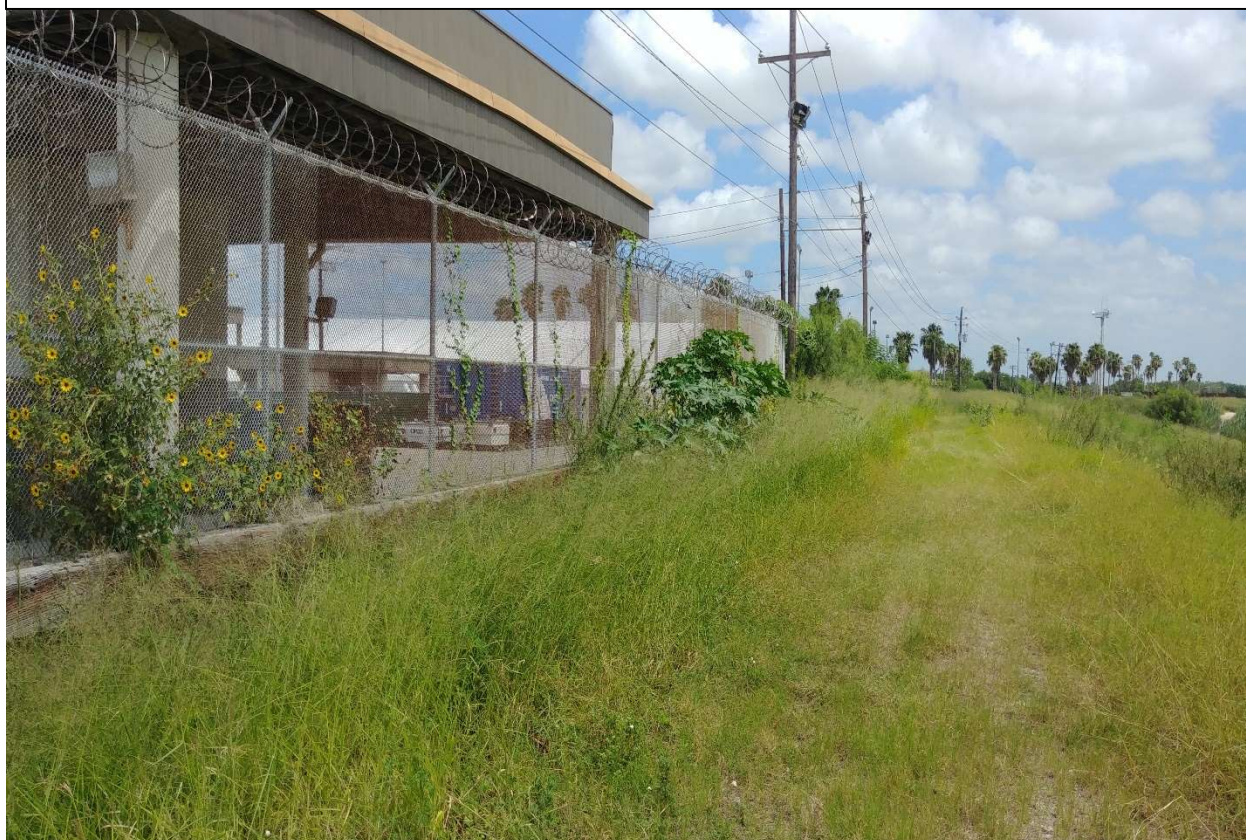
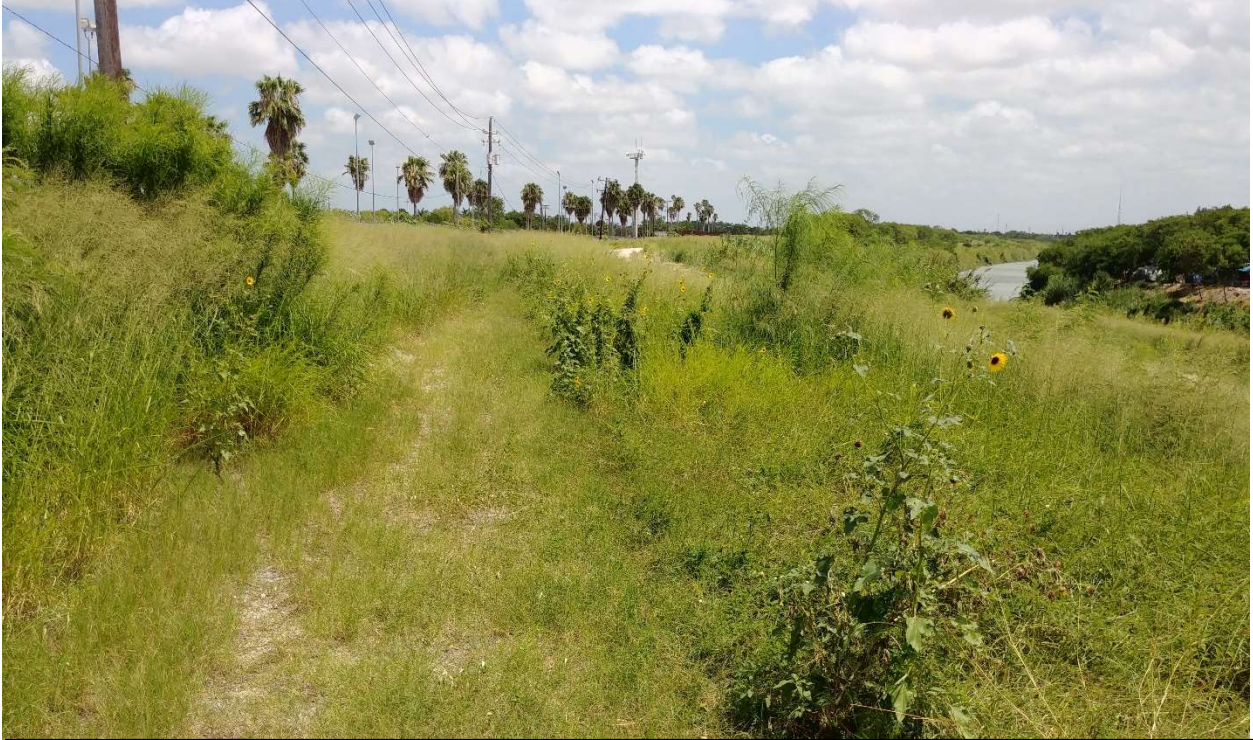
As noted in the March report, several pins that were installed June 14, 2017 have been removed. The removed pins were predominantly on top of the levee near inclinometer ARC-1 and south of the existing retaining wall. It is assumed that pins were removed by active traffic on the levee roadway and by grass mowing activities. Attachment C shows photos of the top of the levee where tension cracks were present in July 2017.

Photo 1 – Looking North – Top of the Levee.

Photo 2 – Looking North – Top of the Levee.

Photo 3 – Looking South – Top of the Levee.

Photo 4 – Looking South – Top of the Levee.

Photo 5 – Looking South – Top of the Levee.

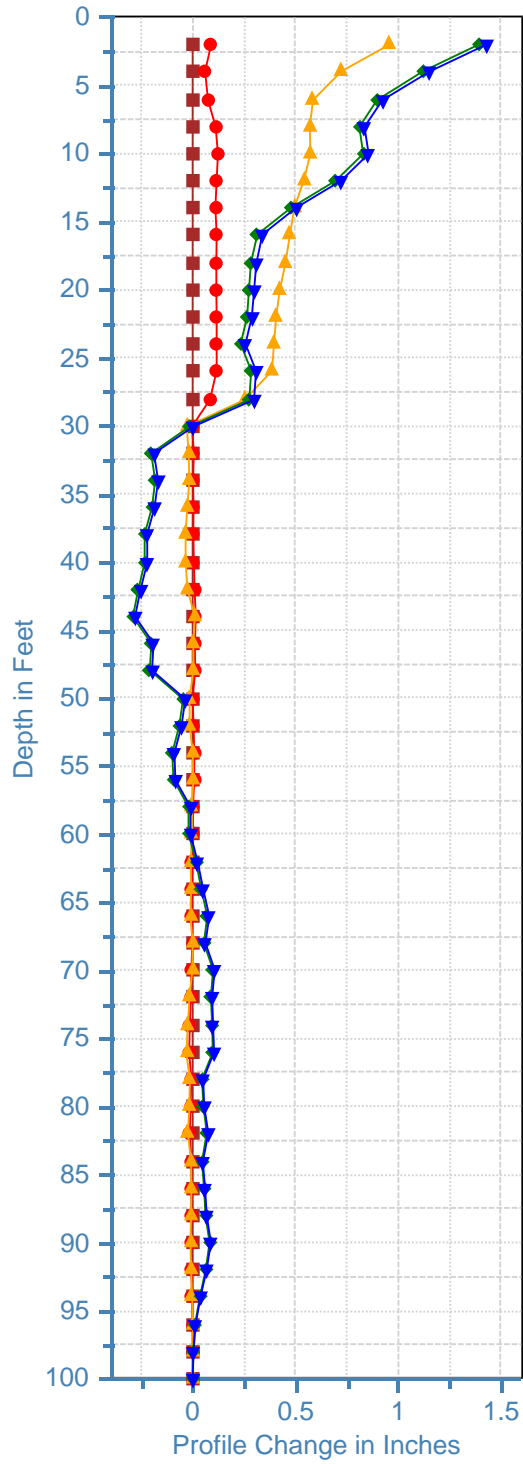
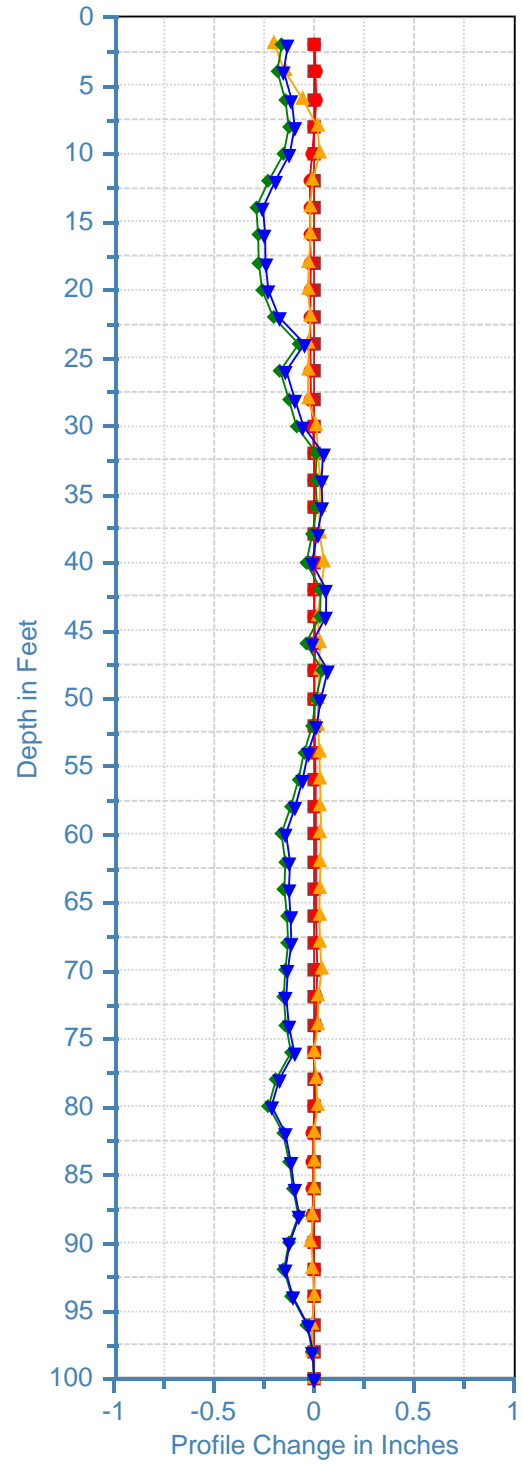
### **CUMULATIVE PLOTS OF INCLINOMETER ARC-1**

A, the incremental readings appear similar to previous readings and the cumulative readings are different especially beneath depths of 40 feet. After reviewing the cumulative readings, a second reading at ARC-1 was taken on July 13<sup>th</sup> to compare with the July 10<sup>th</sup> reading to help ensure the July 10<sup>th</sup> readings from the new equipment was accurate. Attachment D presents the cumulative print out of ARC-1 which shows the two readings were virtually identical.
