ERDC Report to USIBWC

Geotechnical Evaluation of the Brownsville Levee Cracking and Partial Slope Failure

July 2015

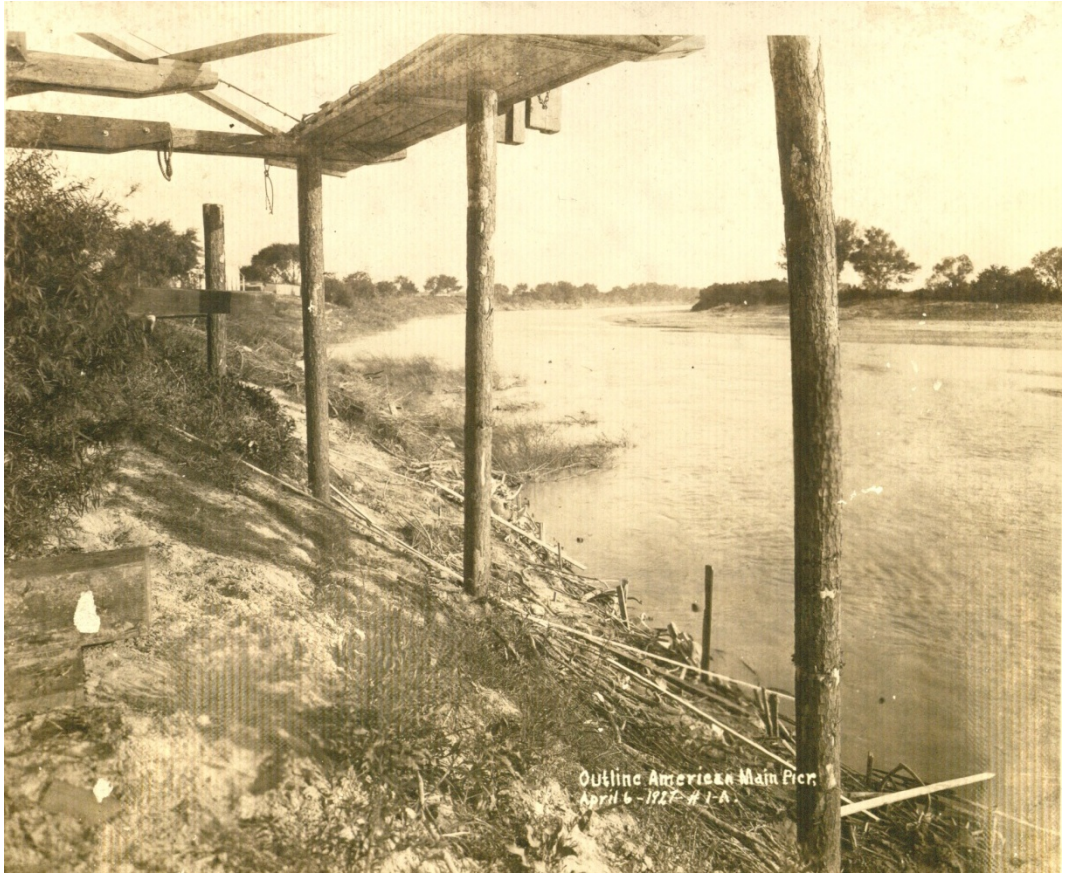
Figure 3.9 is taken from beneath the pier with a view looking downstream shows riverbank conditions along the entire study reach. As this photograph clearly shows, the river channel and bank are significantly different than conditions that currently exist today. The channel is much wider, with a moderate side slope that is approximately 1V to 3 H. The bridge was completed by 1928. The USGS topographic map from 1930 (Figure 3.4) identifies the bridge alignment and is consistent with the early photographs showing construction details.

Figure 3.9. View of the study area riverbank in 1927 from beneath the frame support for the Gateway International Bridge pier. View is looking downstream and shows a bank slope of approximately 3H:1V.

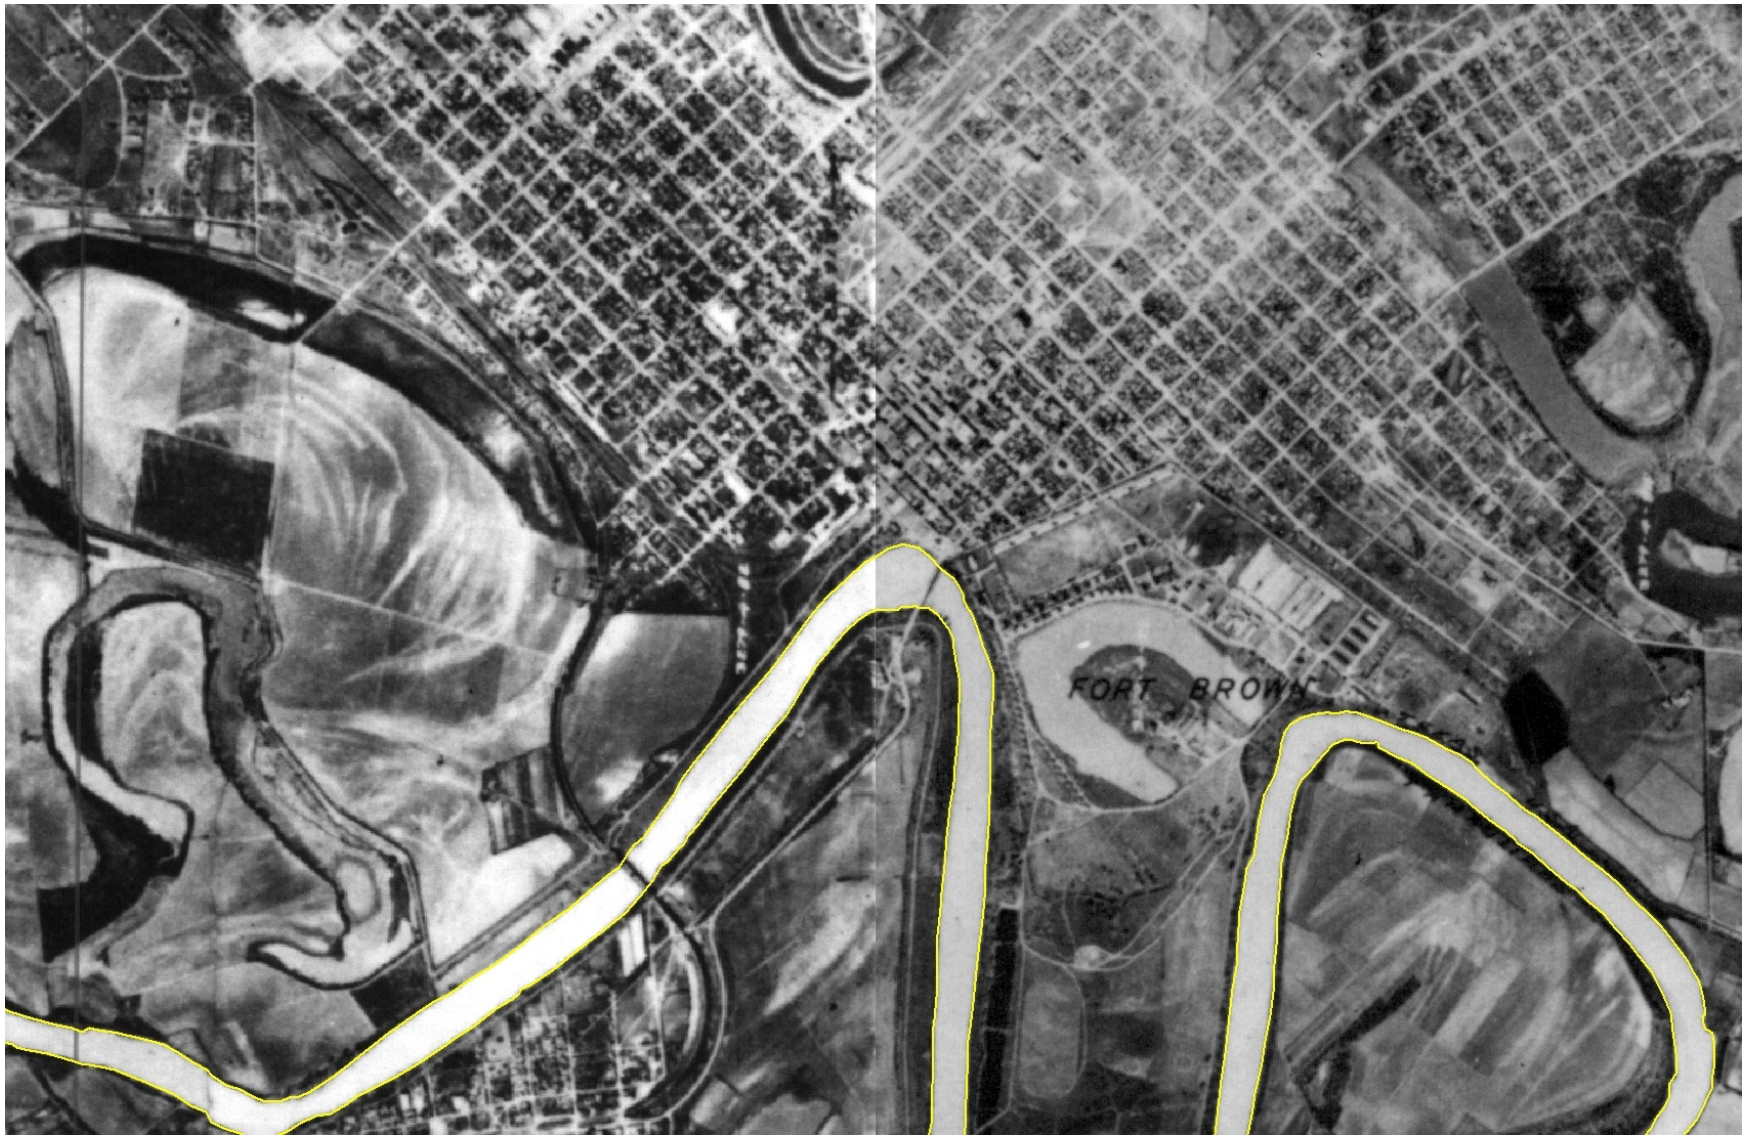
present day limits. The 1930s channel limits have been imposed onto a 2014 Google Earth image of the study reach, which shows the infilling of the Rio Grande by river-borne sediment since 1930 (Figure 3.11). This infilling is the direct consequence of considerably reduced annual river flows caused by the construction of several upstream dams between 1950 and 1970, and the ever increased demands of agricultural irrigation use and water supply within the LRGV from expanding population growth. The maximum limits of the 1930 river channel generally correspond to the current day levee toe (Figure 3.10).

Figure 3.10. East and West Brownsville 1930 Tobin Photographs with channel limits of Rio Grande outlined in yellow.

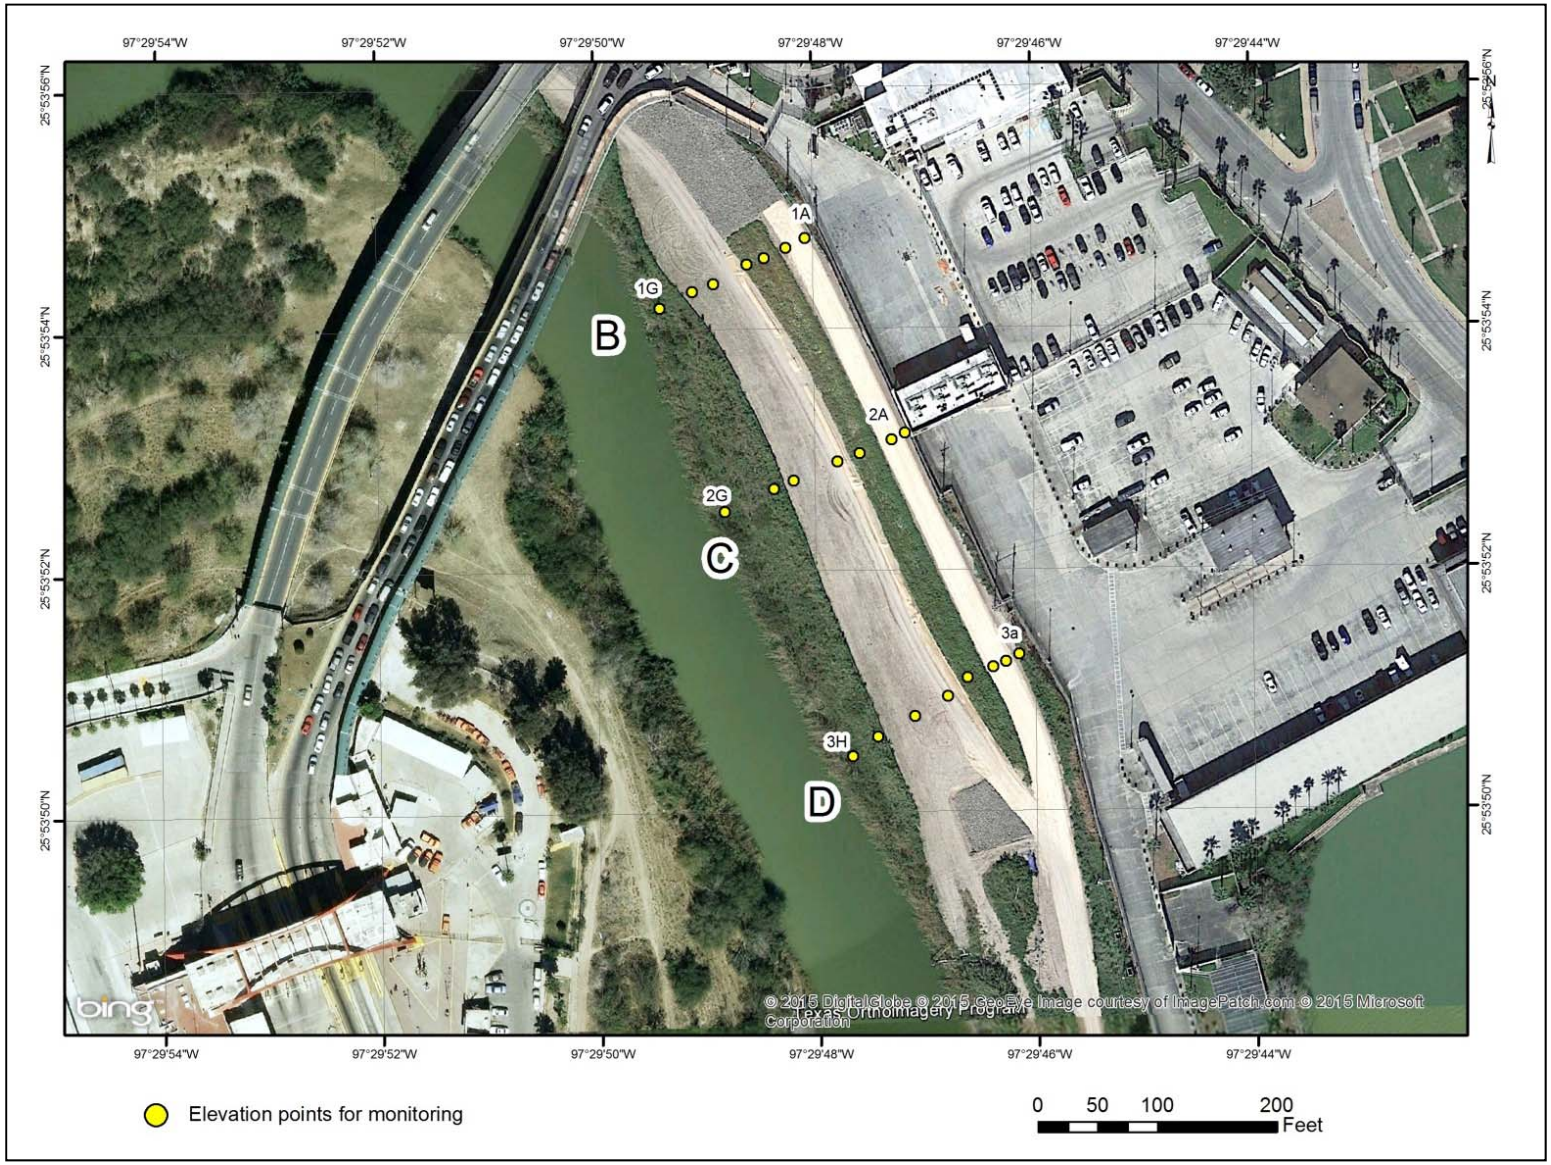
Figure 4.12. Location of survey profiles to monitor bank movements. Merged Bing and Google Earth background image is from 2014 prior to levee cracking.

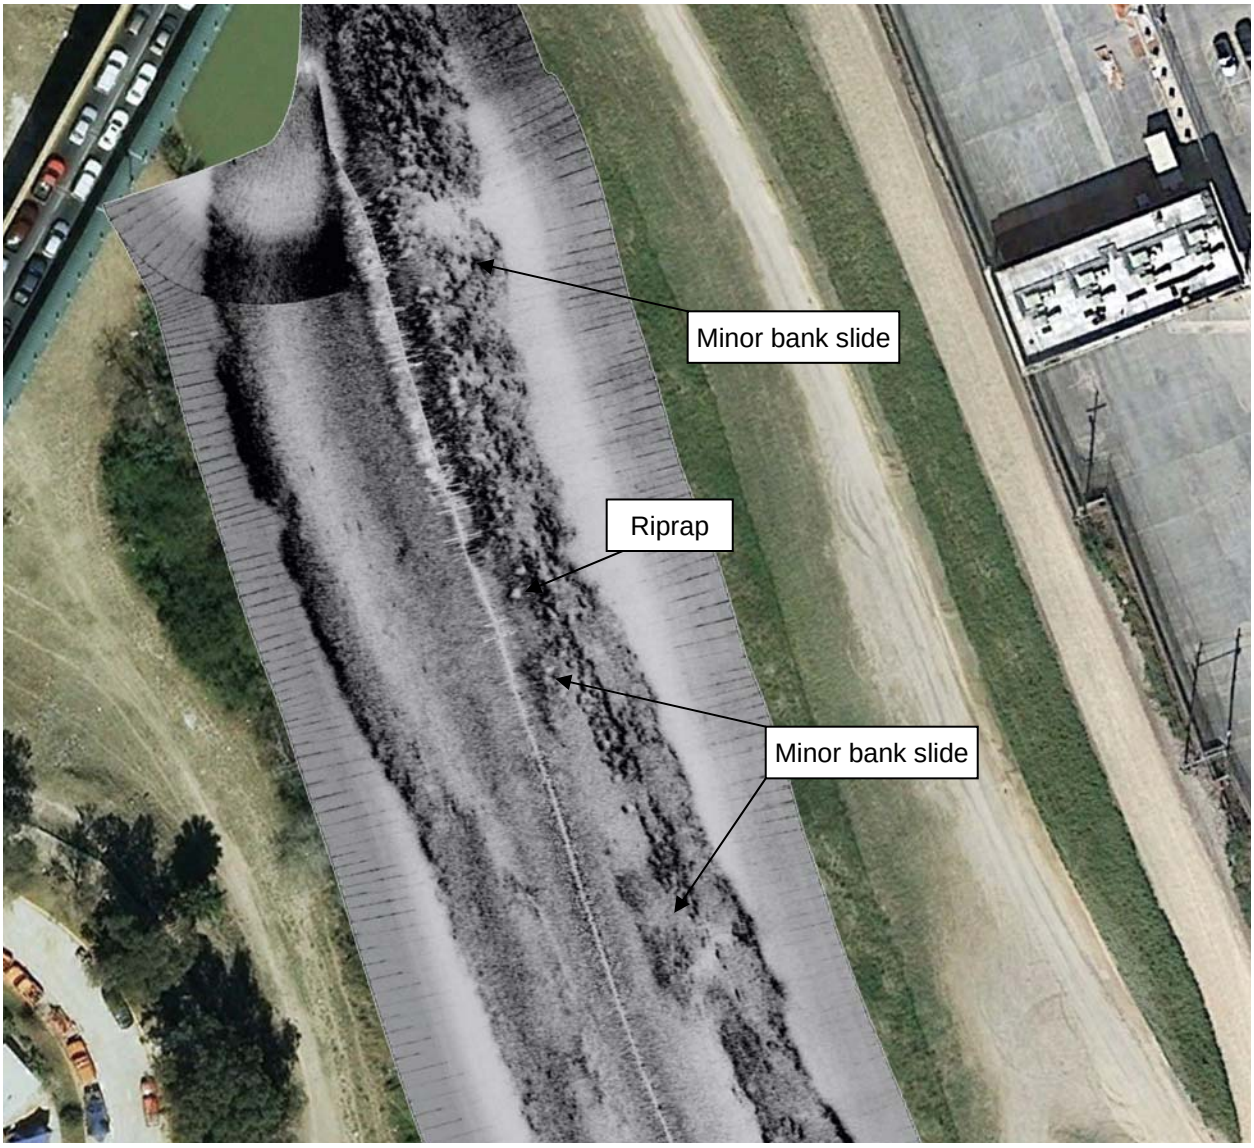
Figure 4.19. Close-up view of the side scan sonar data overlain on 2014 Google image. Note the presence of rip-rap and small bank slumps/ slides on U.S side. White line corresponds to center of boat track moving toward the bridge.

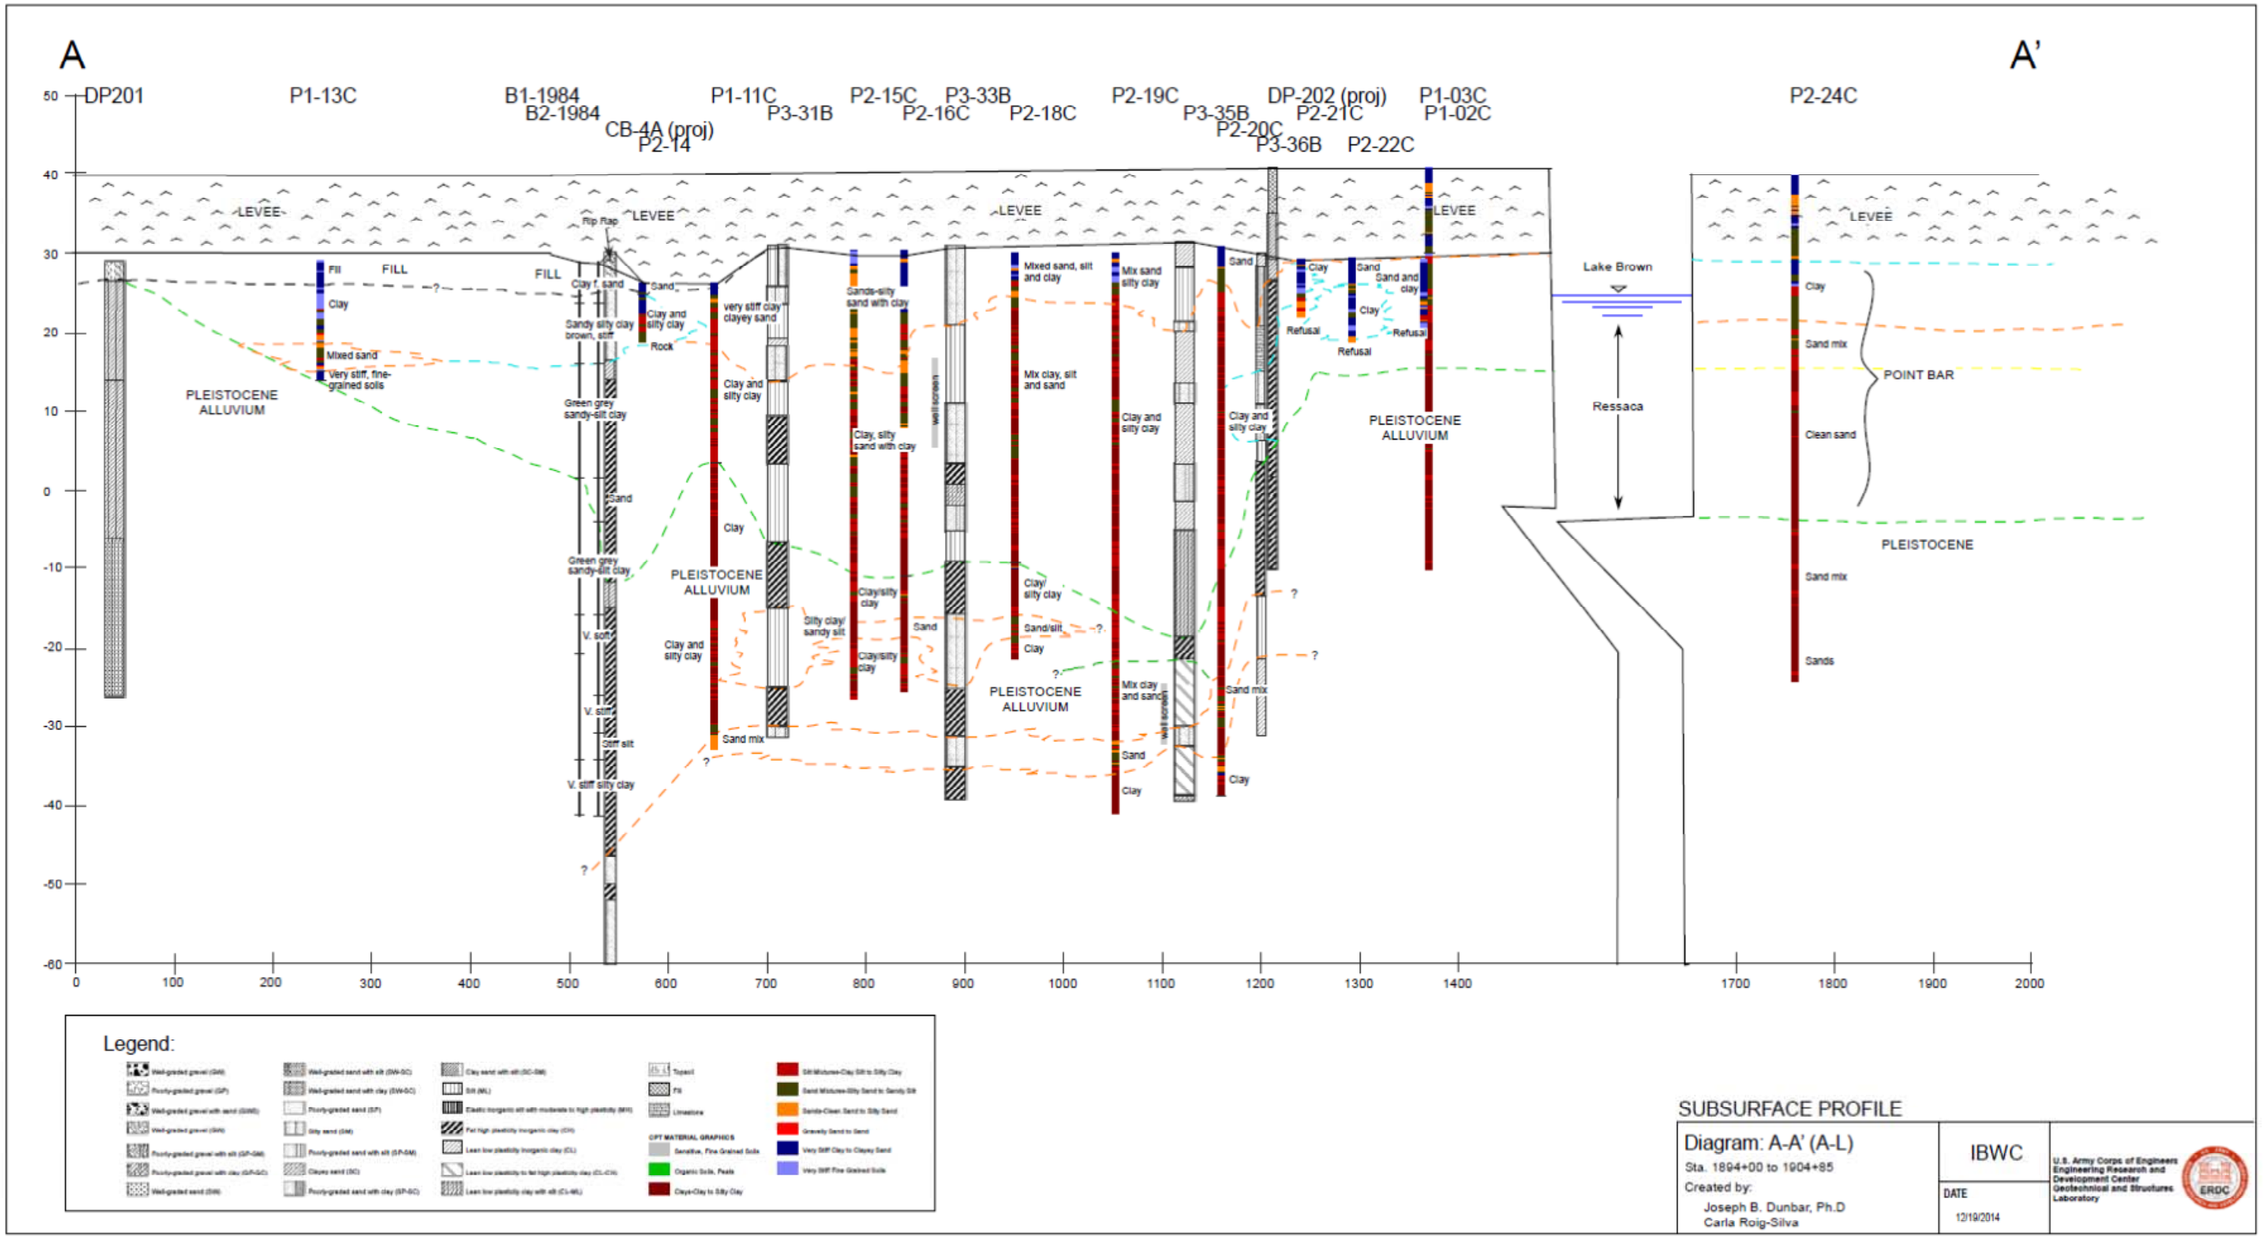
The Pleistocene surface is defined by the green-dashed line and is relatively shallow at boring DP-201 at elevation 26 ft. The contact deepens in the bend way of the river at the bridge pier borings (B1-1984, B2-1984, and CV-4A) where it ranges between 0- and -10-ft elevation. Through the failure reach, this surface varies between -10- and -20-ft elevation. Near boring P3-36B, the surface rises again to about 15-ft elevation. Downstream of the study area at CPT P2-24C the surface drops to the 0-ft elevation, which corresponds to maximum depth of fluvial scouring observed at the bridge by the bathymetry data.

Figure 5.5. Longitudinal geological cross section. This section extends from upstream of the bridge starting with the Raba-Kistner boring DP-201 to downstream of the study area at CPT P2-24C (see Figure 5.4).
