Riparian Habitat Restoration at Four Sites in New Mexico and Texas: Shalem Colony, Vinton A and B, and Title: Valley Creek Restoration Sites

Final Interim Annual Restoration Report Version: October 2017 to October 2018

Date: February 4, 2019

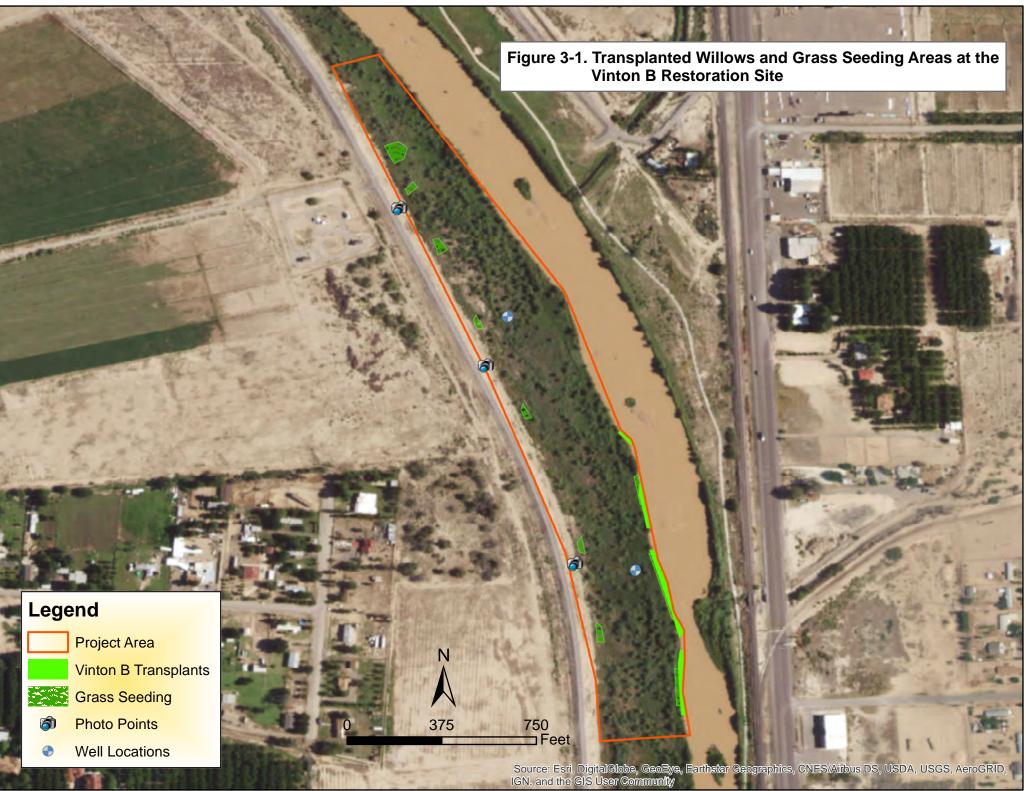
This 25-acre site on the west side of the river is a mixed-shrub habitat with scattered four-wing saltbush (*Atriplex canescens*) and rabbitbrush (*Chrysothamnus nauseosus*) in moderate abundance. Tall, dense patches of smooth pigweed (*Amaranthus powellii*) and screwbean mesquite are abundant through the site. Saltcedar dominated prior to restoration efforts. Siberian elms were found on the site as well as other non-native species such as fescue grass (*Festuca spp.*) and Russian thistle. The site has not been mowed since 2011. Approximately 1,561 of the recommended 3,000 coyote willows were transplanted along the bank at the Vinton B site and 0.6 acre of grass seeding was conducted (Figure 3-1). As of August, minimal saltcedar (less than 1 percent) remained at the Vinton B site and consisted of small re-growth sporadic individuals. August monitoring documented that large screwbean mesquite still occur in moderate

abundance throughout the site as well as milkweed (*Apocynaceae*) and *Solanum*. Several other forb species make up the 70 percent grass and forb vegetation cover on the site (Table 3-2). In October, non-native species such as Bermuda grass, camel thorn, and kochia dominated the cover. Salt grass (*Distichlis spicata*) cover at this site has increased and now is approximately 20 percent cover at the site and is thriving.

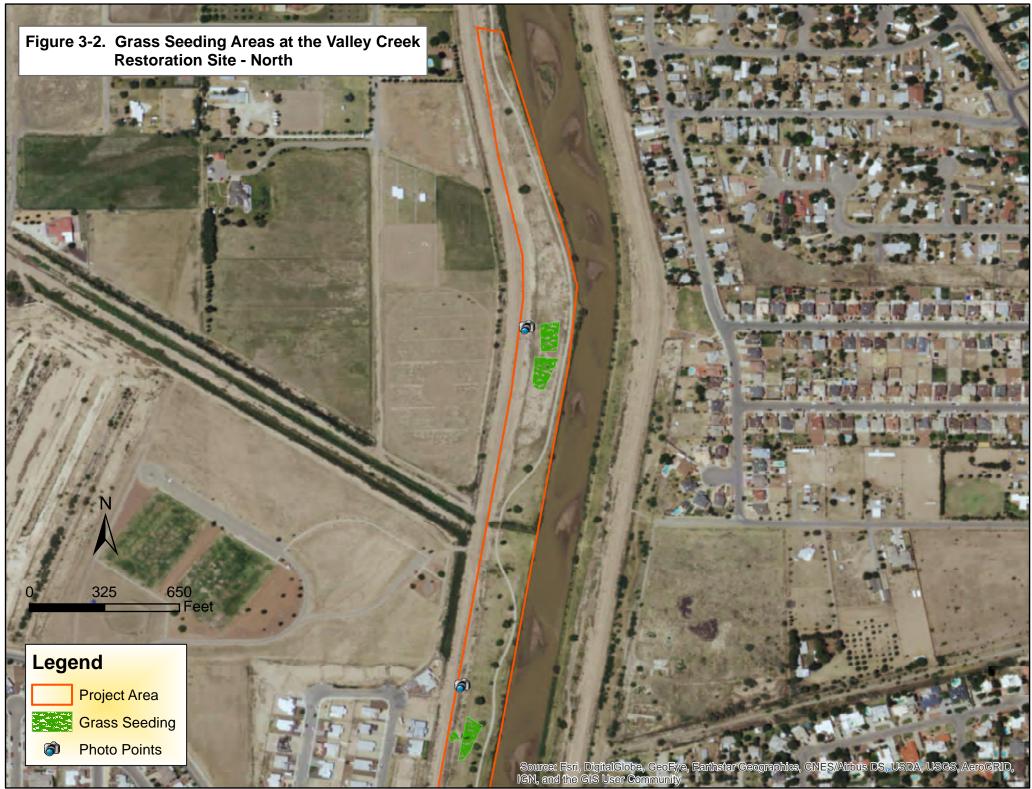
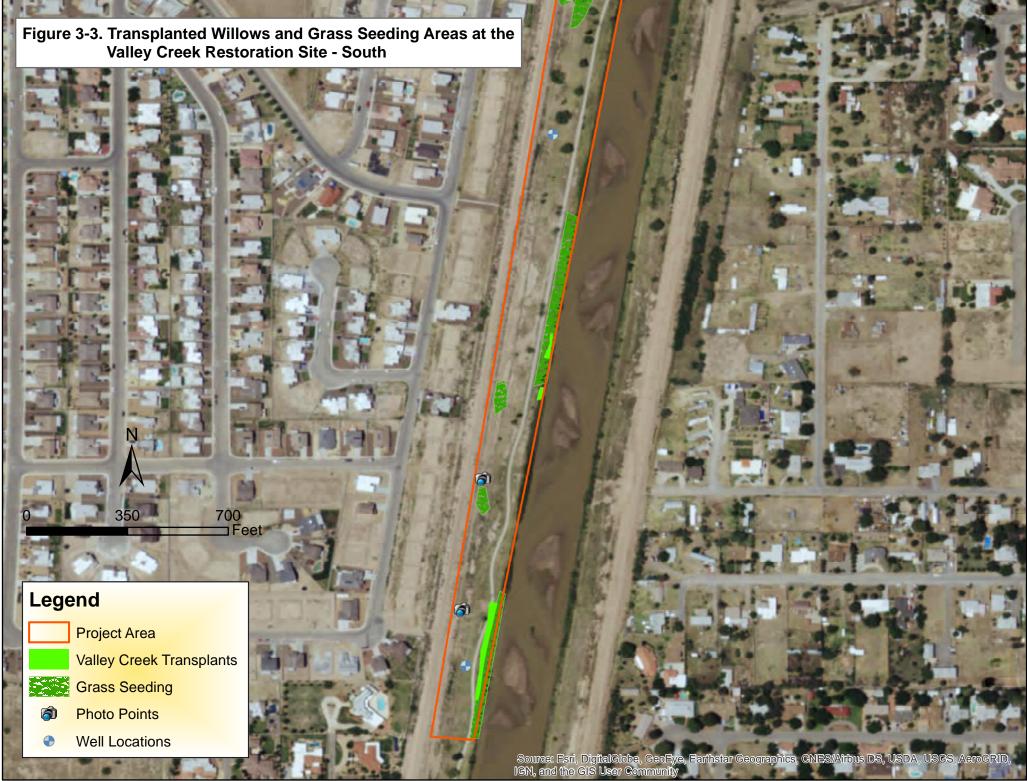
Cottonwood trees damaged by vandals at Valley Creek, 21 June 2018
