USIBWC PLANS MIDDLE RIO GRANDE STAKEHOLDER MEETINGS

AMISTAD DAM

CONSTRUCTION OF A COMPOSITE CUTOFF WALL TO REDUCE THE RISK OF FAILURE AT AMISTAD INTERNATIONAL DAM

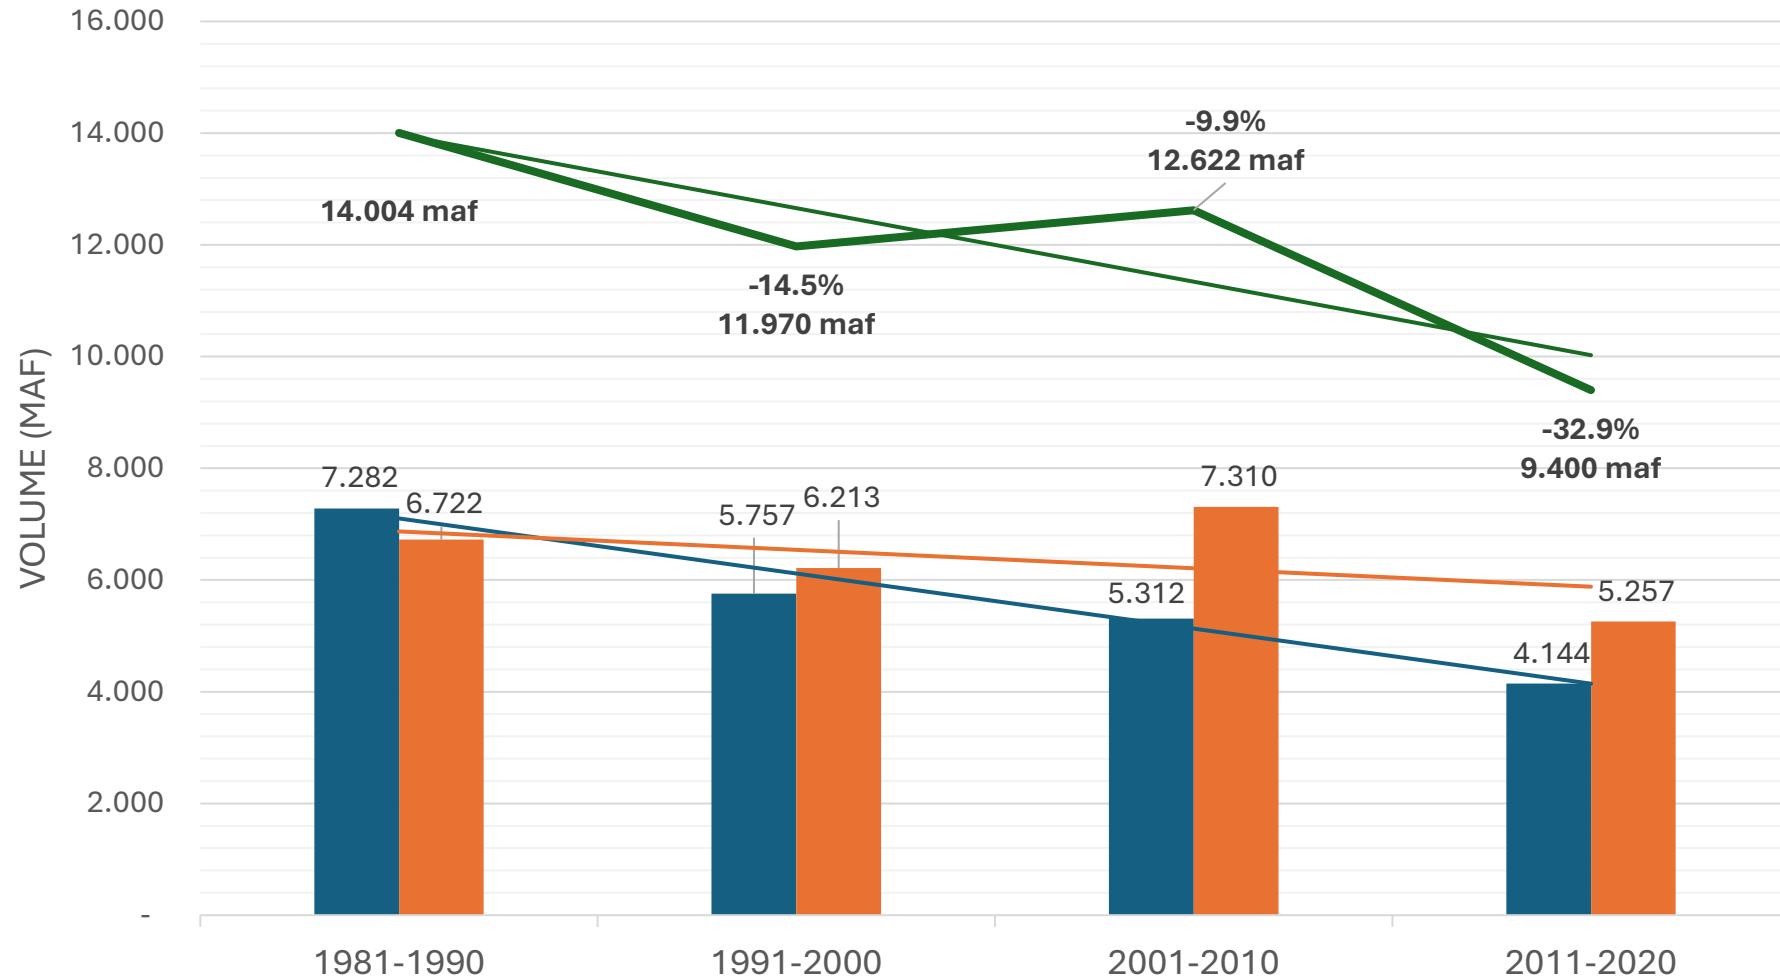
10-Year Volume Totals - U.S. Inflows into Amistad Reservoir (million ac-ft)

■ Total U.S. Mainstem+ Unmeasured Tribs. Inflows (maf)
 ■ Total Pecos+Devils+Springs Inflow (maf)
 — Total US Inflow (maf)

- Last 10 – Compared to 2000s
 - 3.2 maf less in Total U.S. Inflow
 - 2.1 maf less from U.S. Tribs. flowing into Amistad
 - 1.1 maf less from the Mainstem U.S. Inflows

- Last 10 - Compared to 1980s
 - 4.6 maf less in total U.S. Inflow
 - 1.5 maf less from U.S. Tribs. flowing into Amistad
 - 3.1 maf less from the Mainstem U.S. Inflows

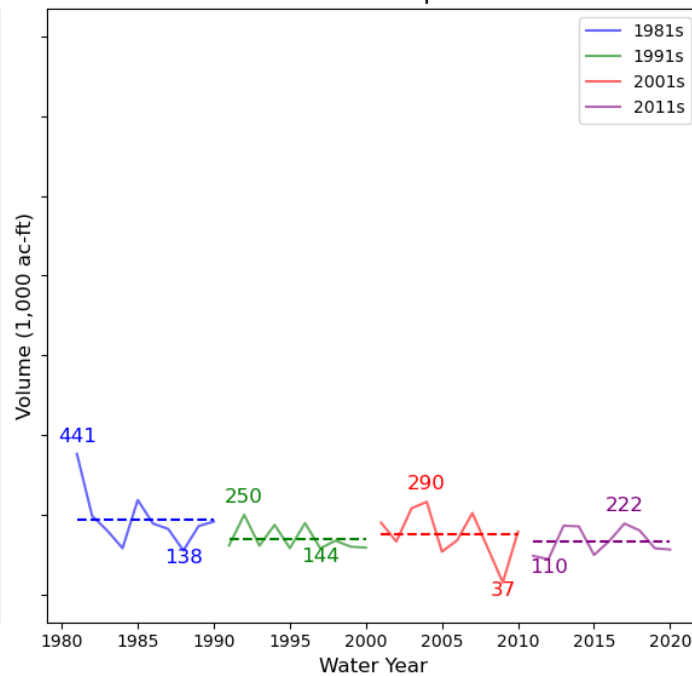
U.S. Unmeasured Tributaries Upstream of Falcon Dam

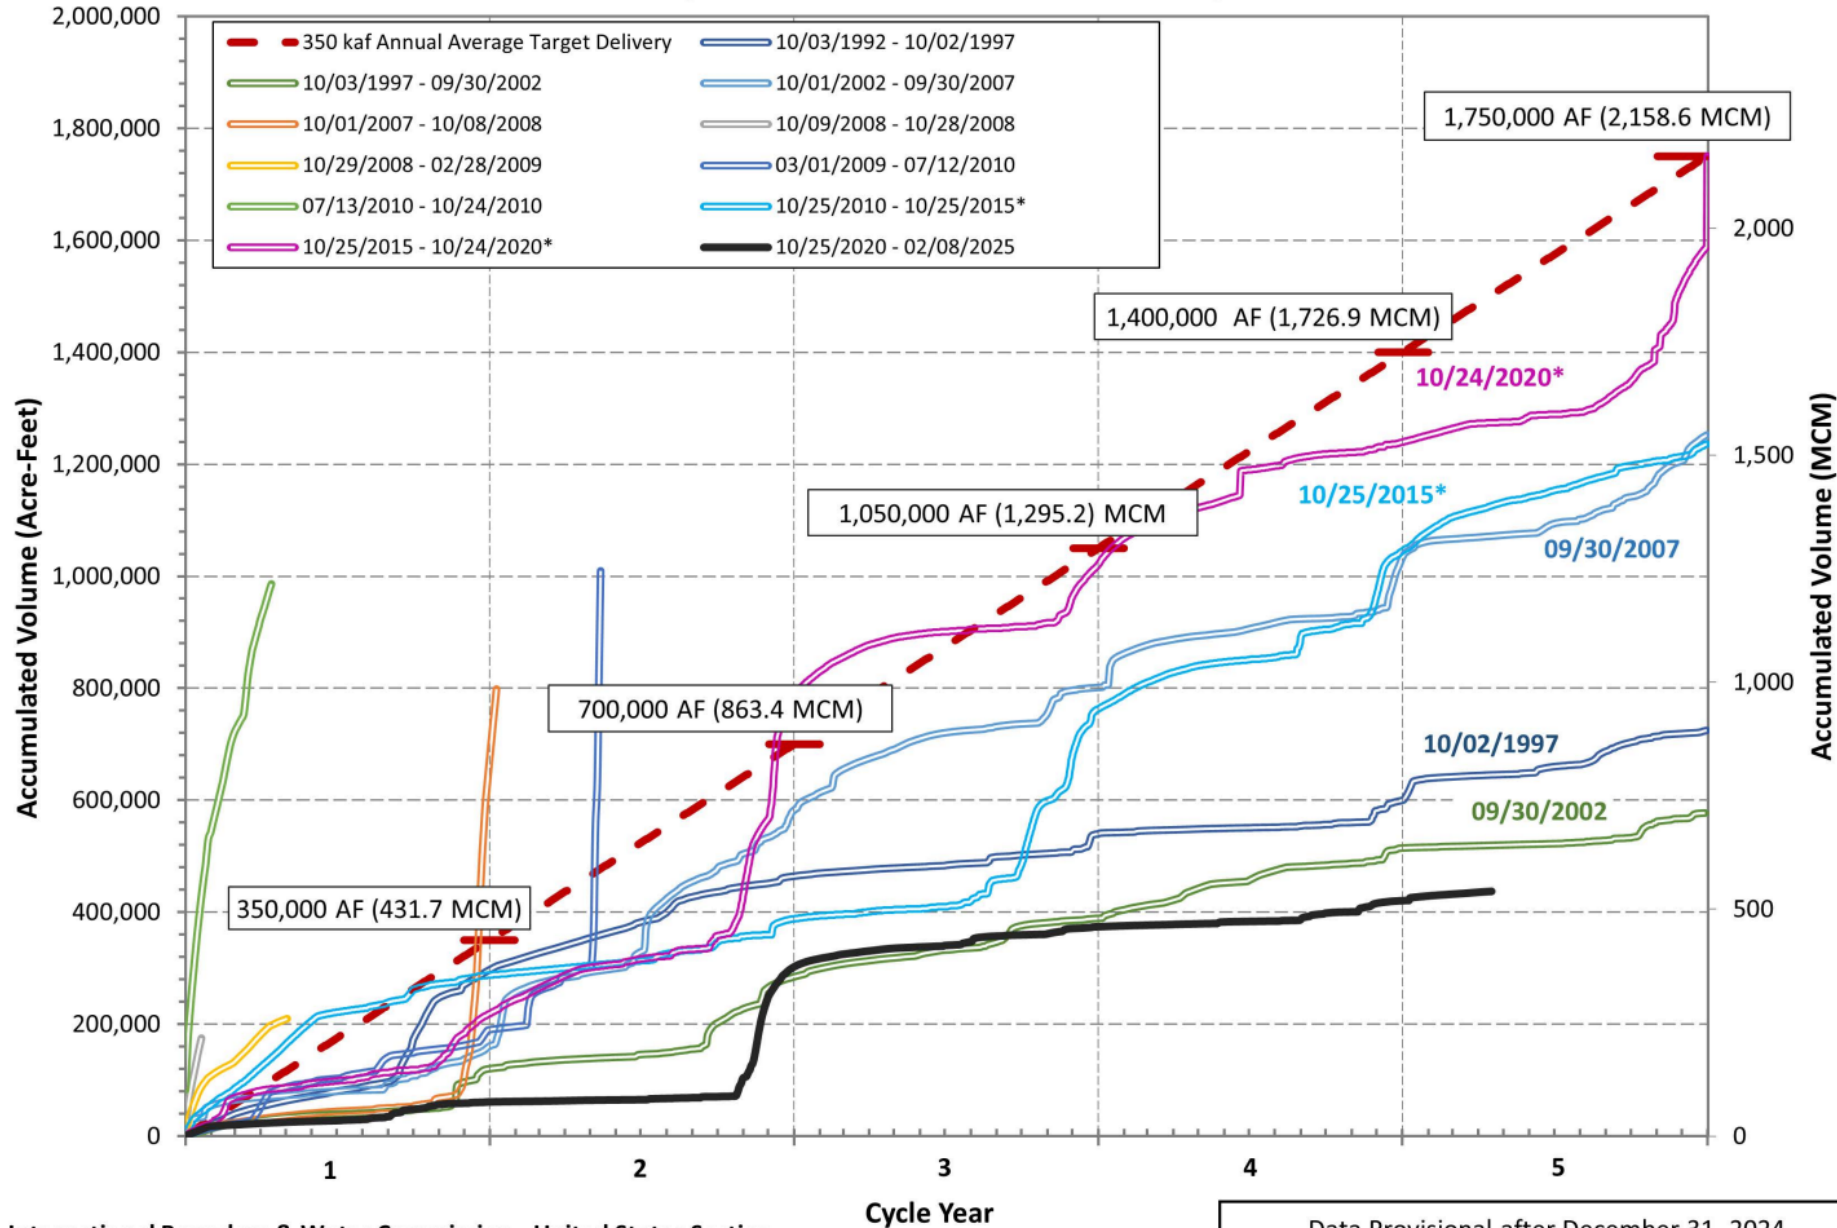
Rio Grande River Basin

Estimated Volumes Allotted to the United States by Mexico from Six Named Mexican Tributaries and Other Accepted Sources* under the 1944 Water Treaty

Current Cycle: October 25, 2020 thru February 8, 2025

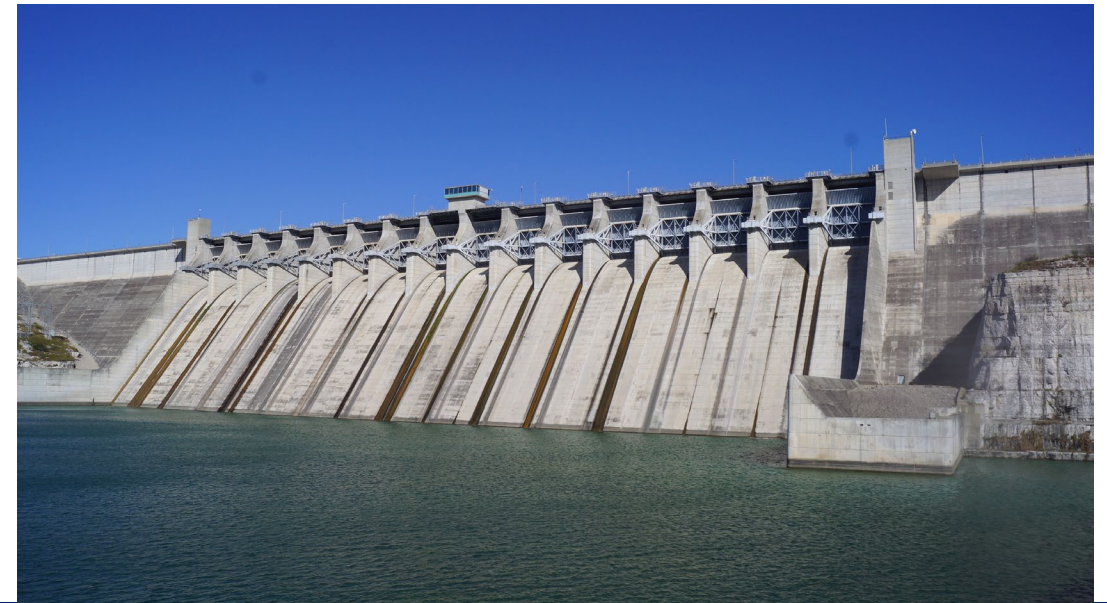
Amistad Dam Infrastructure

1. ***Power Plant (2 Generators)***
2. ***Dam Concrete Section & Control Building***
3. ***(4) Miles Dam Embankment***
4. ***(8) Radial (Tainter) Gates***
5. ***(8) Stoplogs at Radial Gates***
6. ***(5) Penstocks***
 - ***(4) Headgates (Roller Slide)***
 - ***(2) Irrigation Gates: 1 Hydraulic & 1 Roller Slide***
 - ***(1) Bulkhead Gate***
7. ***(5) Admin. & Warehouse Buildings***
8. ***(6) Gov.'t Rental Housing***
9. ***Water Storage Tank***
10. ***21 Hydrological Gauging Stations & 15 Wells***
11. ***(28) International Reservoir Buoy's***
12. ***(4) Demarcation Boundary Markers on Bridges***

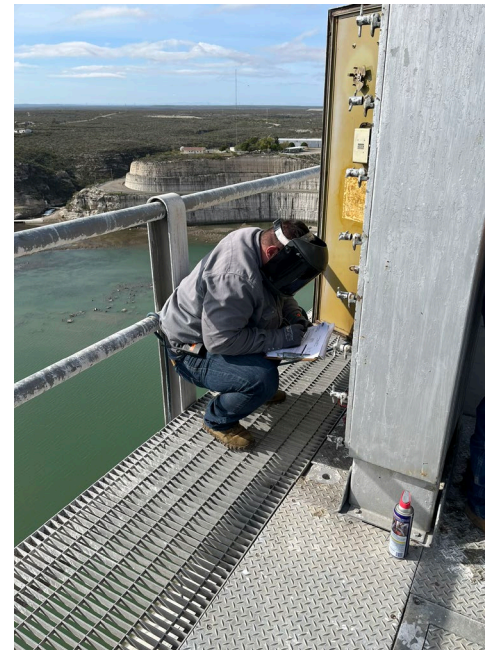
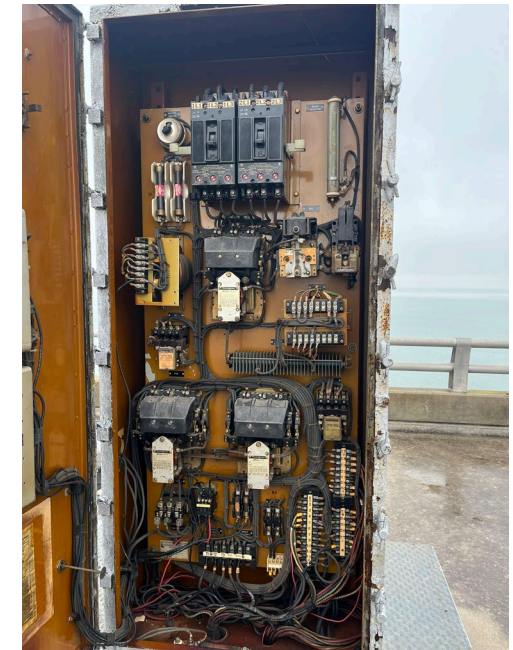
2025 Dam Capital Projects (Contractor)

1. Penstock 4 Concrete Plug
2. Penstock 5 Irrigation Gate Repair
3. Radial Gates Electrical Panel Upgrade

Priority	Work Type	Fiscal Year
1	Continue Treatment of New Sinkholes	FY24
1	Evaluation of New Sinkholes	FY24
1	Geophysical Study on New Sinkholes	FY24
2	Cutoff Wall Design	FY24
1	Penstock #4 Plugging	FY25
1	Penstock #5	FY25
3	Cutoff Wall Construction	FY25
3	Evaluation of the Gradation for the Material for Treating Sinkholes & Purchase more Material	FY28
4	New Bulkhead	FY28
6	Remove and Replace all 28 International Buoys	FY29
6	Remove Stilling Basin Debris from Crance Accident	FY29

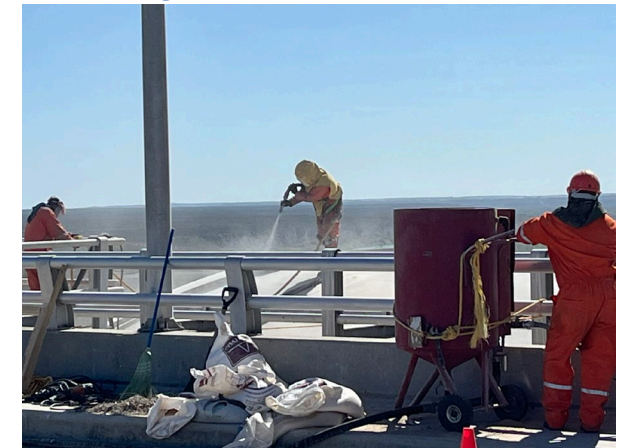
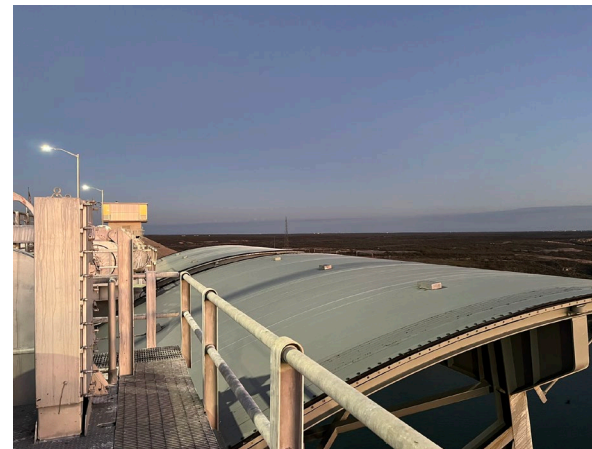
2025 Dam Deferred Maintenance Projects (Contractor)

1. Radial Gates Sandblast and Painting
2. Radial Gate Seal Replacements
3. Radial Gate Anode Replacements
4. Radial Gate Cable Tensioning

Priority	Work Type	Fiscal Year
1	Radial Gate Cable Tension	FY25
1	Radial Gate Trunnion Friction	FY25
2	Gate Sandblast & Repaint	FY25
4	Repair Concrete on Deck	FY27

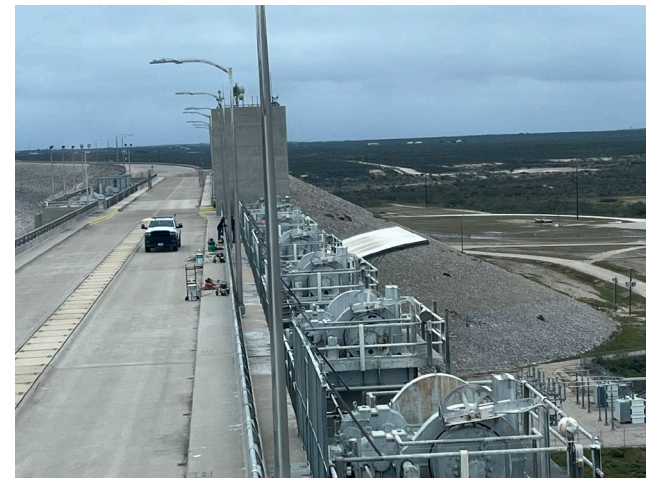
2025 Dam In-house Projects

1. Radial Gates Mechanical Hoistway Components Rehabilitation
2. Radial Gates Trunnion Pin Inspection and Lubrication
3. Radial Gates U-bolt Inspection and Lubrication
4. Continue with routine maintenance
5. Continue with roadwork and vegetation removal at hydro gauging stations.
6. Continue with buoy maintenance
7. Continue with boundary demarcation markers maintenance.

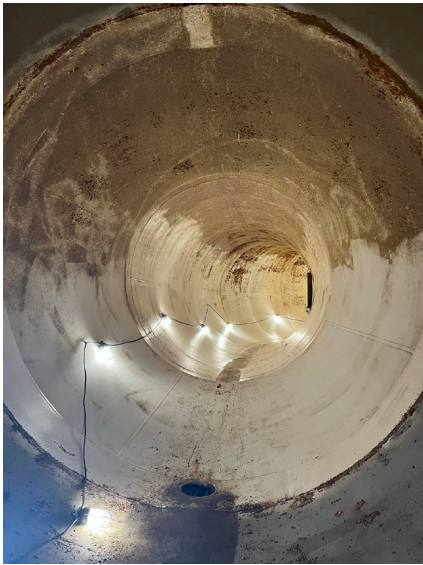
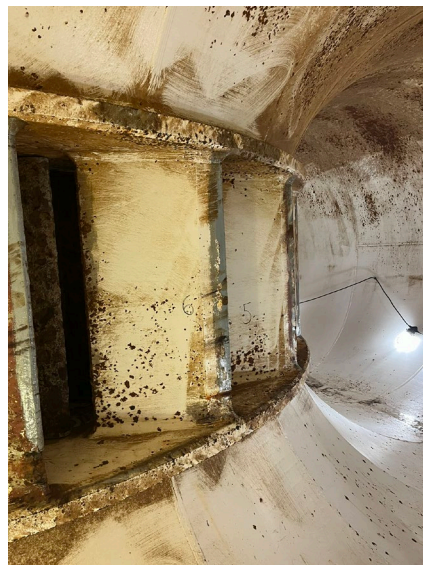
2025 Powerplant Capital Projects

1. Sandblast and repaint Runner Cone and Wicket Gate Seal Replacement for Generator #2.

- **Ongoing rehabilitation of the Power Plant, to include sandblasting, epoxy repairs, and painting of the wicket gates, spiral case, draft tube, and the runner cone on Generator #1. Replacement of the wicket gate seals on Generator #1 will also be completed, followed by Generator #2.**

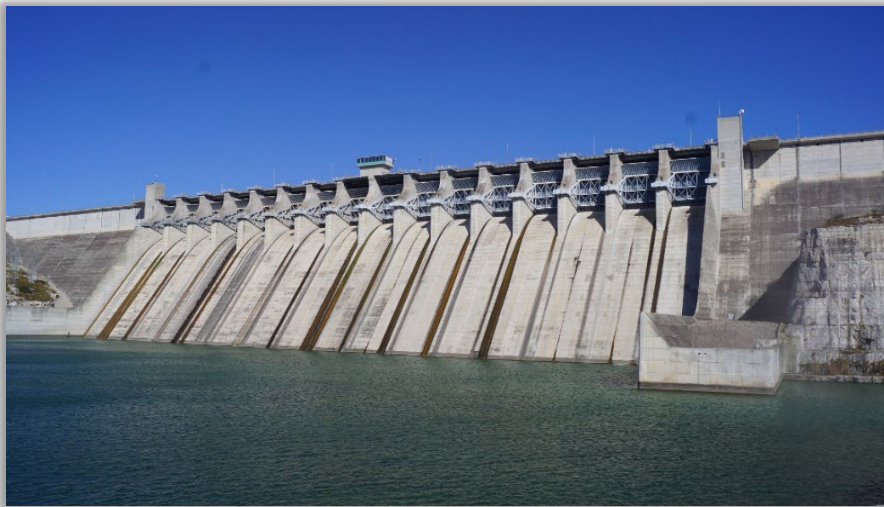
**AMISTAD DAM
DEL RIO, TEXAS**

DSAC II Very High Urgency

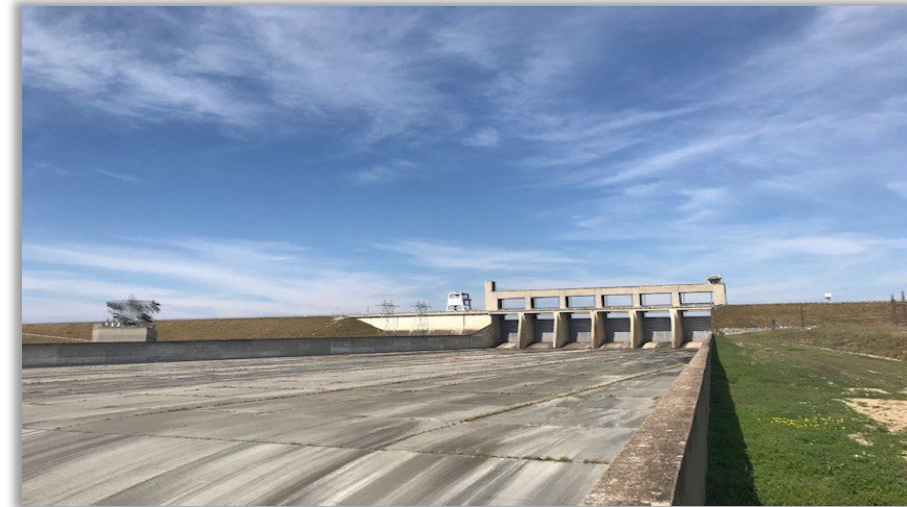
**FALCON DAM
FALCON HEIGHTS, TEXAS**

DSAC III Moderate Urgency

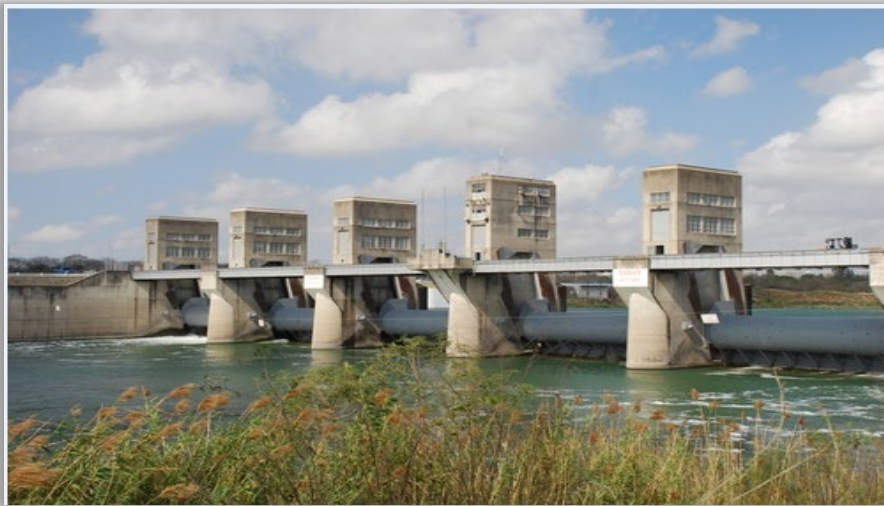
ANZALDUAS DAM
HIDALGO COUNTY, TEXAS
DSAC IV Low Urgency

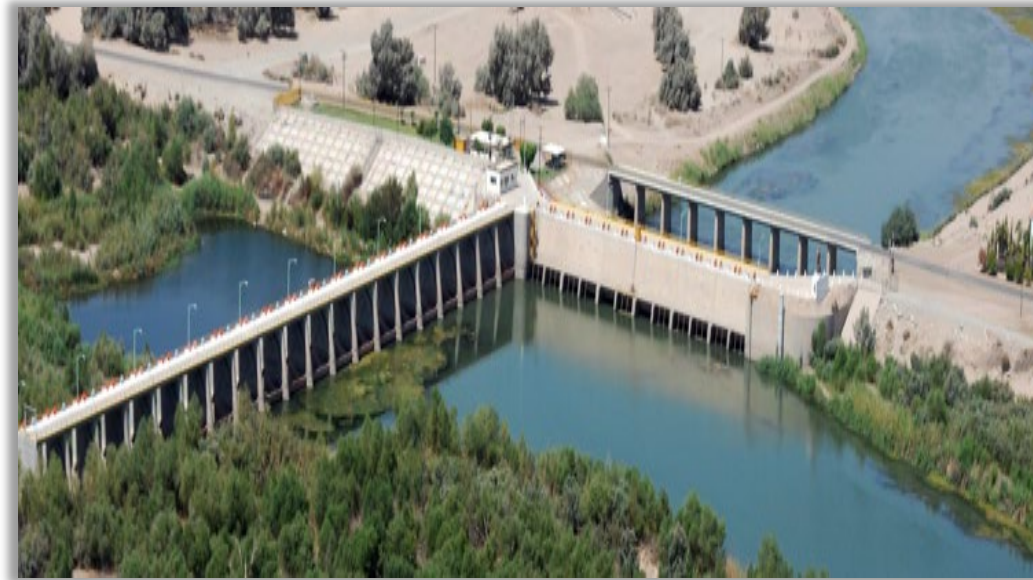
IBWC DAMS – MEXICO'S MORELOS DAM DIVERSION DAM

MORELOS DAM
ALGODONES, BAJA CALIFORNIA
MEXICO
DSAC III Moderate Urgency

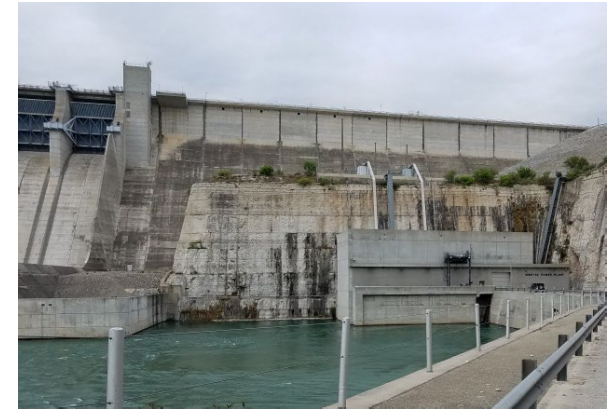
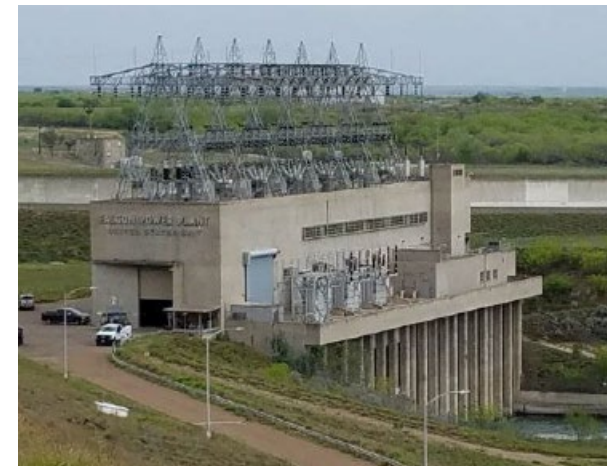
IBWC HYDROELECTRIC POWER PLANTS

- **Amistad Dam**
 - Completed in 1983
 - Located in Val Verde County, Texas
 - Two – 33 MW Francis Turbine Generator Units
 - Condition is Good Overall (USACE)
- **Falcon Dam**
 - First Commercial Generated Power in 1954
 - Located in Starr County, Texas
 - Three – 10.5 MW Francis Turbine Generator Units
 - Condition is Fairly Good Overall (USACE)

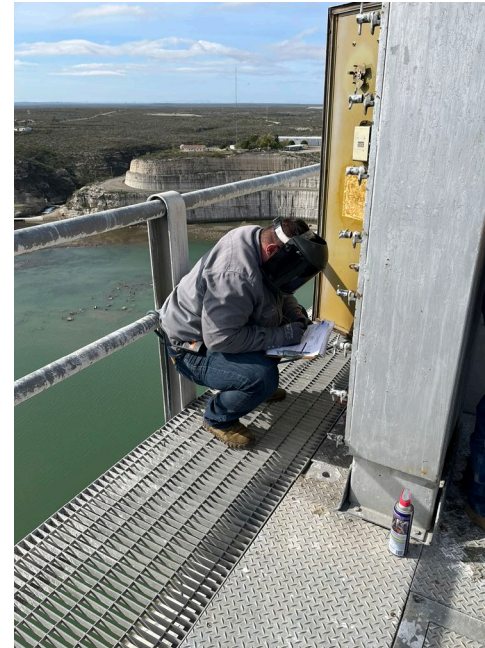
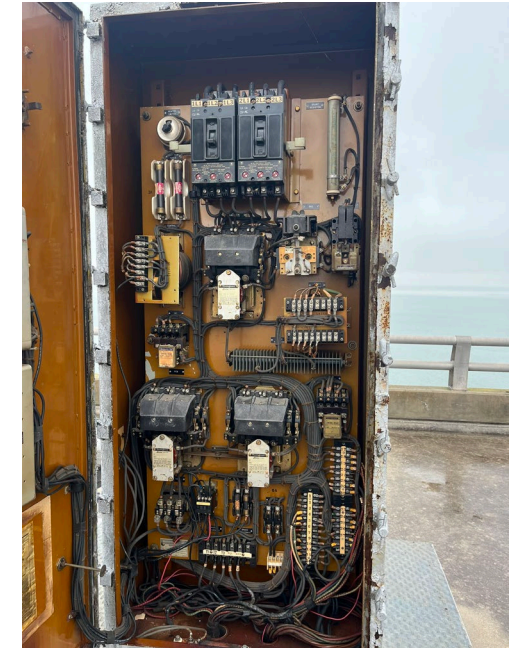
2025 Dam Capital Projects (Contractor)

1. Penstock 4 Concrete Plug
2. Penstock 5 Irrigation Gate Repair
3. Radial Gates Electrical Panel Upgrade

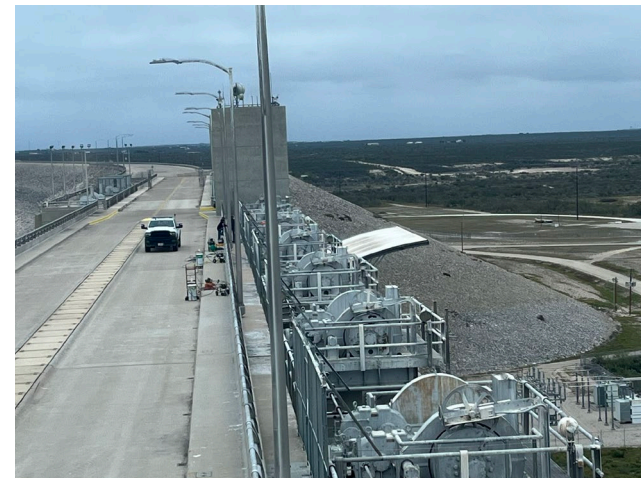
2025 Dam In-house Projects

1. Radial Gates Mechanical Hoistway Components Rehabilitation
2. Radial Gates Trunnion Pin Inspection and Lubrication
3. Radial Gates U-bolt Inspection and Lubrication
4. Continue with routine maintenance
5. Continue with roadwork and vegetation removal at hydro gauging stations.
6. Continue with buoy maintenance
7. Continue with boundary demarcation markers maintenance.

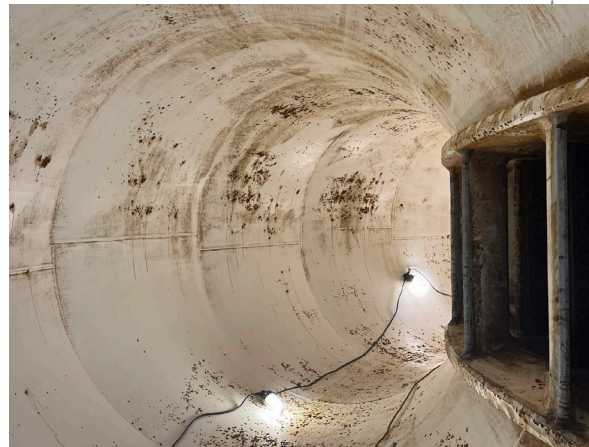
2025 Powerplant Capital Projects

1. Sandblast and repaint Runner Cone and Wicket Gate Seal Replacement for Generator #2.

- **Ongoing rehabilitation of the Power Plant, to include sandblasting, epoxy repairs, and painting of the wicket gates, spiral case, draft tube, and the runner cone on Generator #1. Replacement of the wicket gate seals on Generator #1 will also be completed, followed by Generator #2.**
