**Channel Maintenance Alternatives and
Sediment-transport Studies for the
Rio Grande Canalization Project:
Final Report**

**Statement of Work and Statement of Work Addendum for Channel Maintenance Alternatives
and Sediment-transport Studies for the Rio Grande Canalization Project**

October 20, 2015
Contract No. IBM09D0006
Order No. IBM14T0016

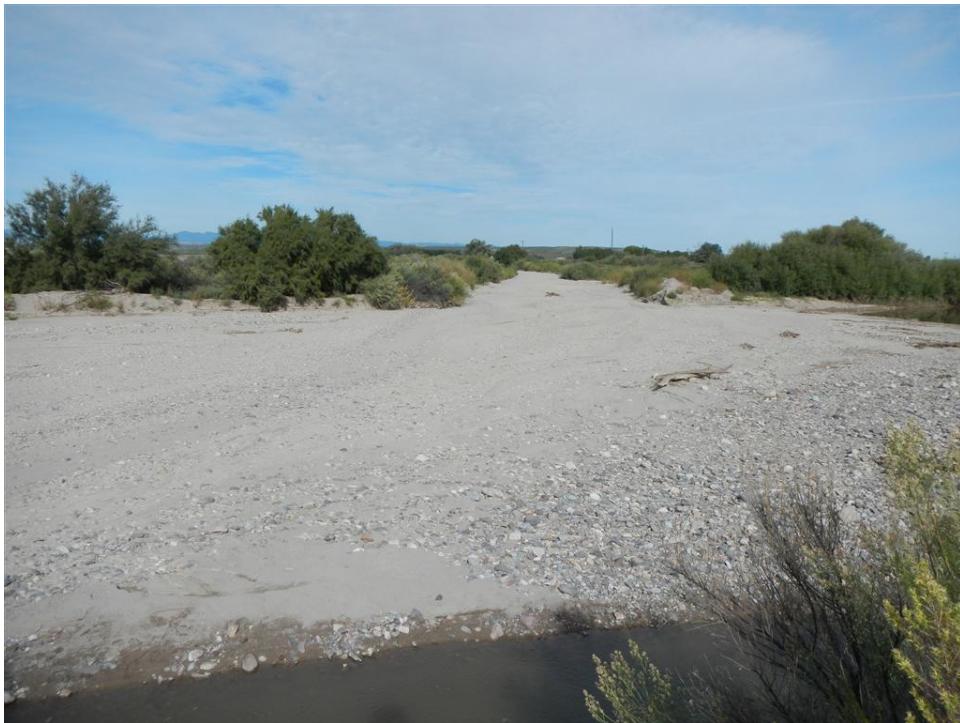
This problem location experiences sediment loading from 3 significant tributaries. Tierra Blanca Creek and Sibley Arroyo are west side tributaries and Green Arroyo is an east side tributary with its mouth adjacent to the mouth of Tierra Blanca Creek. During recent monsoon season tributary flow events (i.e., 2006 and 2013), Tierra Blanca Creek and Sibley Arroyo delivered significant quantities of sediment to the RGCP (**Photos A.3 and A.4**). The damage to the existing bank protection on the east (left) bank of the river opposite the Tierra Blanca fan has not been repaired, and no sediment has been removed from the fan (**Photos A.3 and A.5**). The bank erosion along the left bank that is being caused by the Sibley Arroyo fan is not as significant (**Photo A.6**). The fans for both of these tributaries results in significant backwater effects in the upstream reaches (**Photos A.7 and A.8**). The NRCS flood control and sediment detention dam on Green Arroyo has significantly reduced the amount of sediment delivered to the RGCP (**Photo A.9**). The USIBWC has not performed any channel maintenance activities at this location since 2007.

Photo A.3. View across the Tierra Blanca Creek fan to the mouth of the tributary.

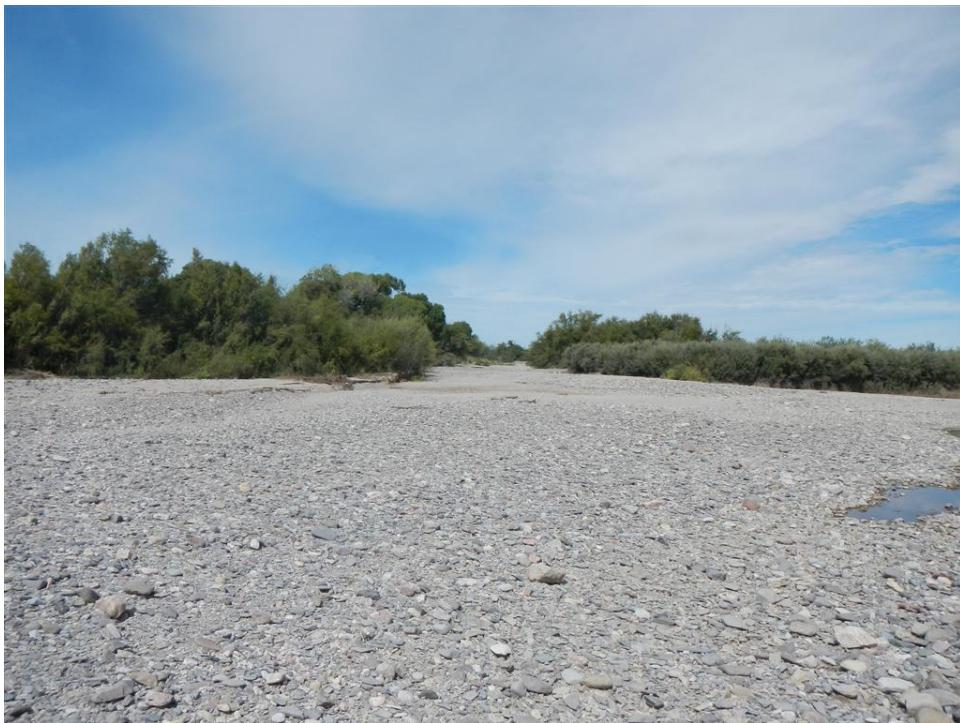
Photo A.4. View across the Sibley Arroyo fan surface to the mouth of the tributary.

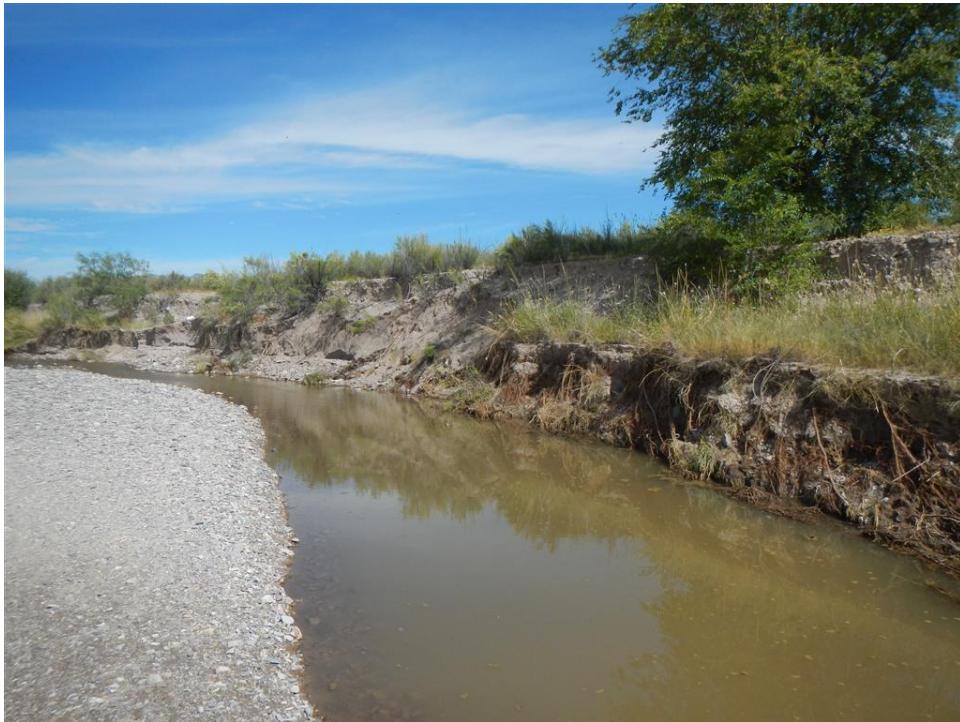
Photo A.6. View upstream along the eroding left (east) bank opposite the Sibley Arroyo fan.

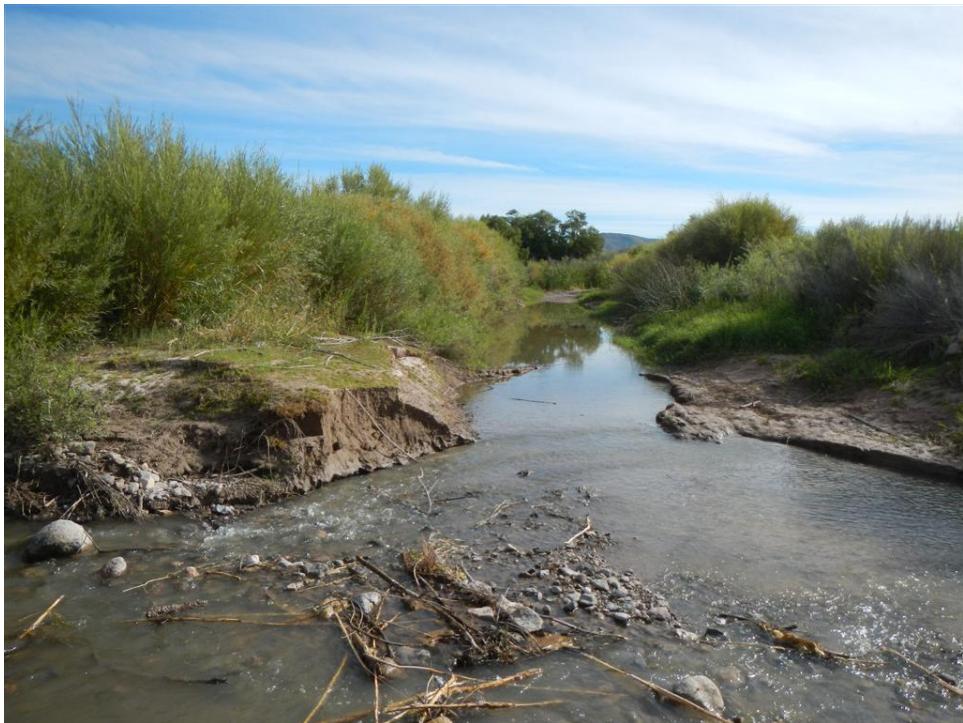
Photo A.9. View upstream to the mouth of Green Arroyo. The coarser material in the foreground is sediments delivered by Tierra Blanca Creek.

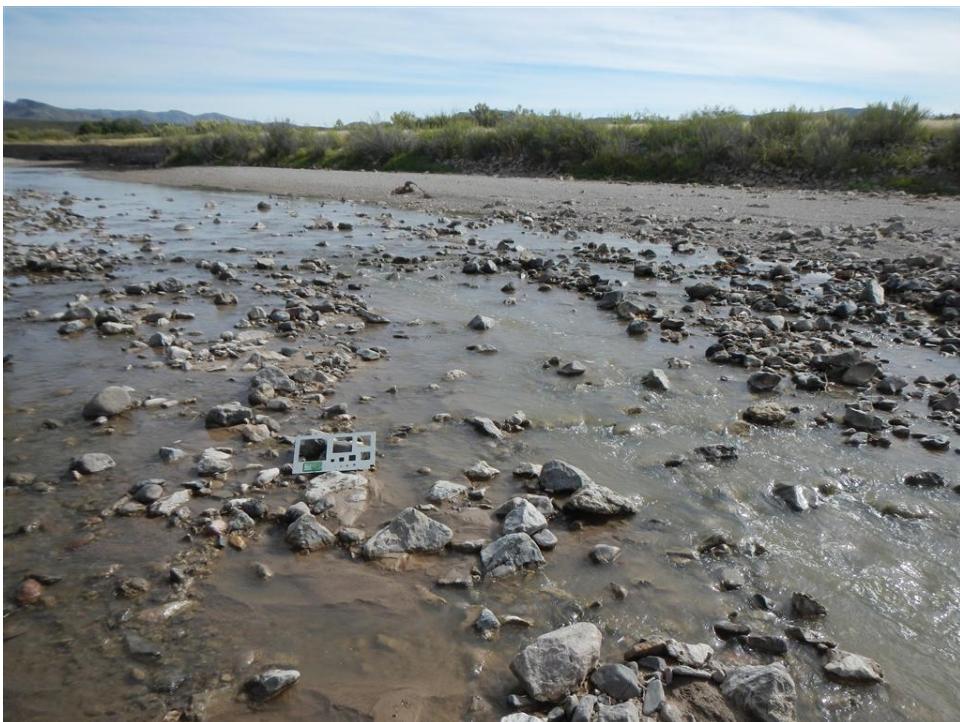
Five sediment samples were collected in the vicinity of Problem Location 1. Pebble Count PC1 represents the fan-derived armor material along the bed of the Rio Grande and was collected from the riffle that has formed along the downstream fringe of the Tierra Blanca Creek fan (**Photo A.10**) and has a median grain size (D_{50}) of about 34 mm (**Figure 3.2**). Bulk Sample S1 ($D_{50} = 2.1$ mm; **Figure 3.3**; **Photo A.11**) was collected from the subsurface materials in the vicinity of Pebble Count PC1 and includes about 50 percent gravel. Pebble Count PC2 was collected from the distal portion of the Sibley Arroyo fan (**Photo A.12**) and has a D_{50} of about 42 mm. Bulk Sample S2 ($D_{50} = 1.8$ mm; **Figure 3.2**; **Photo A.13**) was collected from the subsurface materials in the vicinity of Pebble Count PC2 and has a gradation that is very similar to that of Sample S1. Bulk Sample S3 ($D_{50} = 6.9$ mm; **Figure 3.2**; **Photo A.14**) was collected from the channel bed upstream from the backwater effects of the Tierra Blanca Creek fan about 2,000 feet upstream from the Garfield (New Mexico Highway 187) Bridge after first removing about 2 inches of muddy deposits, and is representative of the upstream sediment supply to the Problem Location 1 reach.

Photo A.10. View of riffle material representative of sediments delivered by Tierra Blanca Creek that was sampled in Pebble Count PC1.

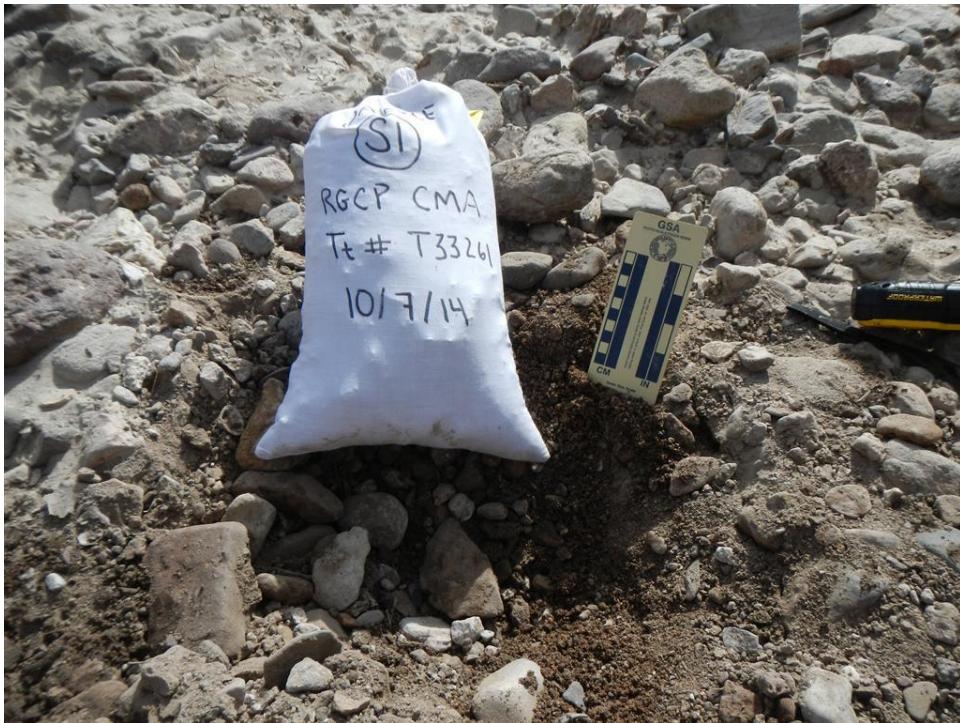
Photo A.11. View of material sampled in subsurface Sample S1 located near the riffle at Pebble Count PC1.

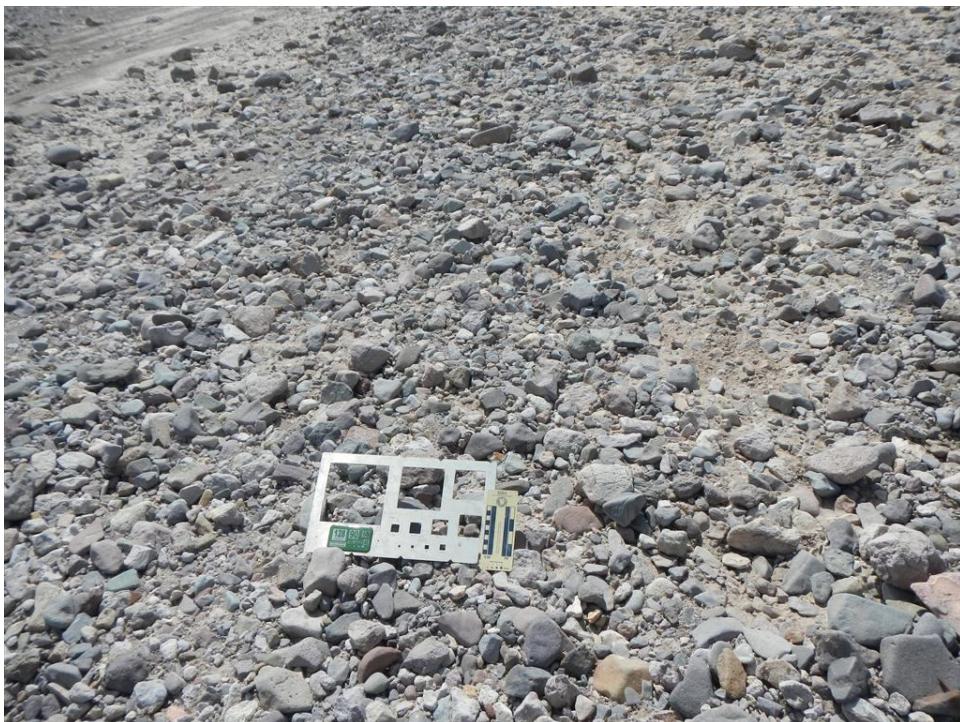
Photo A.12. View of surficial fan material representative of sediments delivered by Sibley Arroyo that was sampled in Pebble Count PC2.

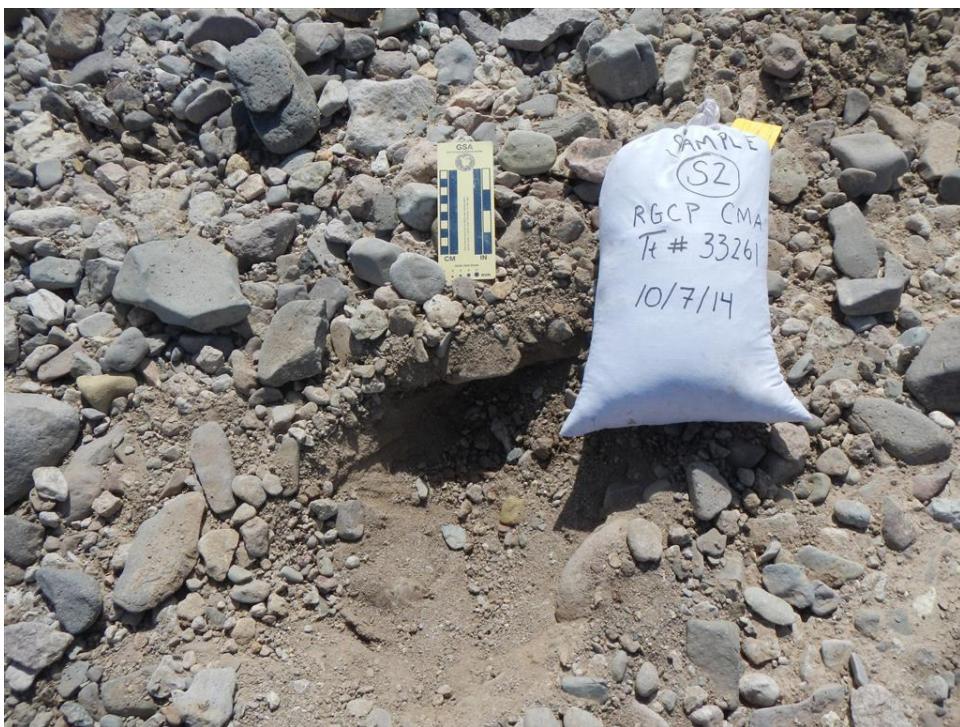
Photo A.13. View of material sampled in the subsurface Sample S2.

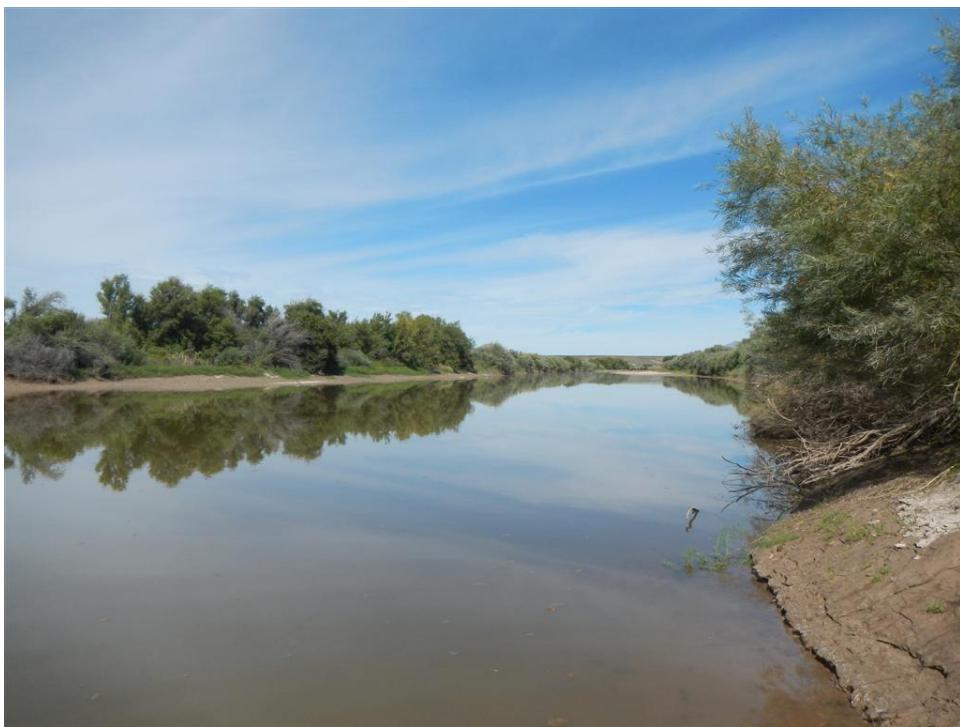
Photo A.14. View upstream to the reach near the upstream limit of the backwater effects from the Tierra Blanca Creek fan in the vicinity of Sample S3 that represents the upstream sediment supply to the Problem Location 1 reach.

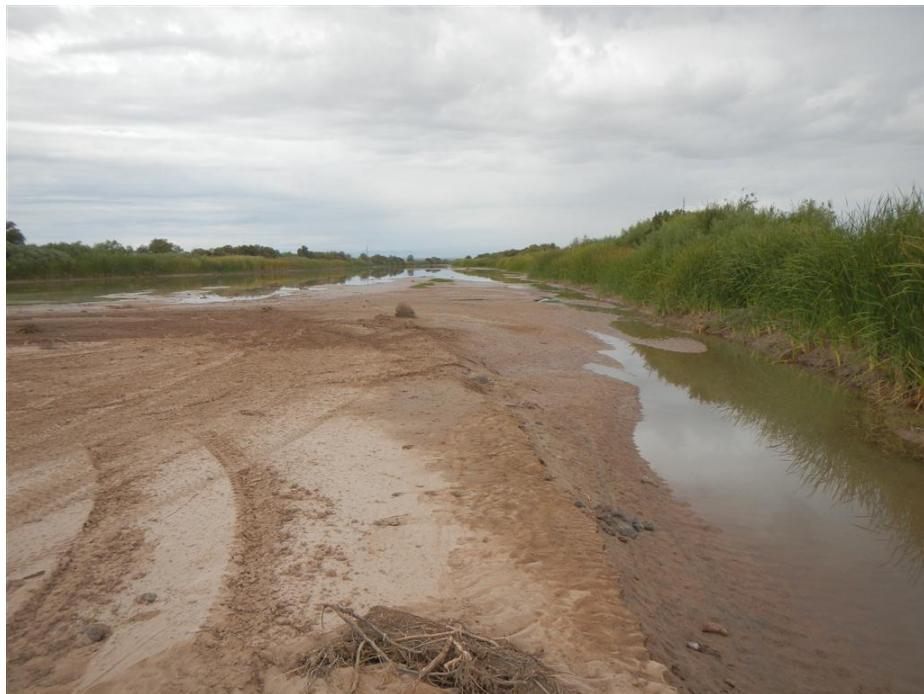
Photo A.18. View along upstream portion of the Placitas Arroyo fan to the zone of backwater effects.

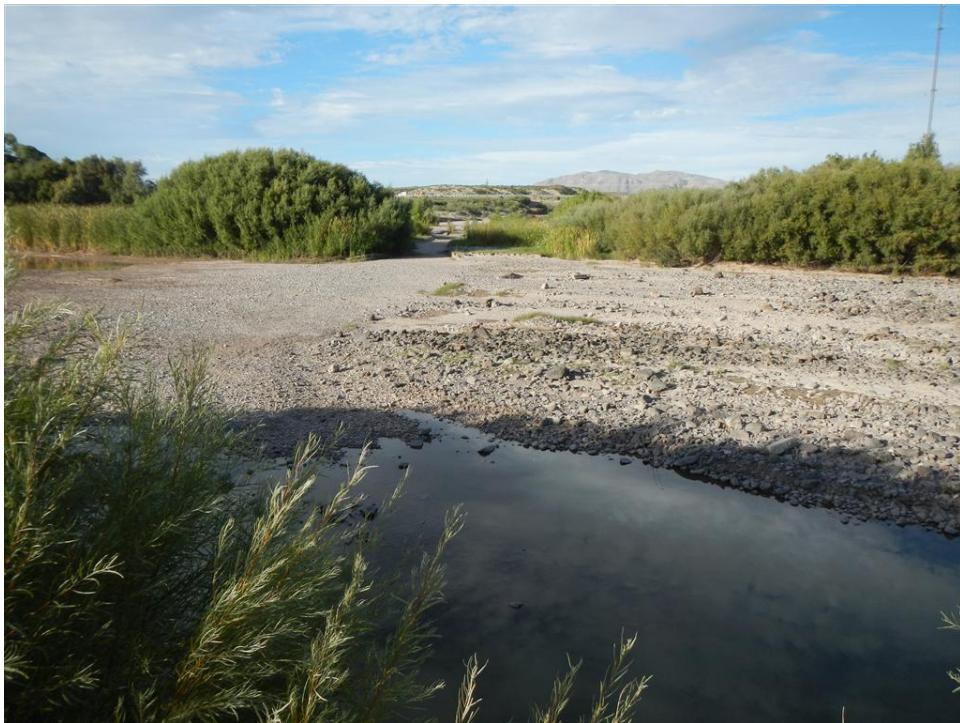
In addition to the west side draining Placitas Arroyo, two east side draining tributaries (Thurman I Arroyo at Sta 4524+00 and Thurman II Arroyo at Sta 4541+00) enter the RGCP on the north (left) bank. During recent monsoon season tributary flow events (i.e., 2006 and 2013), each of these tributaries delivered significant quantities of sediment to the RGCP, and appear to have delivered additional sediment since that time (**Photos A.19 and A.20**). After the 2006 events, USIBWC removed sediment from the river, reconstructed the opposite bank and excavated the mouth of the Thurman I Arroyo, but there does not appear to have been any work undertaken since that time. Evidence of bank protection along the right bank opposite Thurman II Arroyo suggests that similar activities were undertaken at this tributary (**Photo A.21**). Islands have formed along the downstream portions of both of the Thurman Arroyo fans, along with numerous other islands and vegetated bars along the reach.

Photo A.19. View across Thurman I Arroyo fan to the mouth of the tributary.

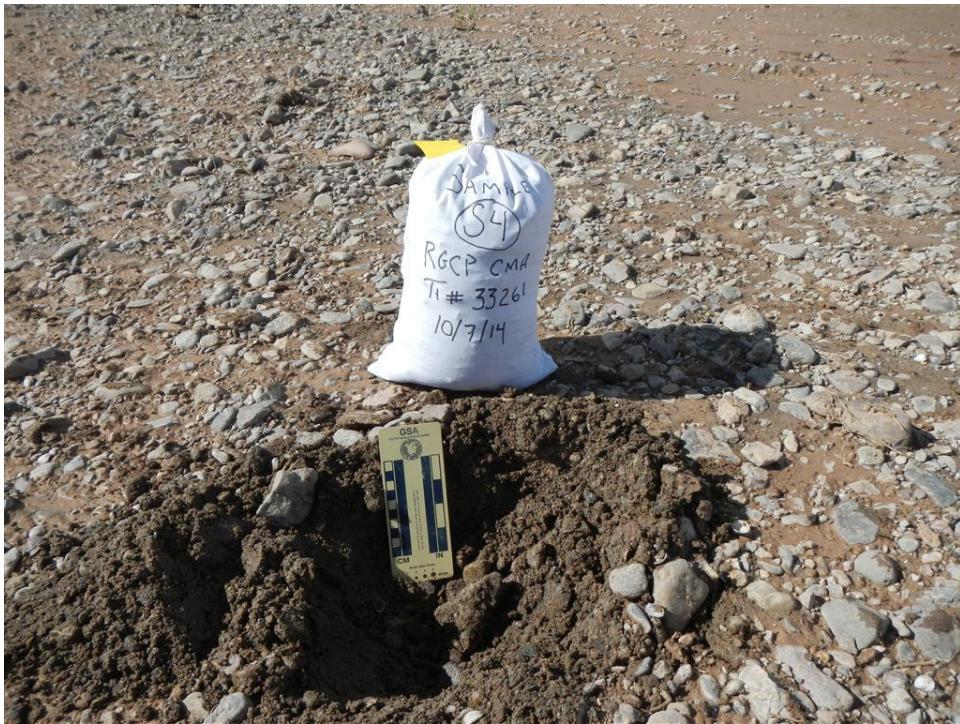
Two bulk samples were collected from the Problem Location 2 reach, including Bulk Sample S4 of the channel bed material near the Salem Bridge (New Mexico Highway 391) that represents the sediment supply to the reach ($D_{50} = 5.0$ mm; Figure 3.2; **Photo A.22**) and Bulk Sample S5 ($D_{50} = 5.0$ mm; Figure 3.2) of the channel bed material near the upstream limit of the backwater effects from Placitas Arroyo (**Photo A.23**). Pebble counts of the coarser material delivered by the tributaries included Pebble Count PC3 that was taken from the surface of the Thurman I Arroyo fan (**Photo A.24**) and Pebble Count PC4 that was taken from a riffle at the downstream fringe of the Placitas Arroyo fan (**Photo A.25**).

Photo A.22. View of material collected in Bulk Sample S4 near the Salem Bridge.

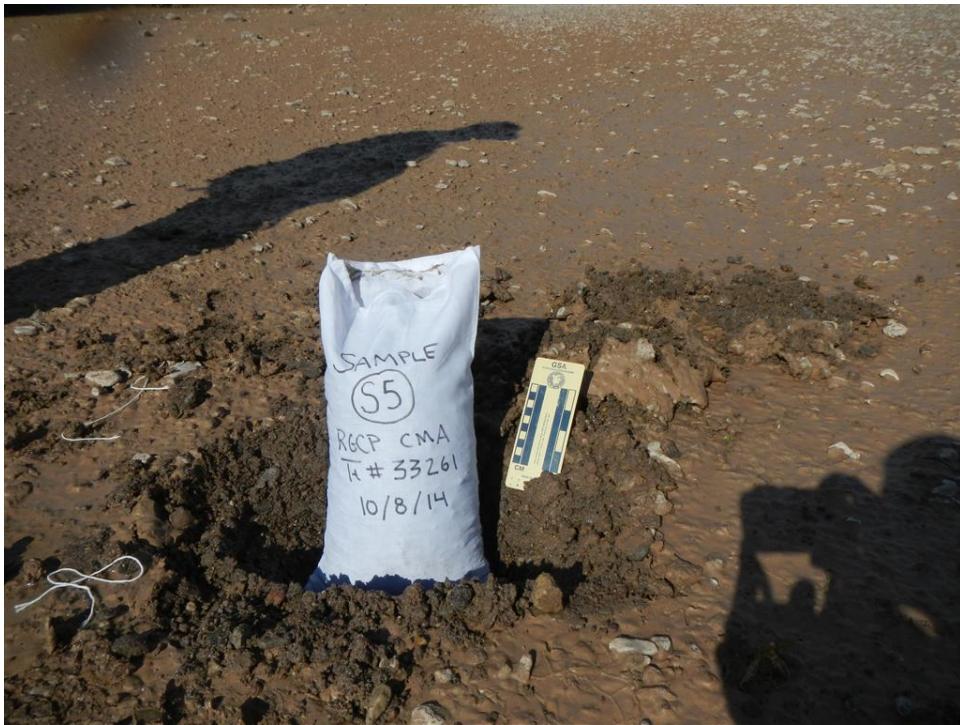
Photo A.23. View of material collected in Bulk Sample S5 upstream from the Salem Bridge.

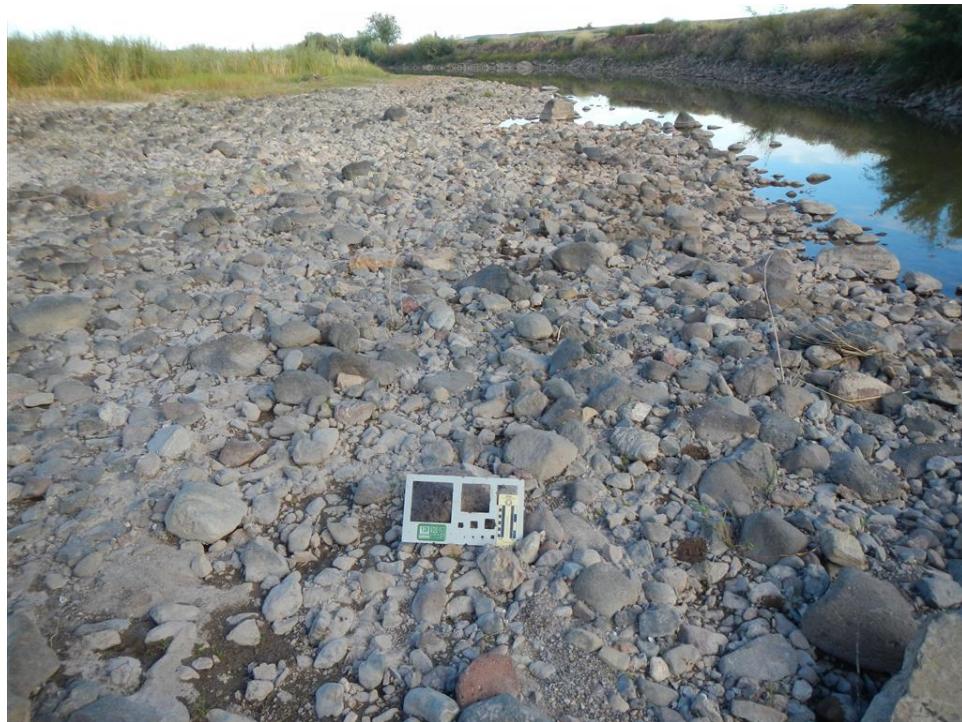
Photo A.24. View of material along the Thurman I Arroyo fan surface that was sampled in Pebble Count PC3.

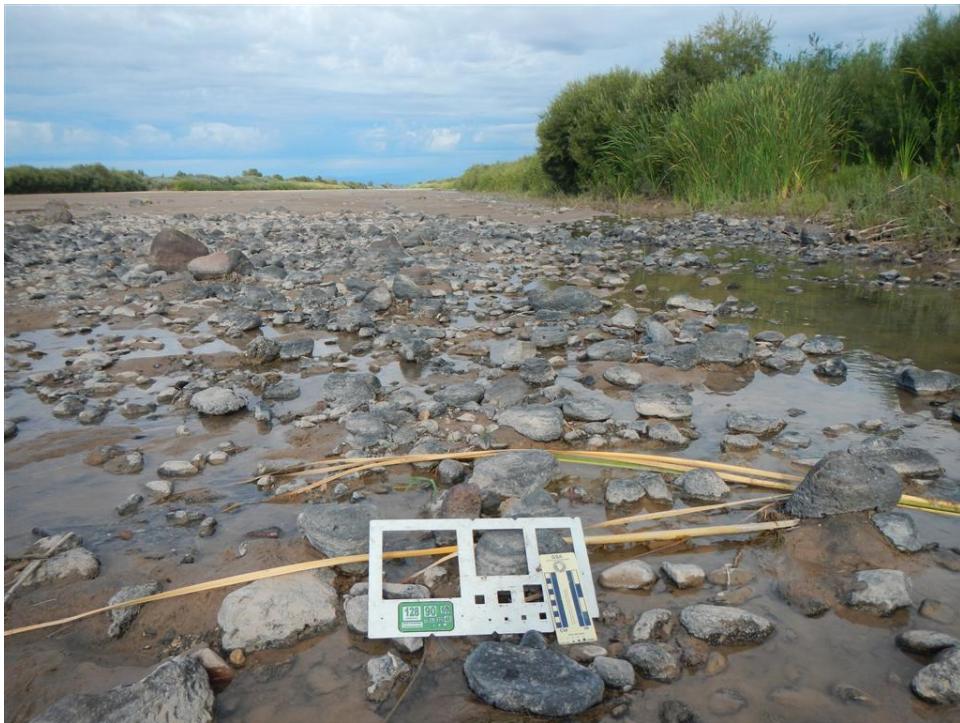
Photo A.25. View upstream of material in riffle along the distal portion of the Placitas Arroyo fan that was sampled in Pebble Count PC4.

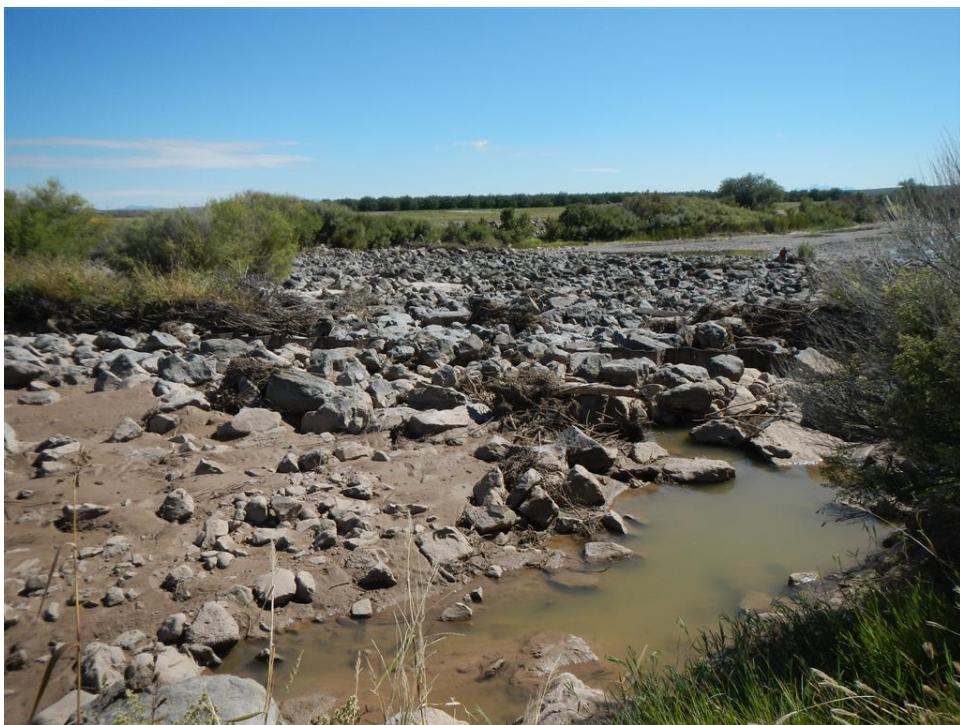
Photo A.28. View downstream along the rock riprap and sheetpile grade control structure for the Rincon Siphon.

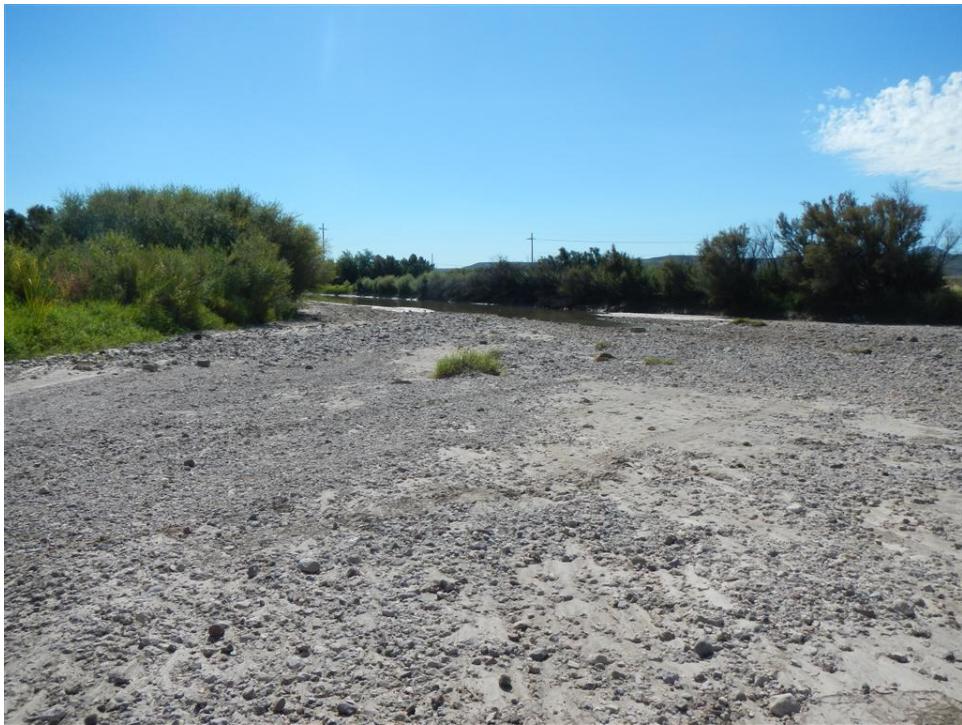
Photo A.29. View downstream along the Garcia Arroyo fan surface.

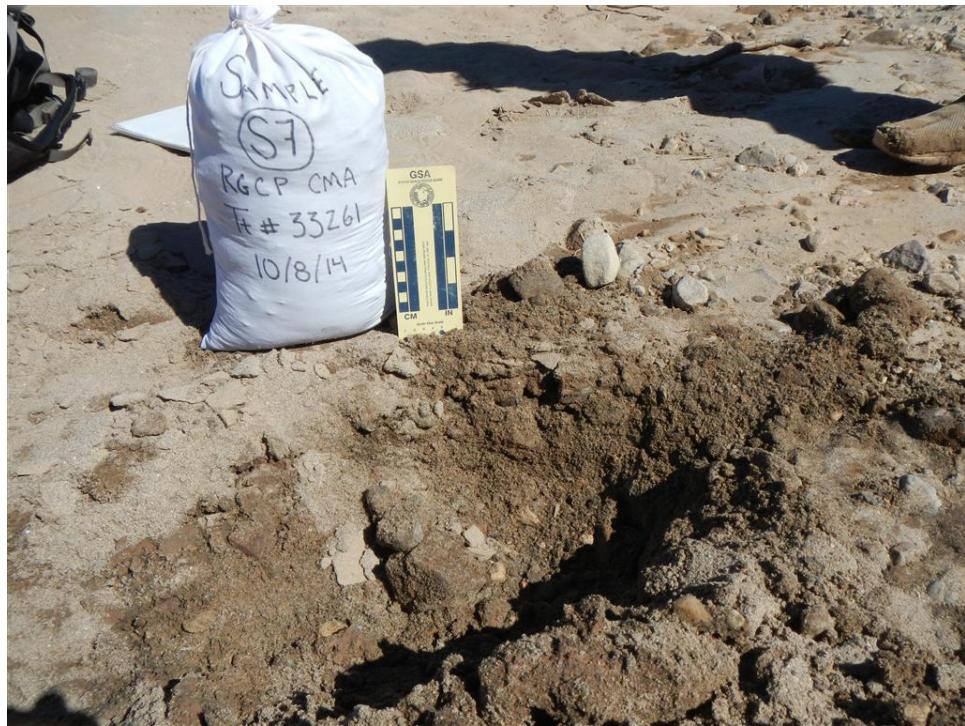
Photo A.30. View of material collected in Sample S7 located near the BNSF Railroad Bridge at Problem Location 3.

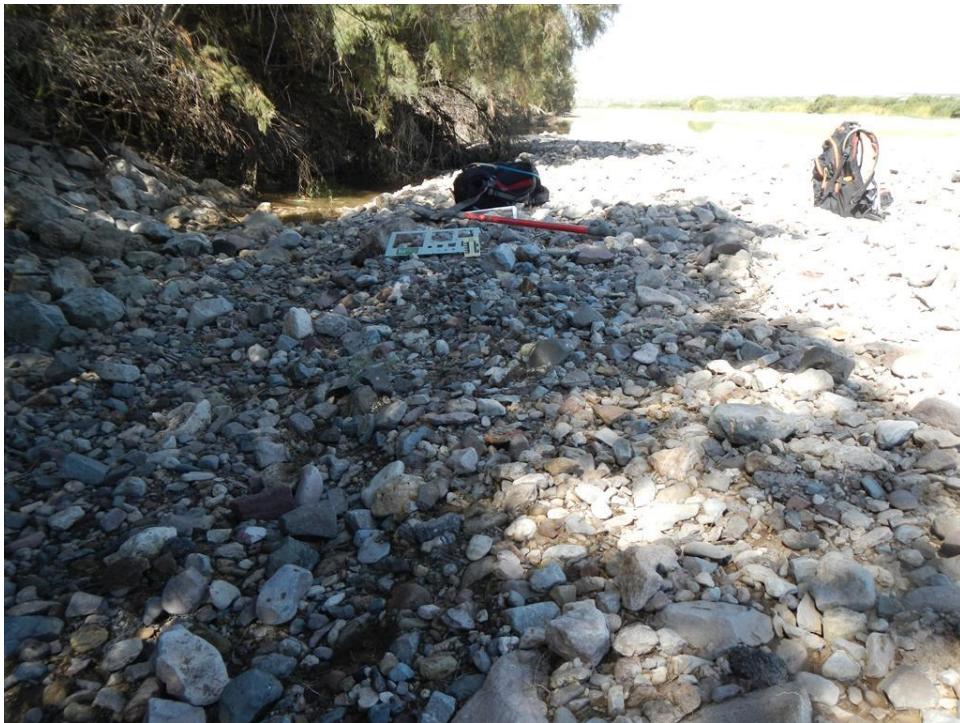
Photo A.31. View upstream to the surficial material along the surface of the Garcia Arroyo fan that was sampled in Pebble Count PC5.

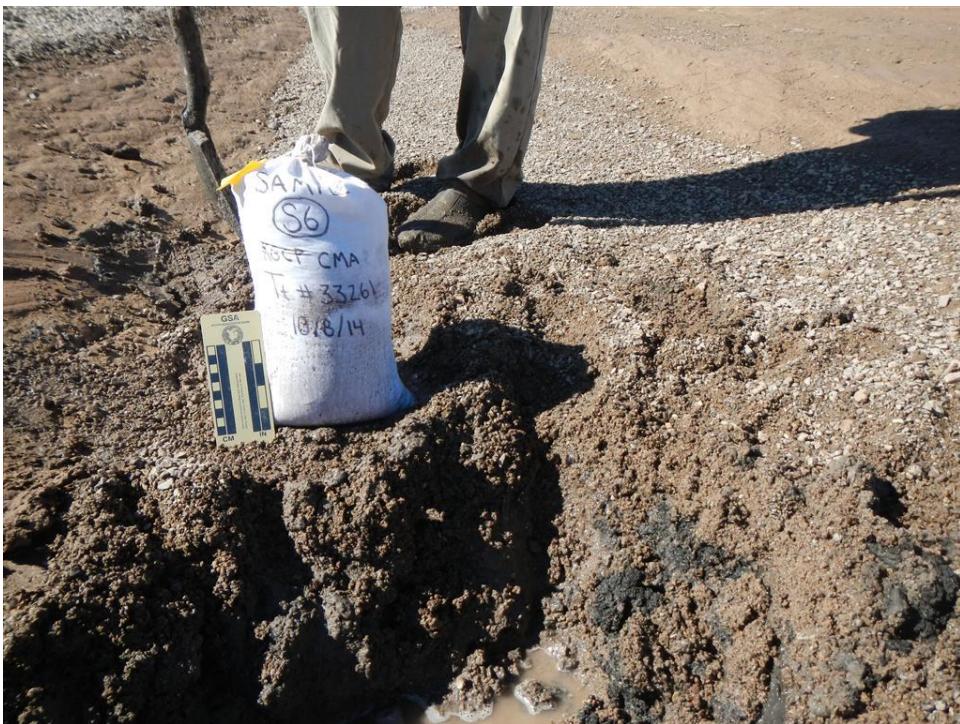
Photo A.32. View of material collected in Bulk Sample S6 near the upstream limit of the Problem Location 3 reach.

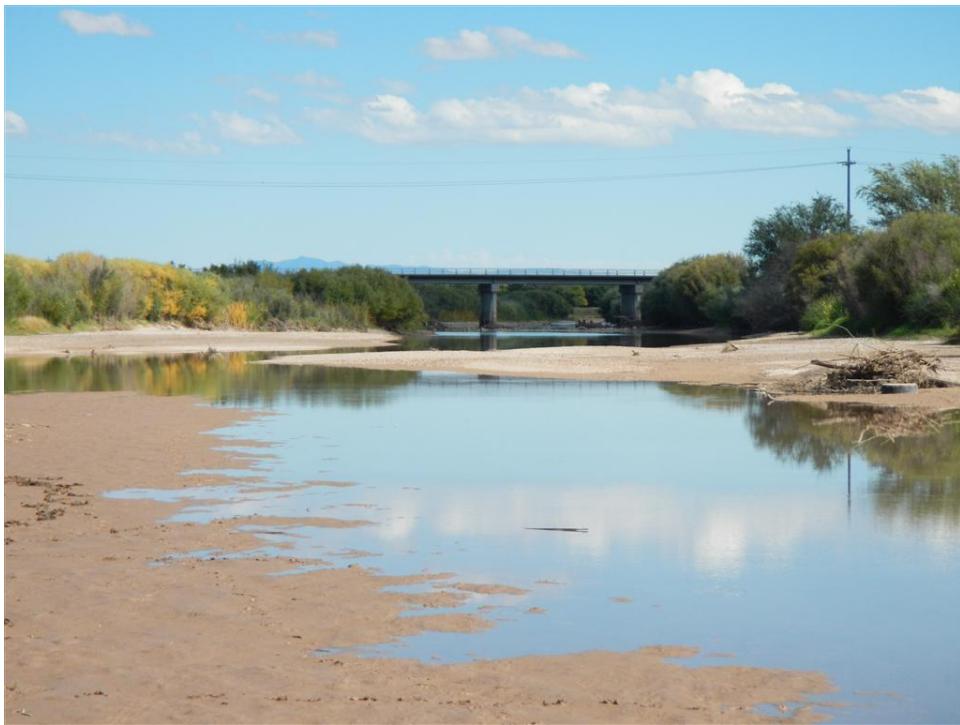
Photo A.33. View downstream to the New Mexico Highway 140 Bridge near the upstream limit of the Problem Location 4 reach.

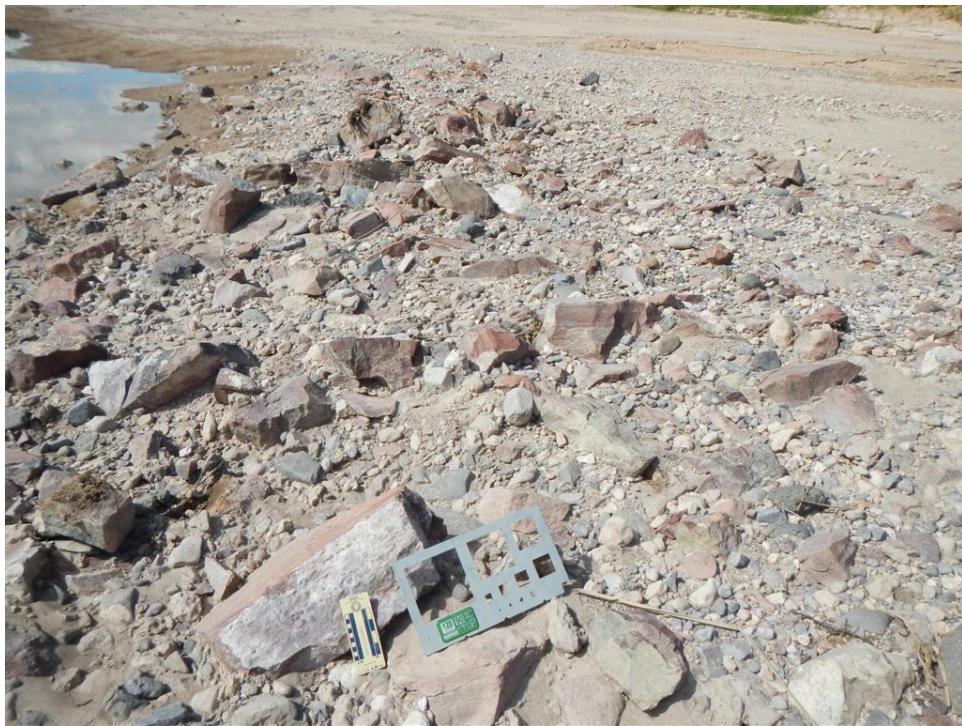
Photo A.36. View of material sampled in Pebble Count PC 6 along the distal portion of the Rincon Arroyo fan.

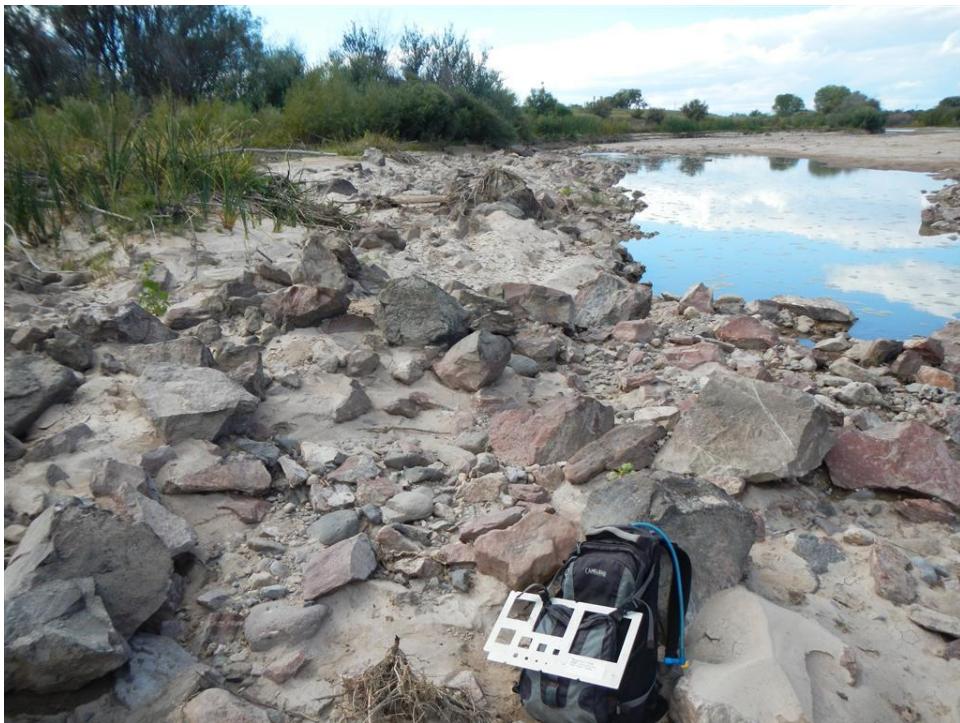
Photo A.37. View of the boulder material in the Rincon Arroyo fan that was sampled in Boulder Count BC1.

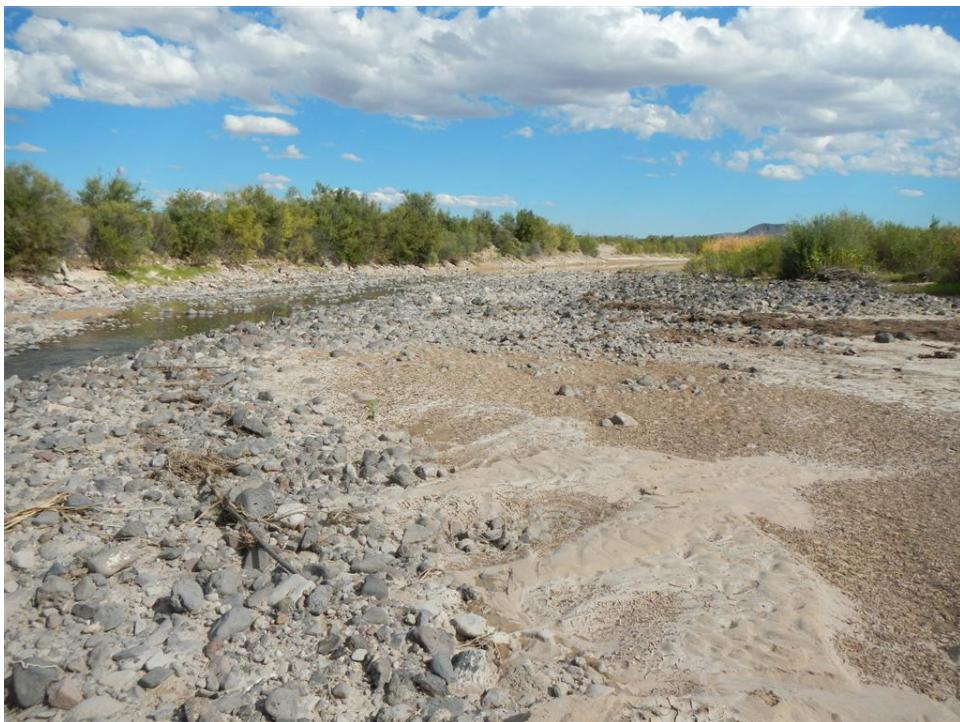
Photo A.38. View downstream along the Reed Arroyo fan showing the right portion of the fan that has become vegetated.

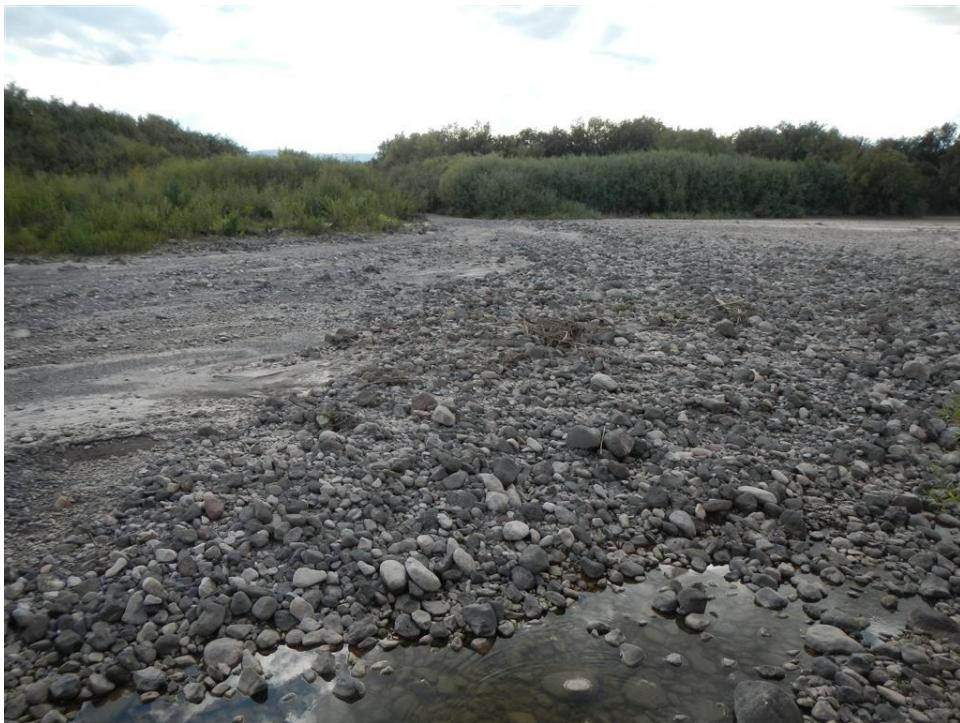
Photo A.39. View from east bank across the Bignell Arroyo fan to the mouth of the tributary.

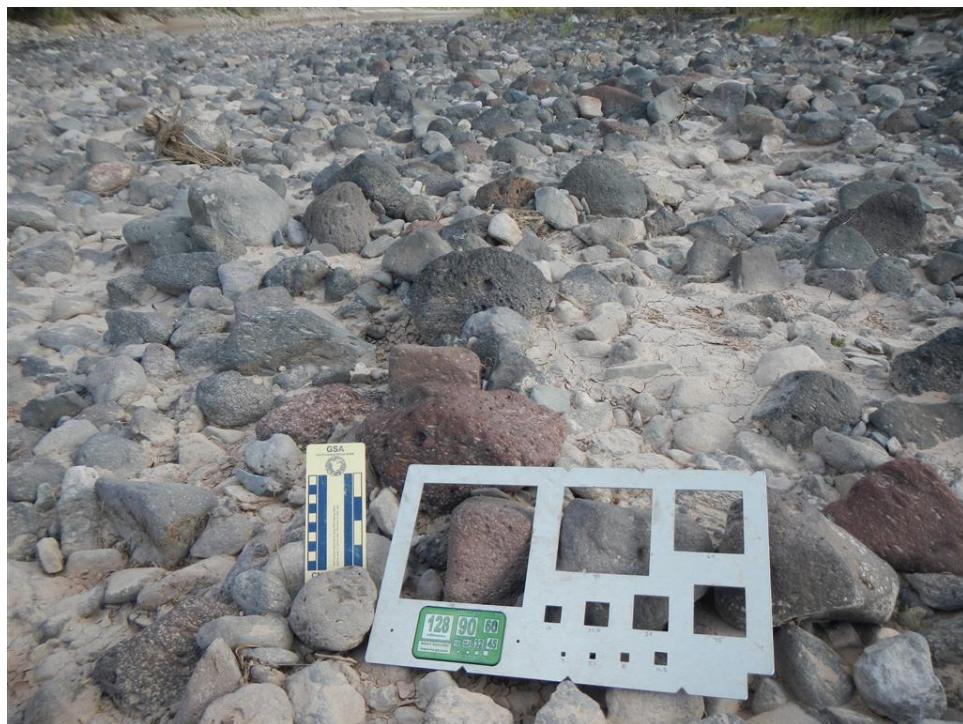
Photo A.40. View of the surface material along the Reed Arroyo fan that was sampled in Pebble Count PC7.

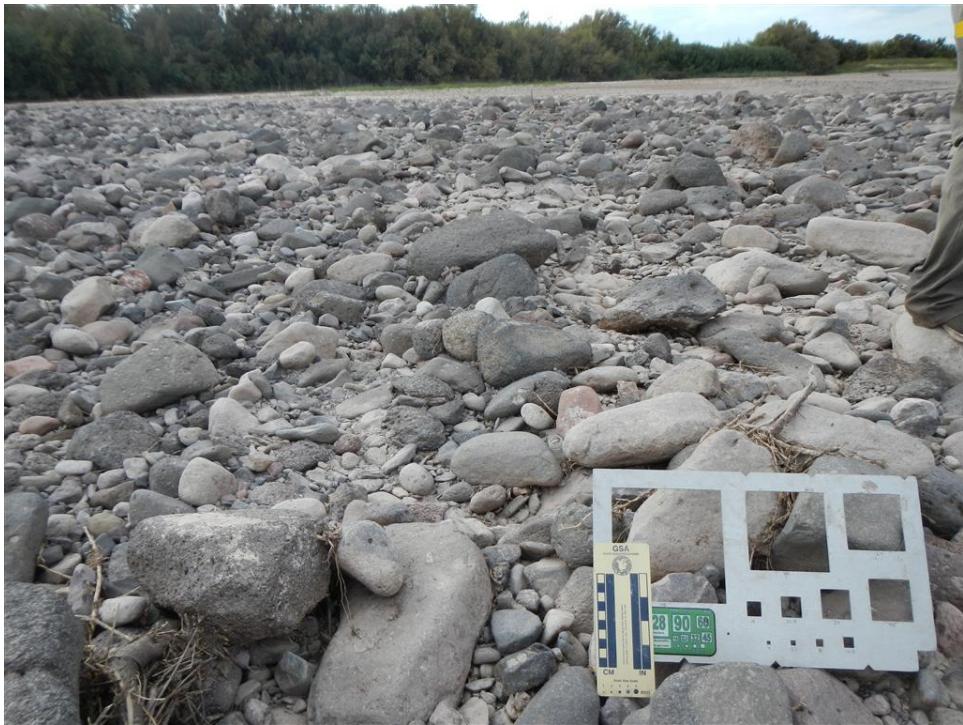
Photo A.41. View of the surface material along the Bignell Arroyo fan that was sampled in Pebble Count PC8.

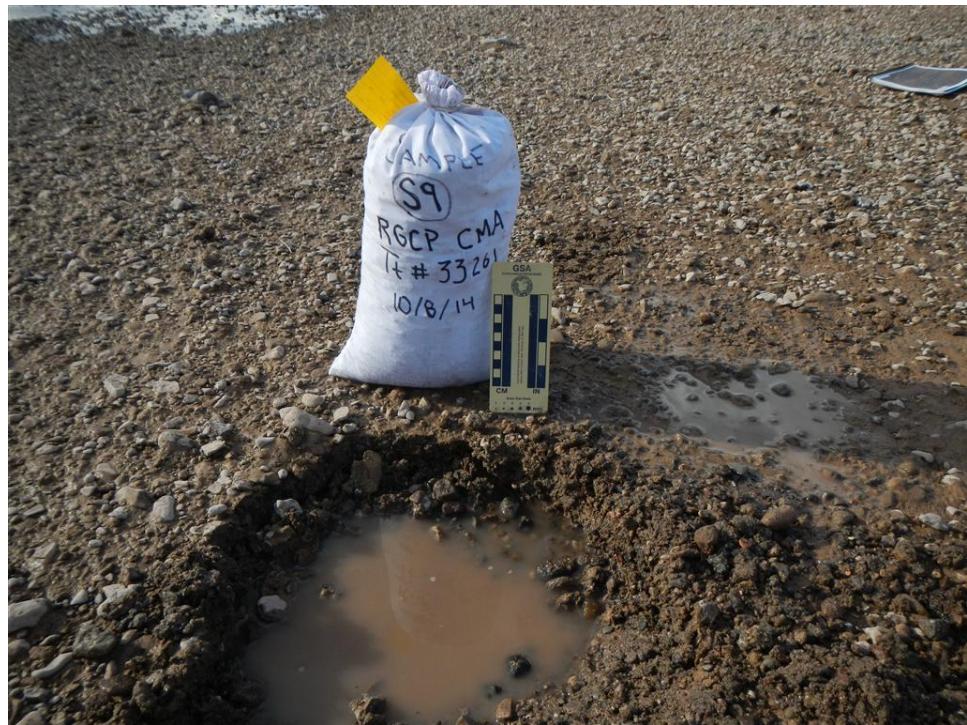
Photo A.42. View of bed material collected in Sample S9 downstream from Reed Arroyo.

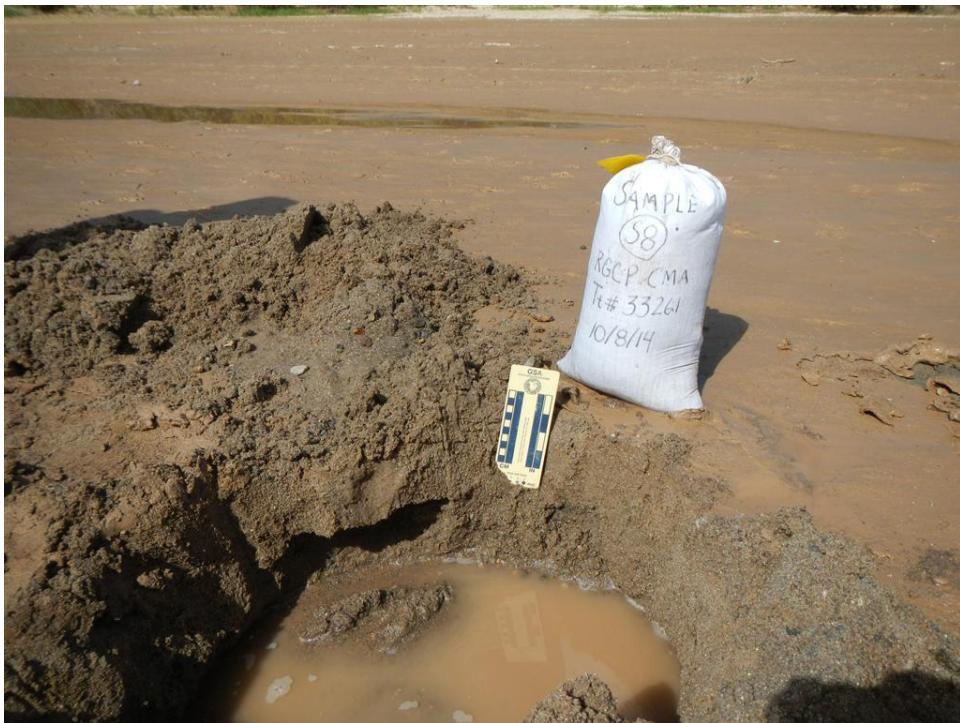
Photo A.43. View of bed material collected in Sample S8 near the upstream limit of the Problem Location 4 reach.

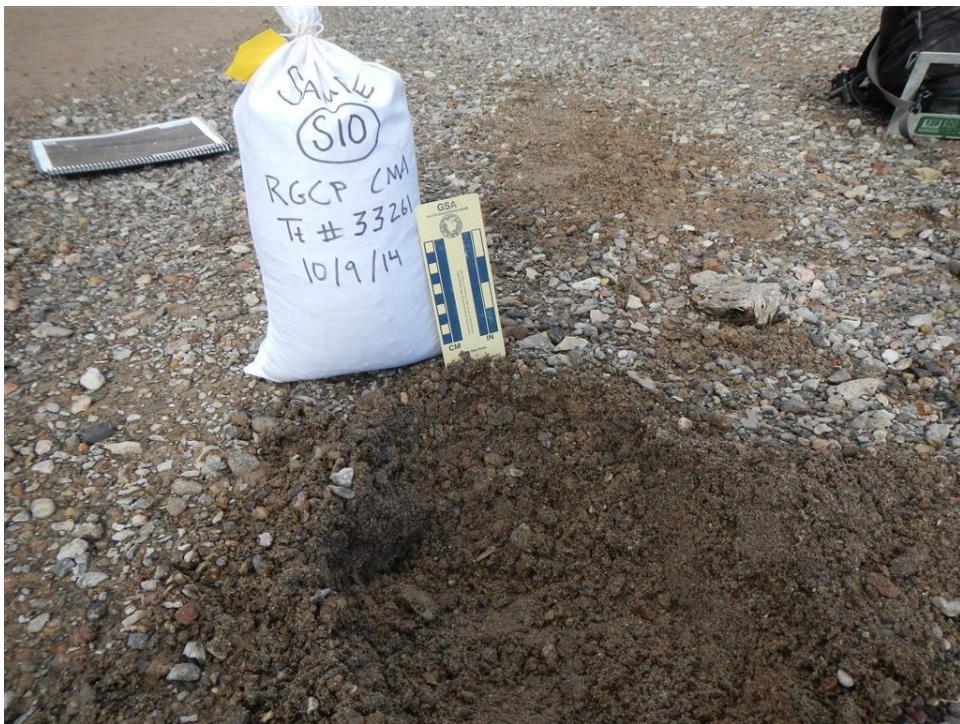
Photo A.44. View of bed material collected from a gravel bar near the upstream limit of Problem Location 5 in Sample S10.
