**Channel Maintenance Alternatives and
Sediment-transport Studies for the
Rio Grande Canalization Project:
Final Report**

**Statement of Work and Statement of Work Addendum for Channel Maintenance Alternatives
and Sediment-transport Studies for the Rio Grande Canalization Project**

October 20, 2015
Contract No. IBM09D0006
Order No. IBM14T0016

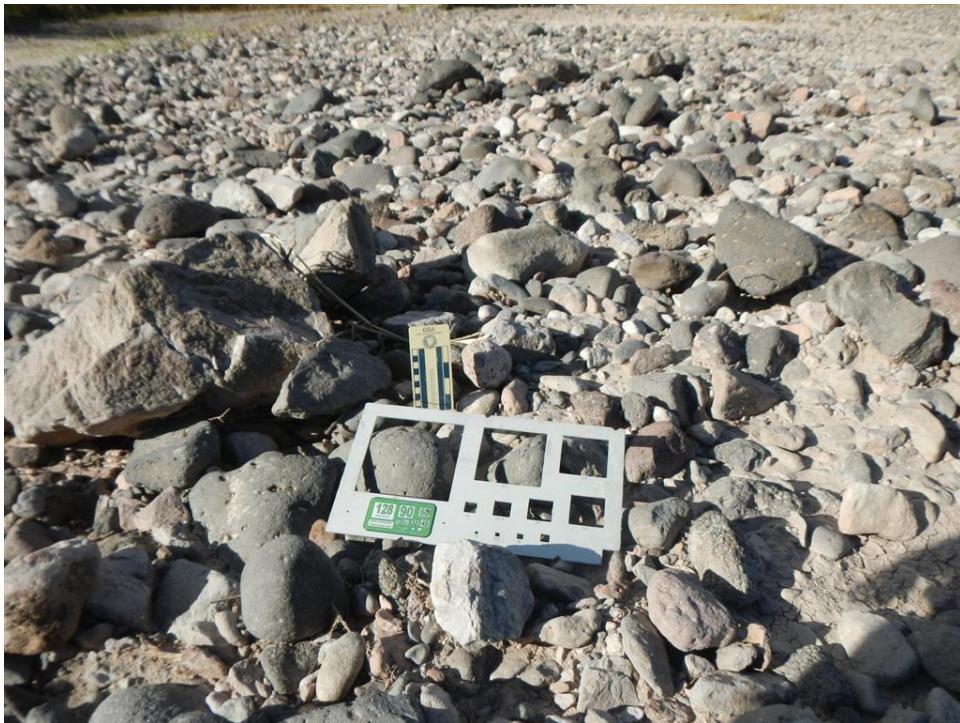
Photo A.48. View upstream to the vegetated islands in the expansion zone through Problem Location 5. Note the relatively young vegetation on many of the islands that indicates the islands have formed during the recent drought period.

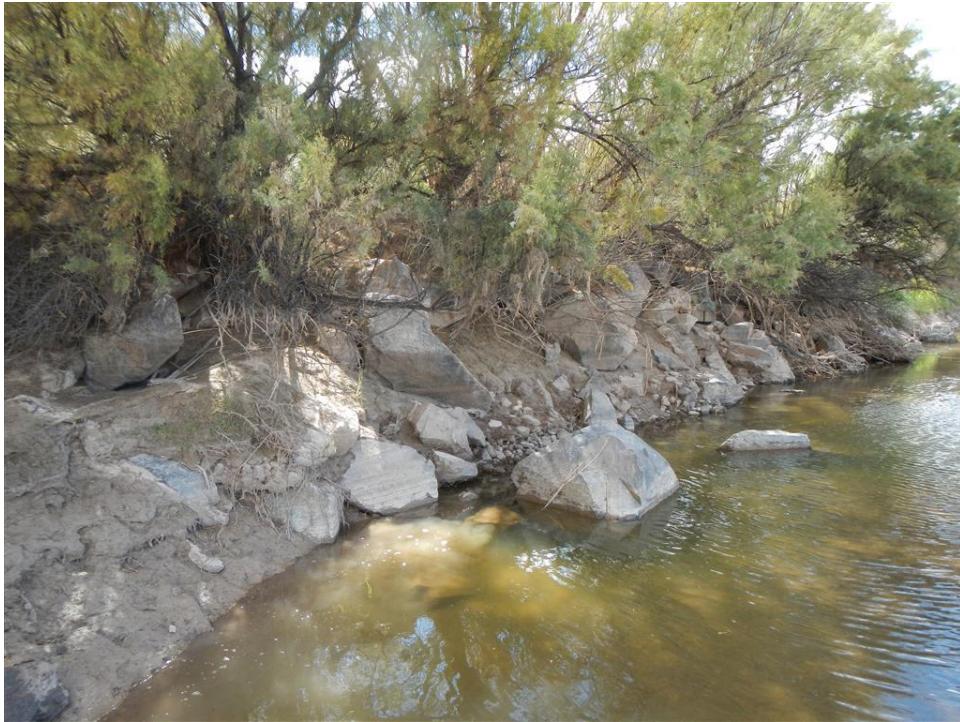
Photo A.51. View downstream to the riprap-protected east bank downstream from the Rincon/Tonuco Drain.

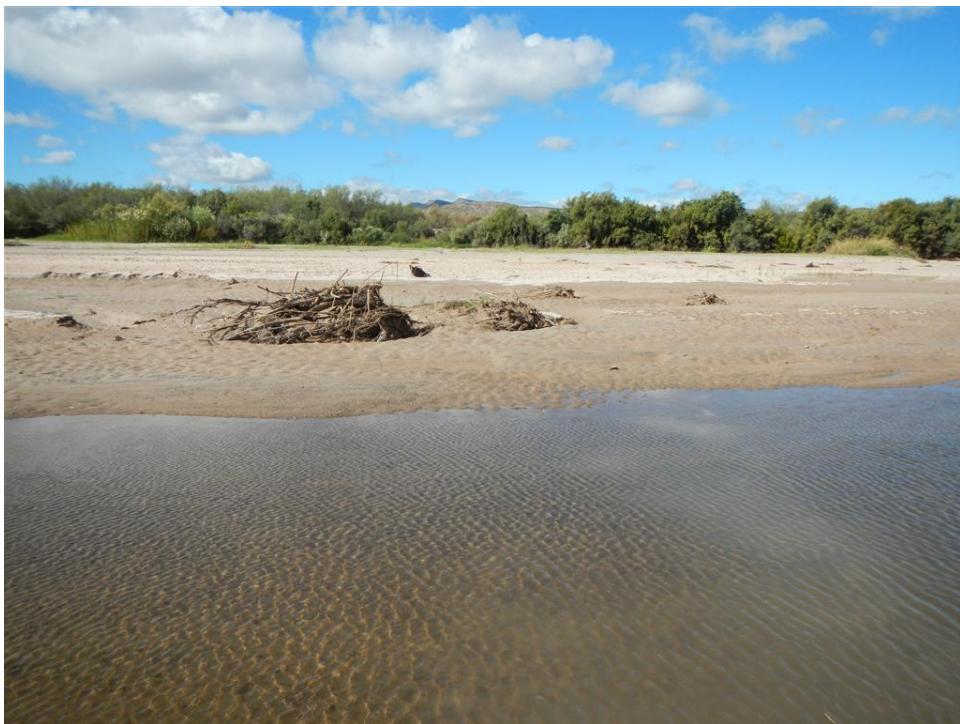
Photo A.52. View looking across the channel to the mouth of Horse Canyon Creek where there is no discernable alluvial fan.

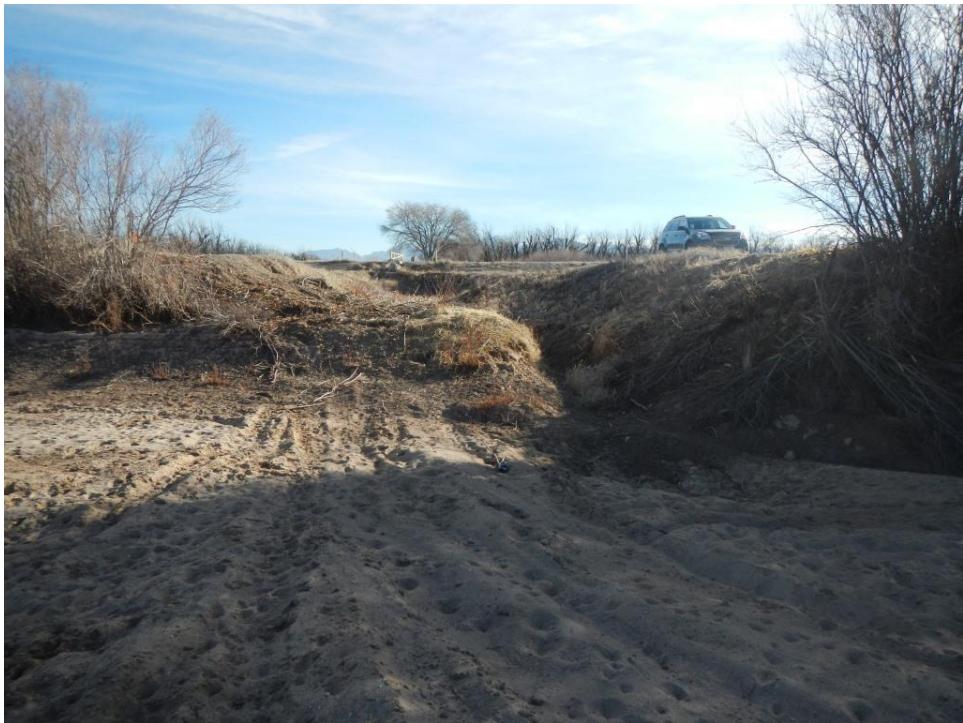
Photo A.55. View of the mouth of drain for the California Lateral, where the invert of the drain is at approximately the same elevation as the riverbed.

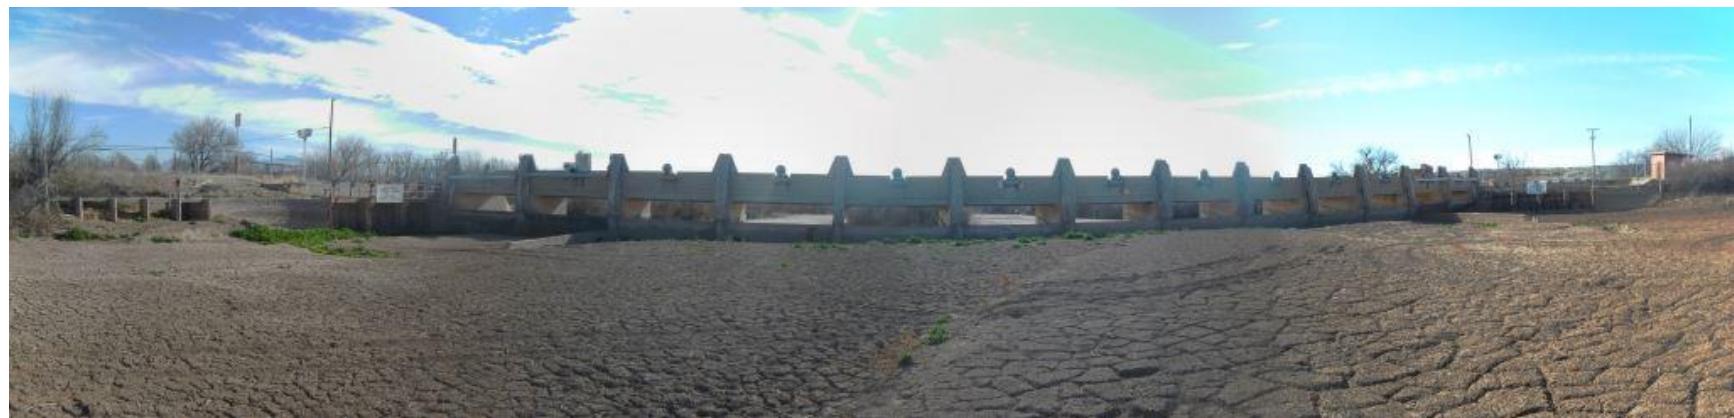
Photo A.56. Panoramic view downstream to the Messilla Dam structure, including from left to right the headgate for the Del Rio Lateral, the headgates for the Eastside Main Canal, the radial gates at Mesilla Dam, and the headgates for the Westside Main Canal.

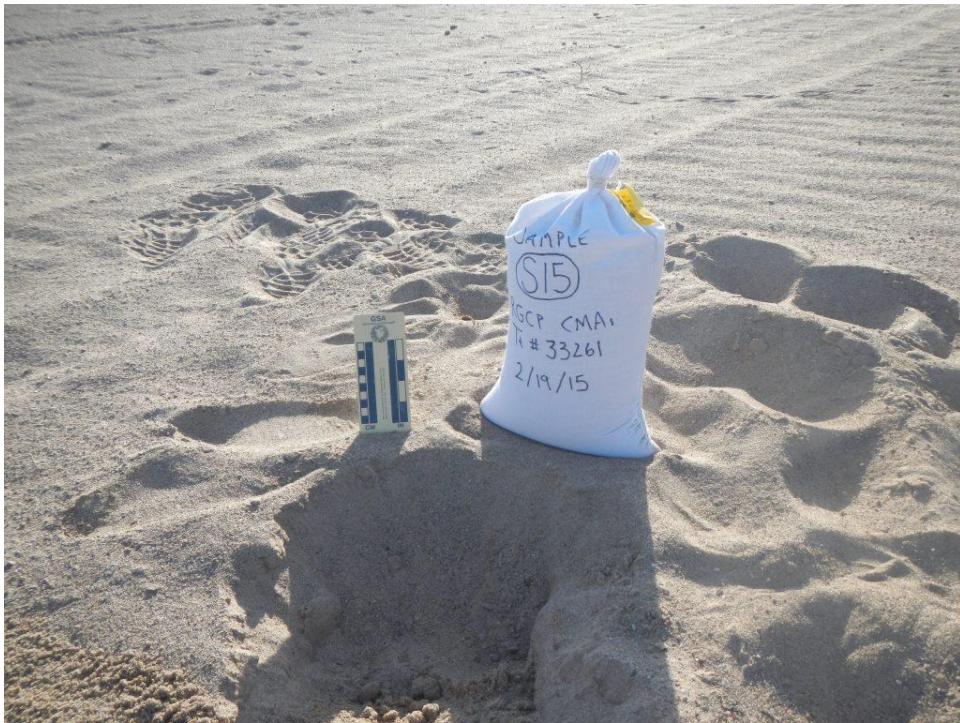
Sample S15, located near the upstream limit of the site and representative of the upstream sediment supply to the reach, is primarily sand with $D_{50} = 0.40$ mm (Figure 3.3; **Photo A.57**). Trace gravels are present in the bed material (**Photo A.58**). Numerous relatively small arroyos and one larger arroyo drain the non-leveed west bank upstream from the dam and deliver sand and gravel to the reach (**Photos A.59 and A.60**). The backwater zone upstream from Mesilla Dam does not extend over a distance of more than 2,000 feet, at least under recent flow and operating conditions, and has resulted in the deposition of significant amounts of material (**Photo A.61**). The surface depositional material appears to progressively fine in the downstream direction in the backwater zone above the dam. Based on Sample S16 ($D_{50} = 0.25$ mm; Figure 3.3; **Photo A.62**) that was collected downstream from the dam, the sediment-trapping effects of the dam results in some minor fining of the bed material below the dam. Upstream from the dam, the banks are at least intermittently protected by riprap over significant distances, and in many cases several feet of bank accretion has buried the riprap. Except for the relatively large, vegetated mid-channel bar immediately downstream from the dam, the reach is mostly void of vegetated bar surfaces.

Photo A.57. View of Sample S15 of the representative bed material sediment supply to the Problem Location 6 reach.

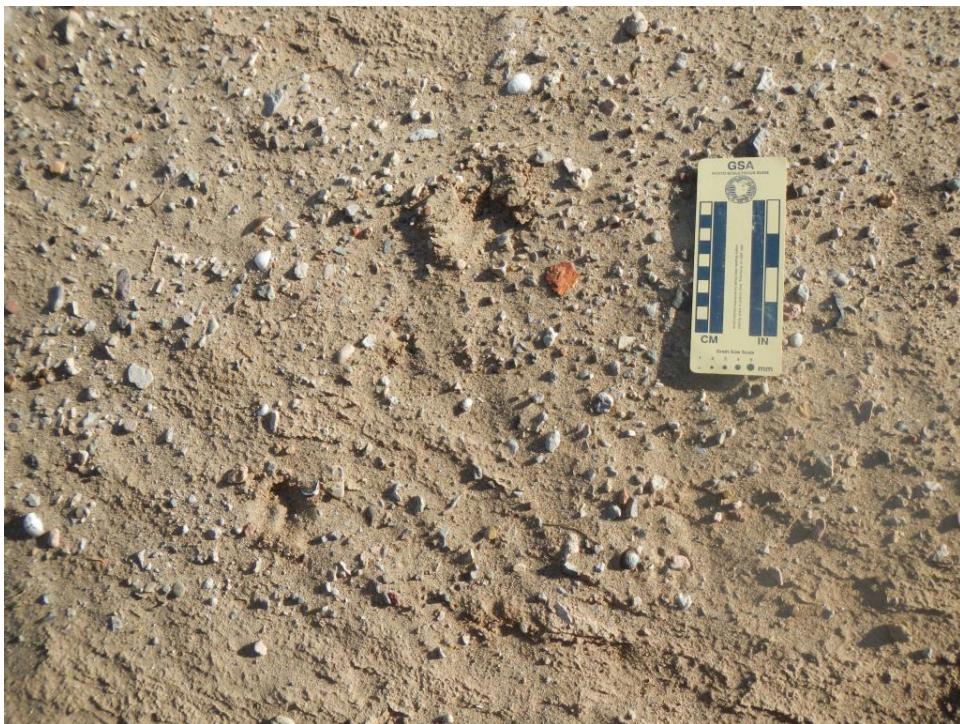
Photo A.58. View of trace gravels in the predominantly sand bed material along the Problem Location 6 reach.

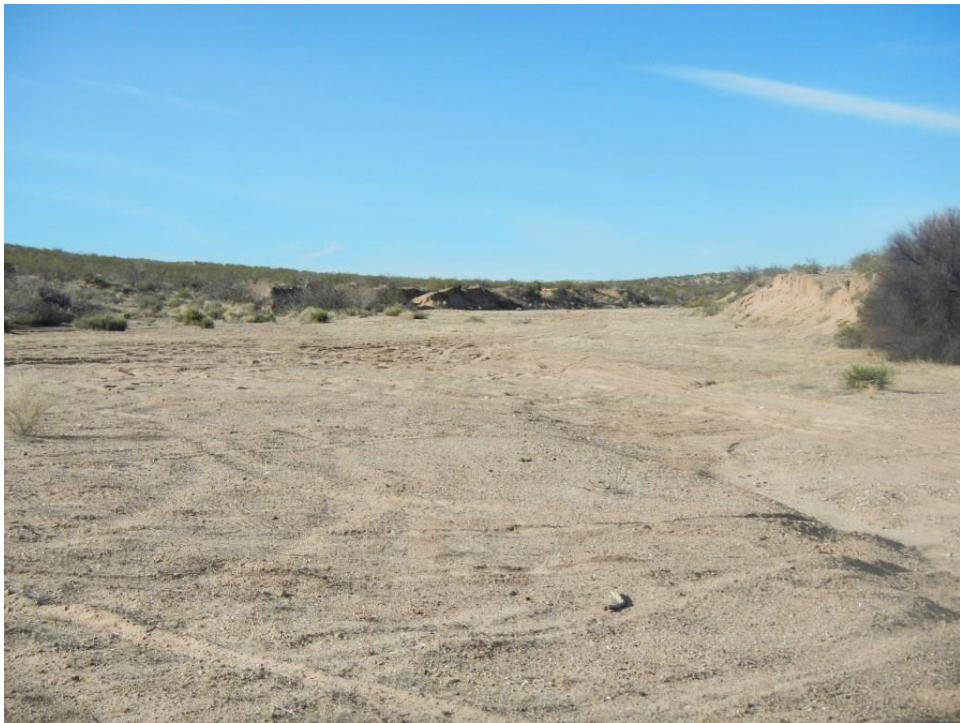
Photo A.59. View upstream to the largest of the right (west) bank arroyos at Problem Location 6.

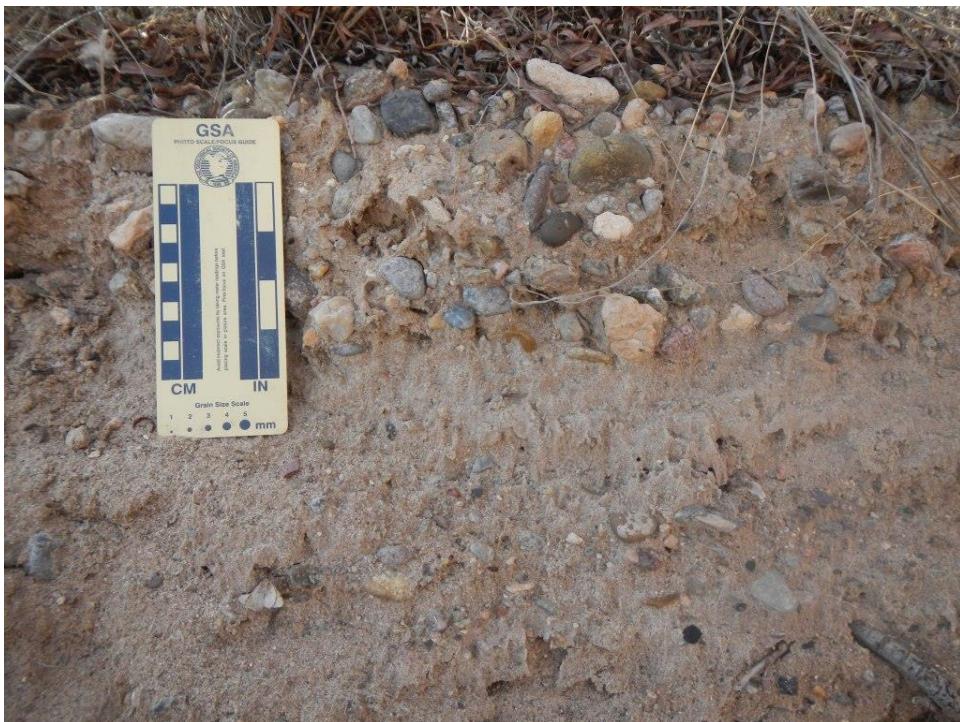
Photo A.60. View of alluvial fan stratigraphy showing the range of sediments delivered by the largest of the right (west) bank arroyos at Problem Location 6.

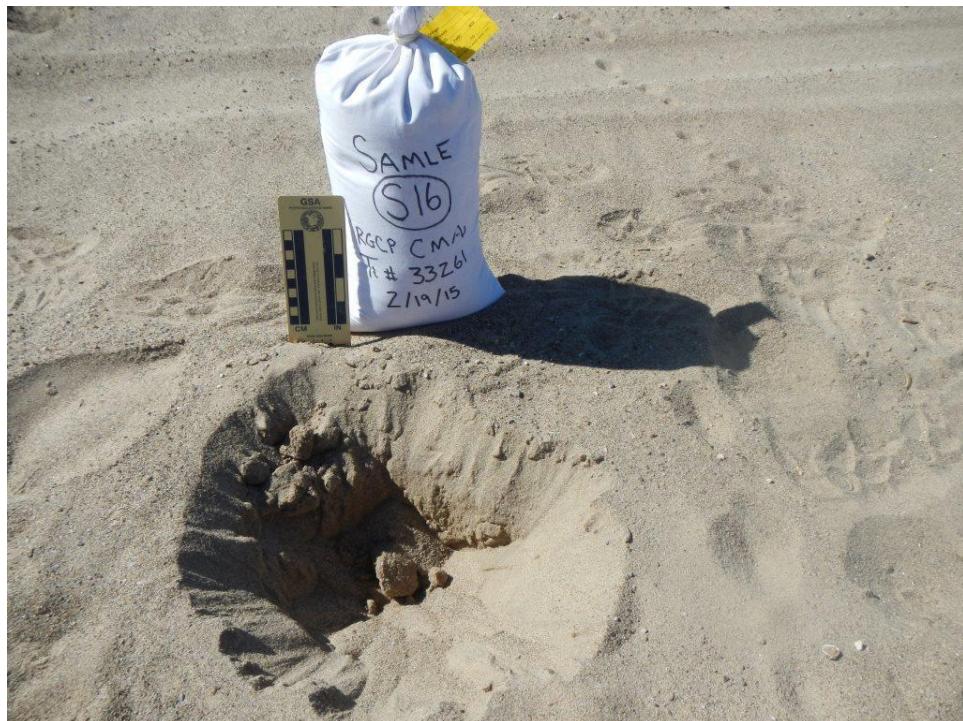
Photo A.62. View of Sample S16 collected downstream from Mesilla Dam, where the bed material is very similar to that near the upstream limit of the Problem Location 6 reach.

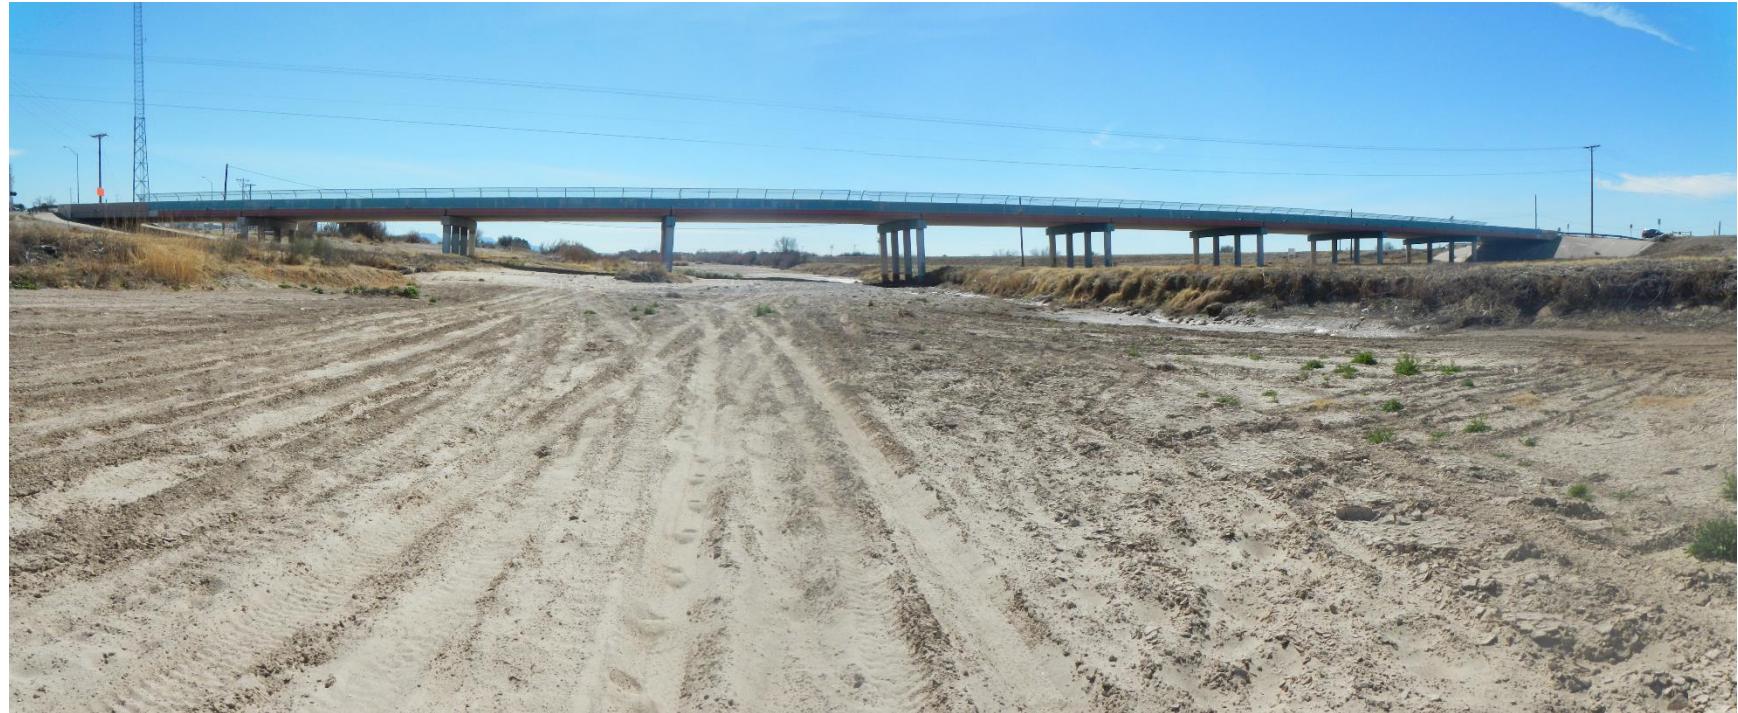
Photo A.63. View downstream to the Vinton Bridge at Problem Location 7, where the bed material is locally coarse due to sediment contributions from the left (east) bank tributary just upstream from the bridge.

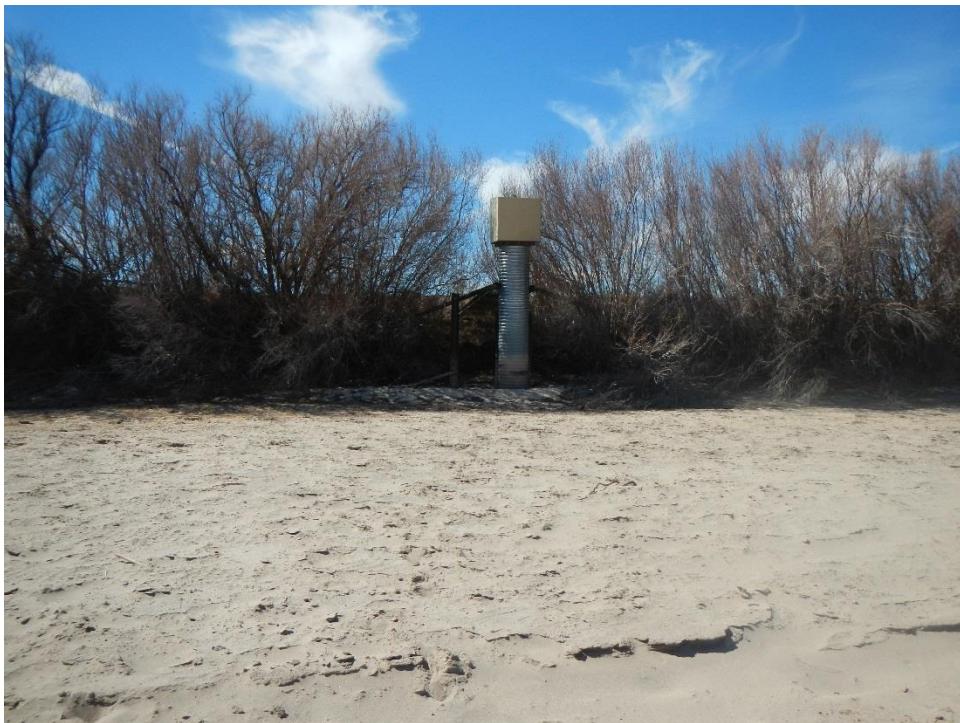
Photo A.64. View of metering station located about 2,000 feet downstream from the Vinton Bridge along Problem Location 7.

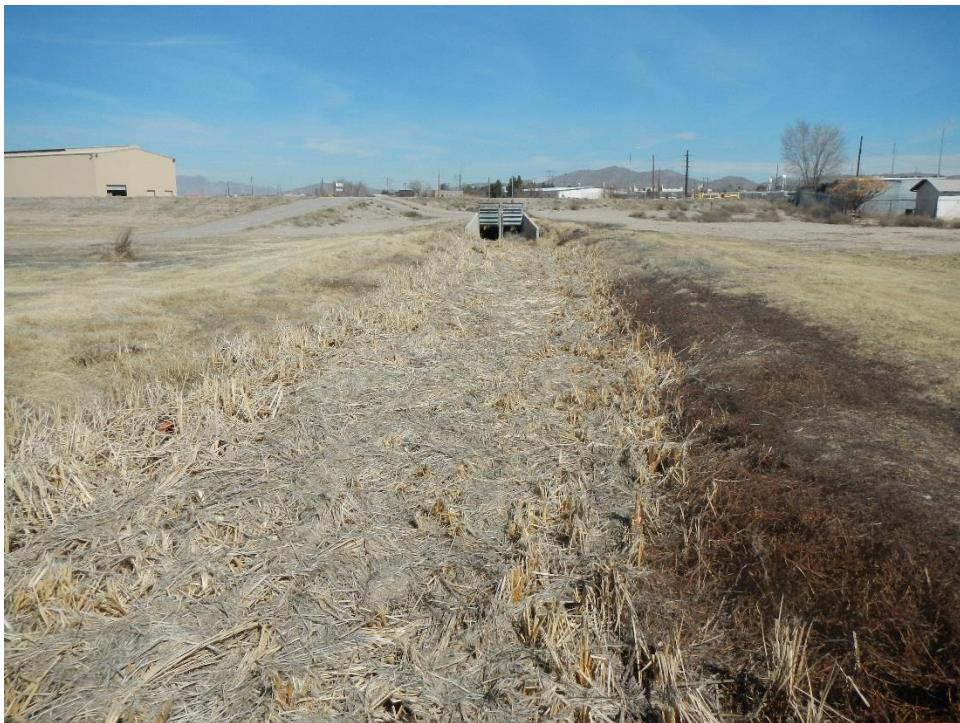
Photo A.66. View upstream along the lower end of the East Drain to the control structure.

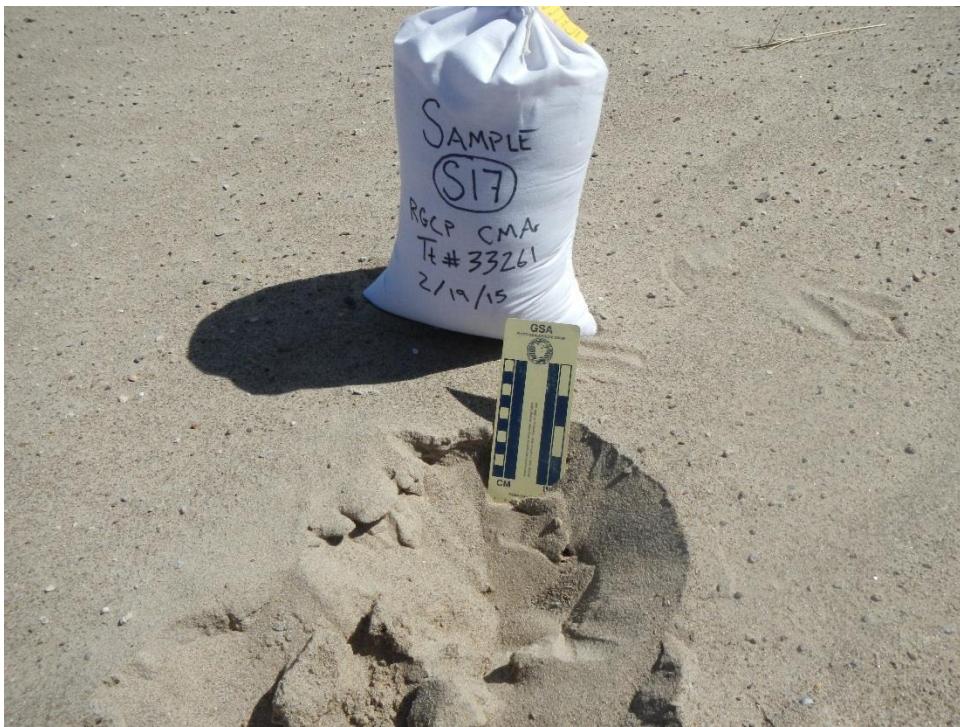
Photo A.67. View of Sample S17 collected from the bed of the channel near the upstream limit of Problem Location 7.

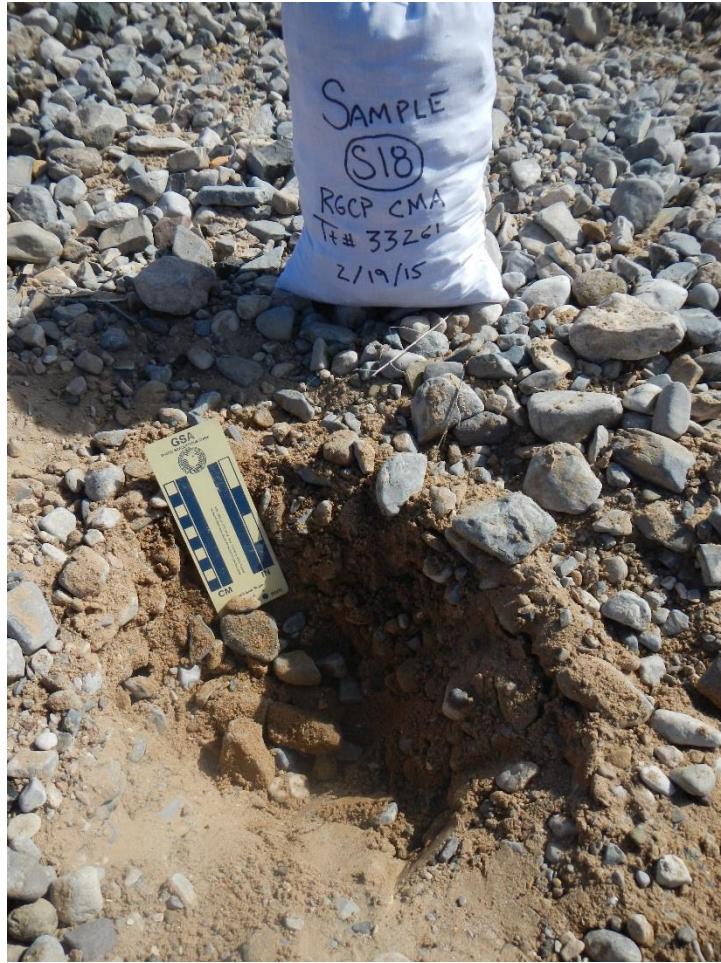
Photo A.69. View of Sample S18 collected from the subsurface of the alluvial fan of the arroyo at Sta 786+50 near the downstream limit of Problem Location 7.

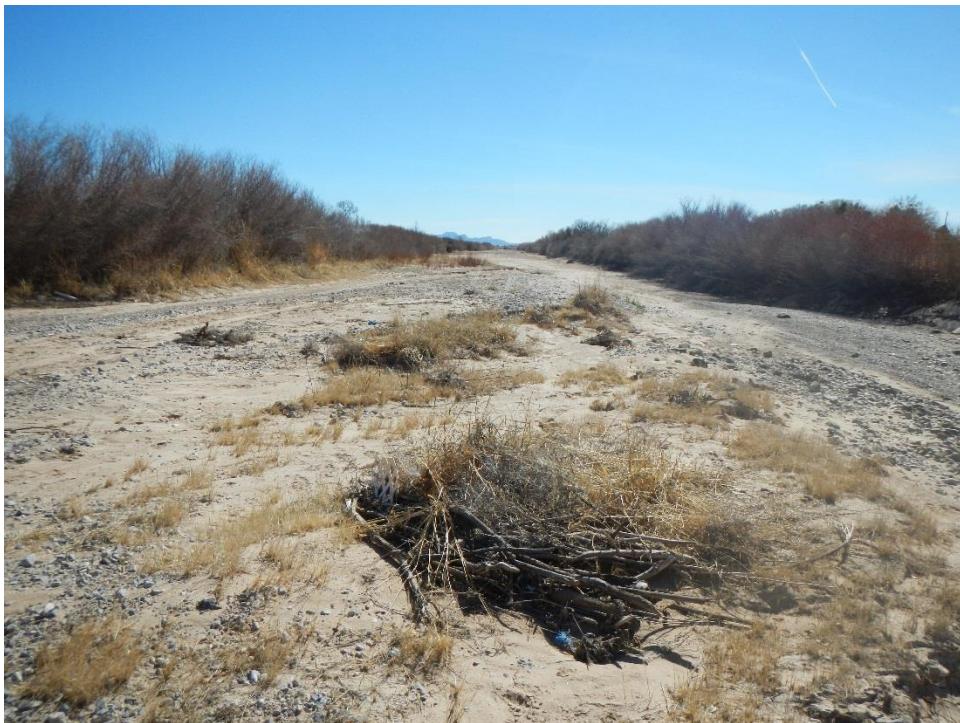
Photo A.70. View downstream along alluvial fan at Sta 786+50 to the downstream limit of surface gravels located about 180 feet below the mouth of the arroyo.

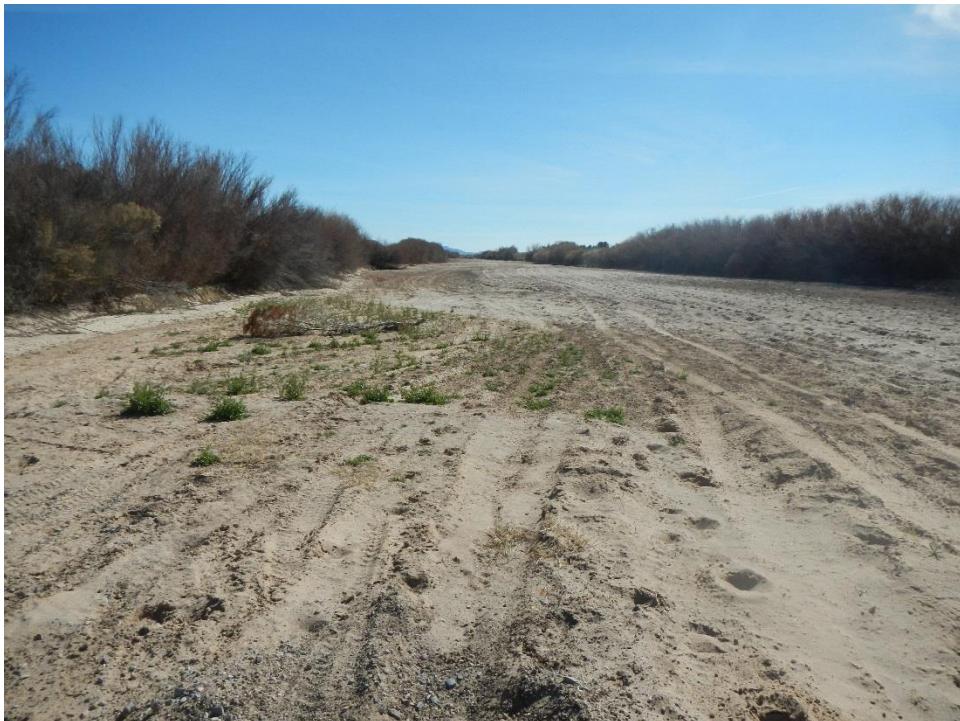
Photo A.71. View downstream from the mouth of the arroyo at Sta 806+50 where there is no alluvial fan, suggesting this tributary has not recently delivered significant sediment loading to the Problem Location 7 reach.

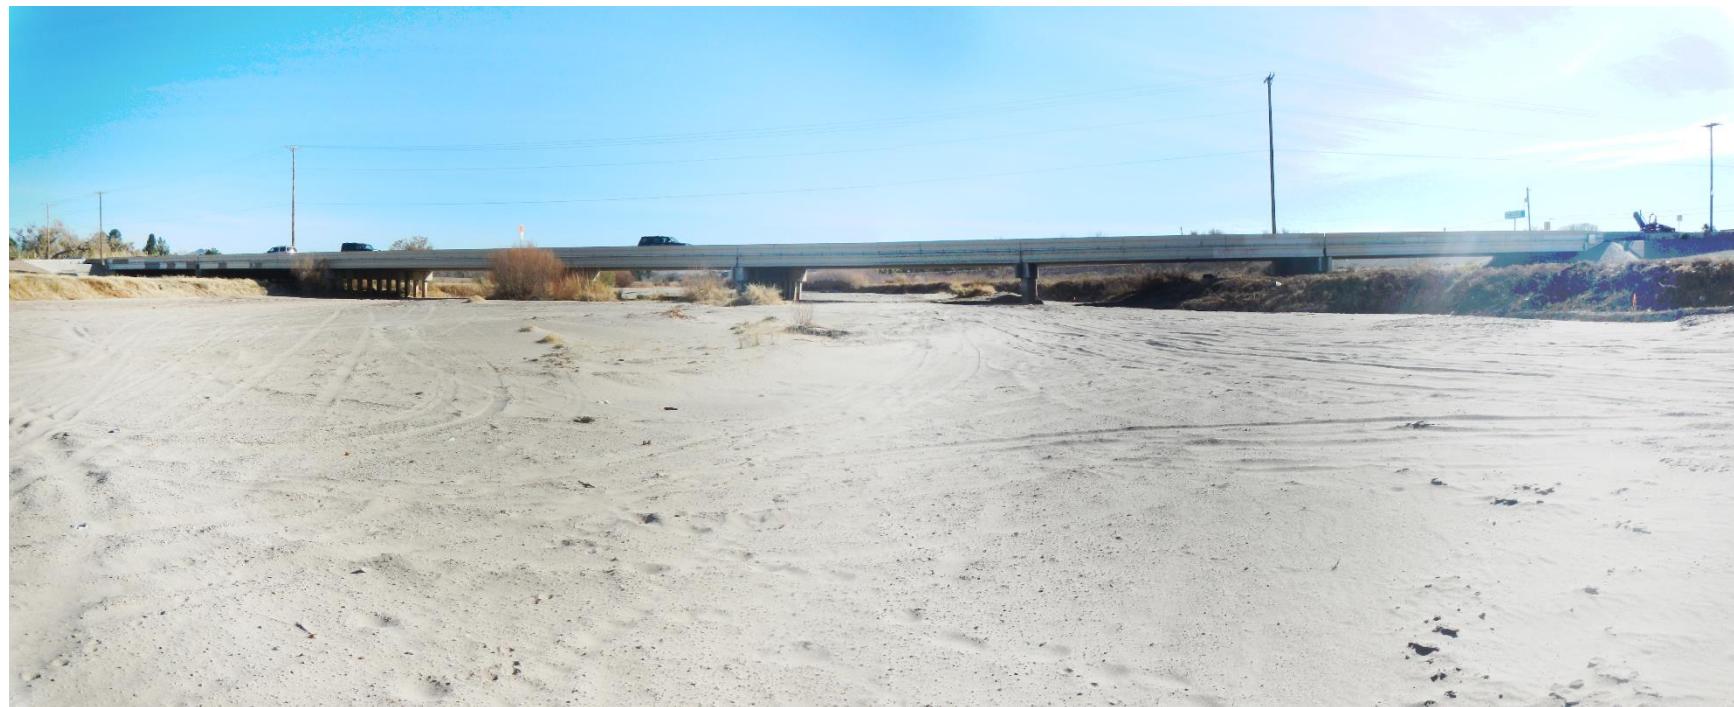
Photo A.72. View downstream to the Country Club Bridge located about midway along the Problem Location 8 reach.

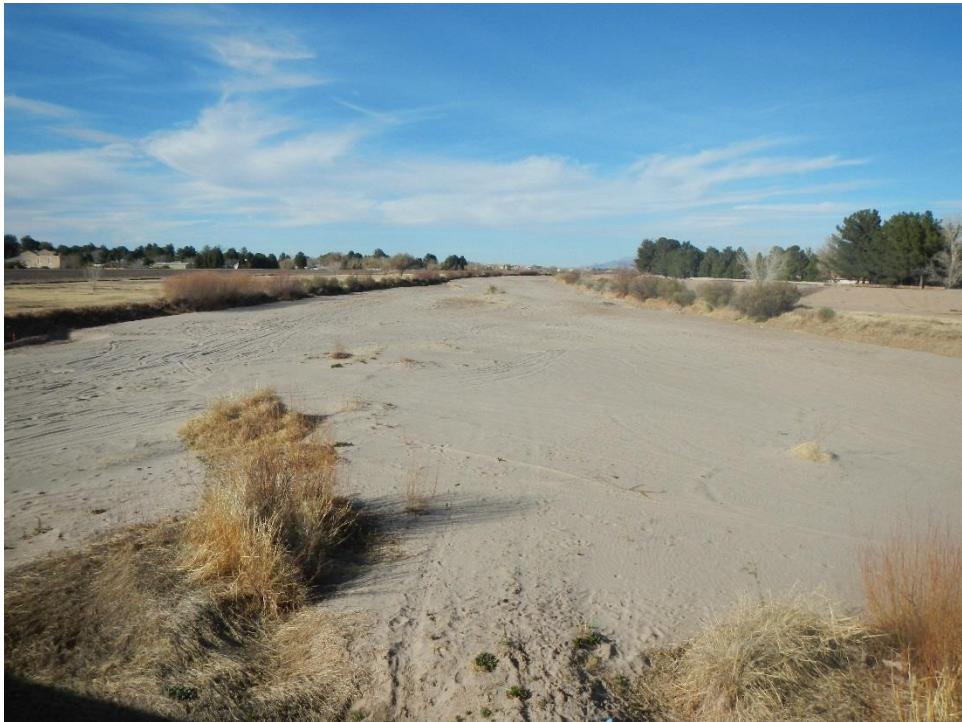
Photo A.74. View upstream from Country Club Bridge showing the intermittent grass and light brush vegetation along the banks.

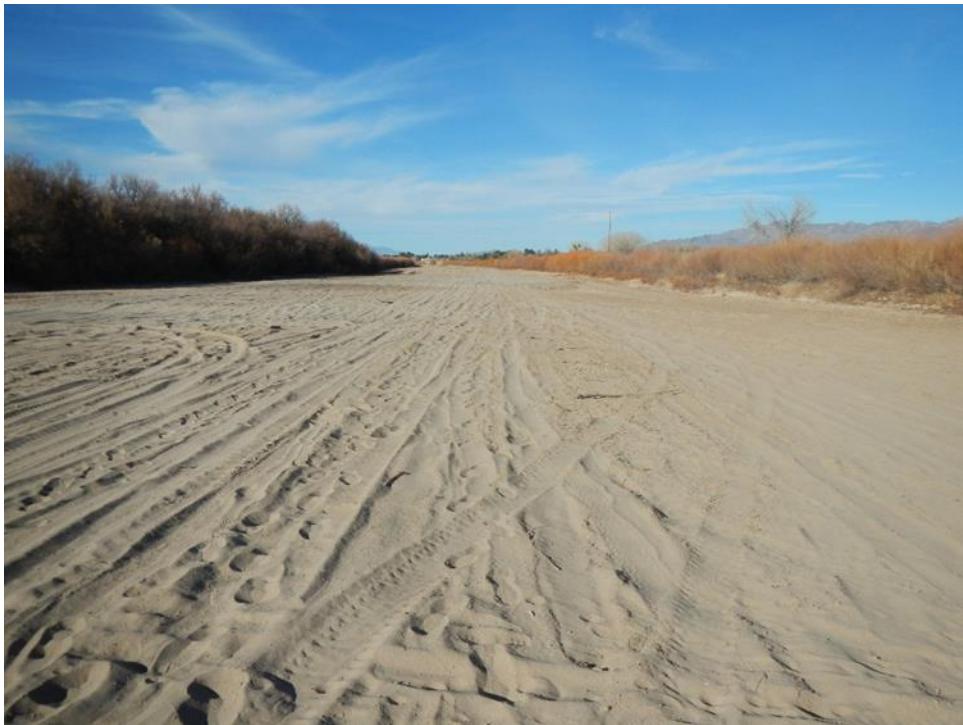
Photo A.75. View upstream from the Nemexas Siphon showing the more dense, older woody vegetation along the right (east) bank on photo left.

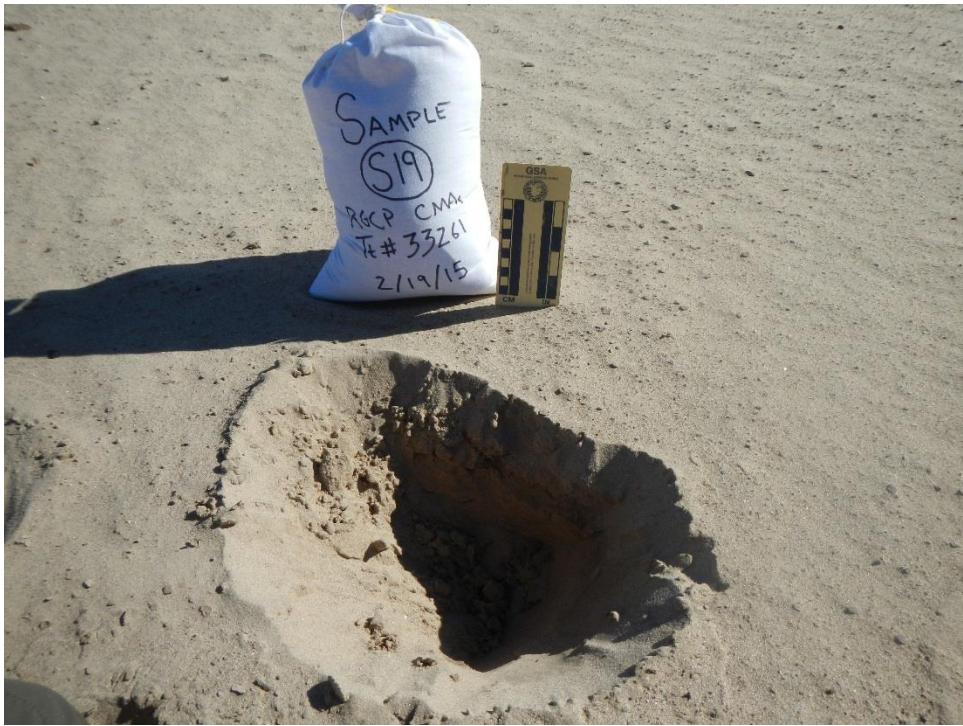
Photo A.76. View of Sample S19 collected from the bed of the channel near the upstream limit of the Problem Location 8 reach.

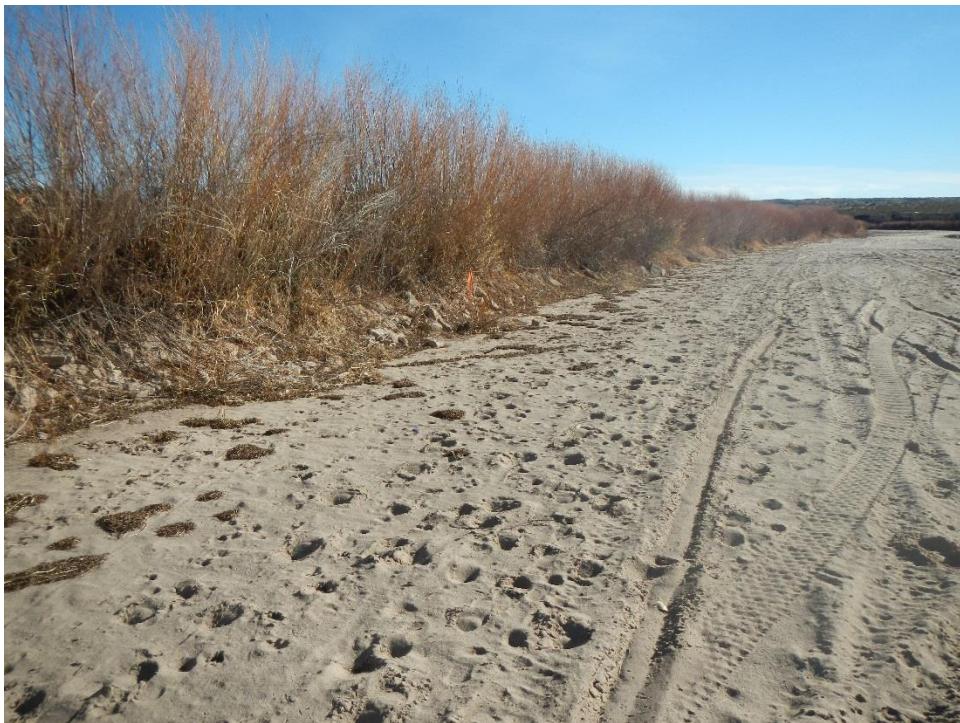
Photo A.77. View downstream to riprap bank protection along the left (east) bank in the vicinity of the Nemexas Siphon at the downstream limit of the Problem Location 8 reach.

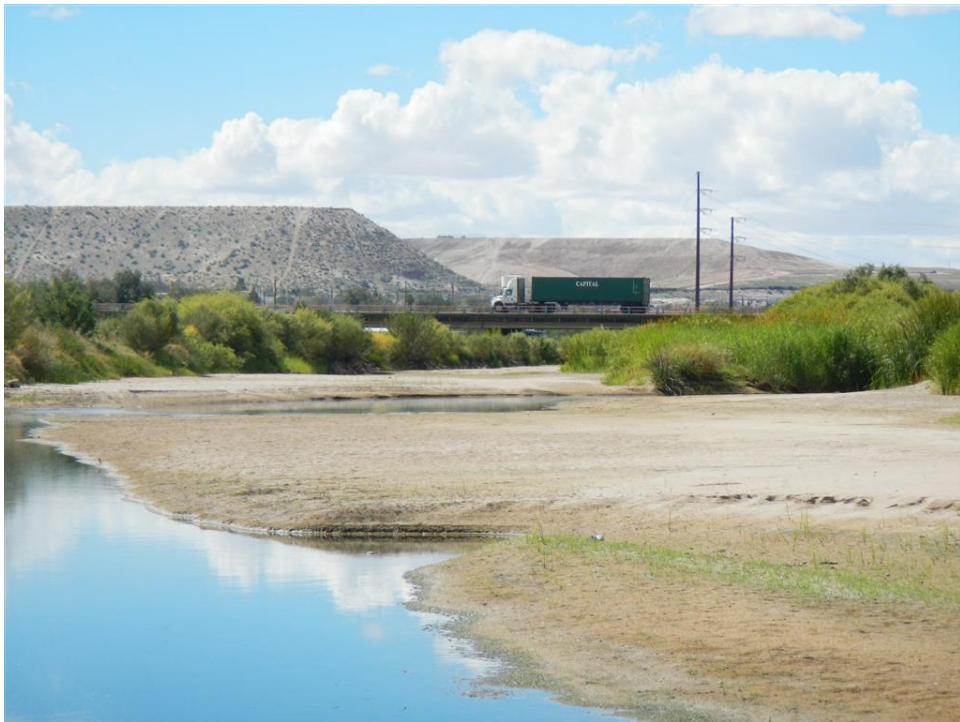
Photo A.78. View upstream to Anapra Bridge (Racetrack Drive).

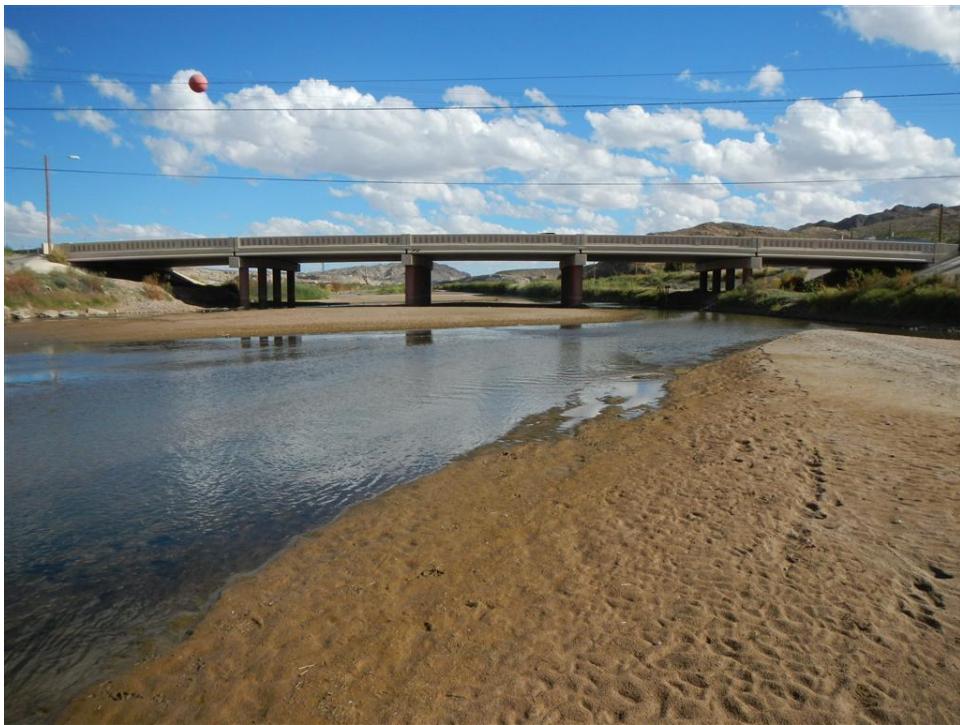
Photo A.79. View downstream to Courchesne Bridge (McNutt Road).

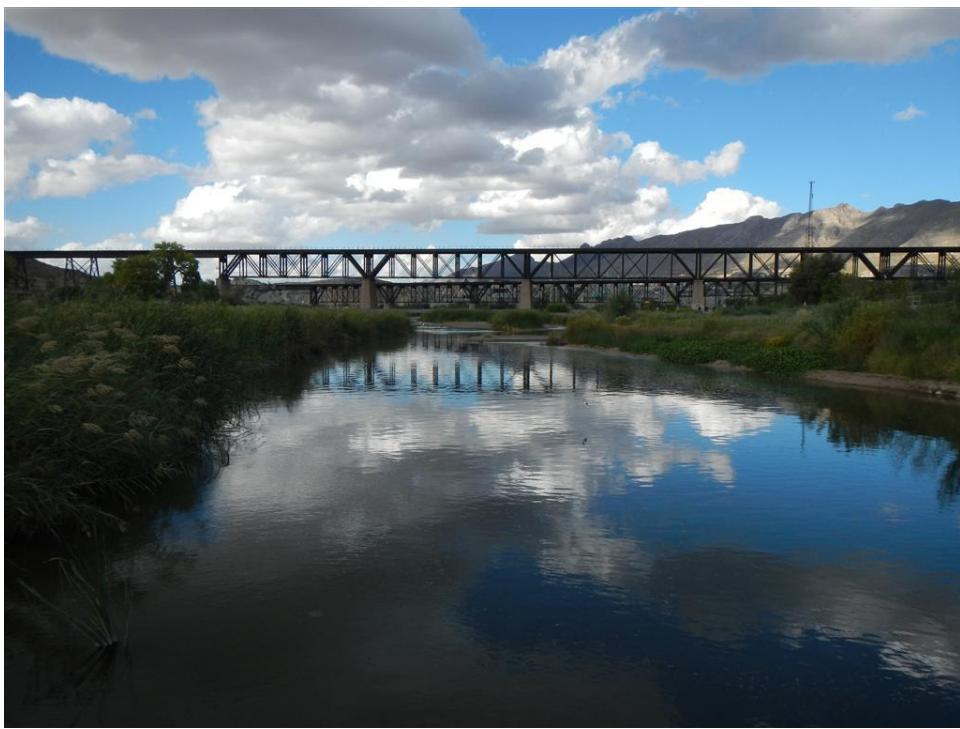
Photo A.80. View upstream to the pair of Southern Pacific Railroad Bridges above American Dam.

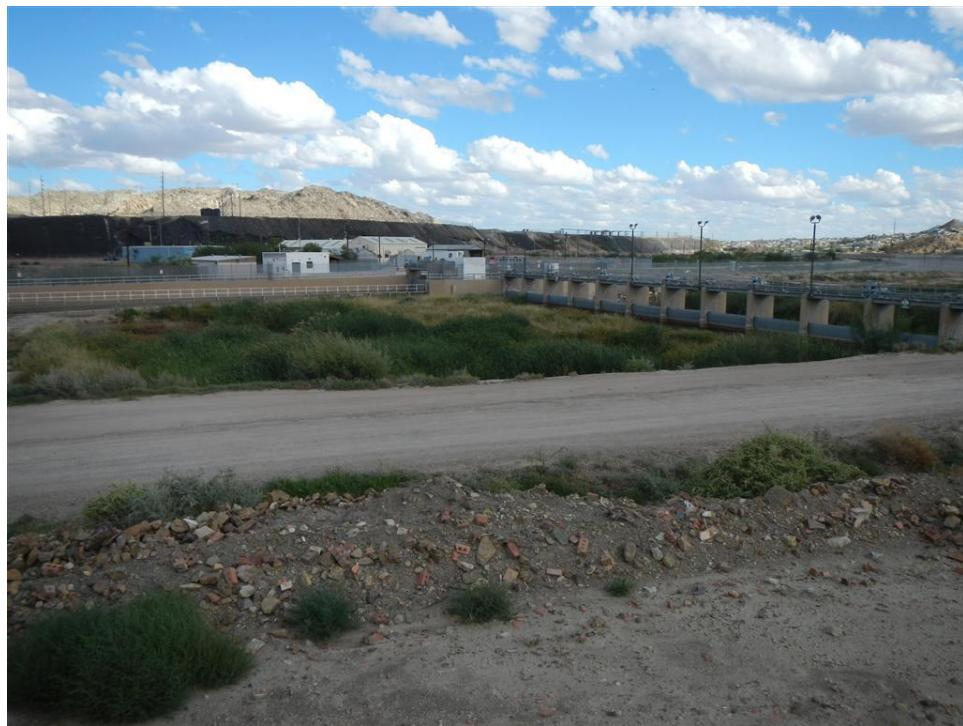
Photo A.81. View across American Dam and the American Canal headworks.

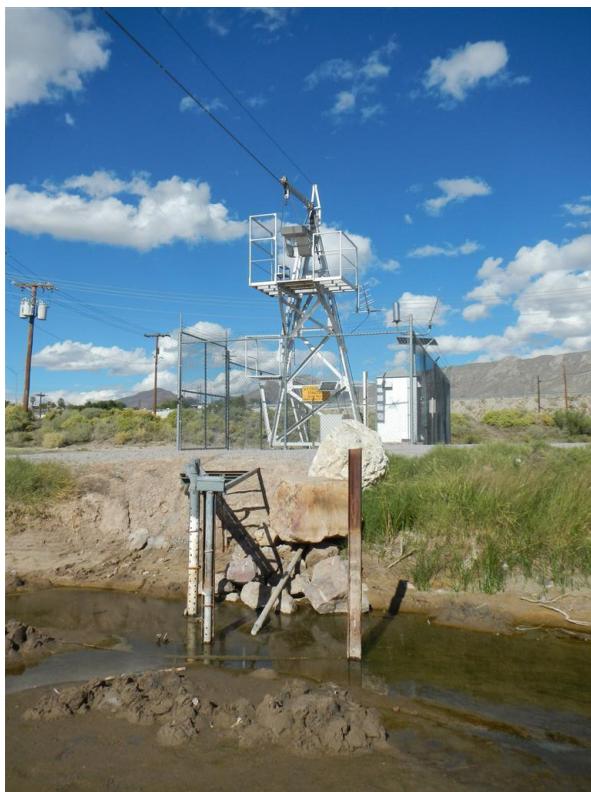
Photo A.82. View of the USIBWC Rio Grande at El Paso Gage (also referred to as the Courchesne Gage; USIBWC Gage No. 08-3640.00).

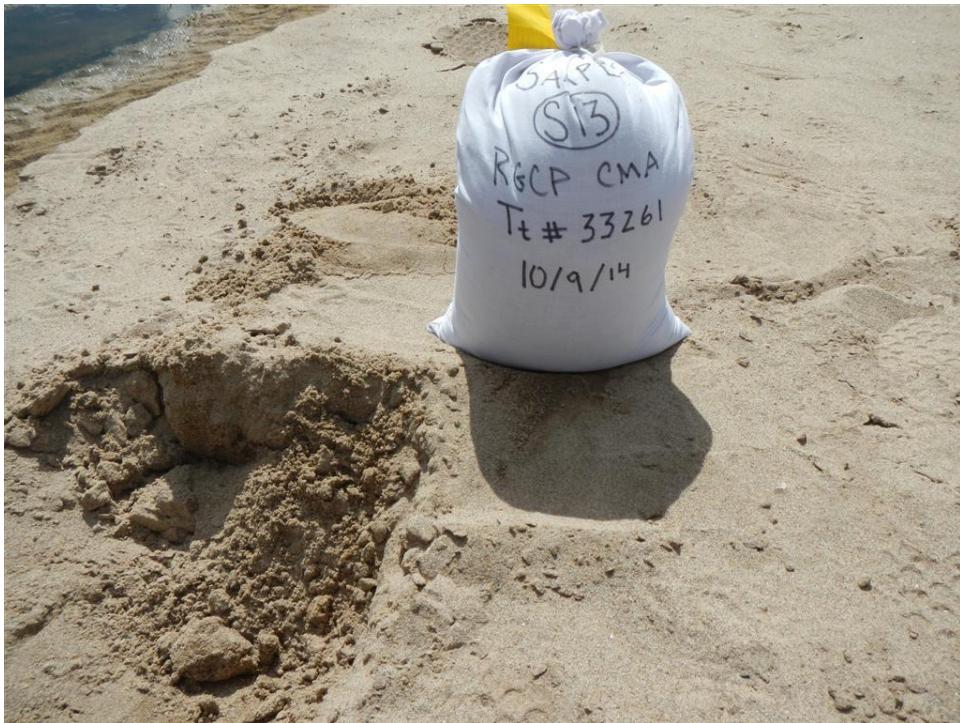
Photo A.83. View of the bed material along the alternate bar upstream from the Anapra Bridge that was collected in Sample S13.

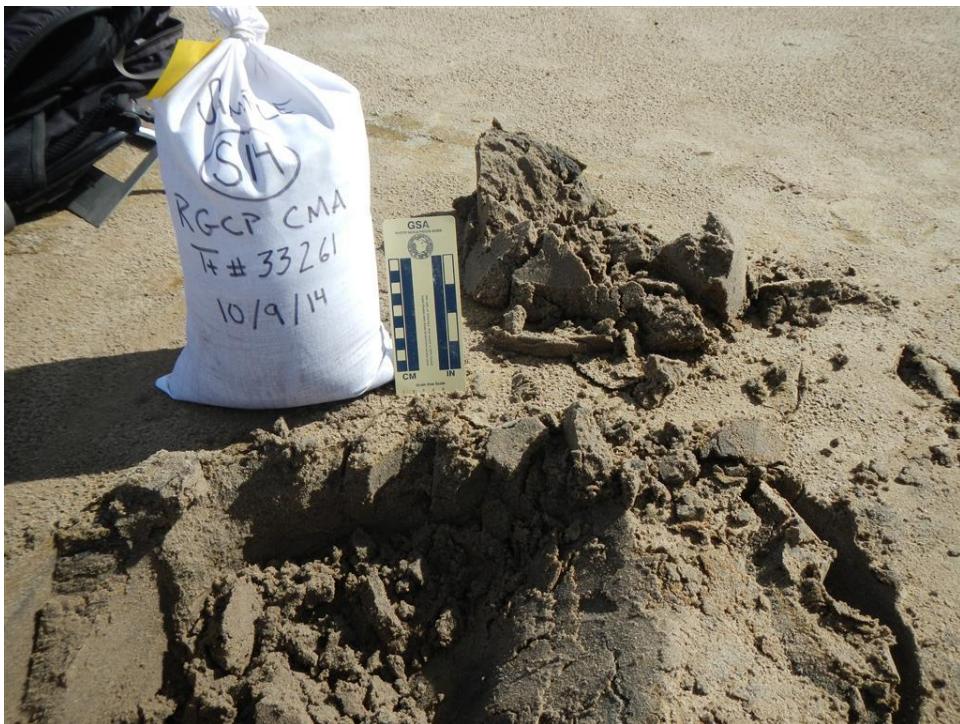
Photo A.84. View of the bed material along the mid-channel bar near the Montoya Drain outlet that was collected in Sample S14.
