**Channel Maintenance Alternatives and
Sediment-transport Studies for the
Rio Grande Canalization Project:
Final Report**

**Statement of Work and Statement of Work Addendum for Channel Maintenance Alternatives
and Sediment-transport Studies for the Rio Grande Canalization Project**

October 20, 2015
Contract No. IBM09D0006
Order No. IBM14T0016

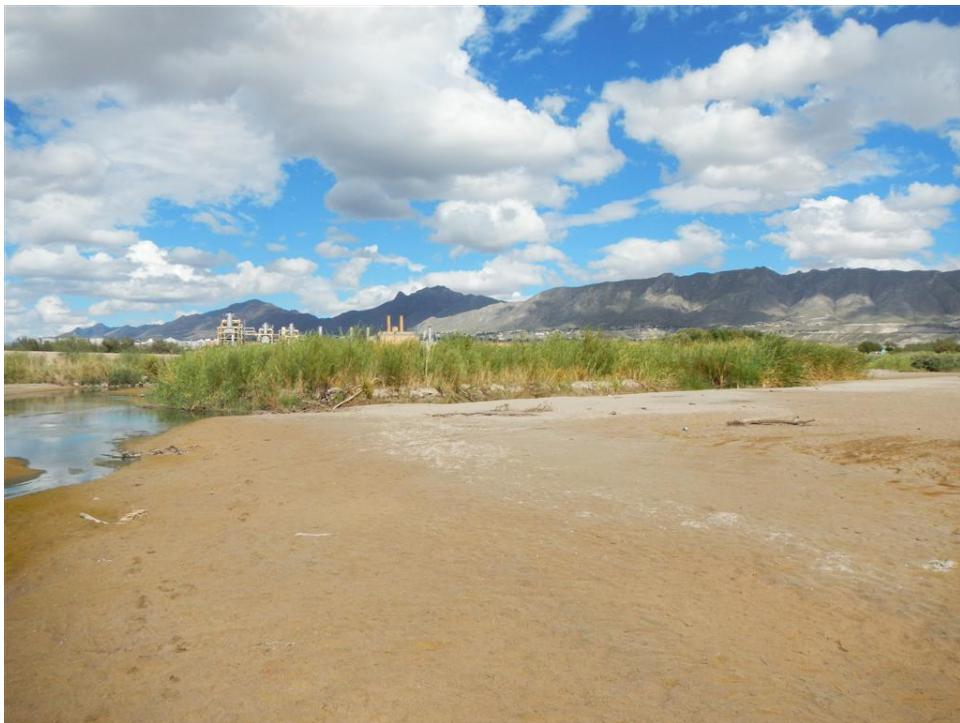
Photo A.85. View downstream to the large island that has formed upstream from the Montoya Drain outlet.

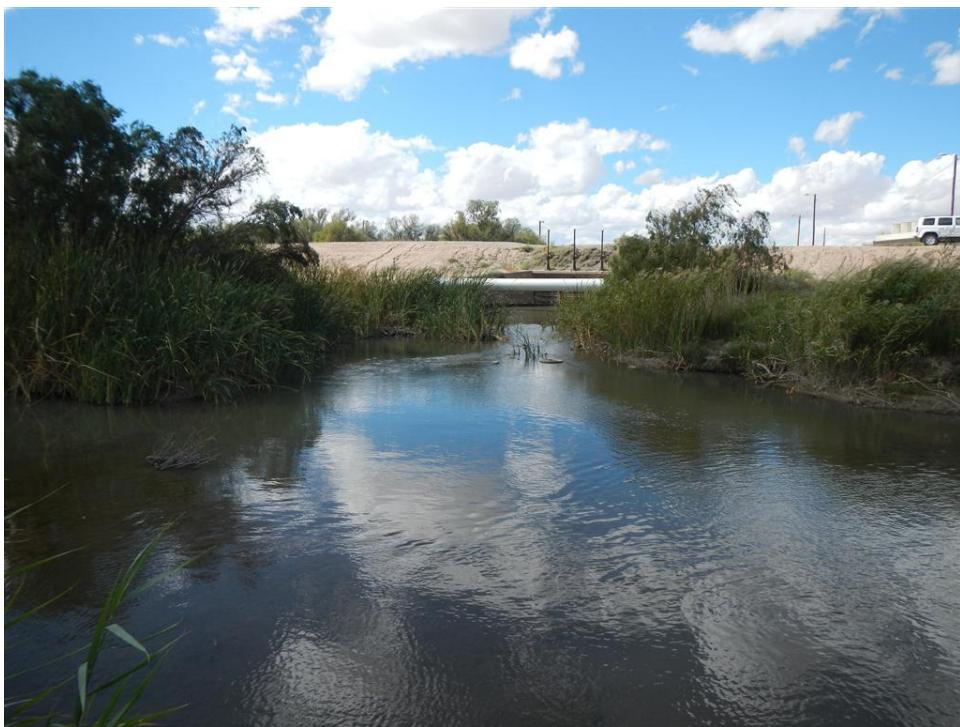
Photo A.86. View across left side channel to the Montoya Drain outlet.

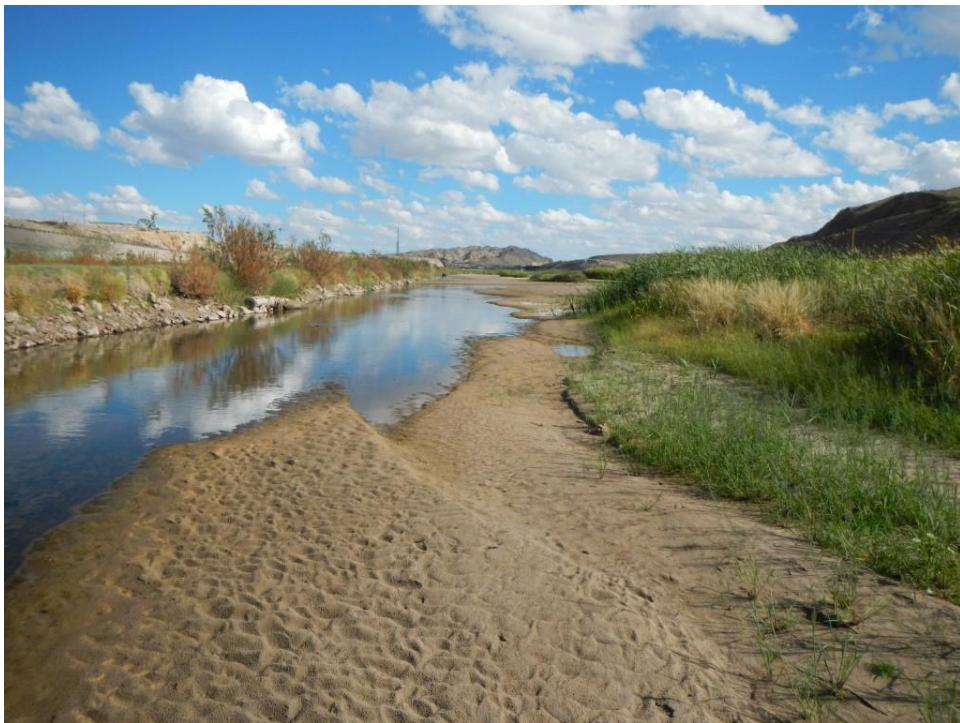
Photo A.87. View downstream along the left bank downstream from the Courchesne Bridge (McNutt Road) where riprap bank protection is visible.
